Inspection Photos

Location Name: TEP ROCKY MOUNTAIN LLC Burchfield RWF 44-32 Pad

Location ID: 416774

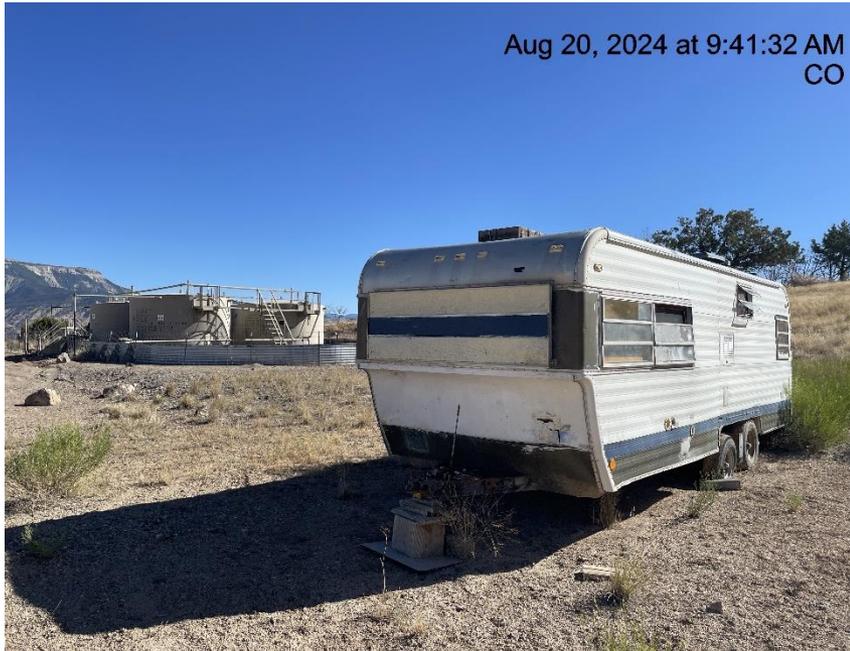
Photo # 5477 Stored camper on location

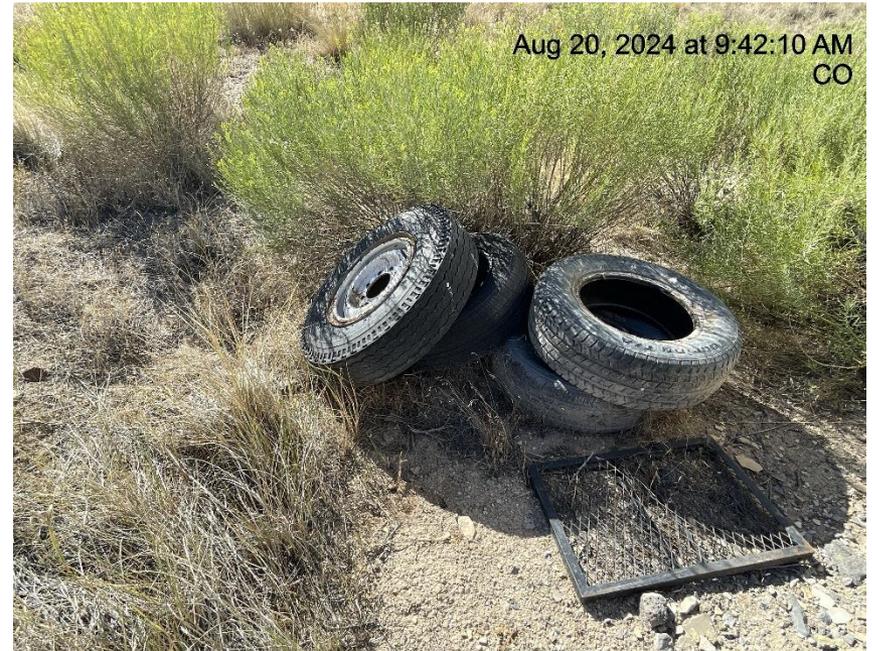
Photo # 5478 Debris

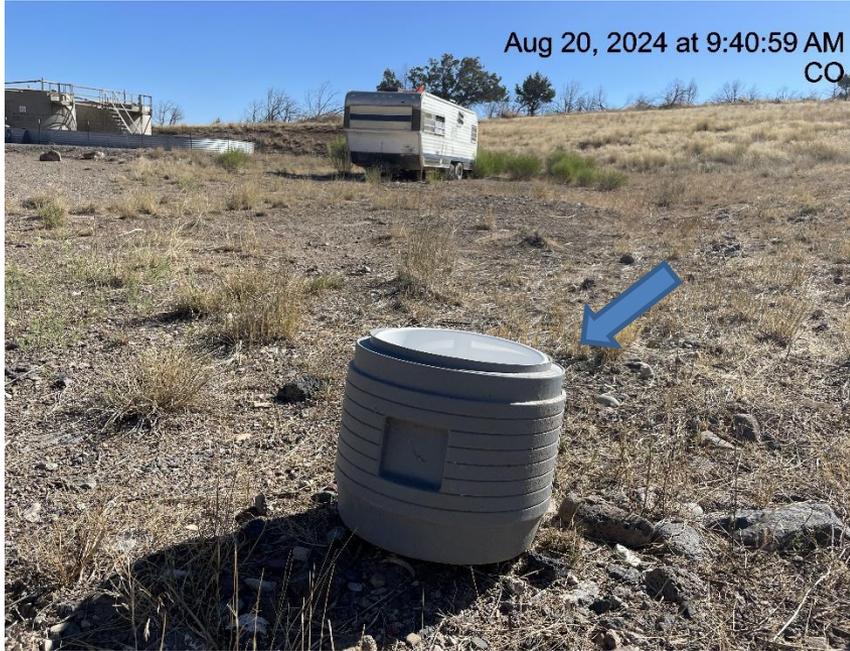
Photo # 5479 Debris

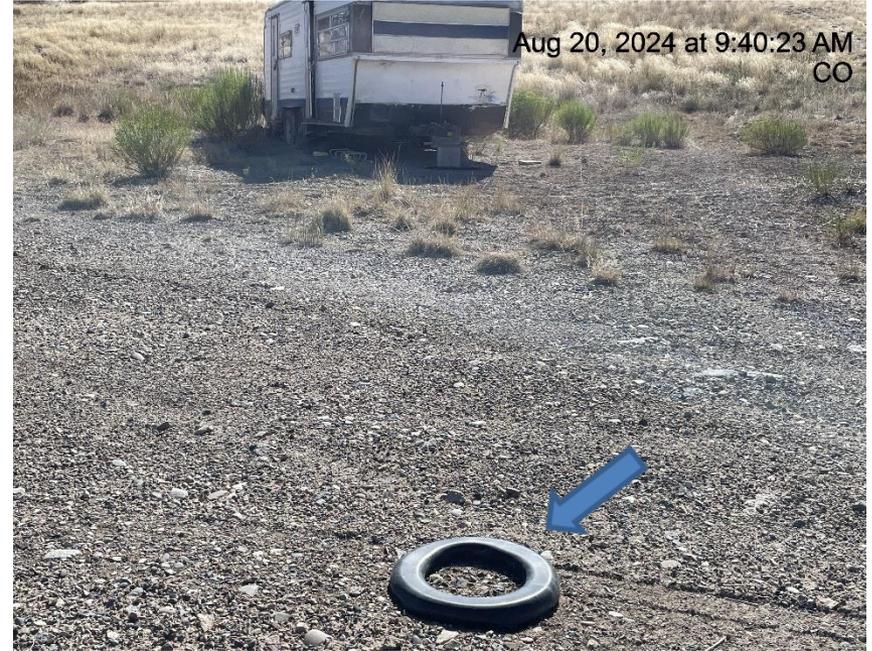
Photo # 5480 Debris

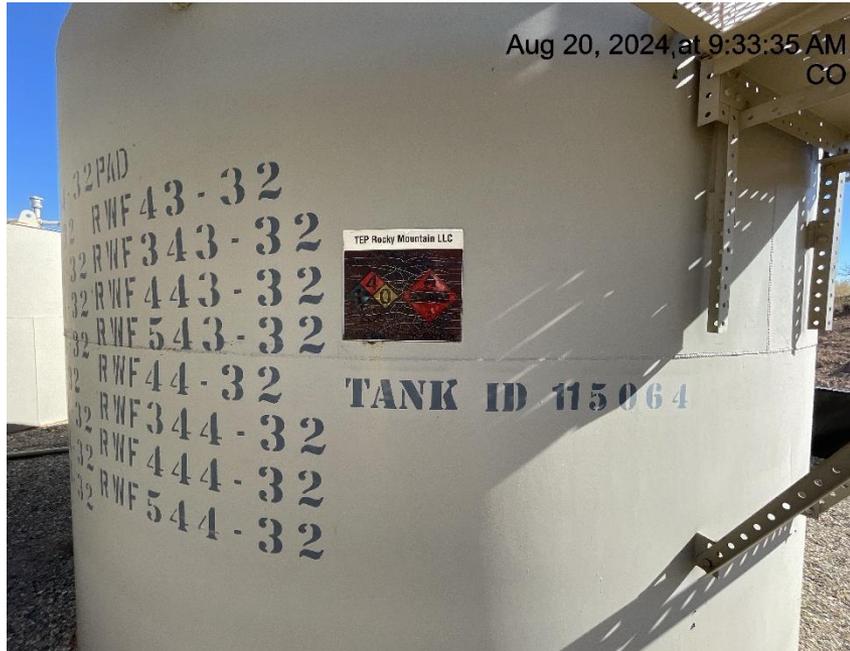
Photo # 5481 Tank label weathered & some required info is illegible

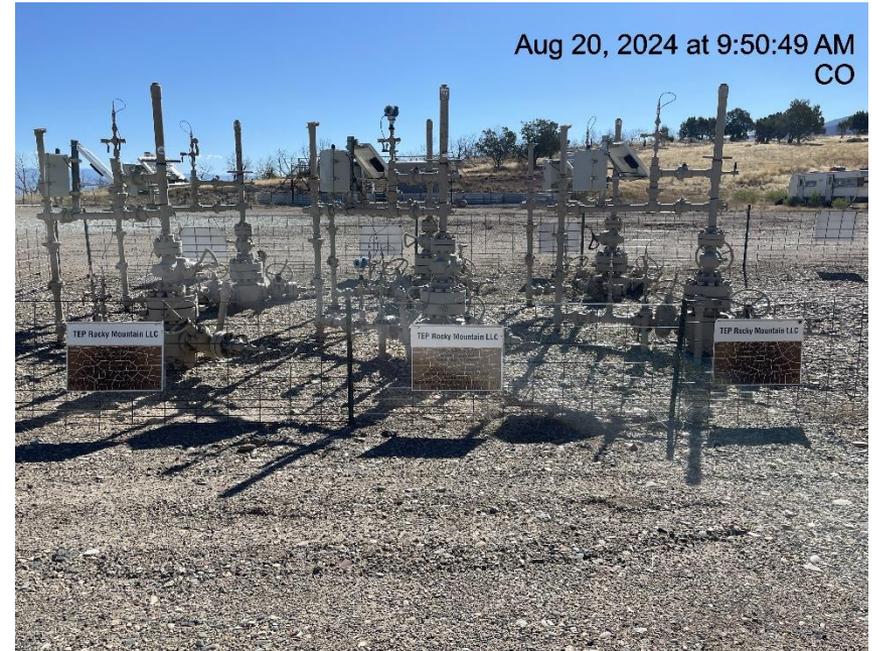
Photo # 5482 Wellhead signs weathered & cracking/starting to become illegible

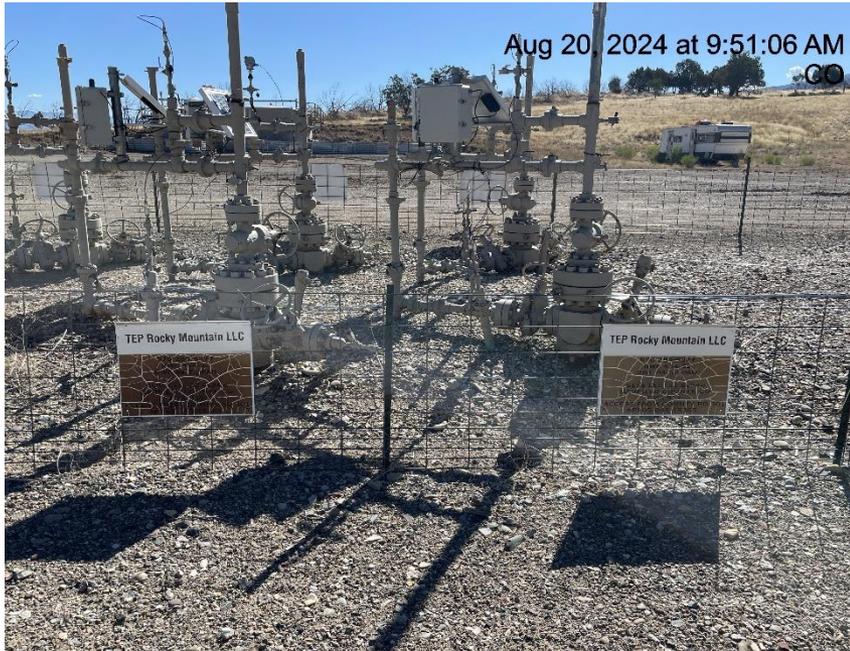
Photo # 5483 Wellhead signs weathered & cracking/starting to become illegible

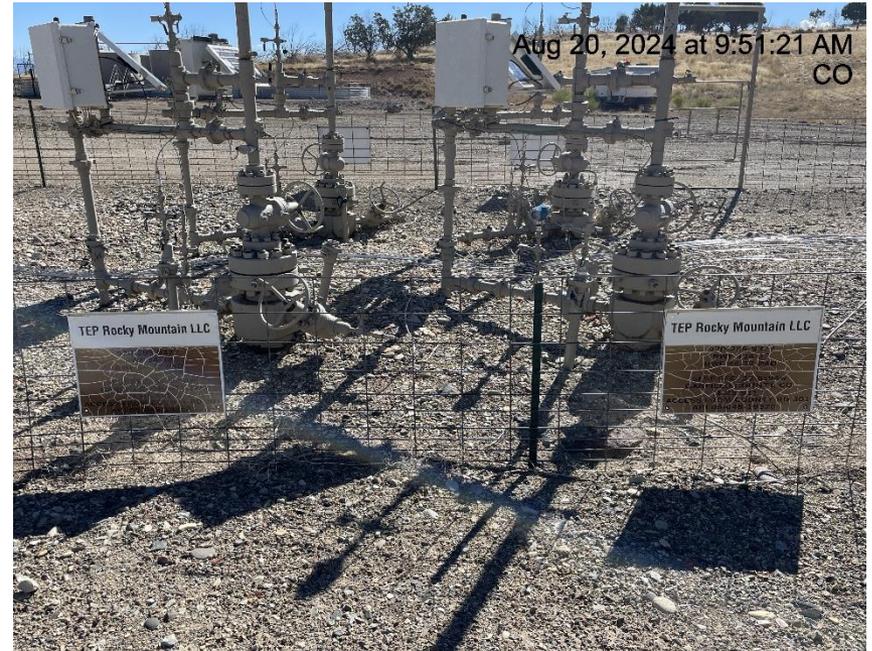
Photo # 5484 Wellhead signs weathered & cracking/starting to become illegible
