Inspection Photos

Location Name: CAERUS PICEANCE LLC, N. Parachute/EF G29 595

Location ID: 335573

Date: 8/14/2024

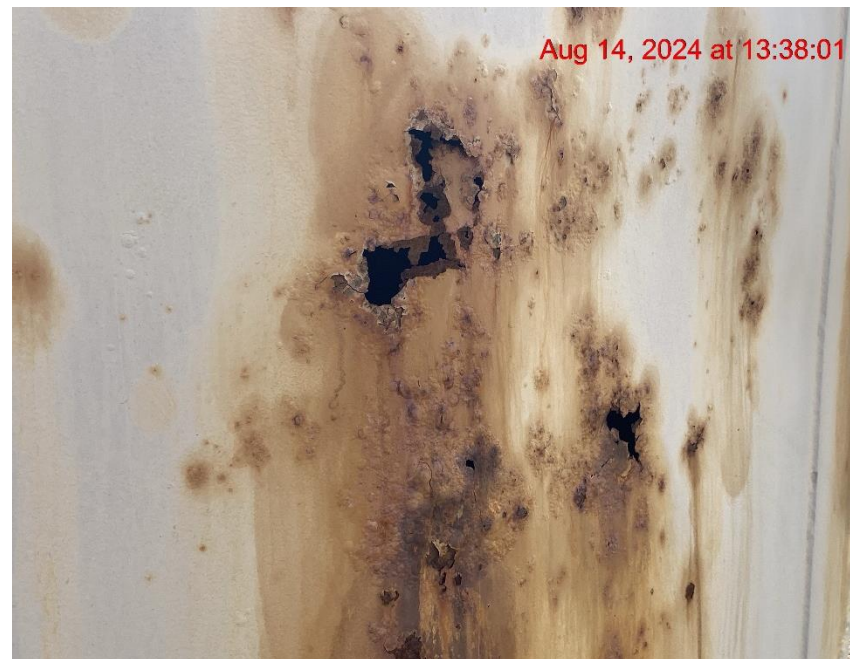
Corrosion in Tank Wall – Photo #02891

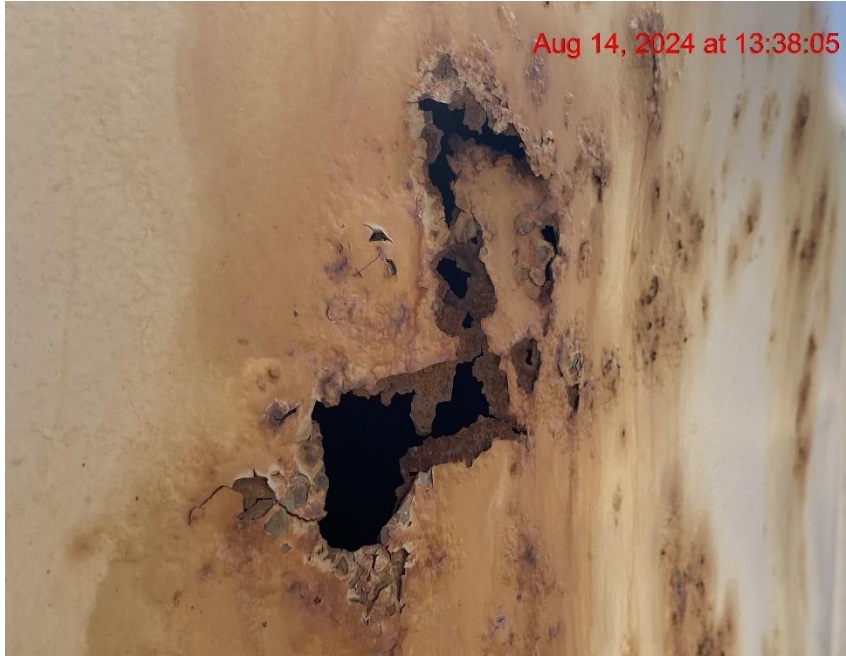
Corrosion in Tank Wall – Photo #02892

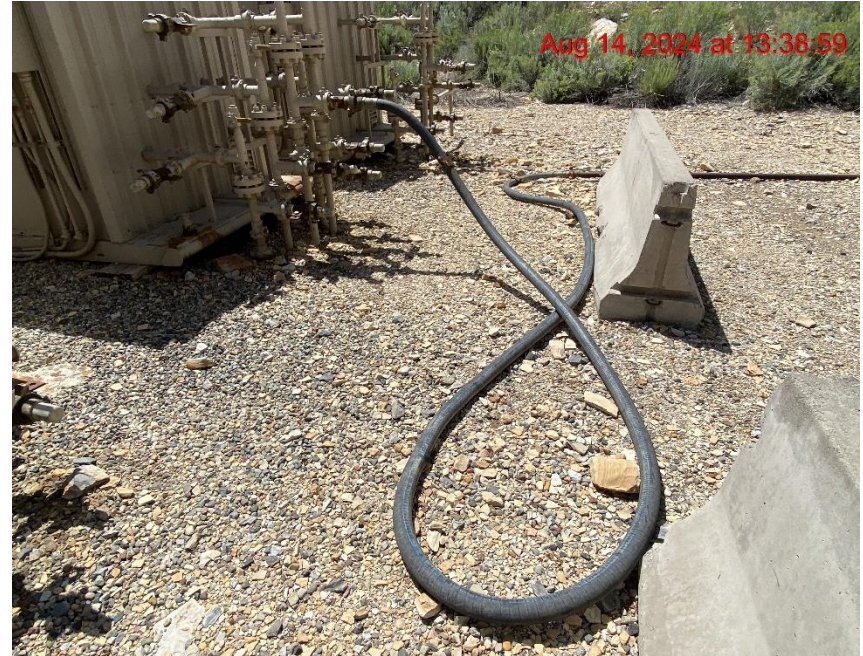
Production to Unserviceable Blowdown Tank – Photo #02893
