Inspection Photos

API: 017-06622

Operator: **WILLIFORD ENERGY COMPANY**

Inspection Date: 8/19/2024

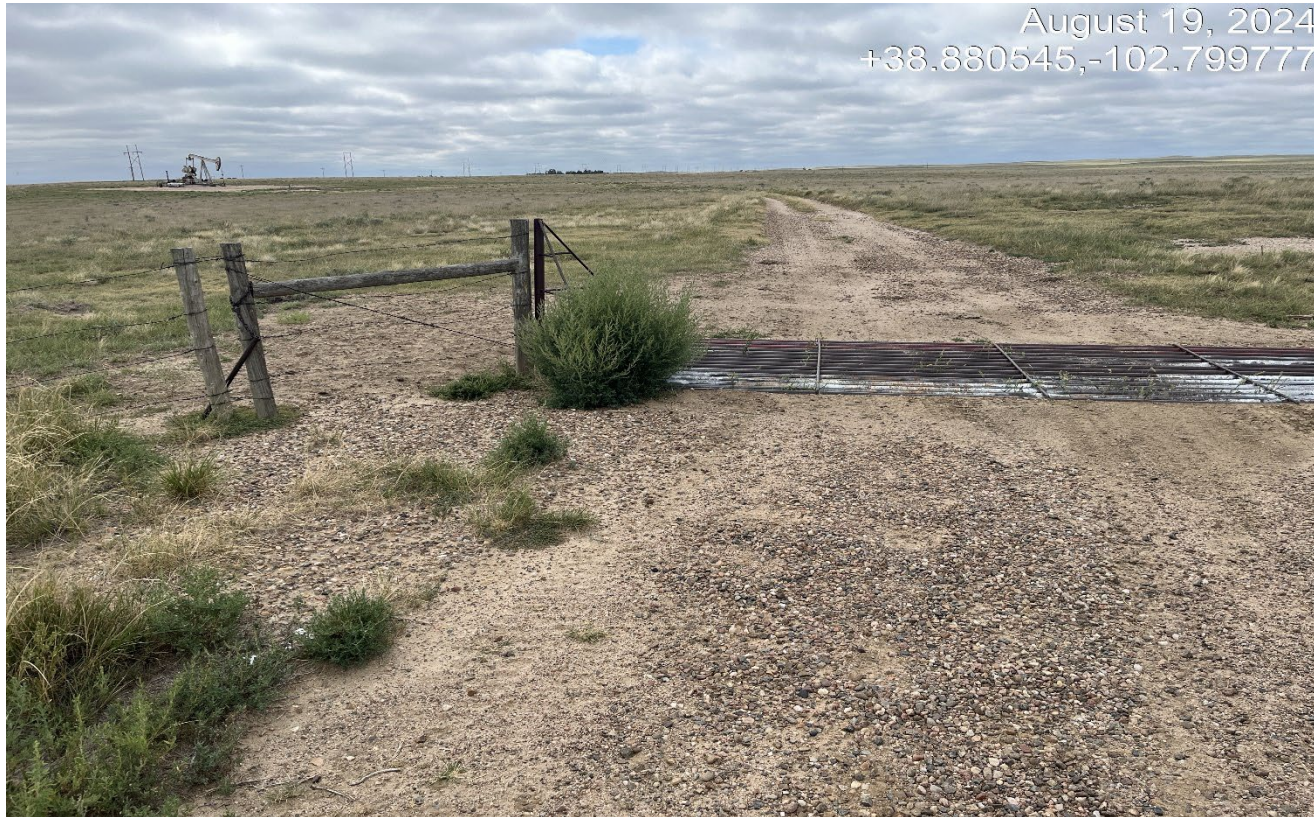
Photo 1. The cattleguard at the beginning of the access road has been cleaned out and the material was removed.

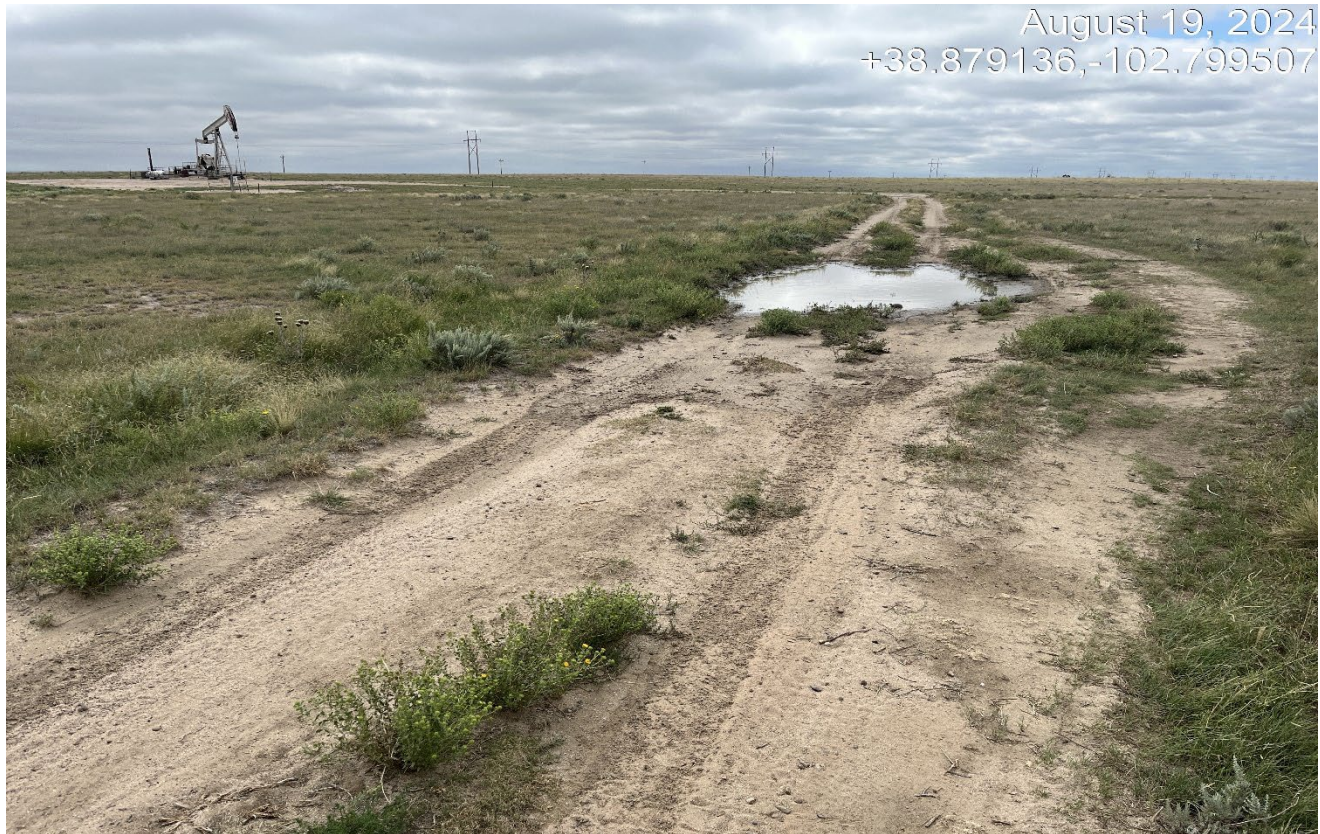
Photo 2. Facing southeast along the access road. Vehicles are causing unnecessary disturbance driving outside of the access road due to stormwater pooling on the road. The access road must be maintained and shall not drive outside of the access road boundary.

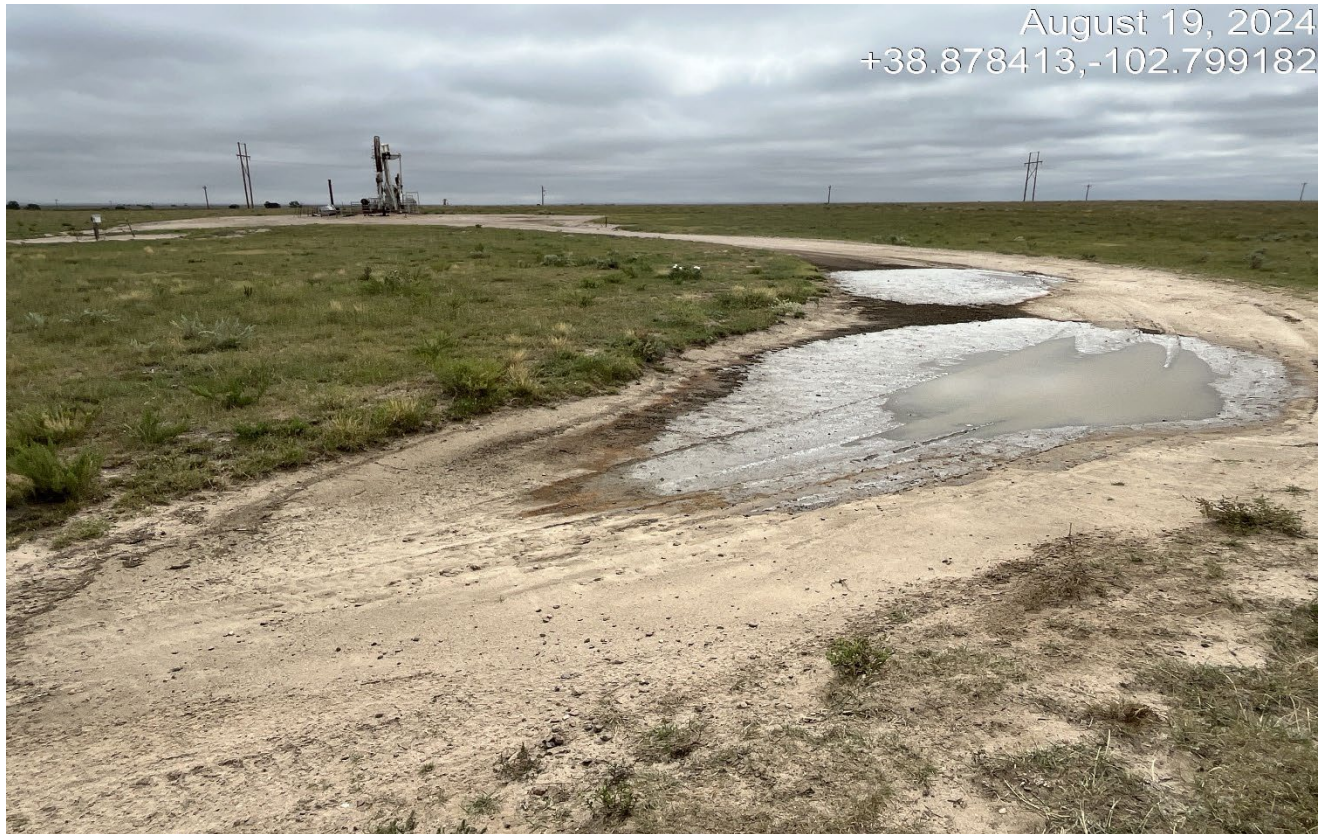
Photo 3. Facing southeast along the access road. Vehicles are causing unnecessary disturbance driving outside of the access road due to stormwater pooling on the road. The access road must be maintained and shall not drive outside of the access road boundary.

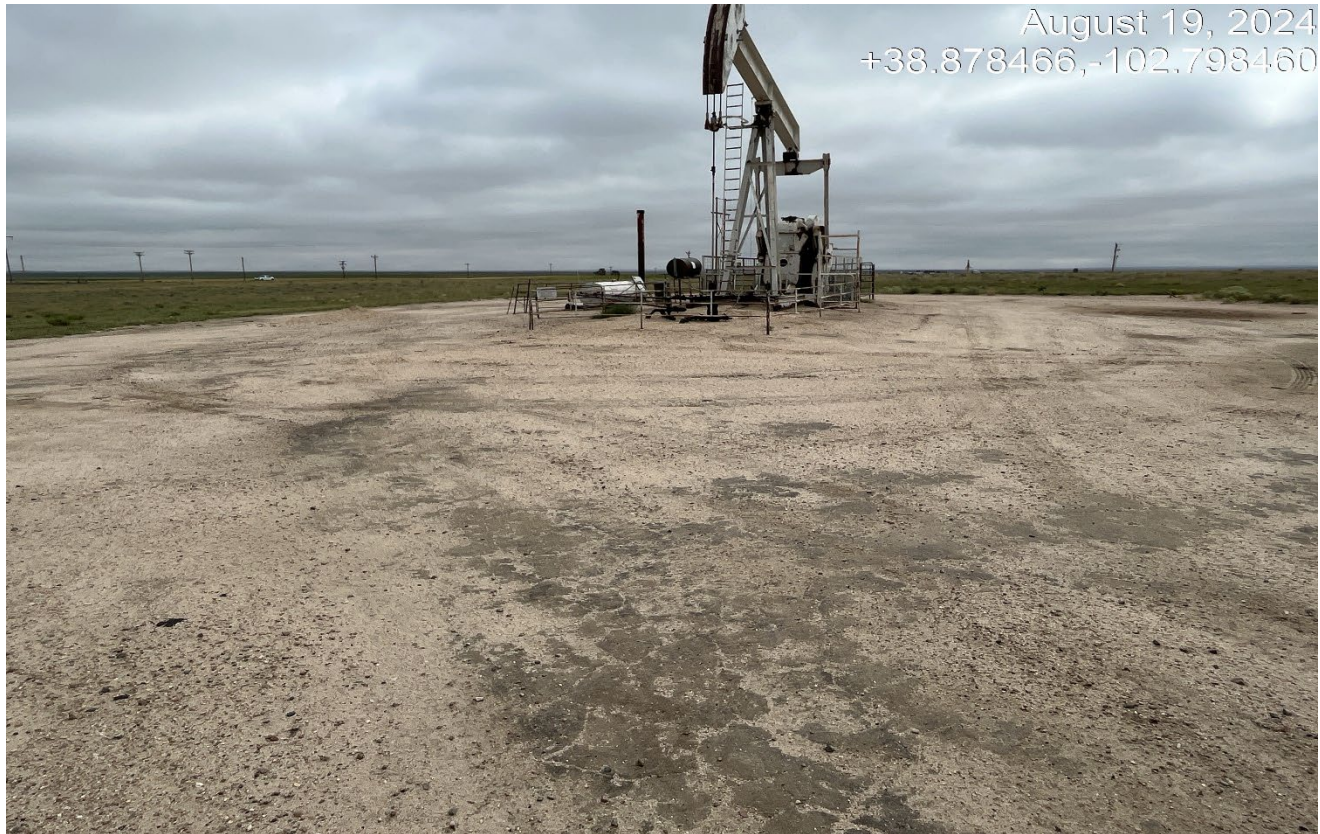
Photo 4. Facing east toward the wellsite.

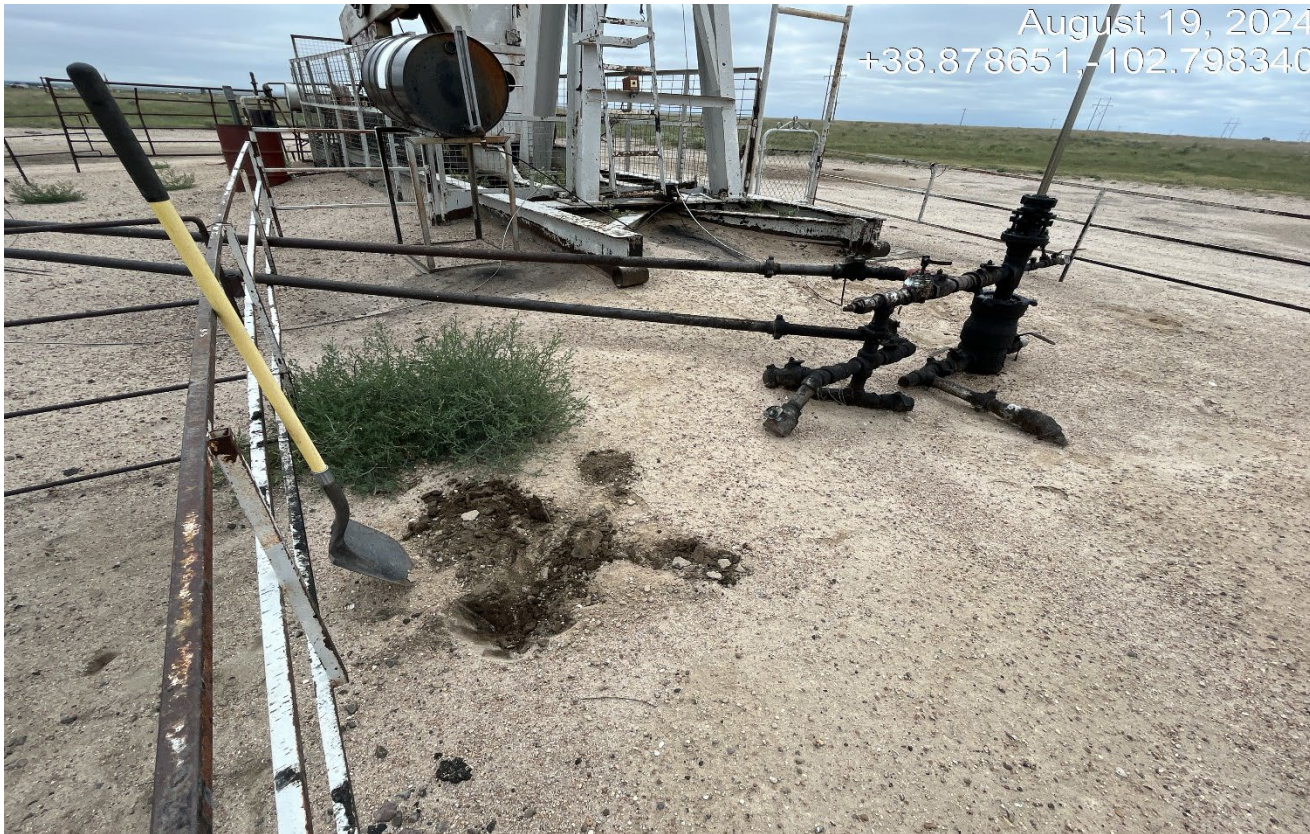
Photo 5. There is still stained soils around the wellhead from a E&P waste spill. It appears there was sand spread on top of the spill which was not cleaned up per the rules. Previous corrective action was not completed.

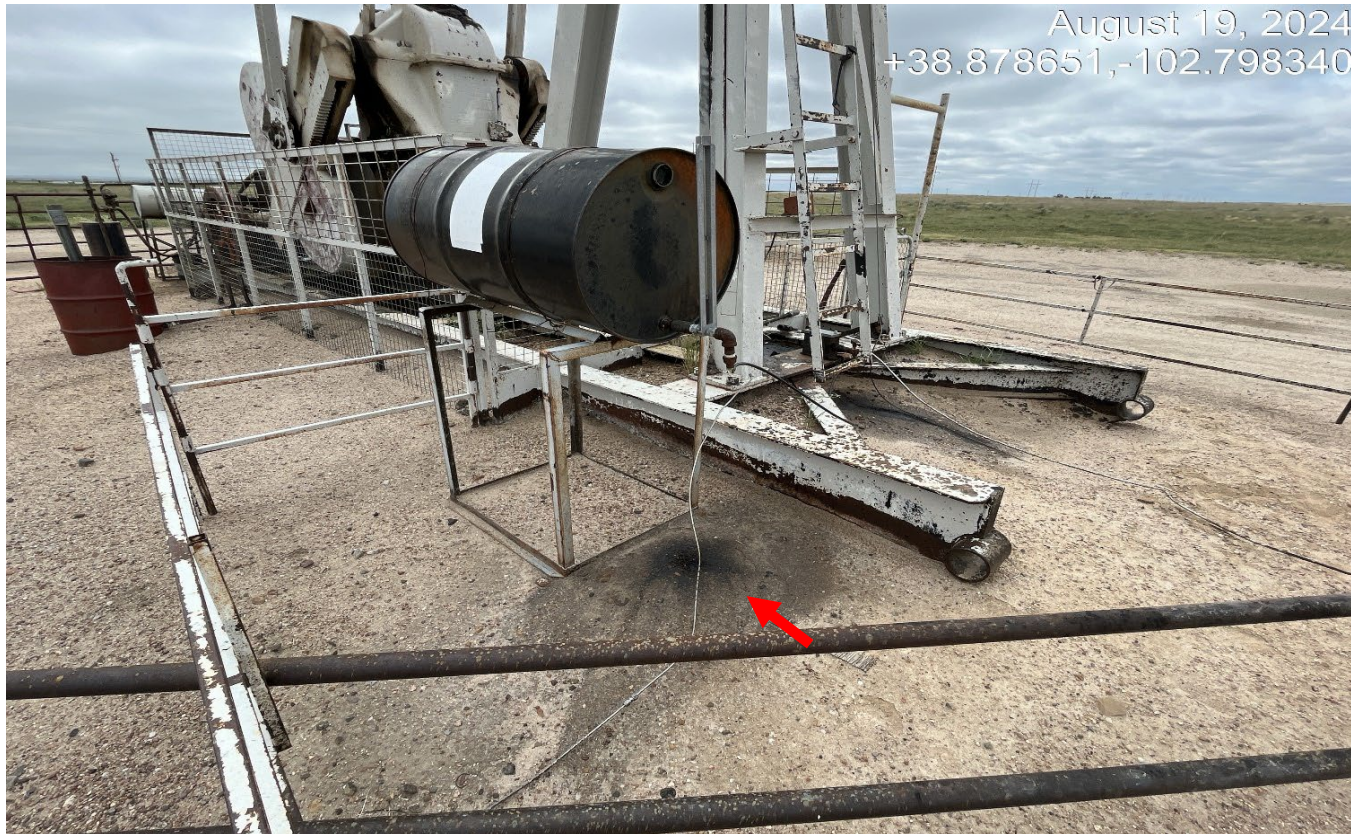
Photo 6. This chemical drum has no secondary containment and has been leaking fluids onto the soils which are stained.

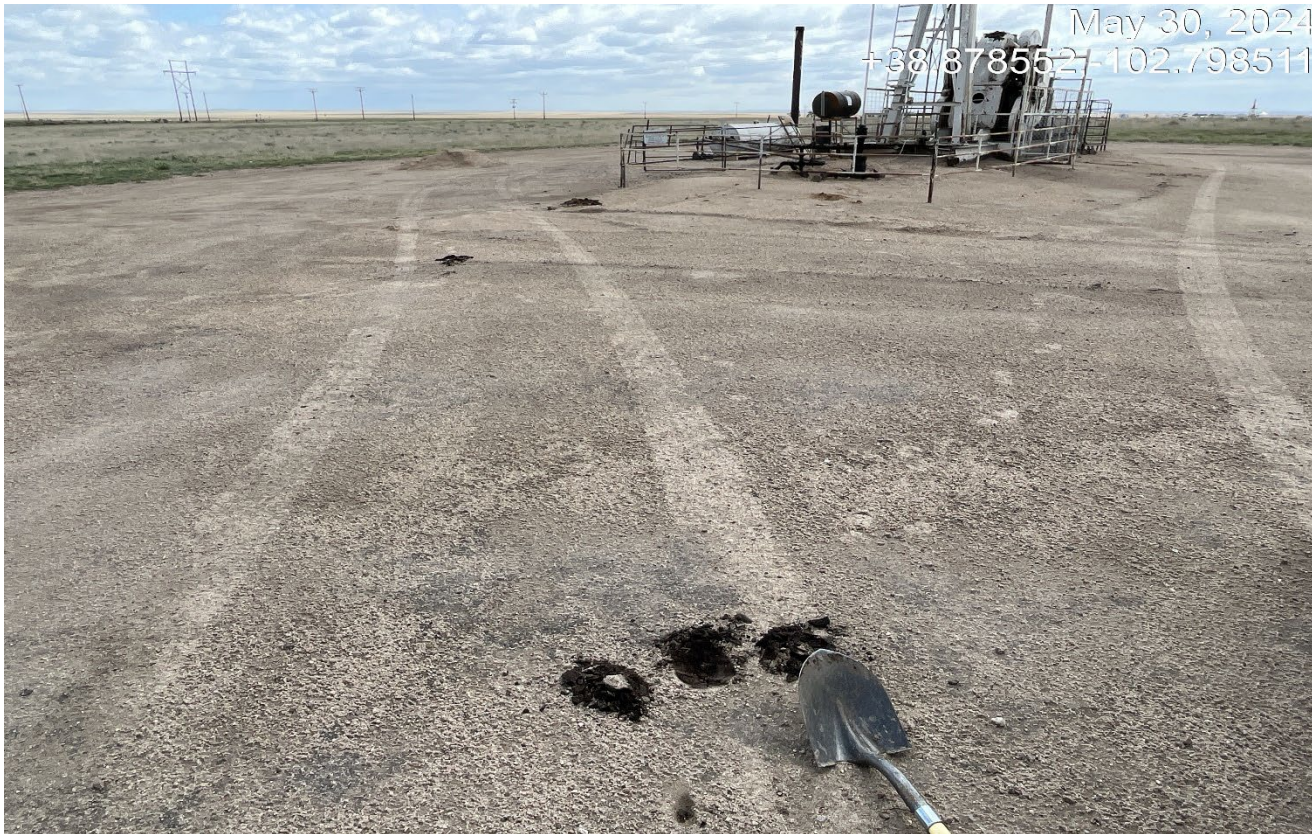
Photo 7. Further out from the well just a few inches below the surface was oil stained soils with a hydro carbon odor. All impacted soils must be cleaned up and removed.

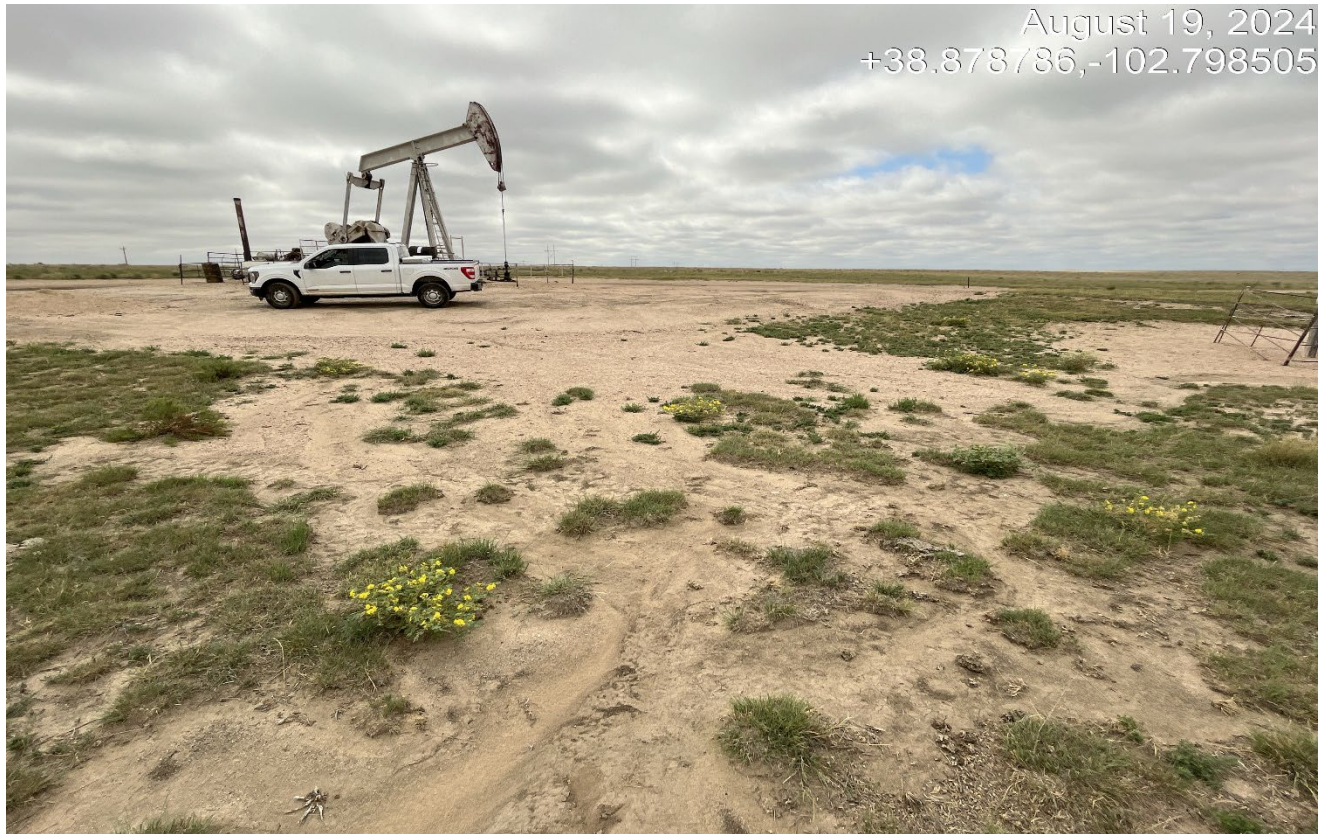
Photo 8. North side of the location facing south. There appears to be impacts to vegetation from a suspected previous spill that flowed downhill to this area.

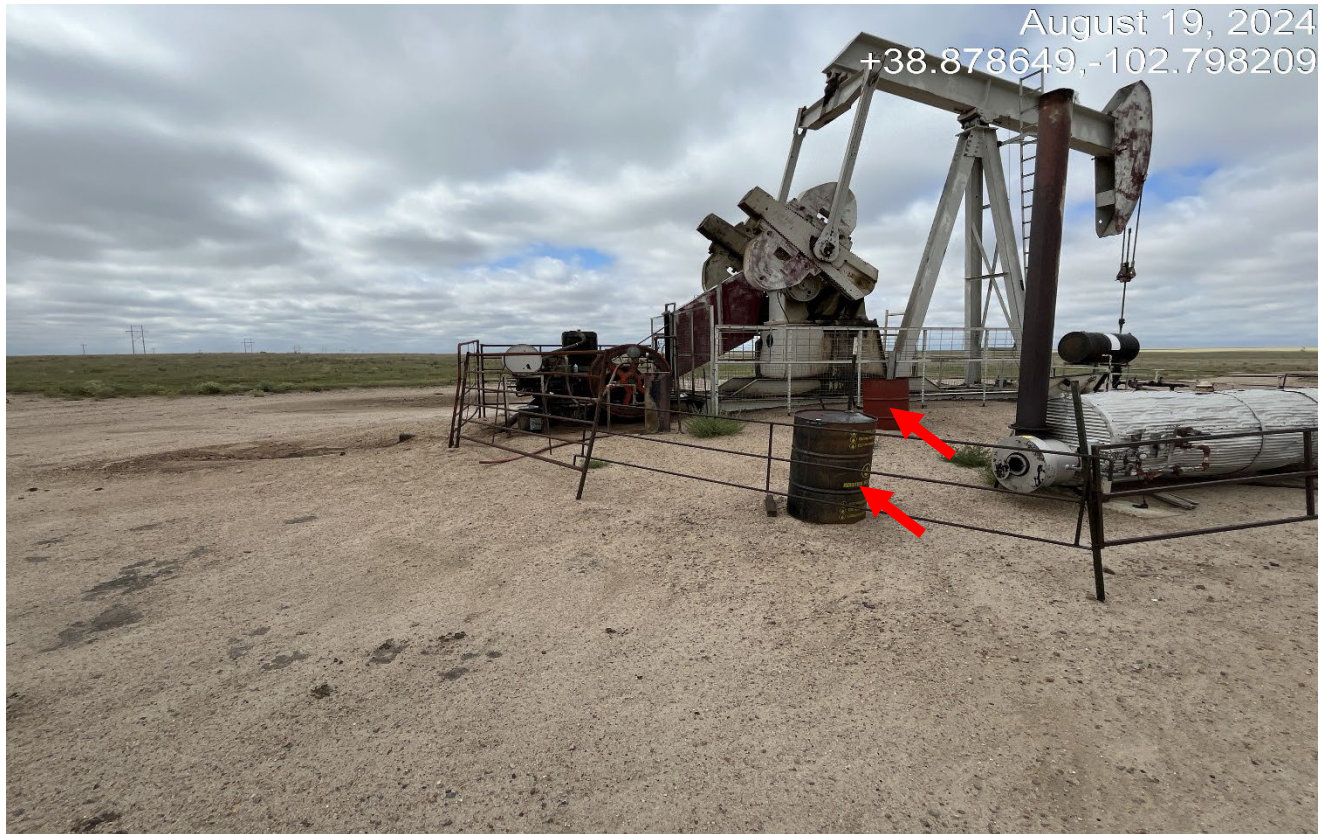
Photo 9. There are chemical barrels with no secondary containment. There is fresh sand spread around the pumpjack where oil staining was previously observed.

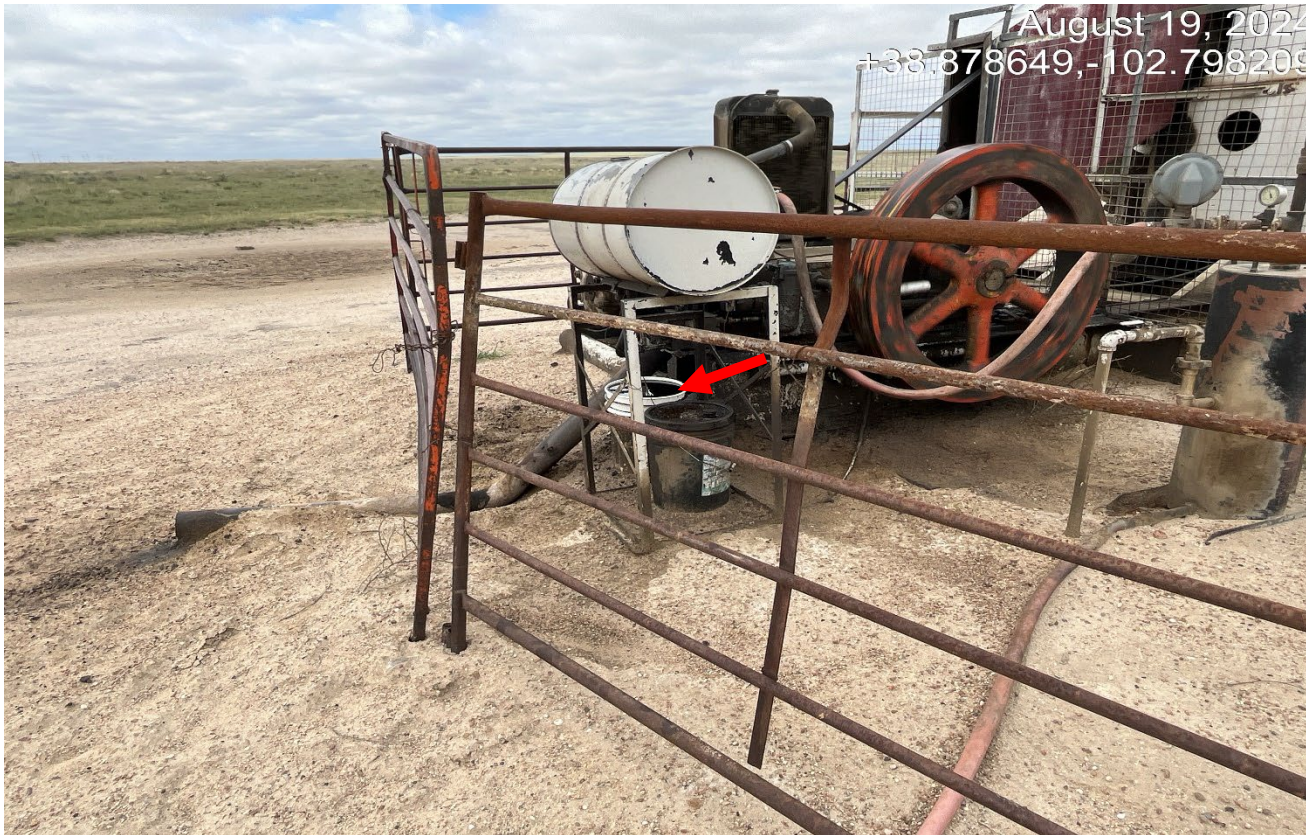
Photo 10. Facing at the backside of the pumpjack where exhaust is located. There is a bucket of oil at red arrow that is about to spill over. There is stained soils around the pumpjack engine that is still leaking. There is oil stained soils at the engine exhaust pipe.

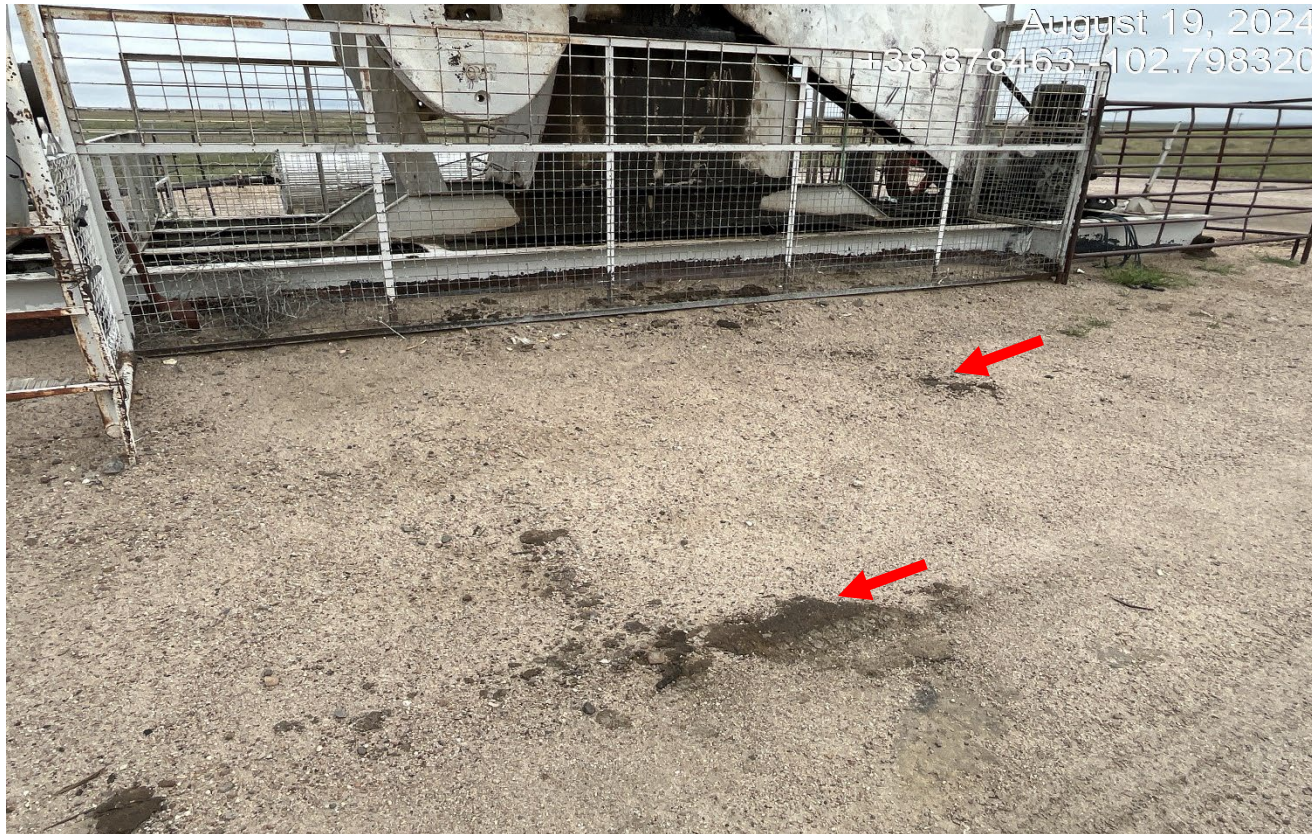
Photo 11. Facing at the south side of the pumpjack. There is oil stained soils shown at the red arrows.

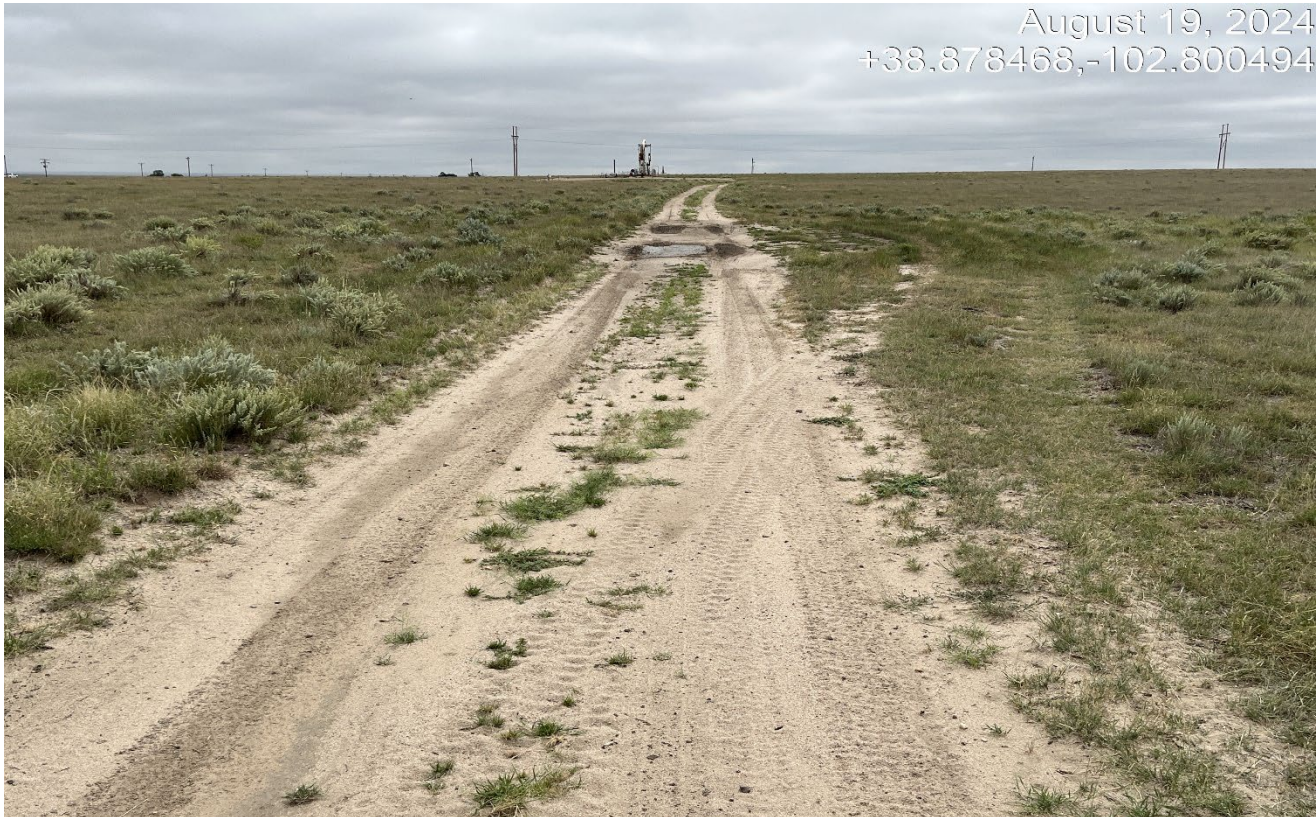
Photo 12. Facing east along the access road. Vehicles are causing unnecessary disturbance driving outside of the access road due to stormwater pooling on the road. The access road must be maintained and shall not drive outside of the access road boundary.
