Inspection Photos

API: 017-06629

Operator: **WILLIFORD ENERGY COMPANY**

Inspection Date: 8/19/2024

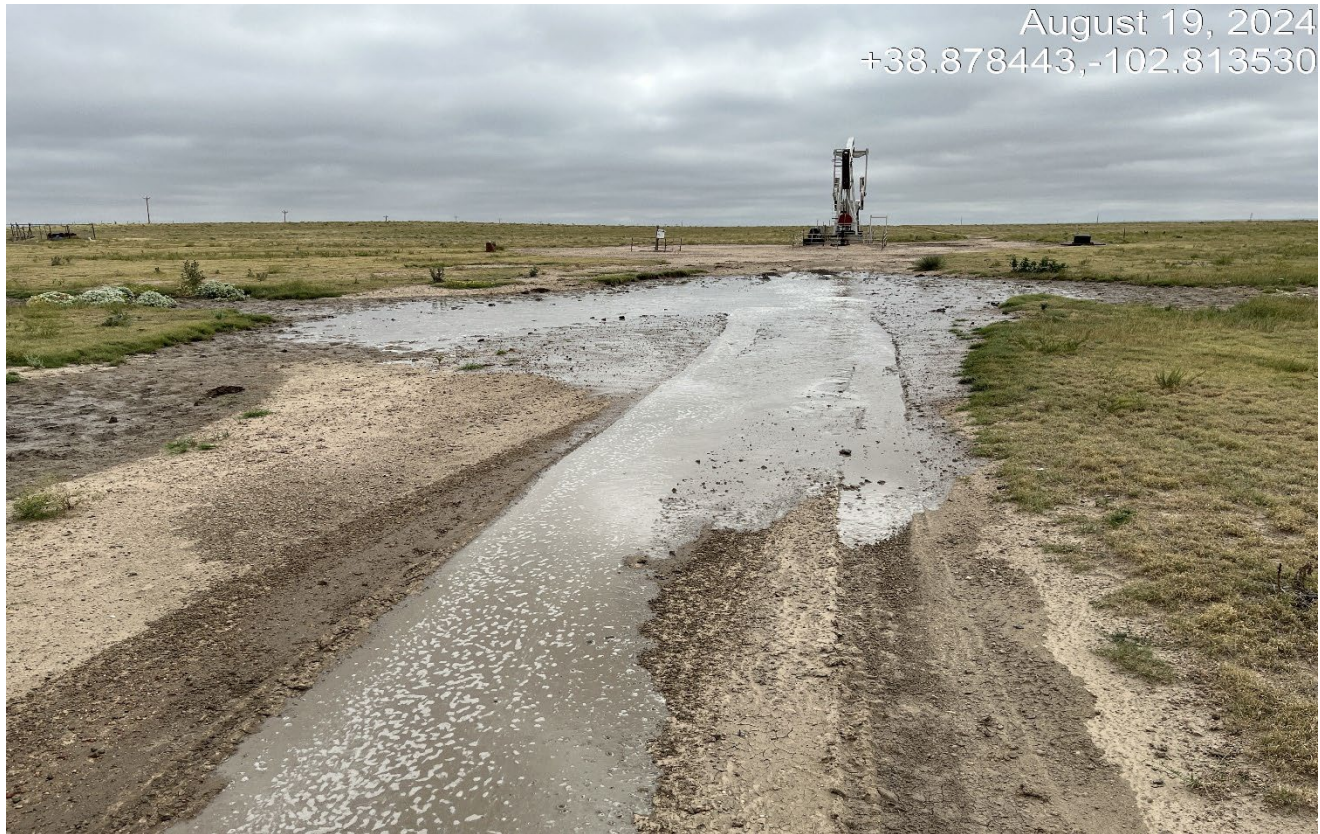
Photo 1. Facing east along the access road. Vehicles are causing unnecessary disturbance driving outside of the access road due to stormwater pooling on the road. The access road must be maintained and shall not drive outside of the access road boundary.

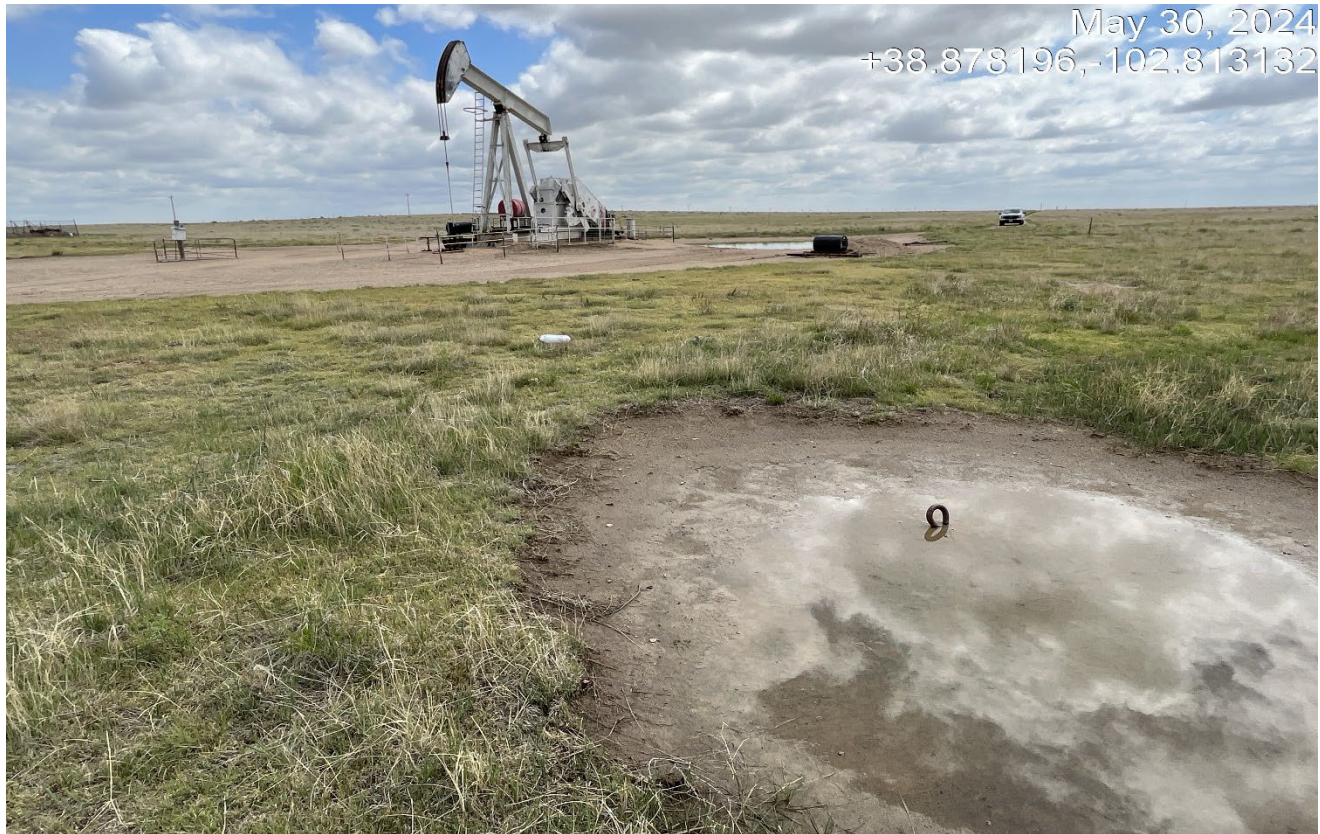
Photo 2. Facing northeast toward the location. There are no guyline markers installed.

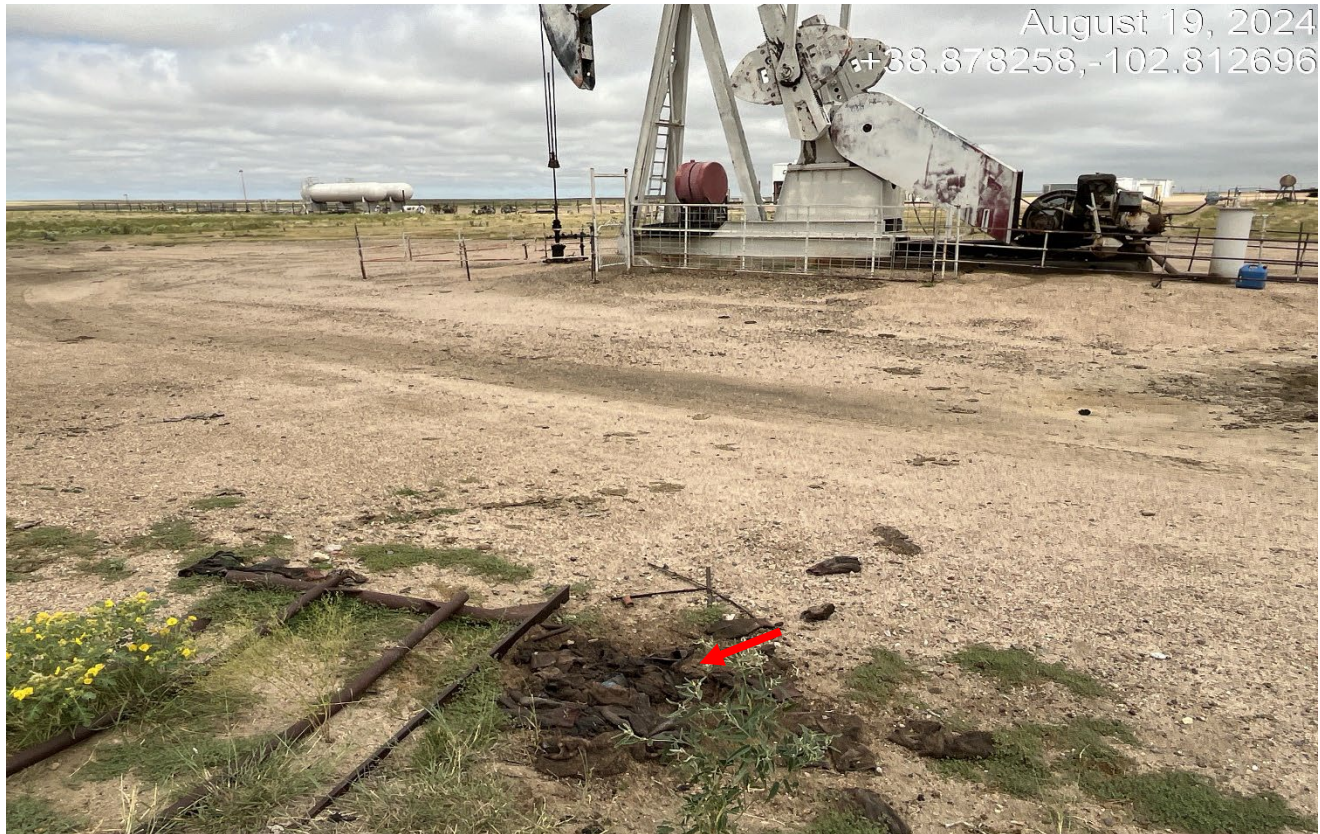
Photo 3. There is a pile of oily rags at the south side of the location. This must be removed and properly disposed.

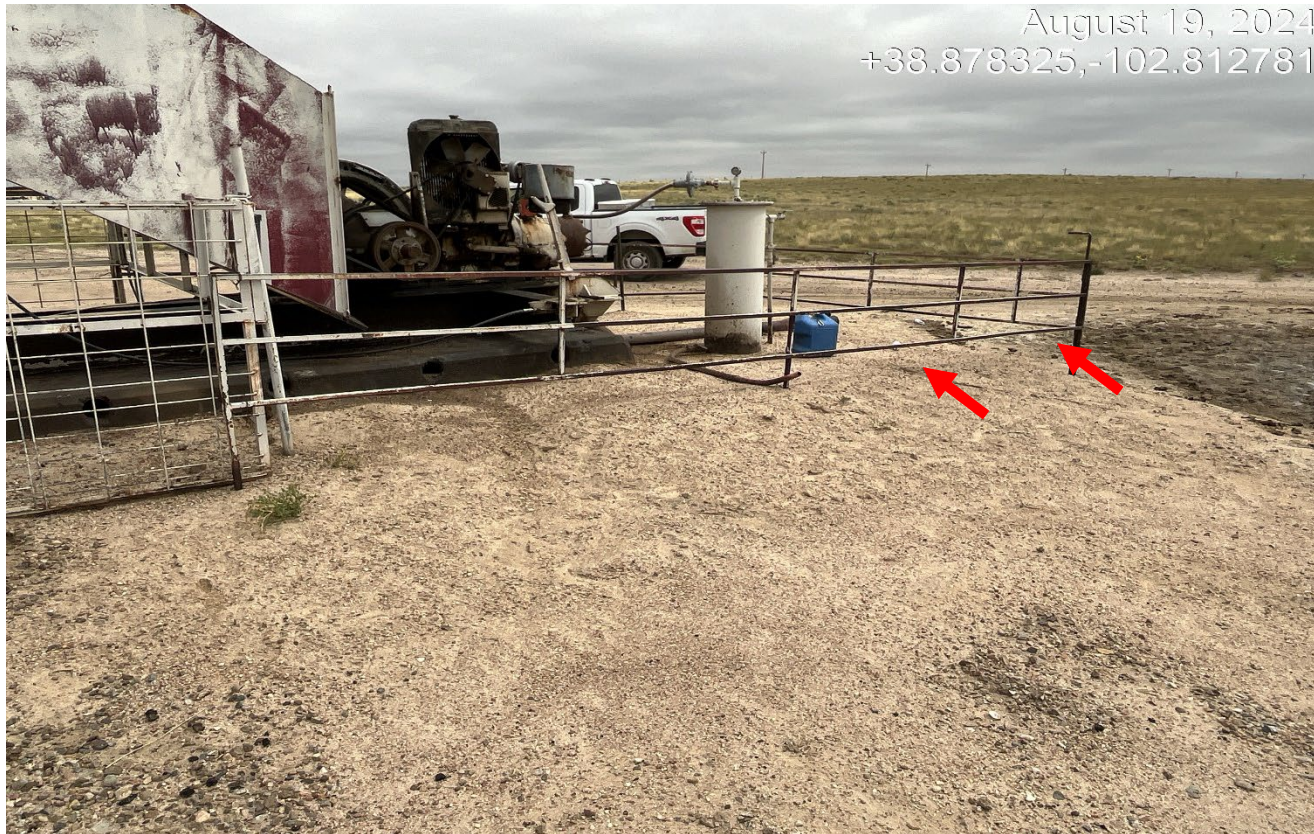
Photo 4. Facing toward the pumpjack engine. There was new sand spread around the pumpjack base to cover up the stained soils which were not cleaned up. There are three cans of starting fluid and the blue can that need to be removed.

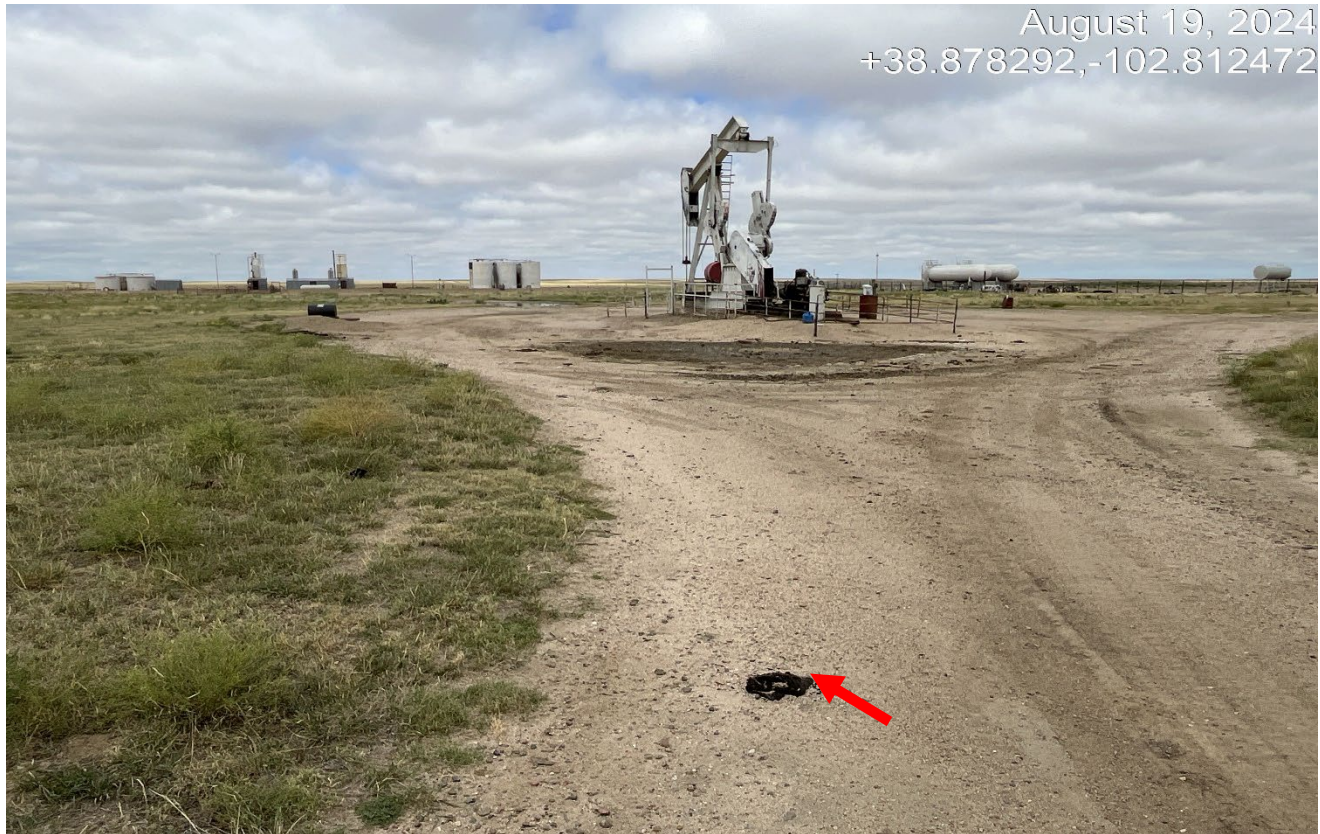
Photo 5. Facing northwest toward the wellsite. The red arrow points to an oily rag.

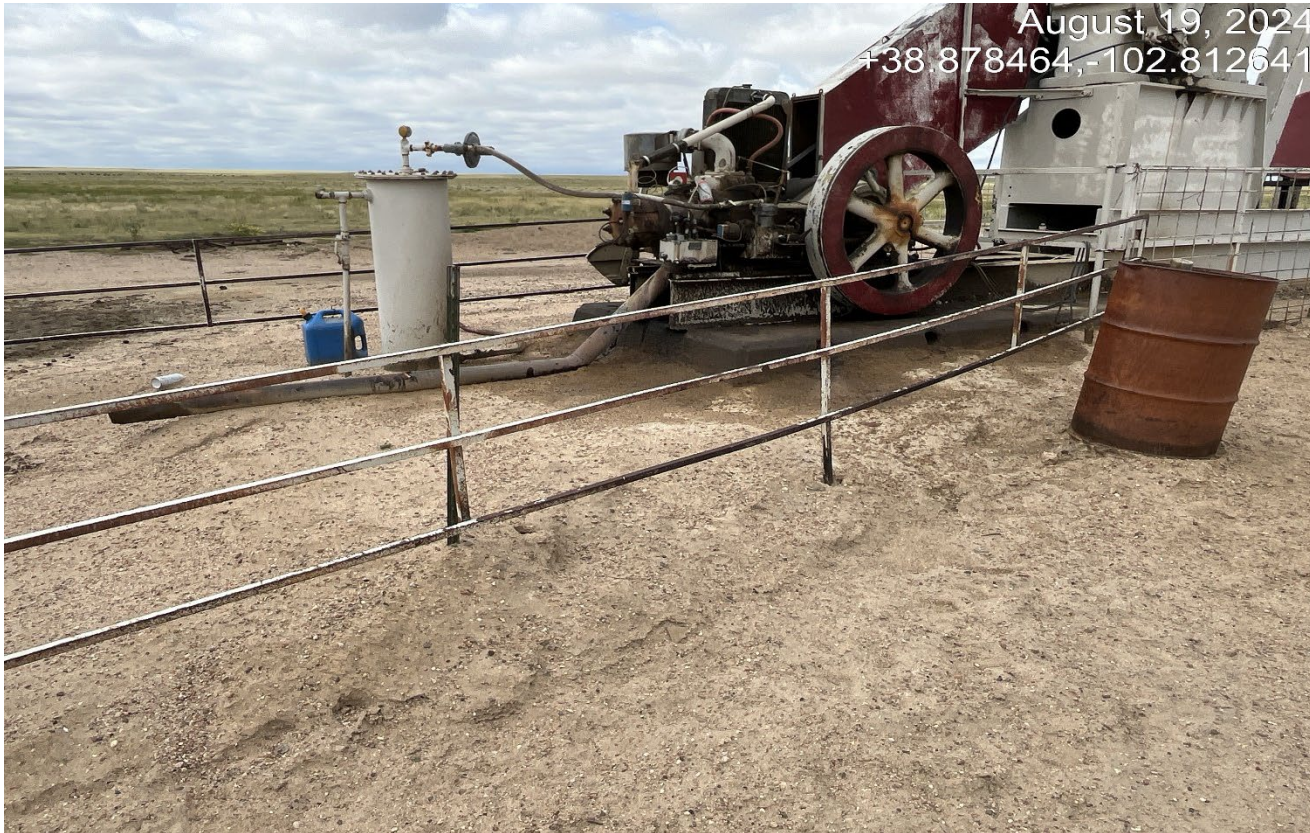
Photo 6. The pumpjack engine is still leaking oil.

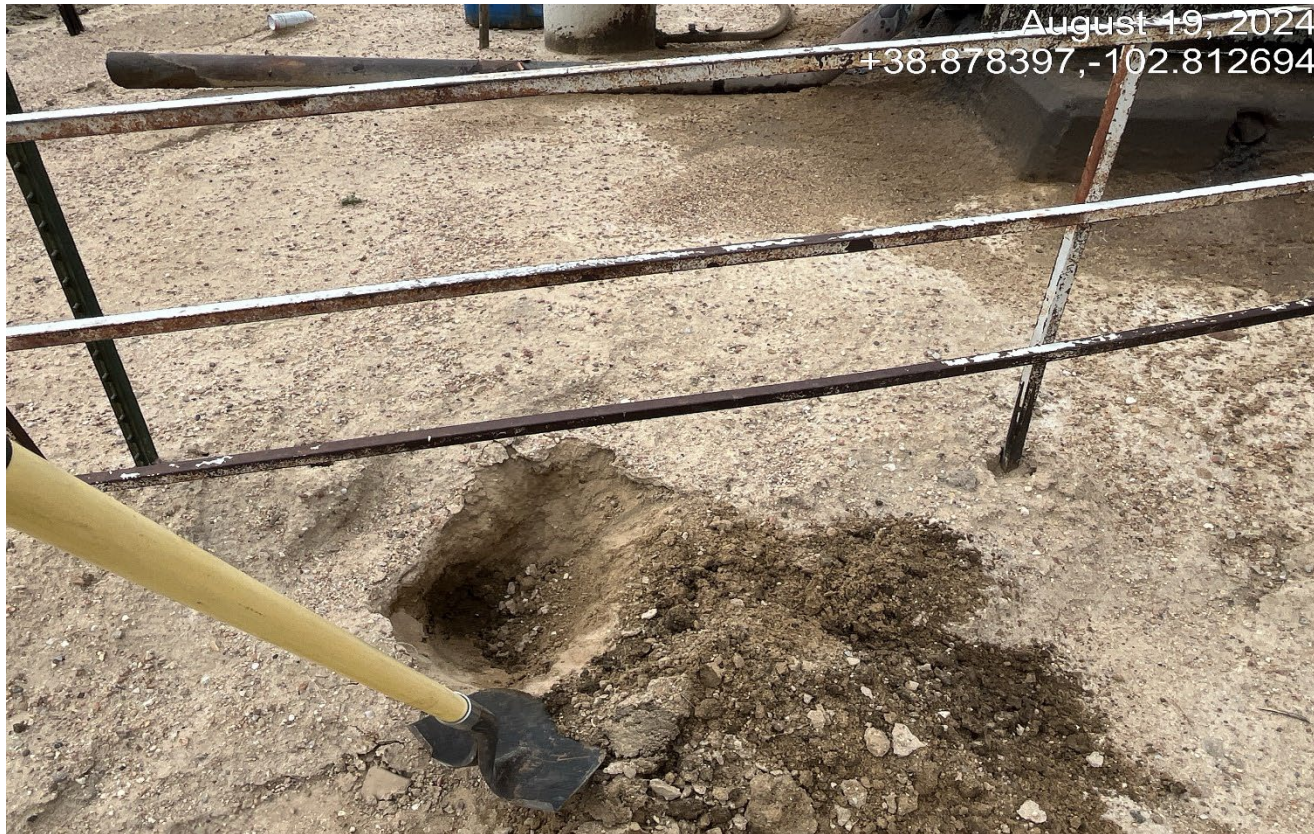
Photo 7. It appears there was sand spread on top of the spill which was not cleaned up per the rules. There is still oily soils that remain underneath the sand that was placed over the stained soils.

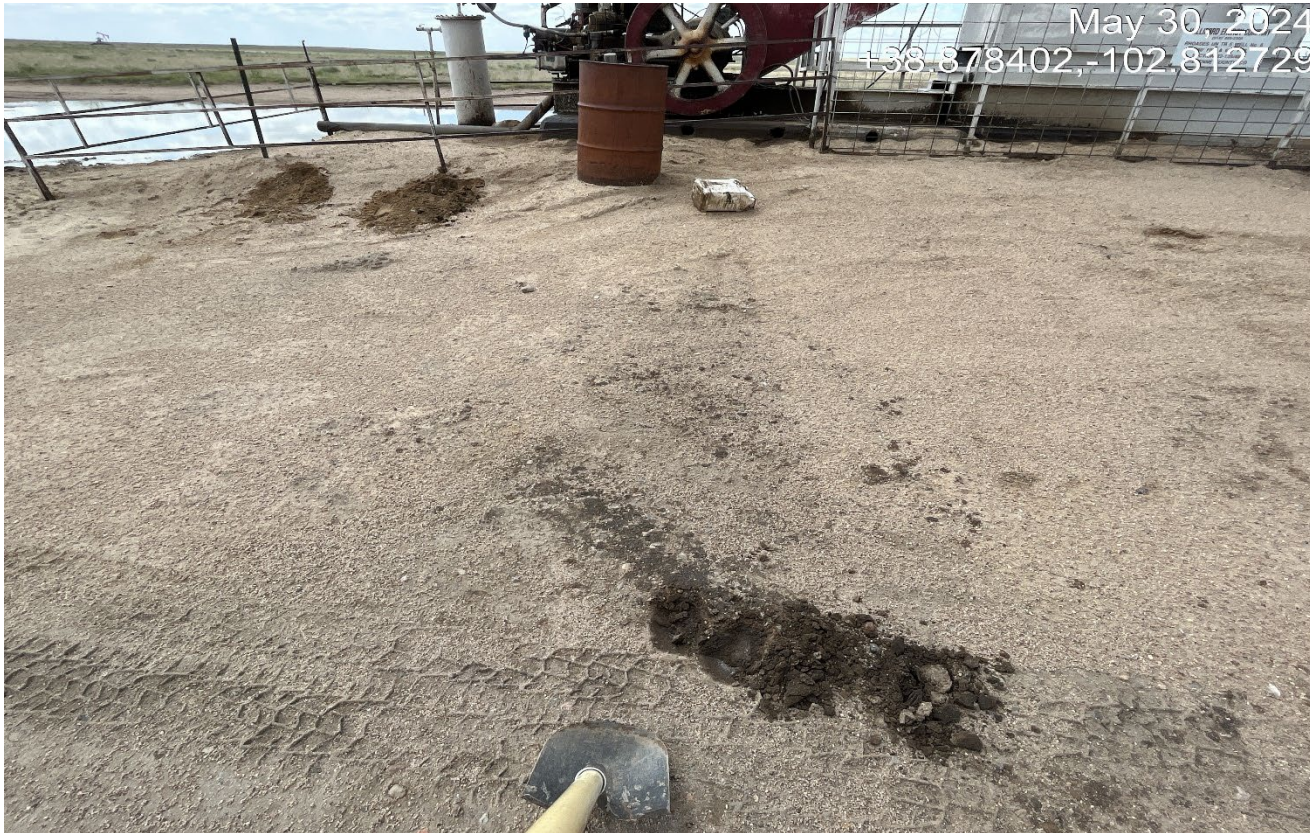
Photo 8. There is impacted soils about 15 ft. north of the pumpjack engine.

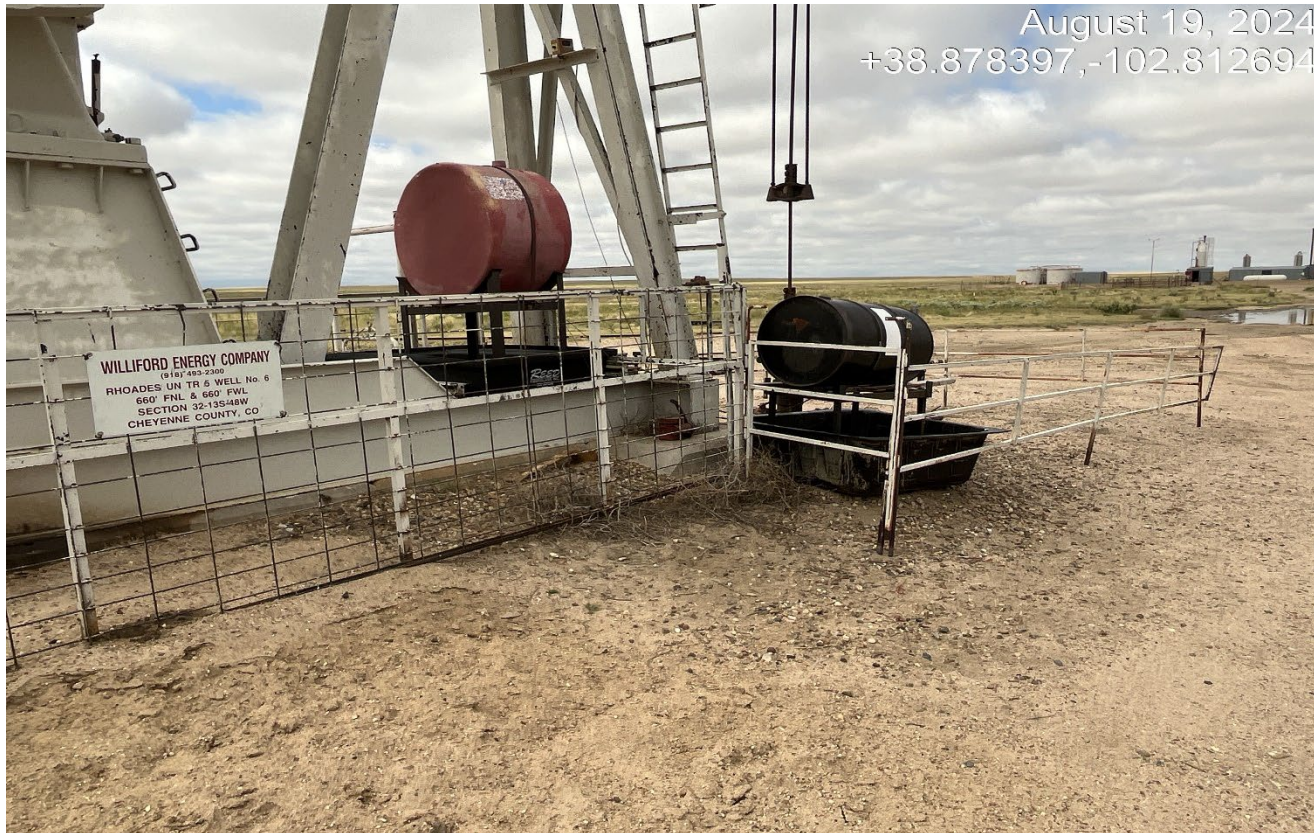
Photo 9. There is oily fluid in the secondary containment and no wildlife protection/netting is installed. The labeling on the barrels is faded and needs to be updated.

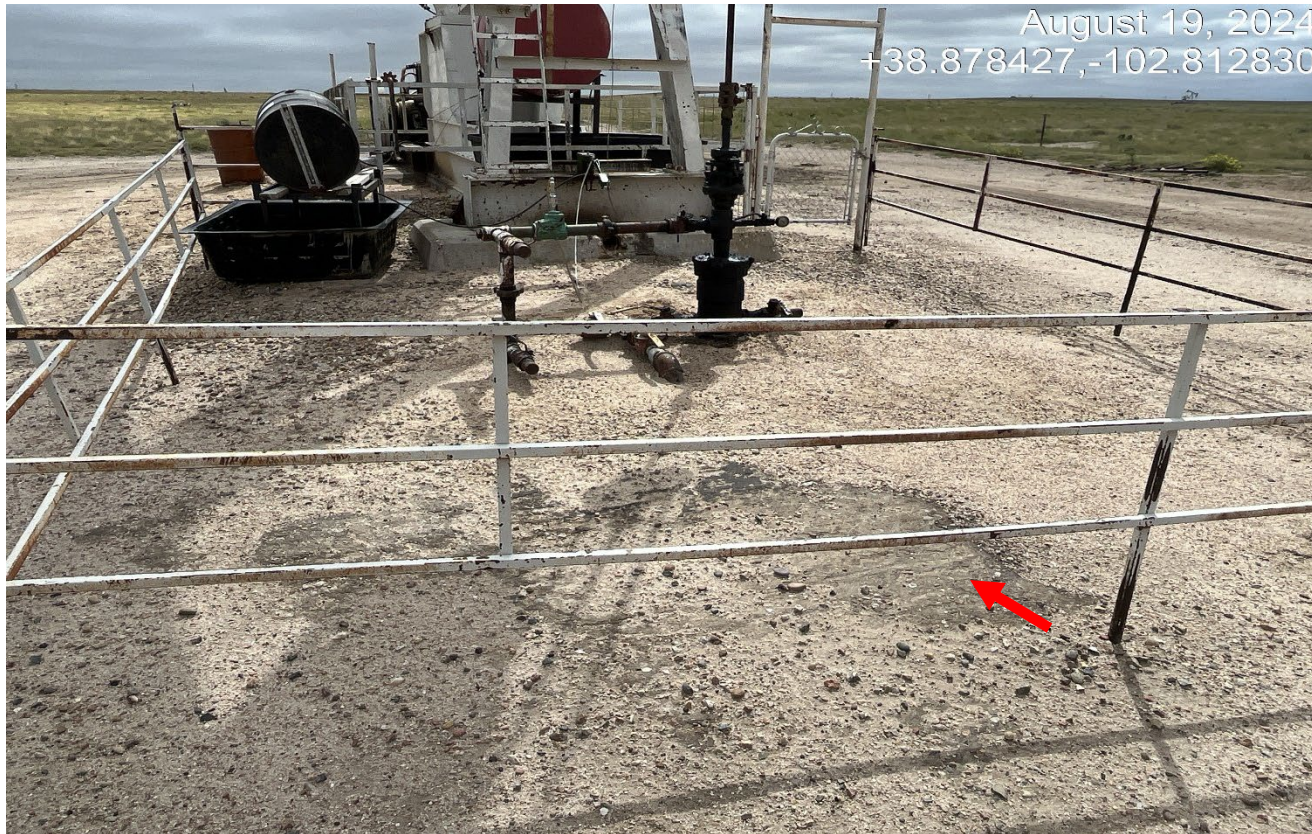
Photo 10. Facing toward the wellhead. There are stained soils by the wellhead shown at red arrow.

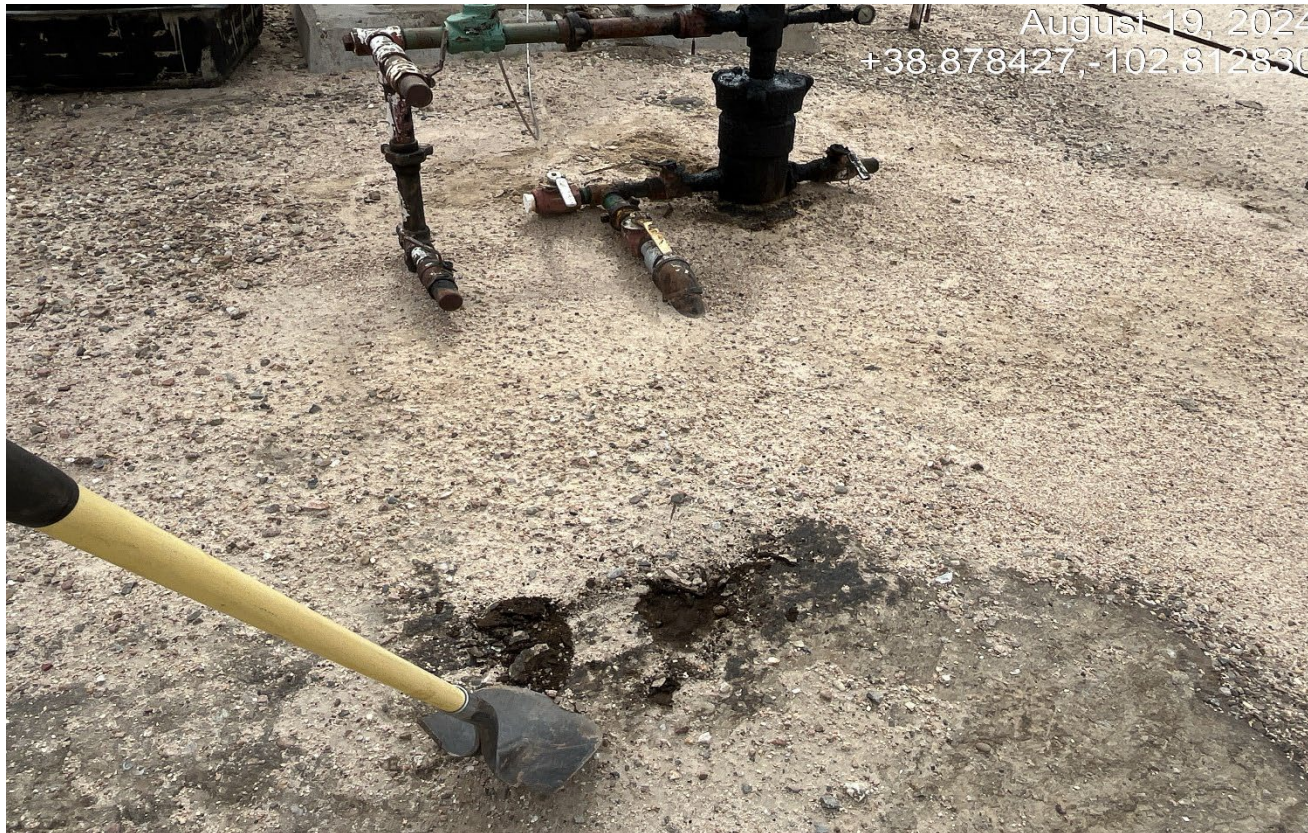
Photo 11. Scratching the soils by the wellhead show oily saturated black staining from E&P waste.
