Inspection Photos

API: 017-06636

Operator: **WILLIFORD ENERGY COMPANY**

Inspection Date: 8/19/2024

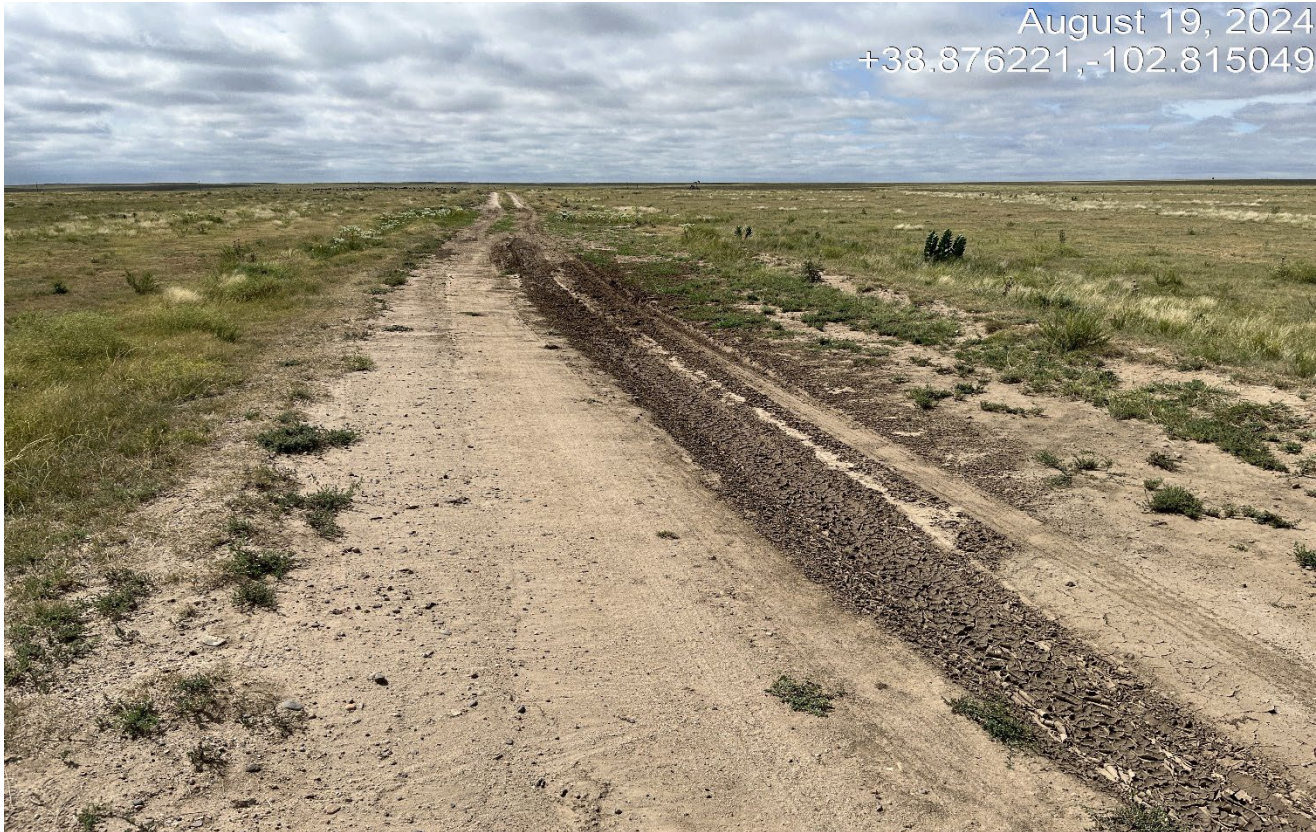
Photo 1. Facing south along the access road. Vehicles are causing unnecessary disturbance driving outside of the access road due to stormwater pooling on the road. The access road must be maintained and vehicles shall not drive outside of the access road boundary. Previous corrective action was not completed.

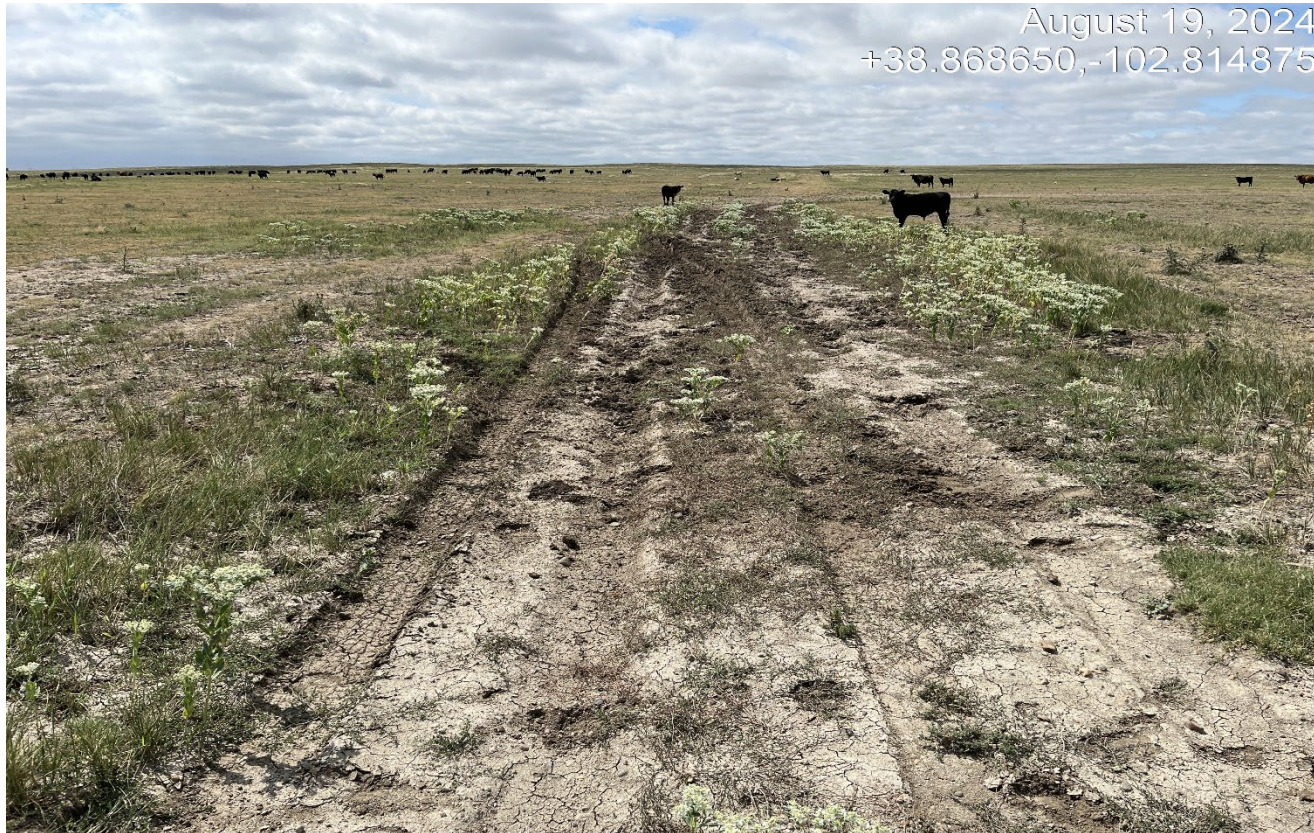
Photo 2. Facing south along the access road. Vehicles are causing unnecessary disturbance driving outside of the access road due to stormwater pooling on the road. The access road must be maintained and vehicles shall not drive outside of the access road boundary. Previous corrective action was not completed.

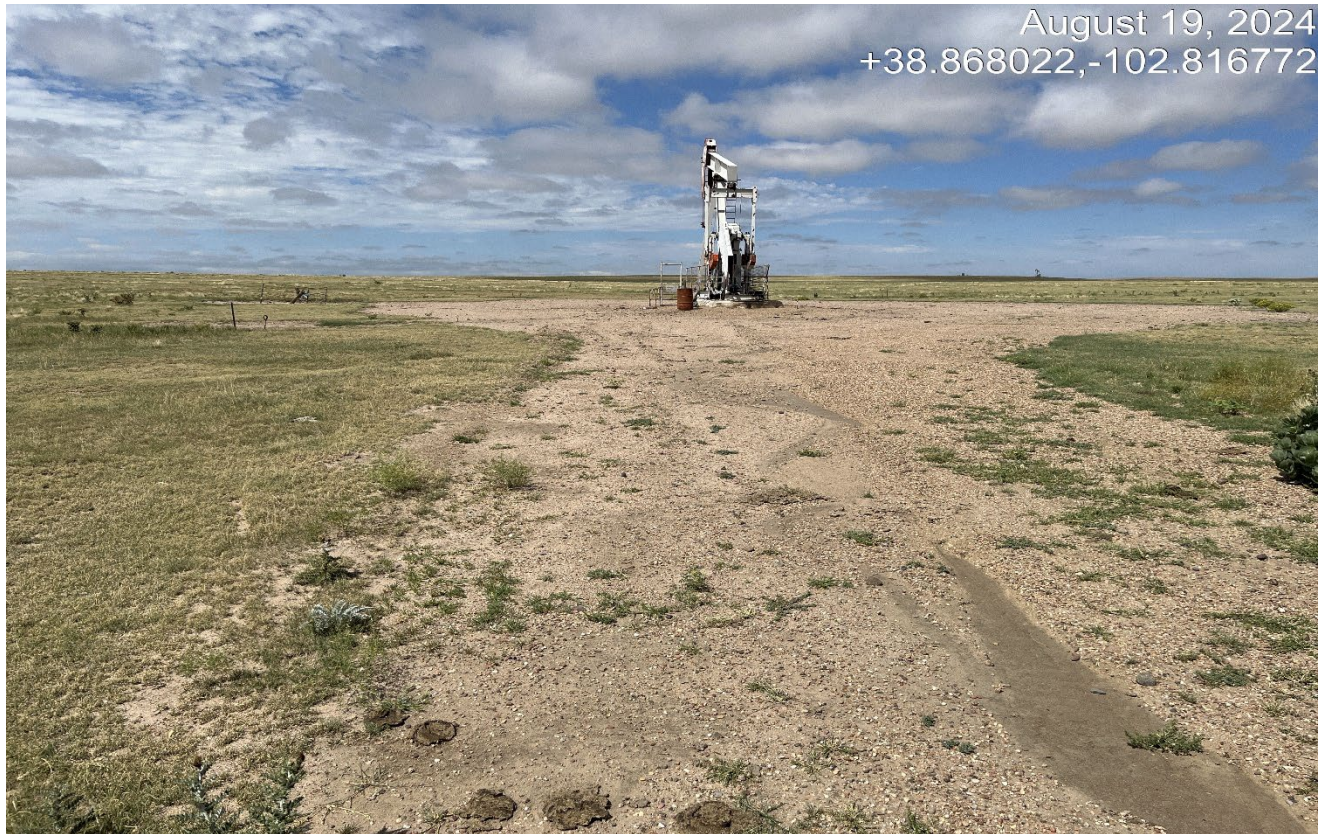
Photo 3. Facing west along the road toward the wellsite. There has been gravel spread along the area where erosion channel was previously observed.

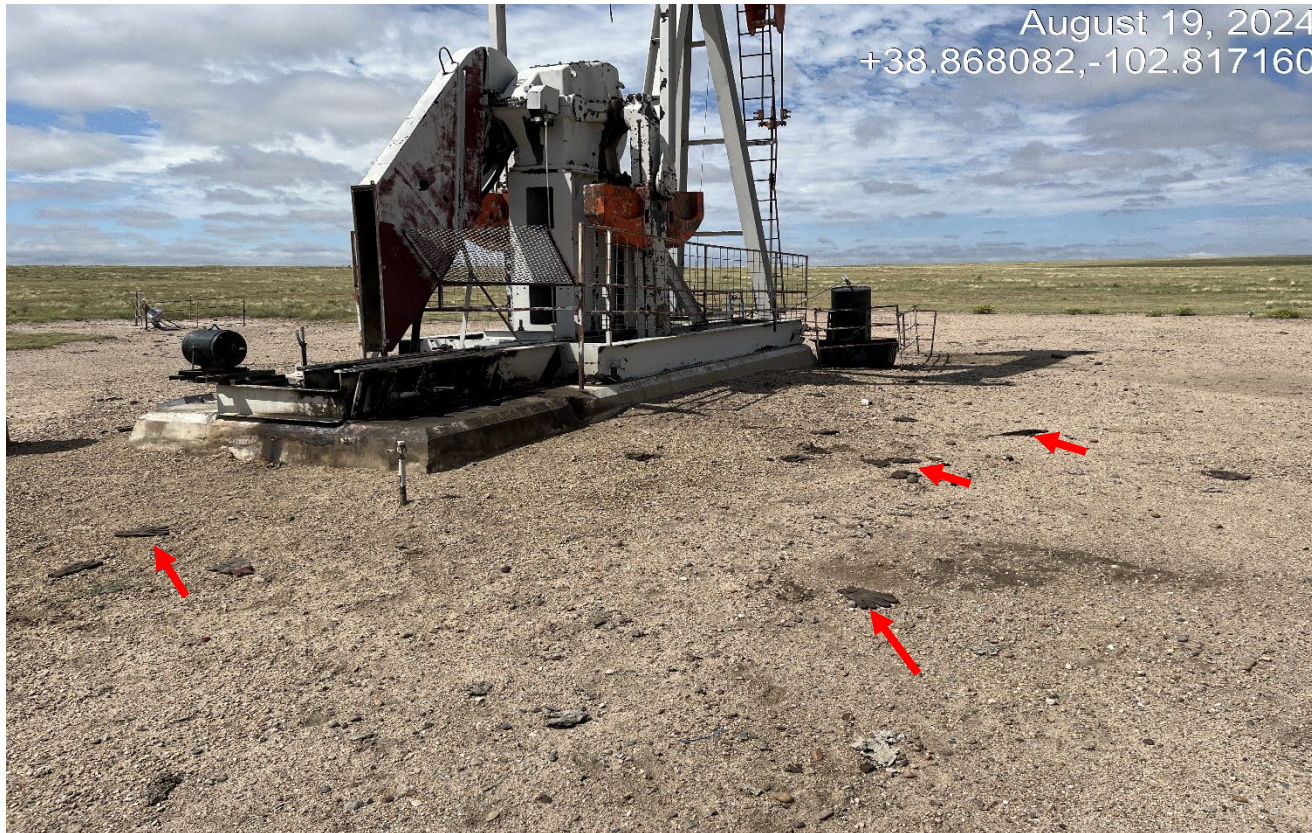
Photo 4. Facing west toward the wellsite. There are oily rags/gloves in this area that must be disposed. Previous corrective action was not completed.

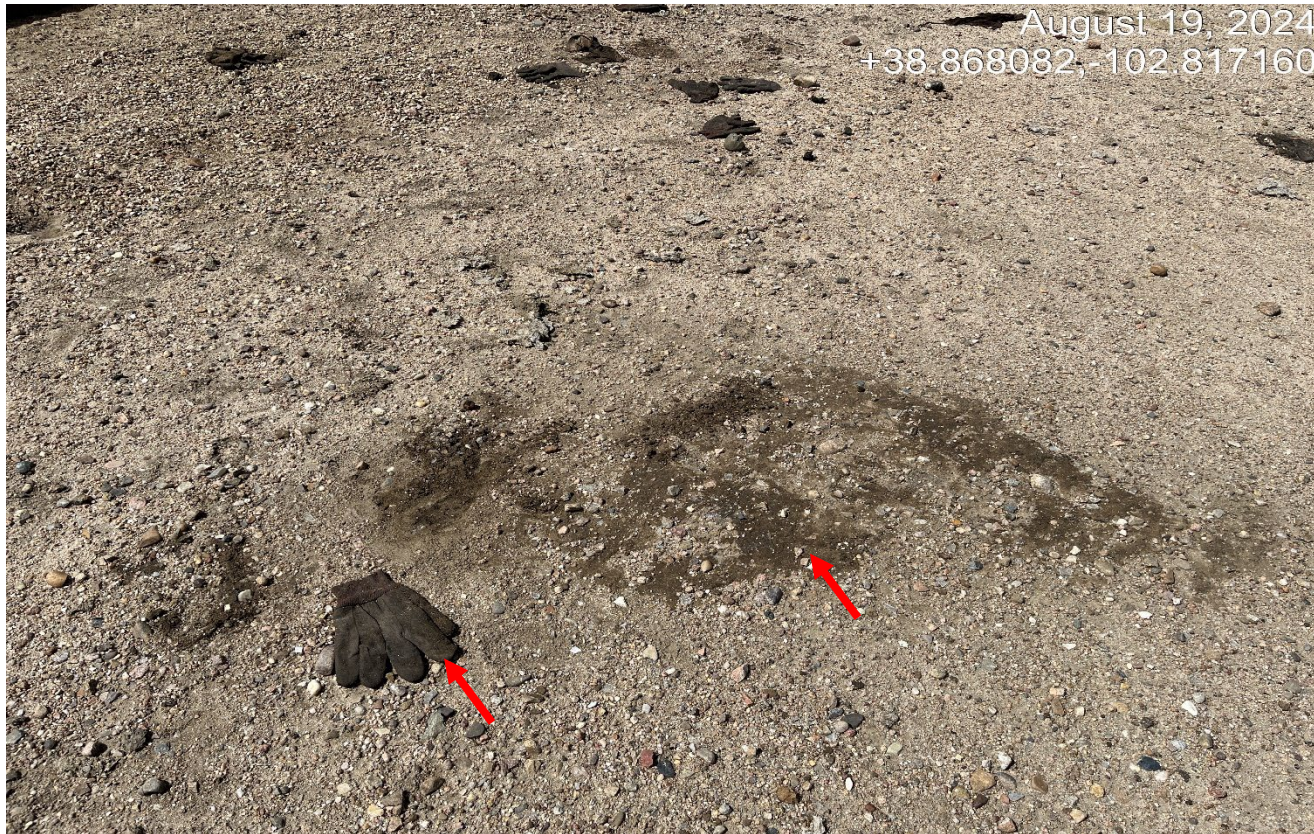
Photo 5. View of stained soils and oily gloves.

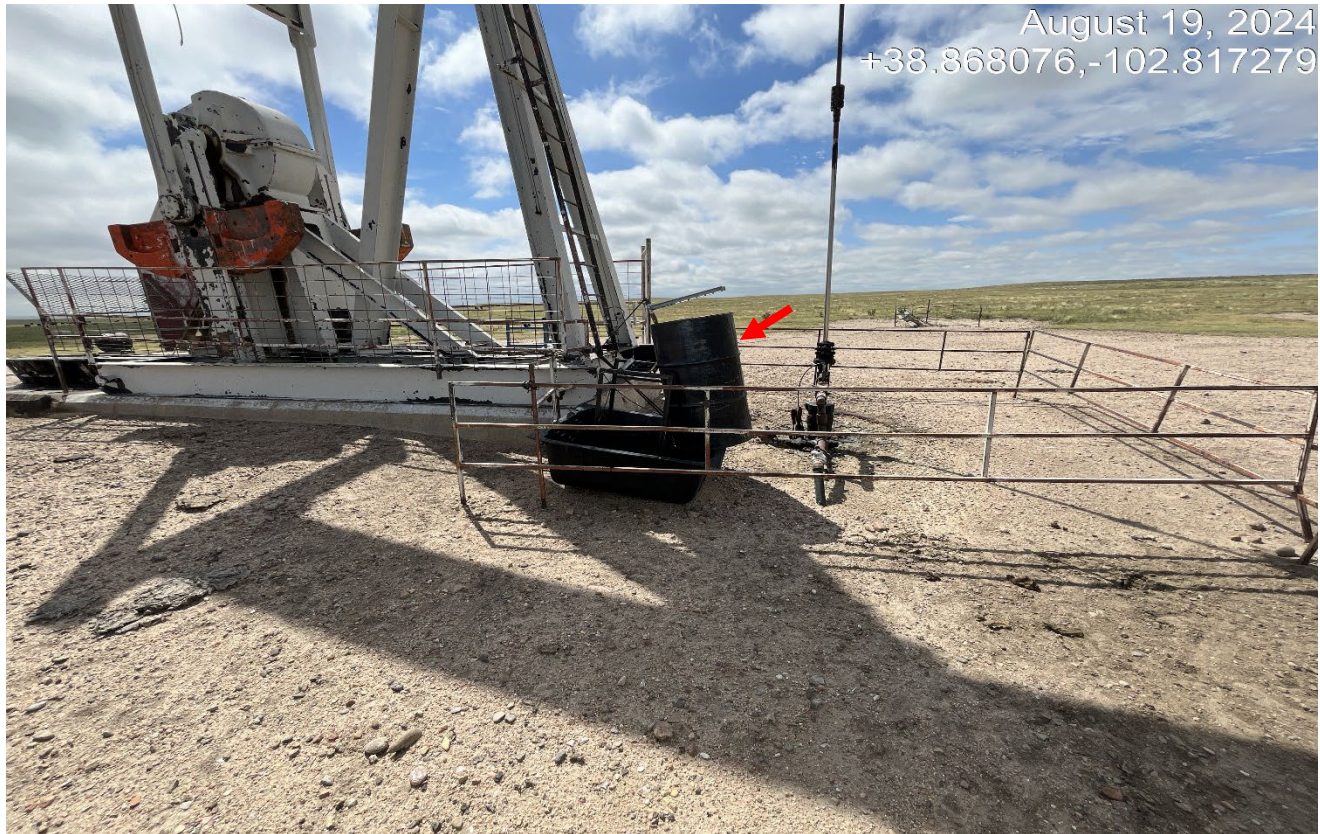
Photo 6. Facing toward the wellhead. The barrel is not properly set in the containment and there is no netting on the secondary containment..

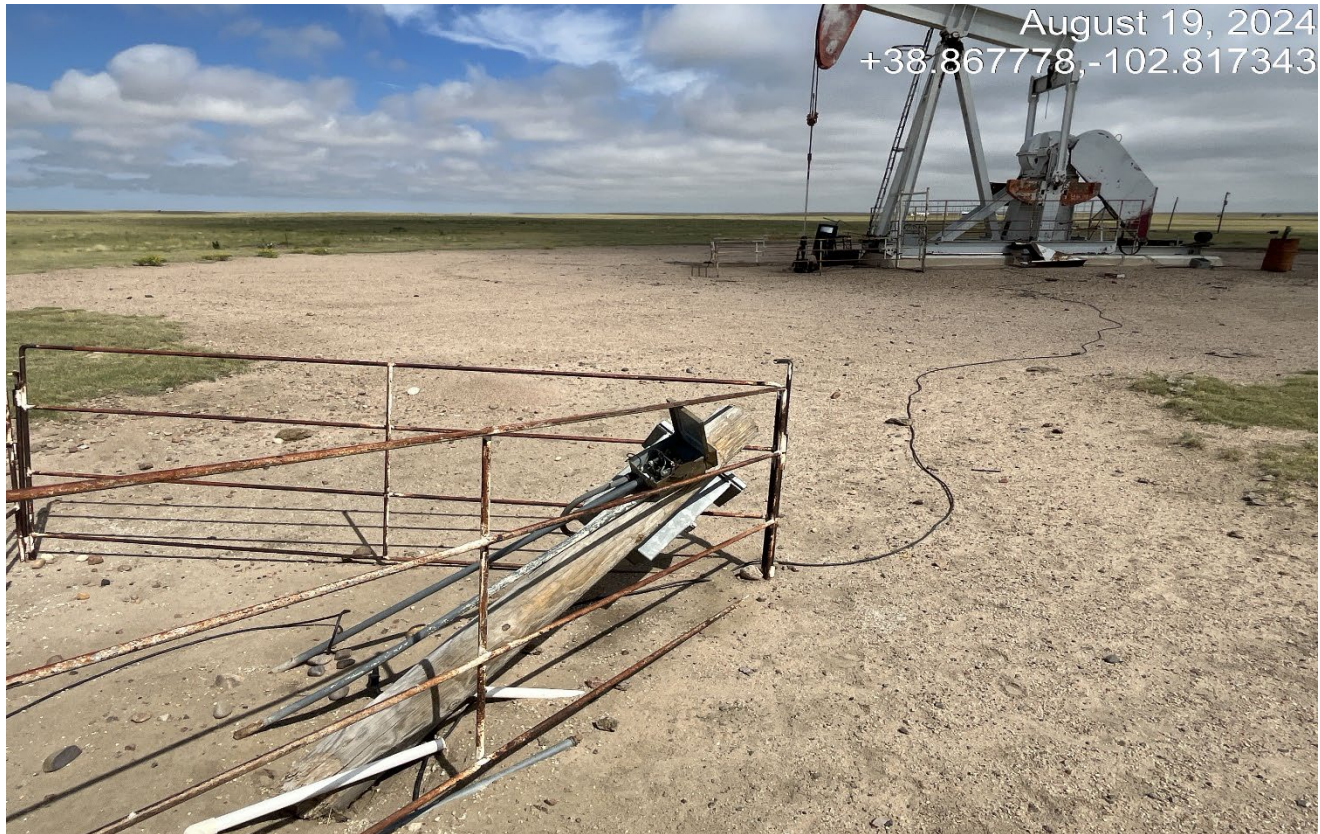
Photo 7. Facing toward the electric utility just south of the well. The electric wire is on the surface and not protected which is a safety concern. The electric breaker is disconnected from the electric line.
