iCem[®] Service

CIVITAS RESOURCES-EBUS

KING 3-65 28-29 2AH

Case 1

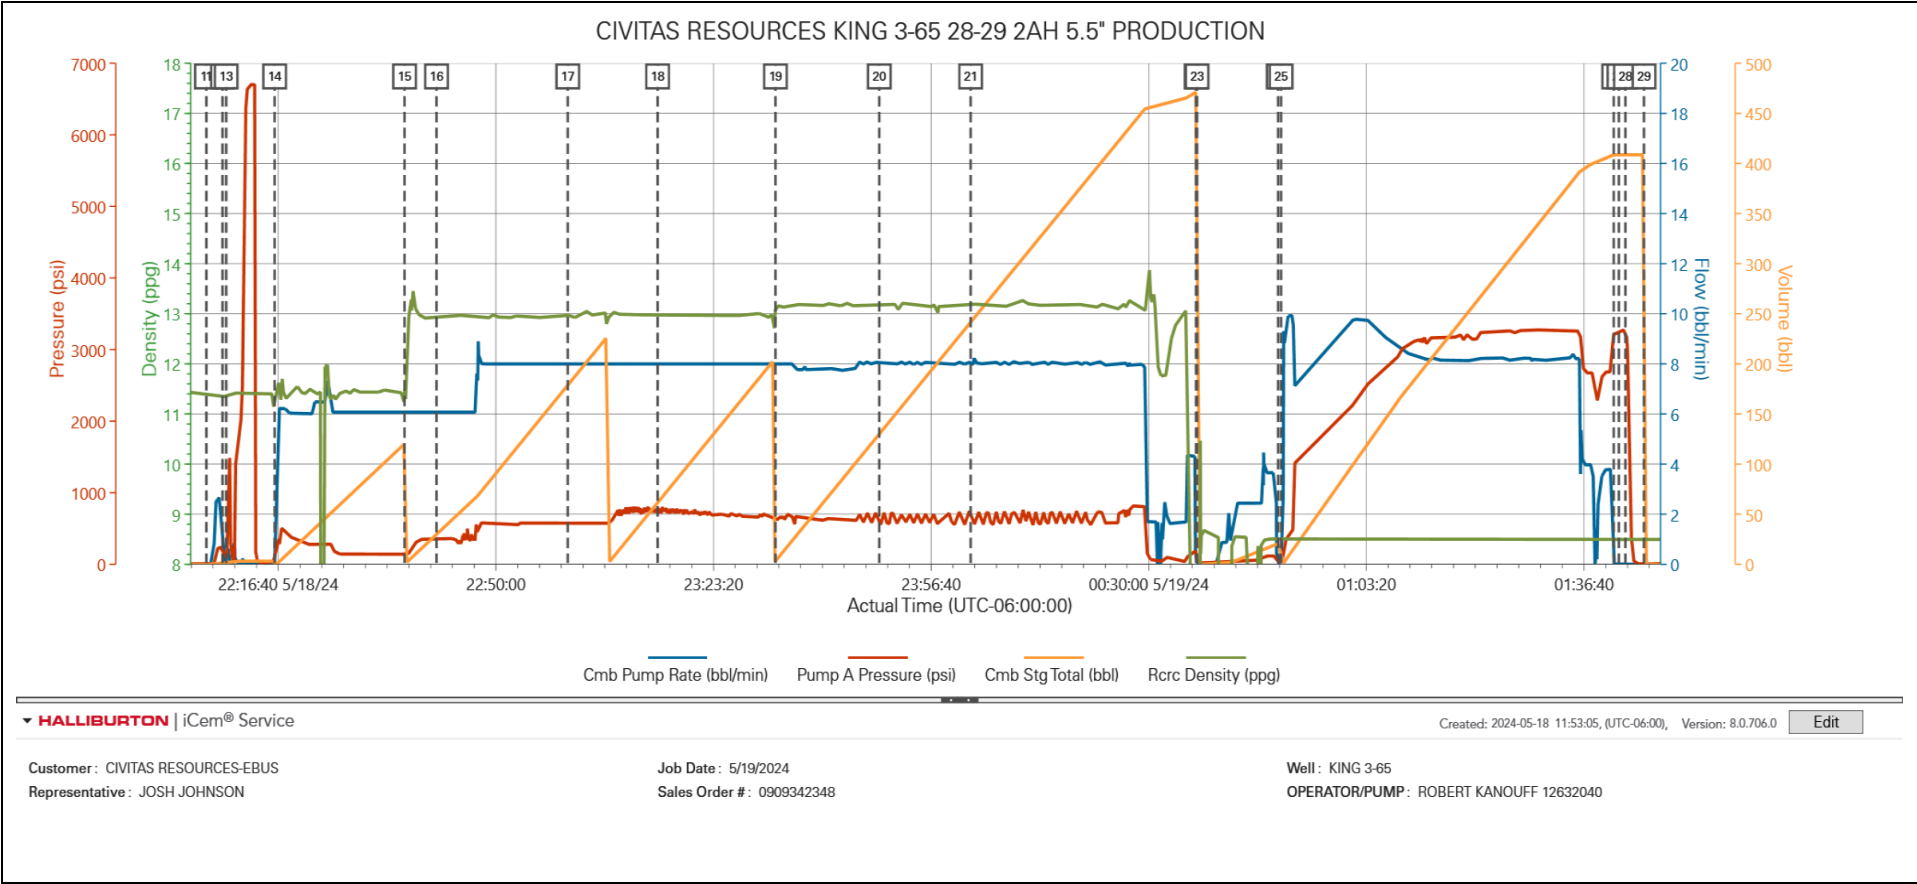
3.1 Real Time Job Chart

- Quality of circulation – Prejob 100% While pumping Cement 100%, While Pumping Displacement 100%
- Final Circulating Pressure and Pump Rate 2700 PSI @ 4 BPM
- Returns to Surface 67 BBLS OF CMT
- Any deviation from plan NO
- Abnormalities on job chart NO
