Inspection Photos

API: 017-06632

Operator: **WILLIFORD ENERGY COMPANY**

Inspection Date: 8/19/2024

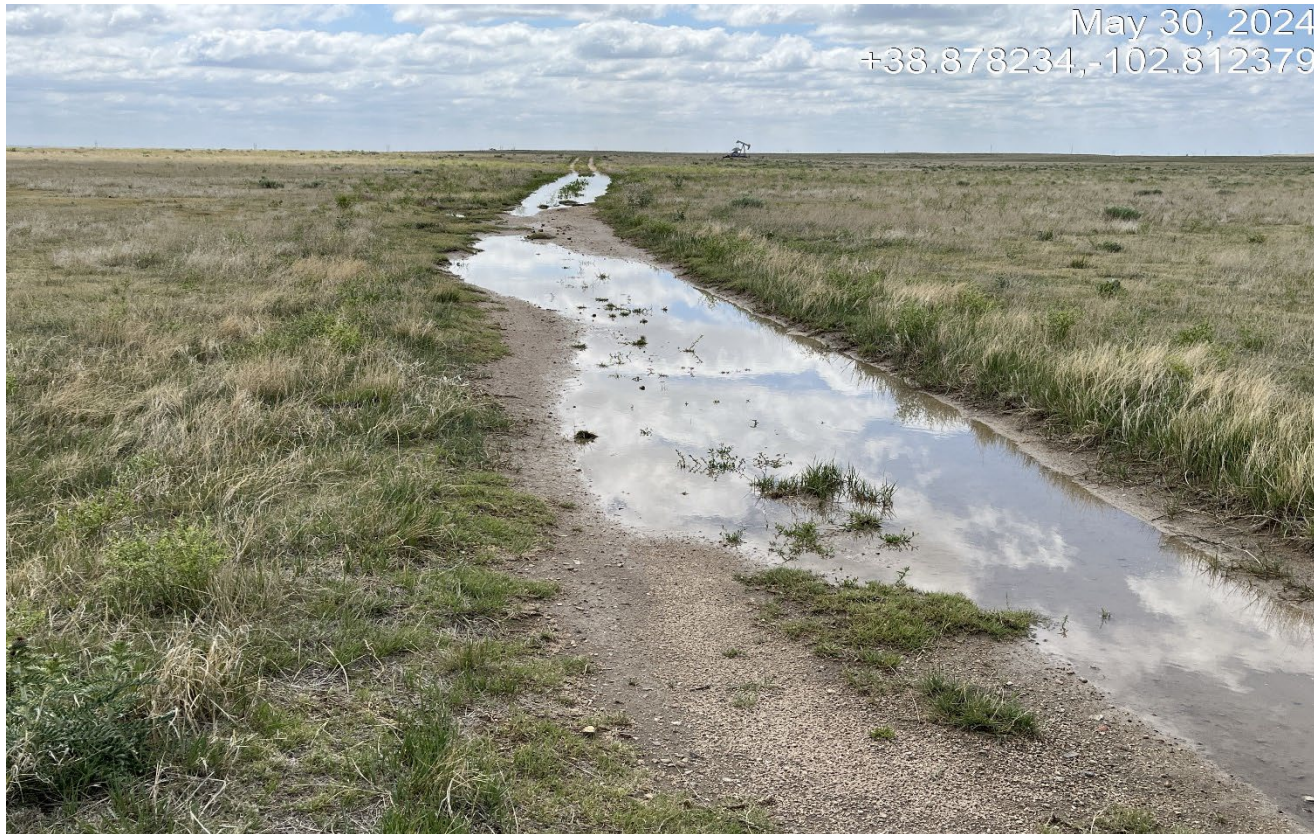
Photo 1. Facing southeast toward the access road. The access road was inaccessible due to water pooling on the road. The road needs to be built up with road base to allow proper stormwater drainage. Photo from previous inspection.

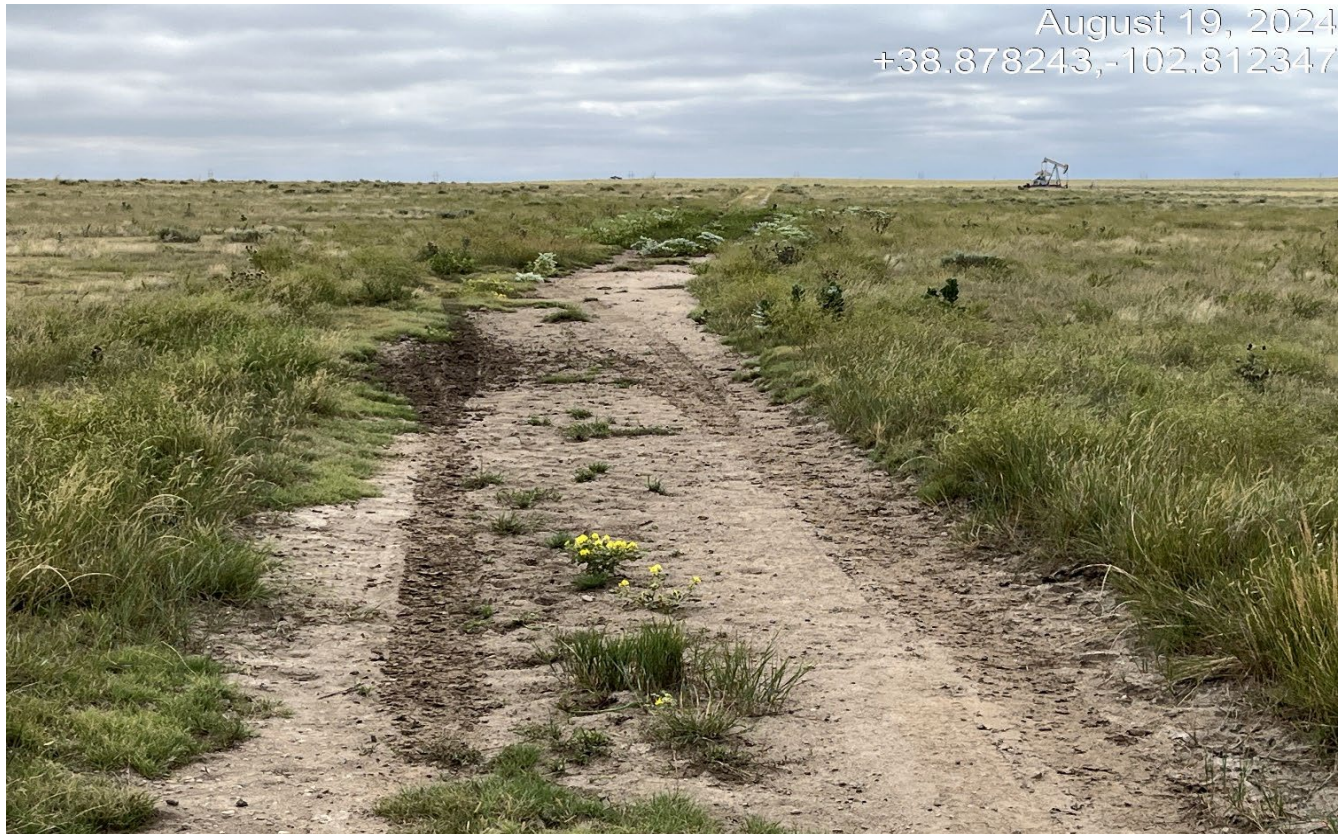
Photo 2. Facing southeast along the access road. Vehicles are causing unnecessary disturbance driving outside of the access road due to stormwater pooling on the road. The access road must be maintained and vehicles shall not drive outside of the access road

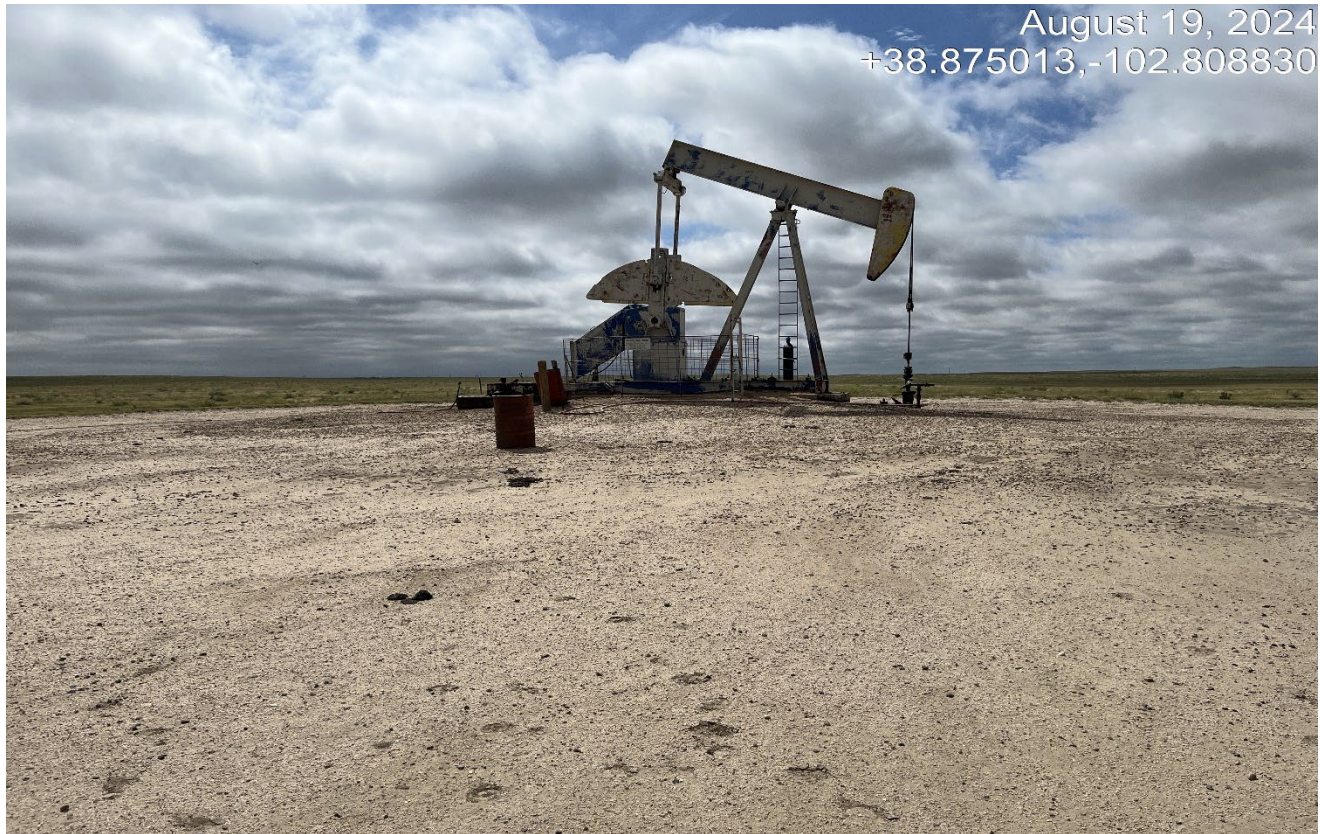
Photo 3. Facing southeast toward the wellsite.

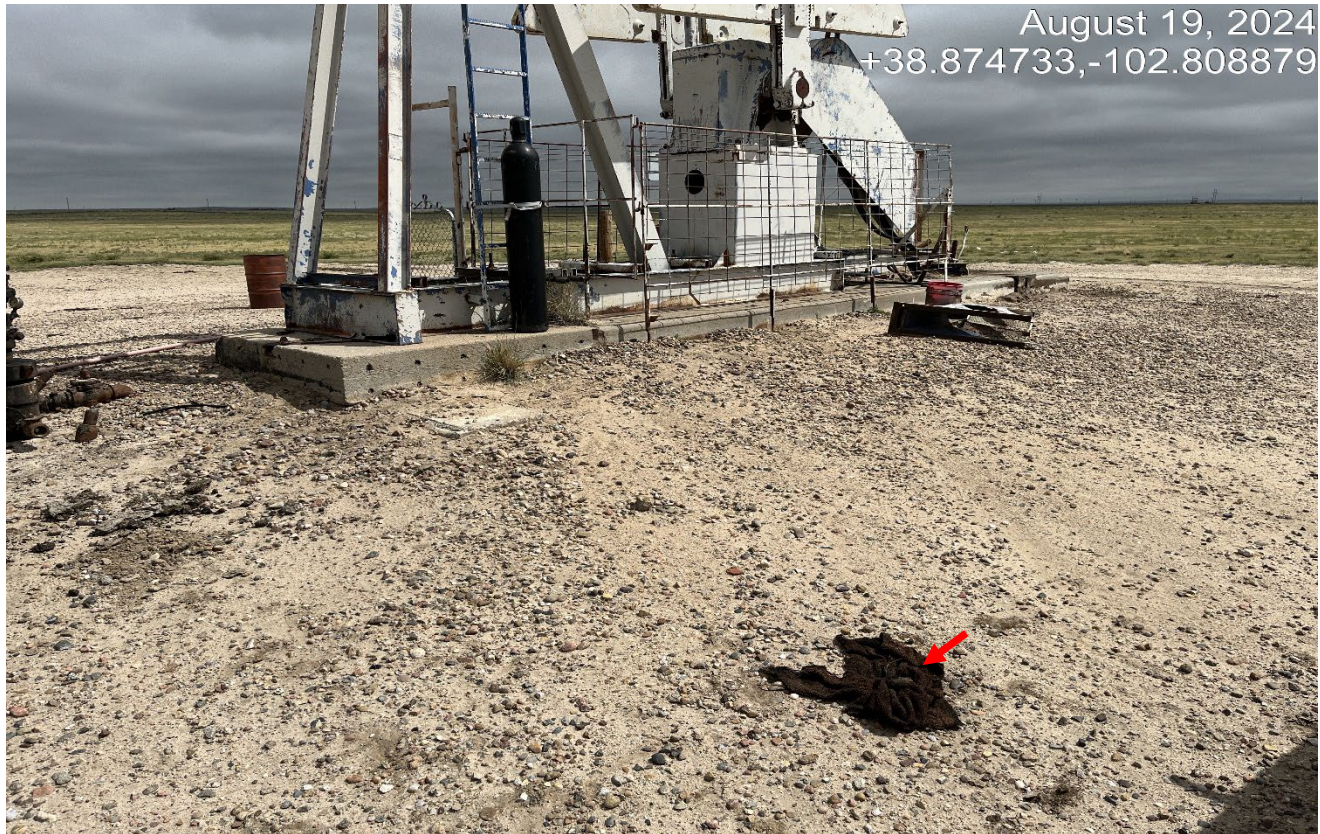
Photo 4. Facing northeast toward the pumpjack. There is an oily rag at red arrow.

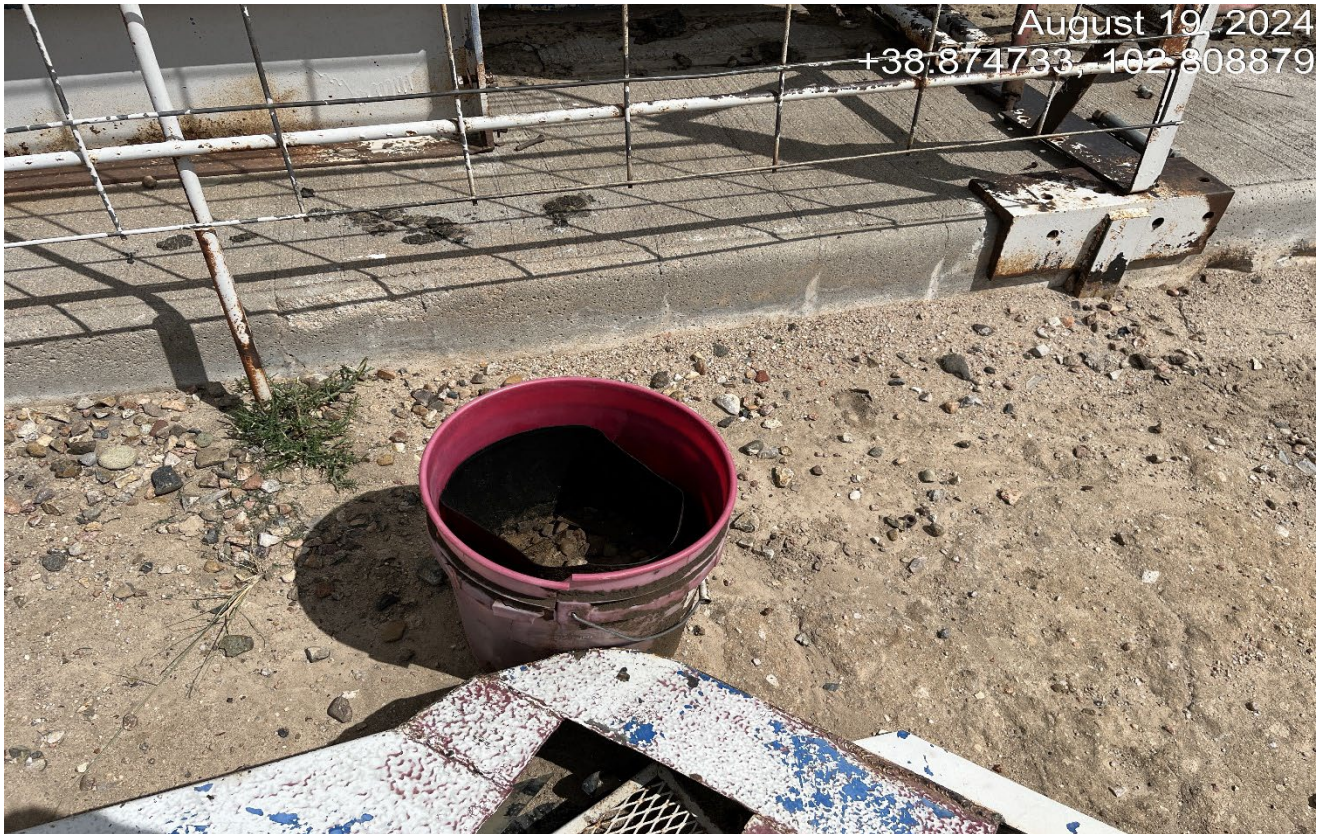
Photo 5. There is oily fluids in the red container that are about to overtop and spill on the ground.

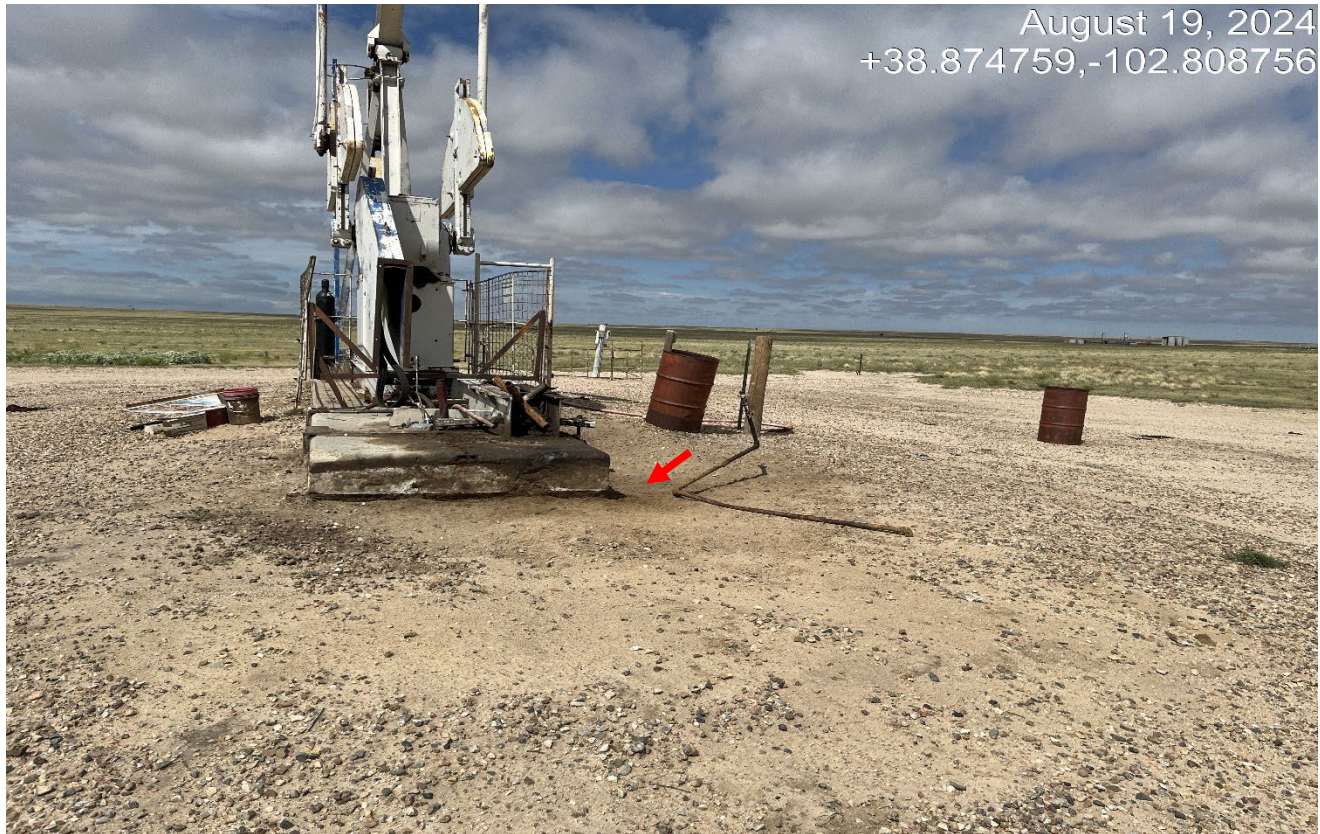
Photo 6 . Facing northwest at the pumpjack. There are stained soils at red arrow and parts laying on the ground.
