Inspection Photos

API: 017-06502

Operator: **WILLIFORD ENERGY COMPANY**

Inspection Date: 8/19/2024

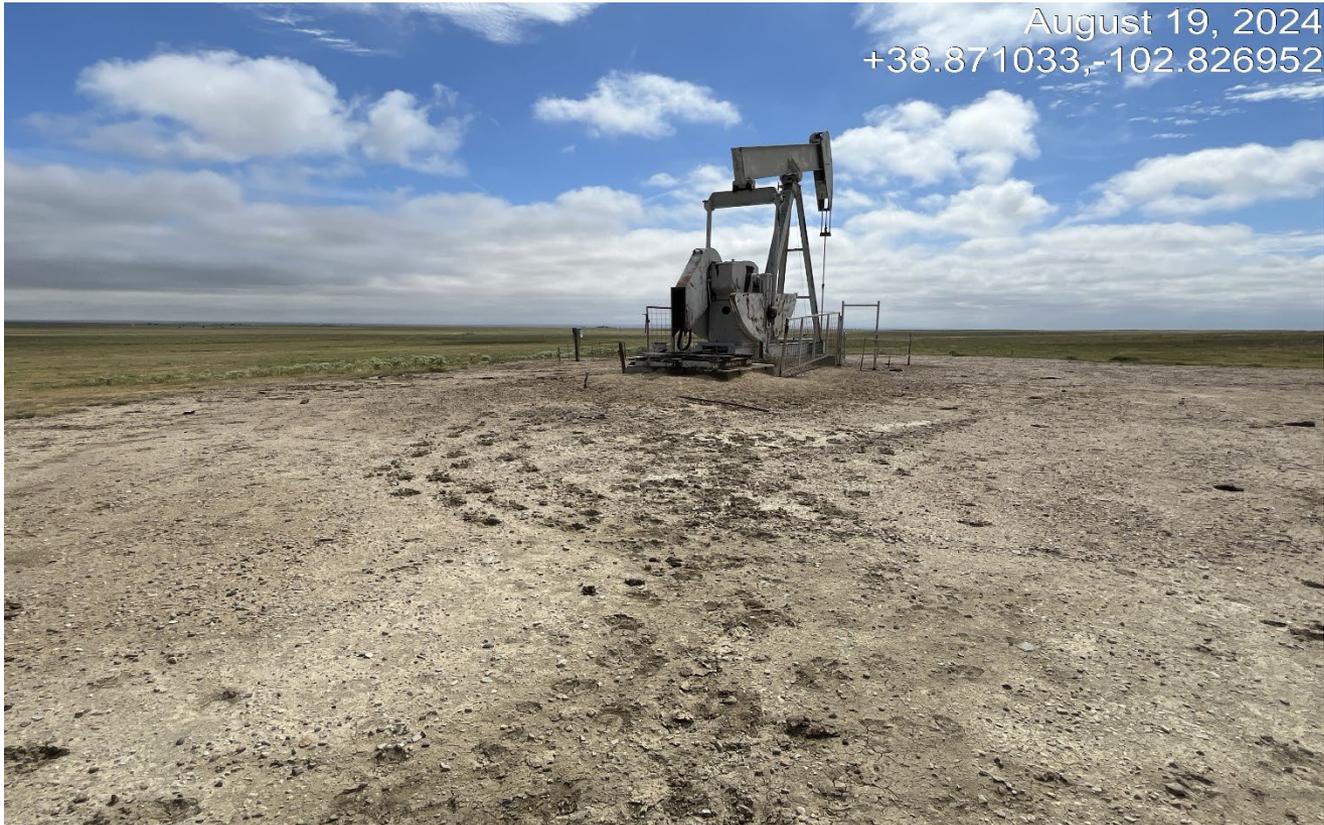
Photo 1. Facing east toward the wellsite.

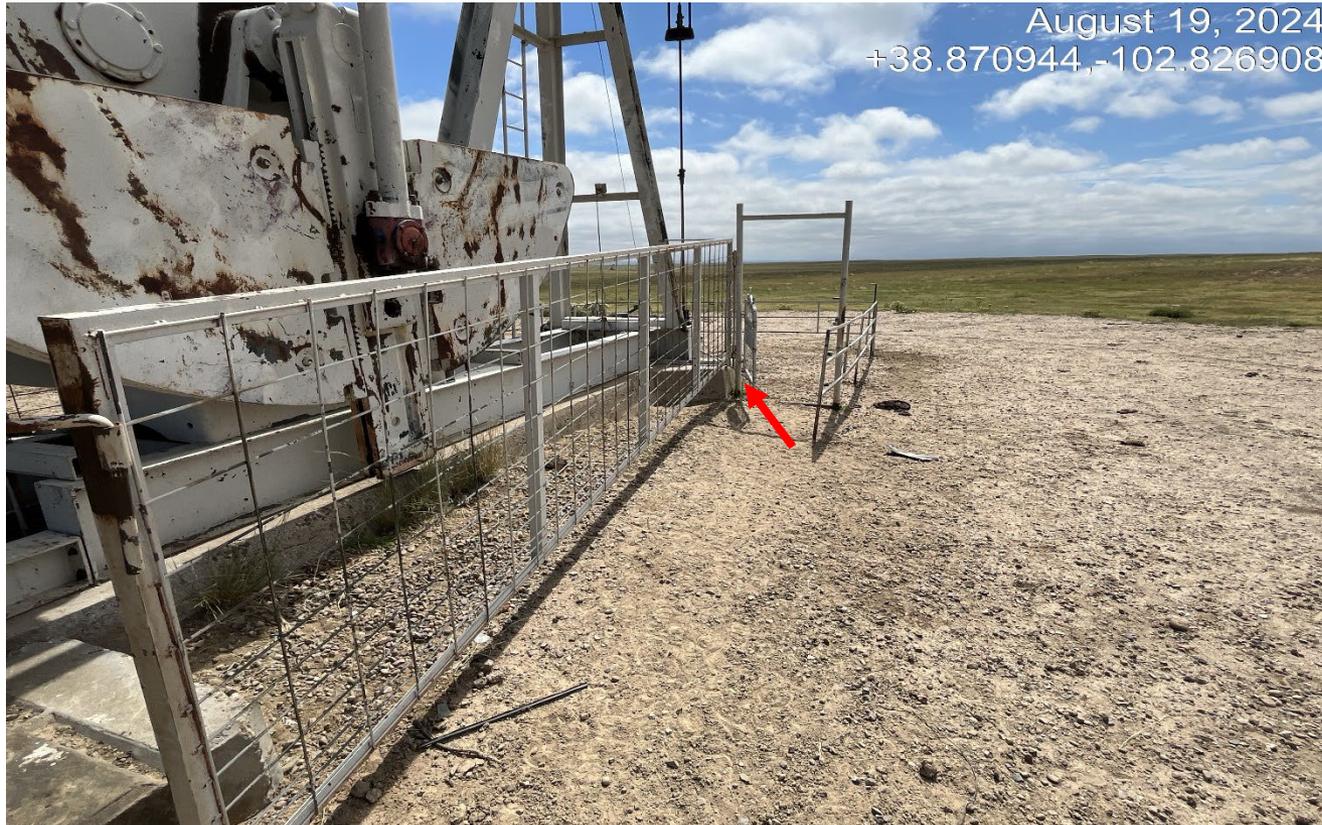
Photo 2. Facing at the pumpjack. The gate was left open and livestock entered in the enclosure. The well sign on the gate is obstructed from view.

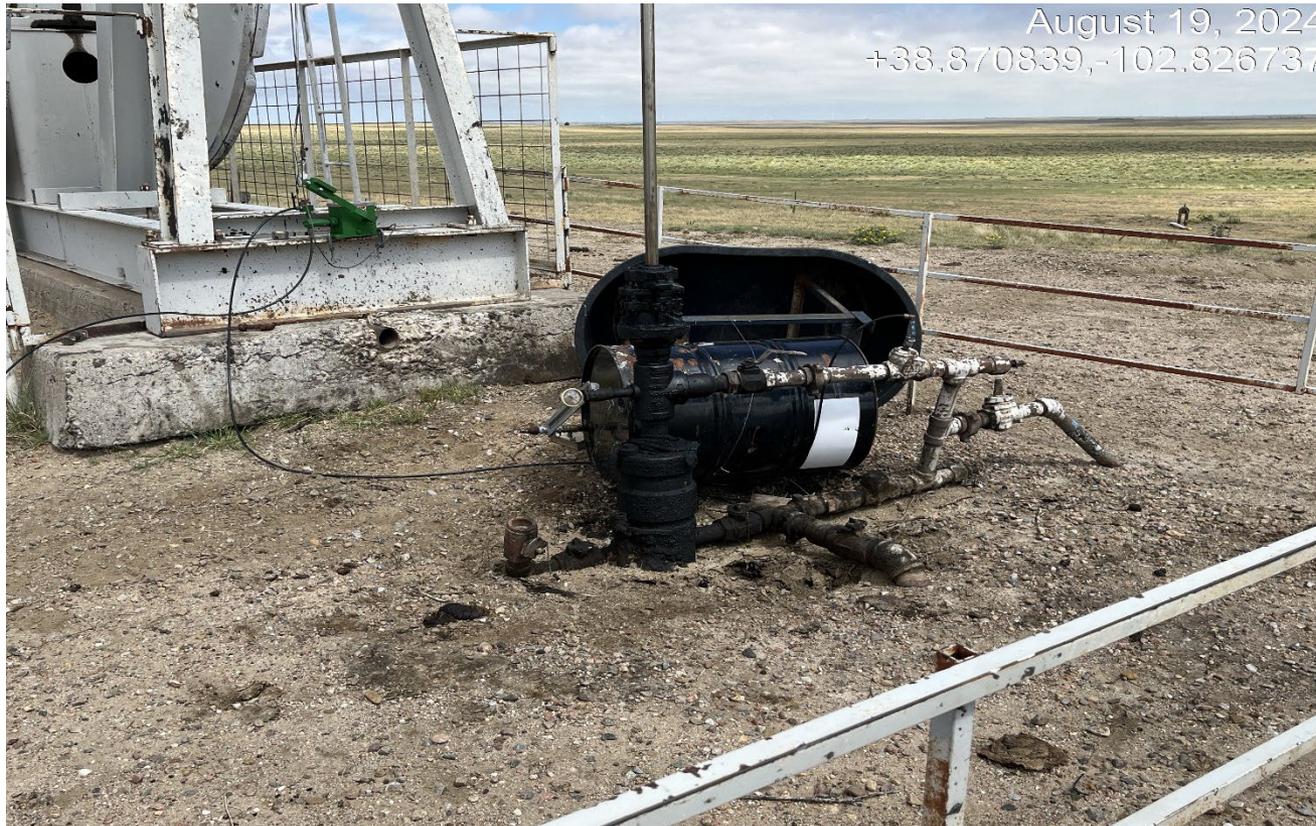
Photo 3. The chemical barrel has tipped over and there are signs that livestock was inside this enclosure. There is oil stained soils at the wellhead.

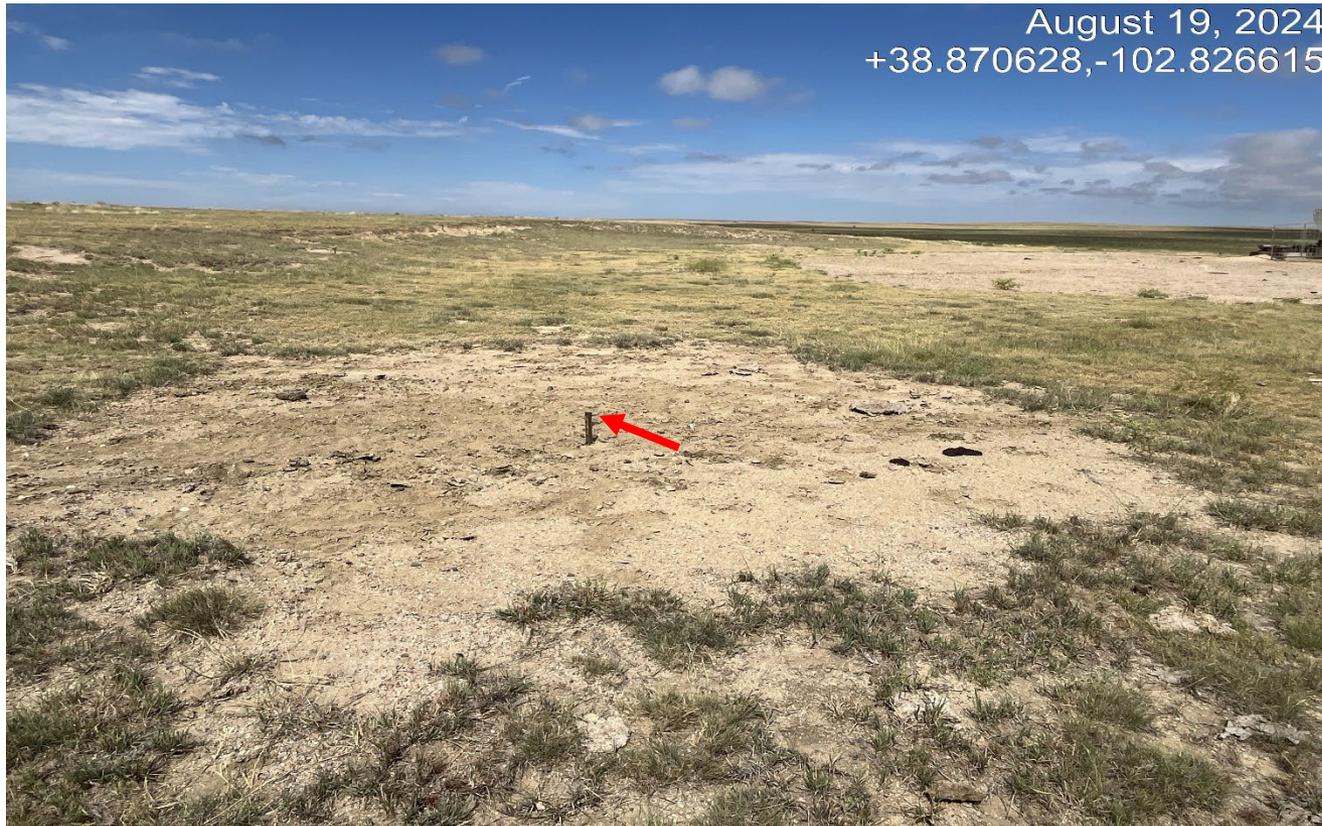
Photo 4. The guyline anchors are not marked.
