**Inspection Photos**  
**Location Name:** RUFF-66N64W/3SEW  
**Location #:** 305536

**Ruff 22-3 (123-23107) Wellsite**  
**Plugged & Abandoned | PA**  
**Plugging Ops; Cementing: Initial plug(s)**

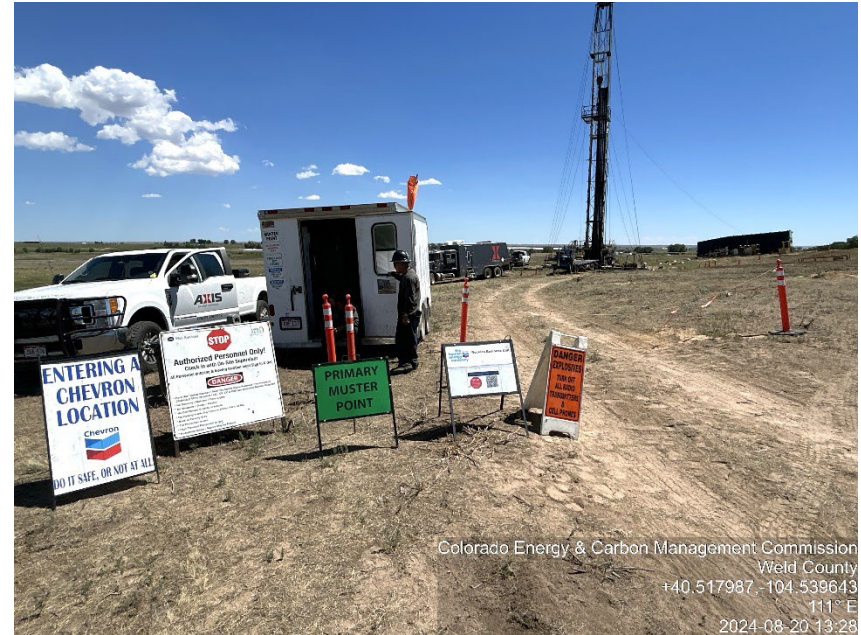
**Photo #2**

**Ruff 22-3 Wellsite**  
**Plugged & Abandoned | PA**  
**Plugging Ops; Cementing: Initial plug(s)**  
*Site safety signage*

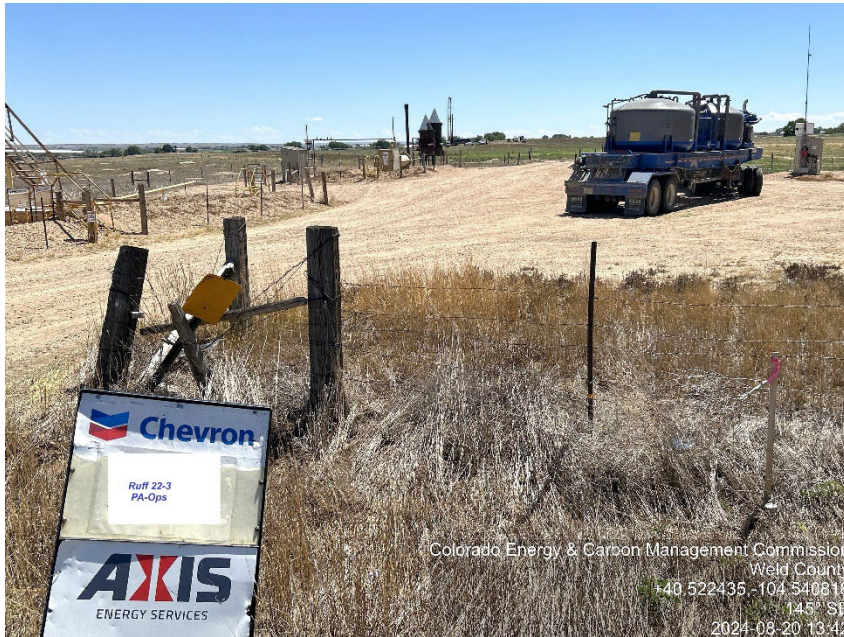
**Photo #3**  
**Ruff 22-3 Wellsite**  
**Plugged & Abandoned | PA**  
**Plugging Ops; Cementing: Initial plug(s)**  
*Wellsite entrance*

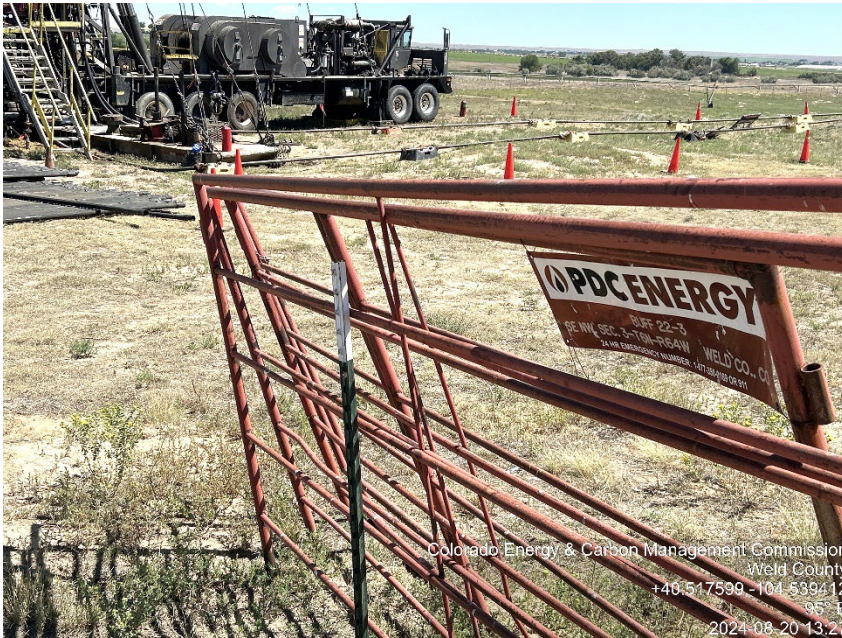
**Photo #5**

*Wellsite sign*
