Inspection Photos

API: 017-06652

Operator: **CITATION OIL & GAS CORP**

Inspection Date: 8/19/2024

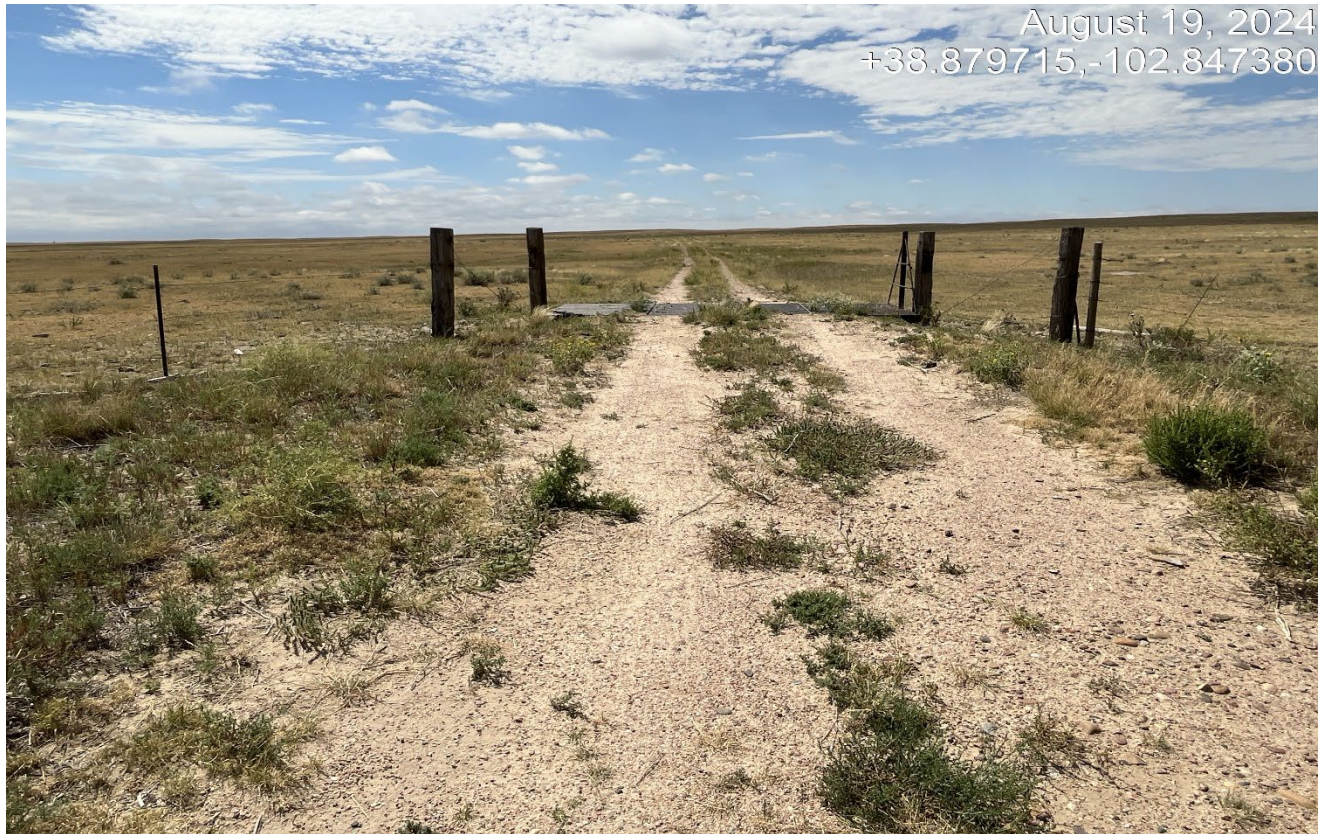
Photo 1. Facing south at the beginning of the access road. The cattleguard will need to be removed and fence installed back to original position. The road needs to be reclaimed.

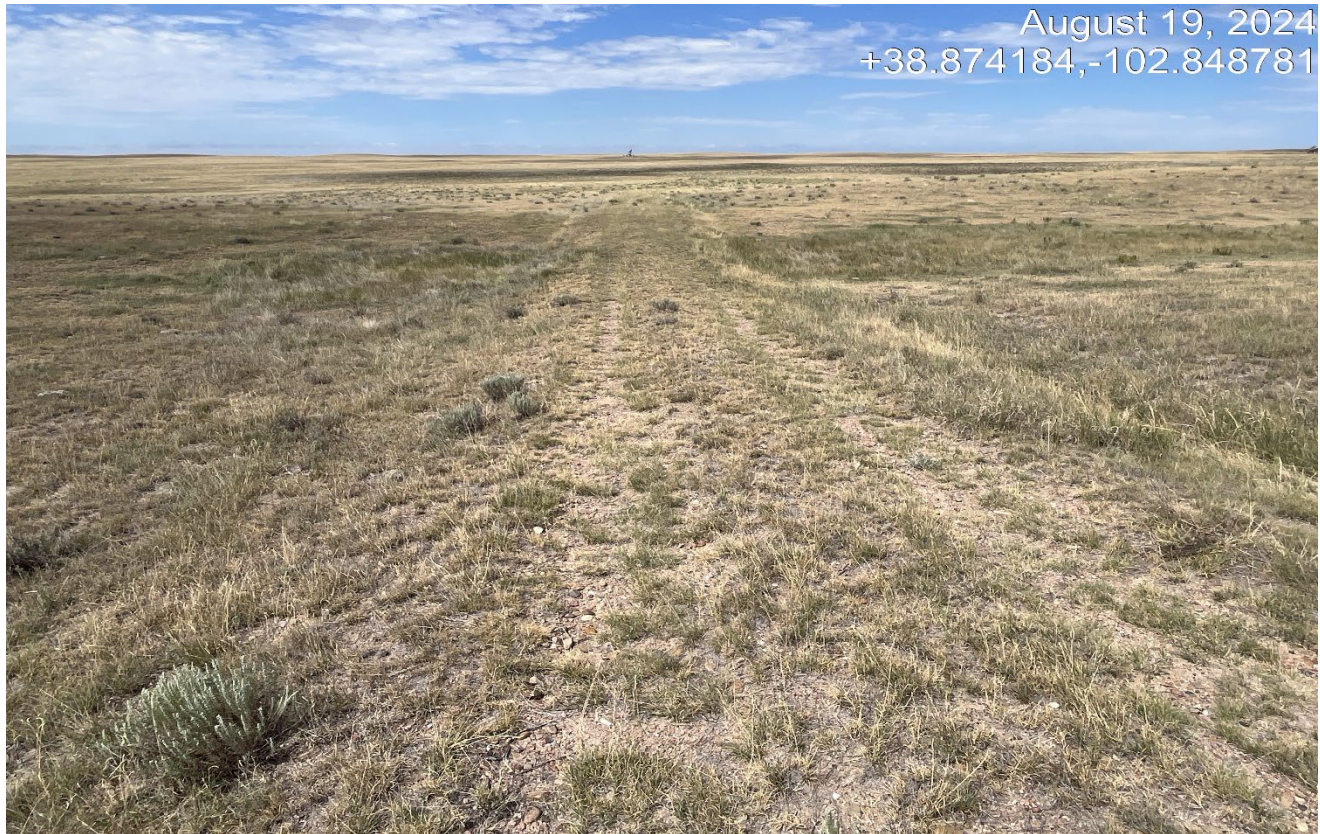
Photo 2. Facing west along the access road. This portion of the road has revegetated.

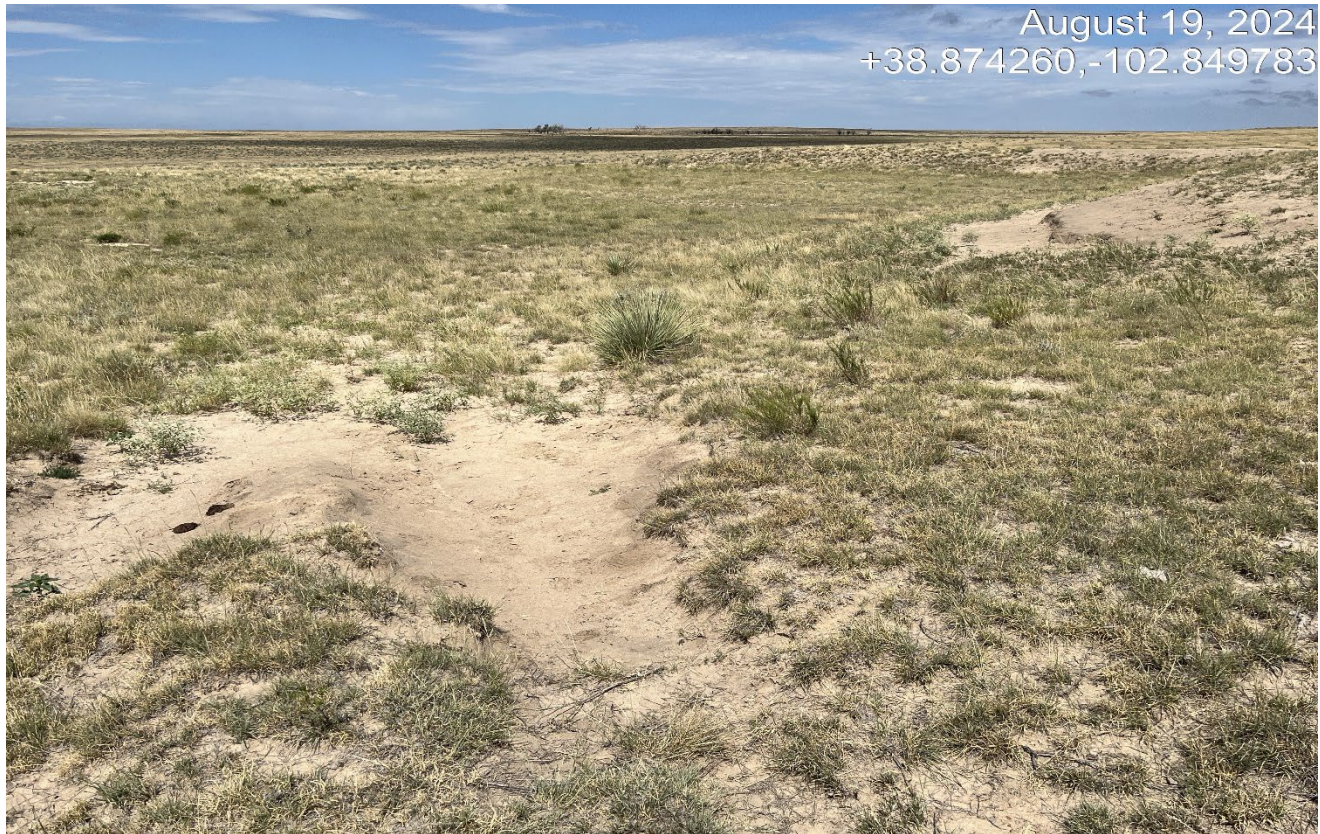
Photo 3. Facing northwest at the location. The cut slope has not been recontoured back to the original terrain contours.

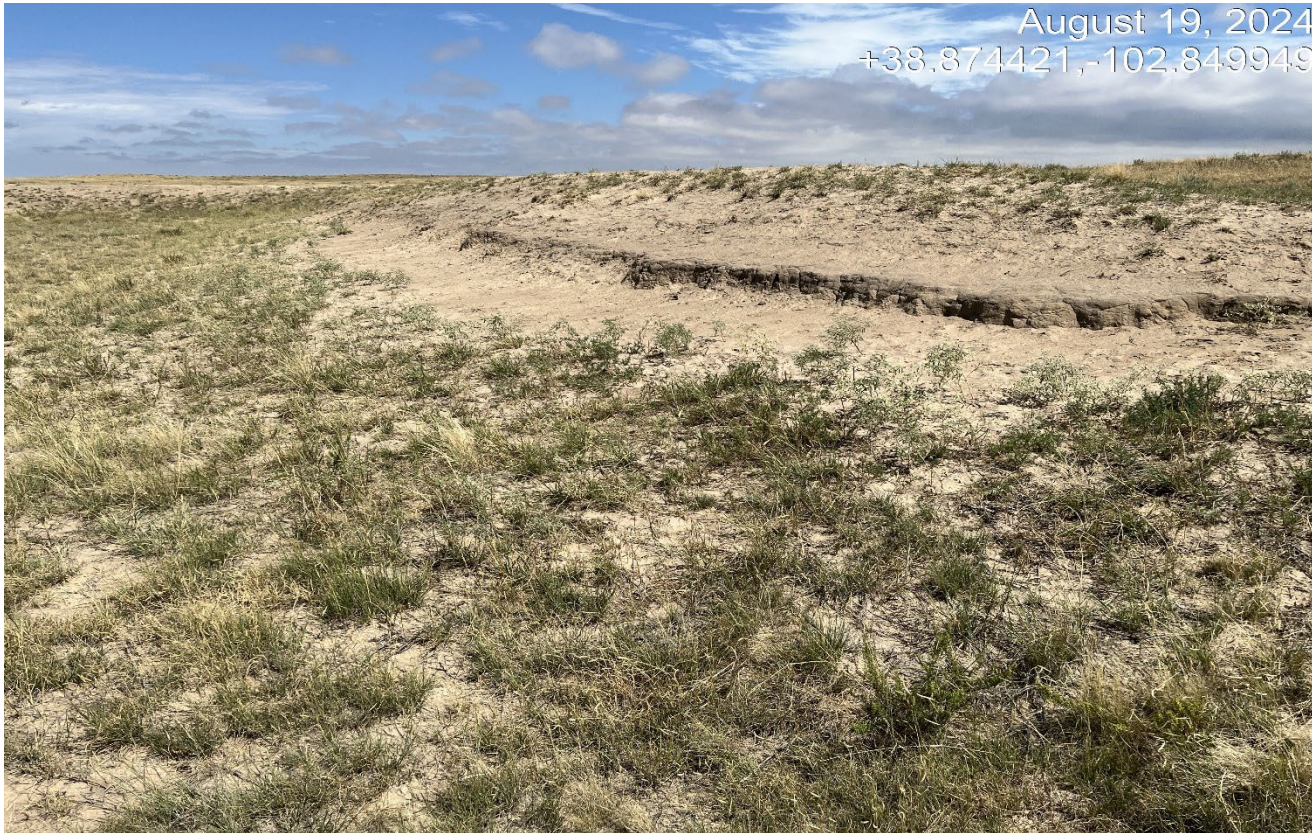
Photo 4. Facing toward the cut slope that has not been recontoured back to the original terrain contours.

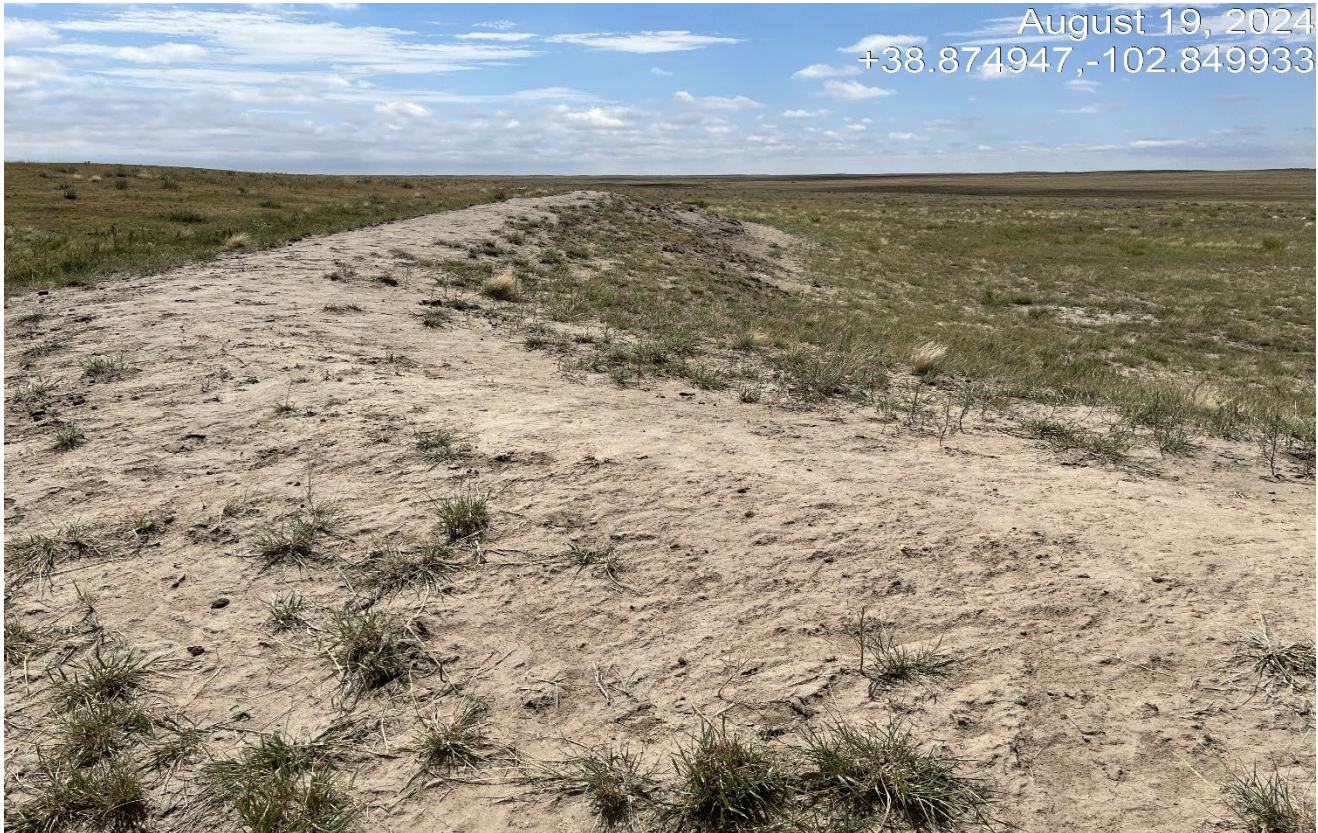
Photo 5. Facing south at the top of the cut slope. There is a berm along the top of the which needs to be recontoured along the cut slope

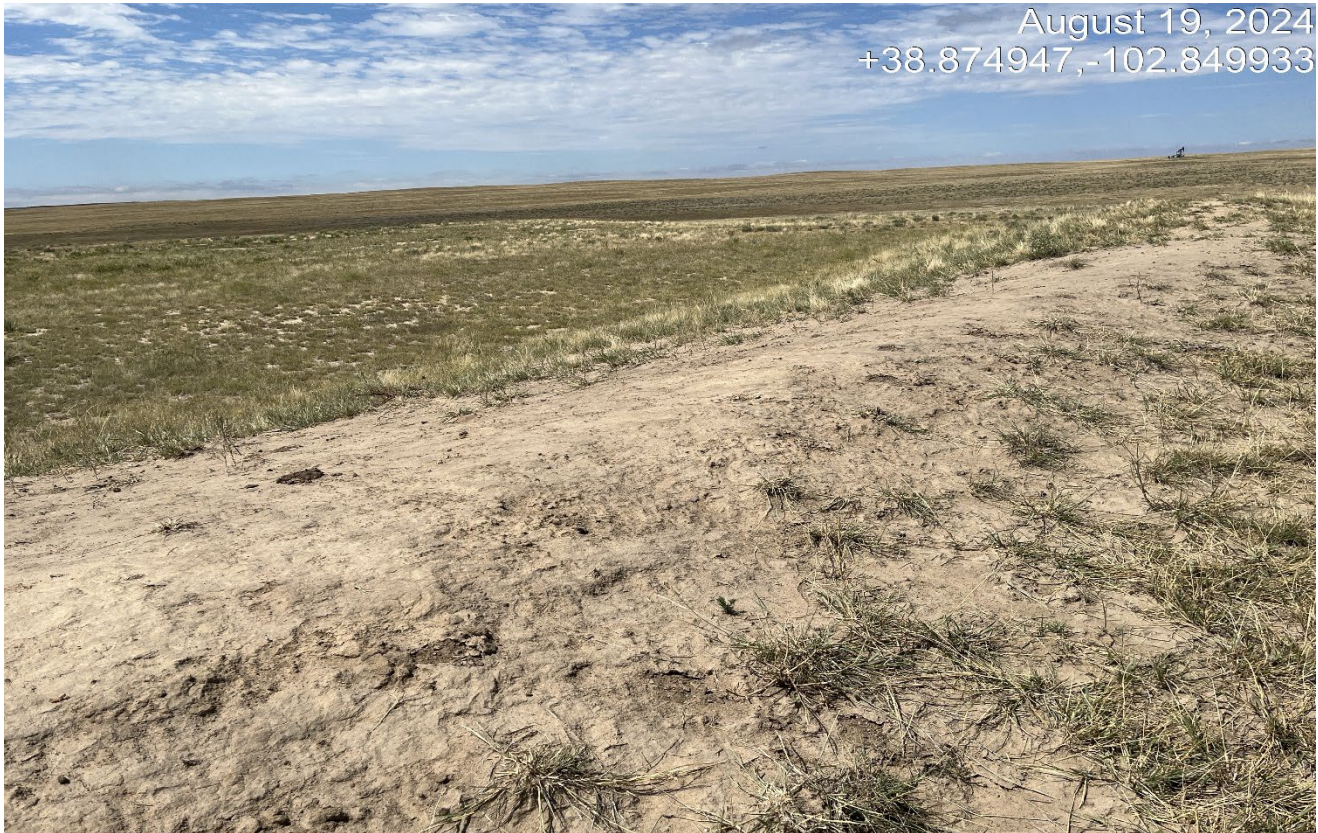
Photo 6. Facing southwest at the top of the cut slope. There is a berm along the top of the which needs to be recontoured along the cut slope

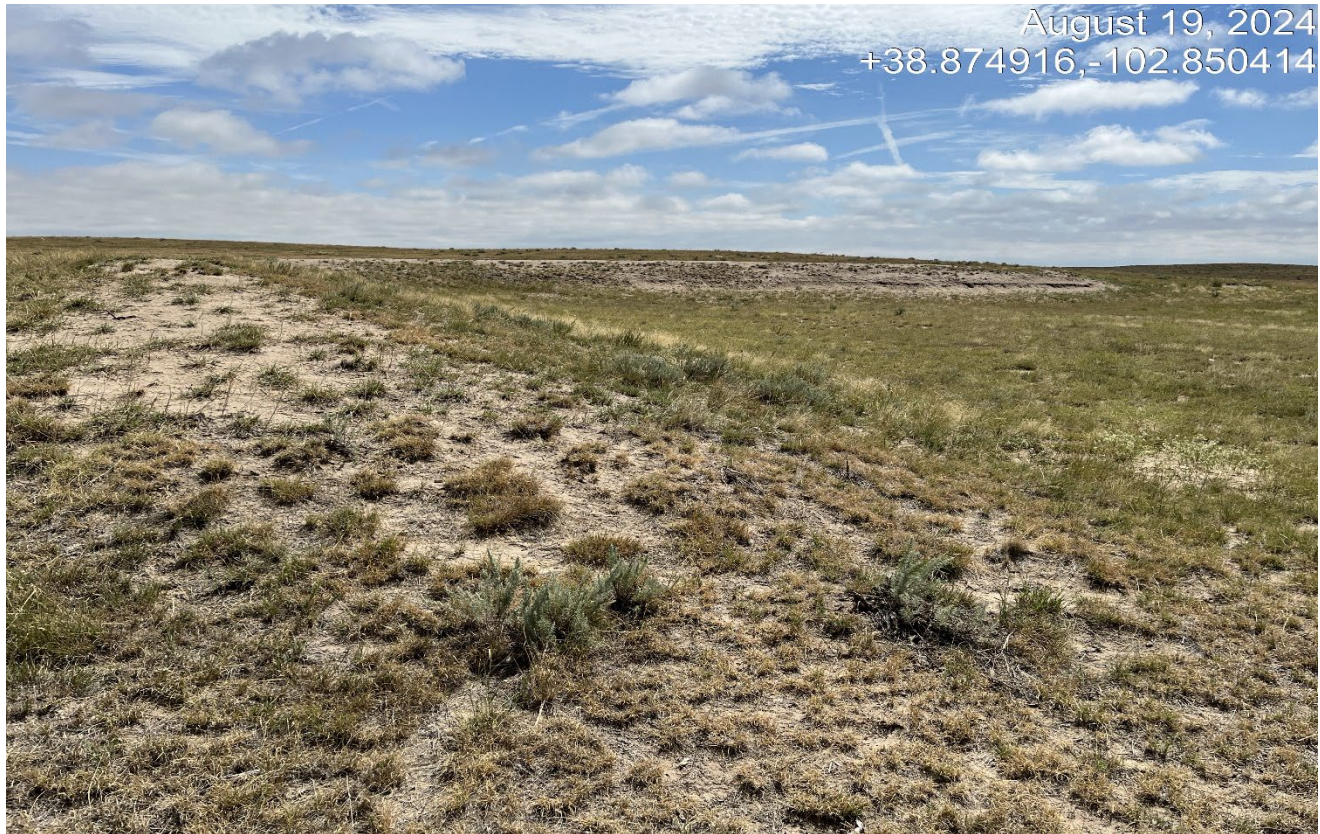
Photo 7. Facing southeast at the top of the cut slope. There is a berm along the top which needs to be recontoured along the cut slope.

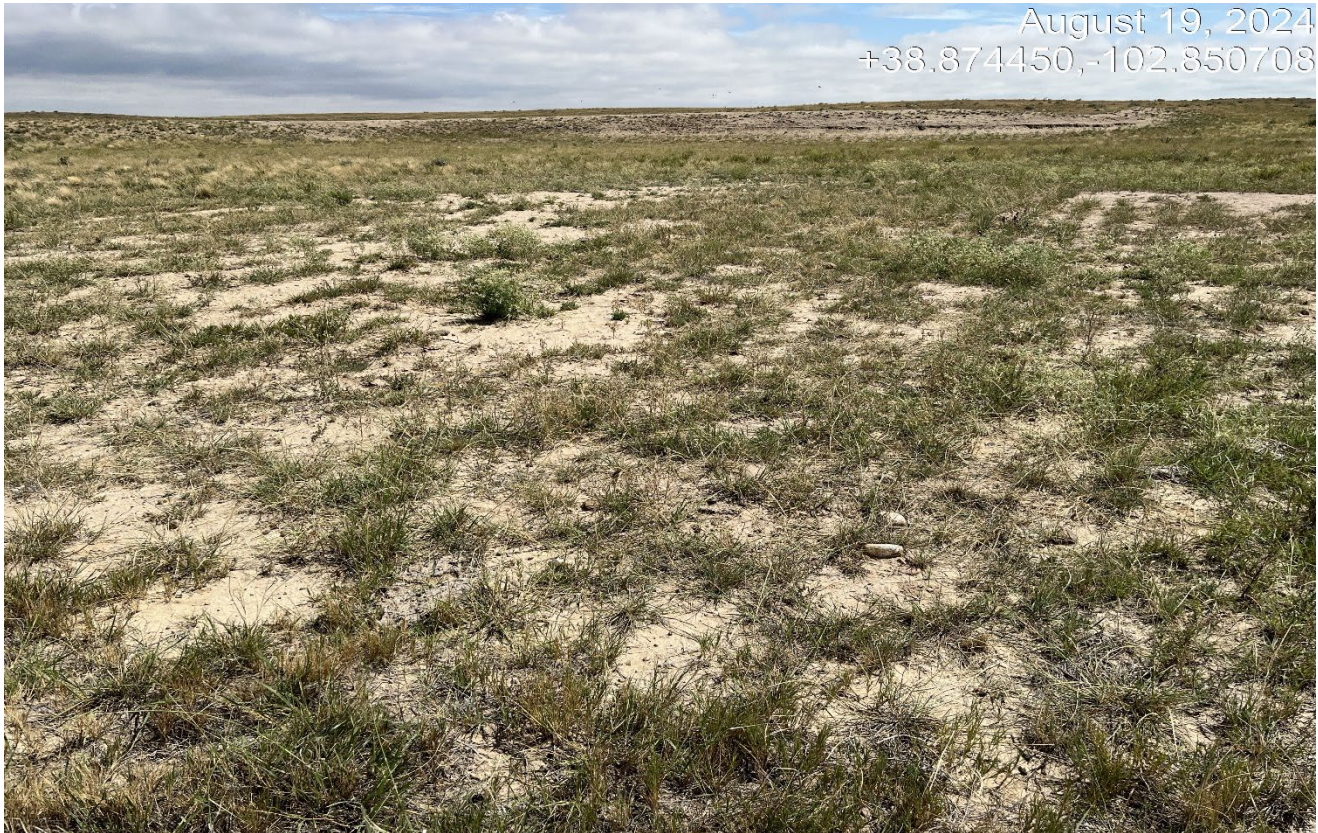
Photo 8. West side of the location facing east.

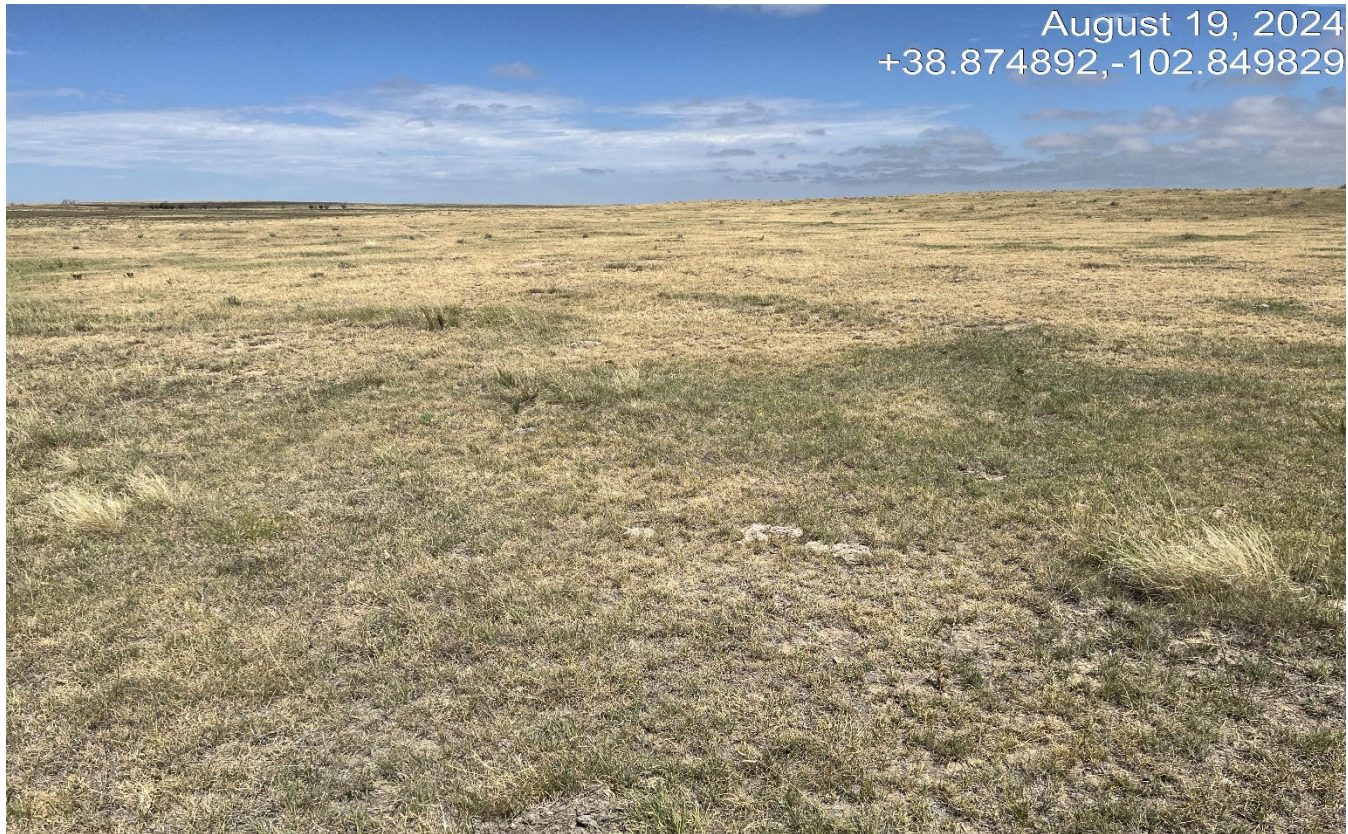
Photo 9. Facing north toward the surrounding undisturbed reference area.
