# Interim Reclamation and Stormwater Inspection

Operator: MDS ENERGY DEVELOPMENT - 10814

Location ID: 471039

Location Name: Castor 7-59 10

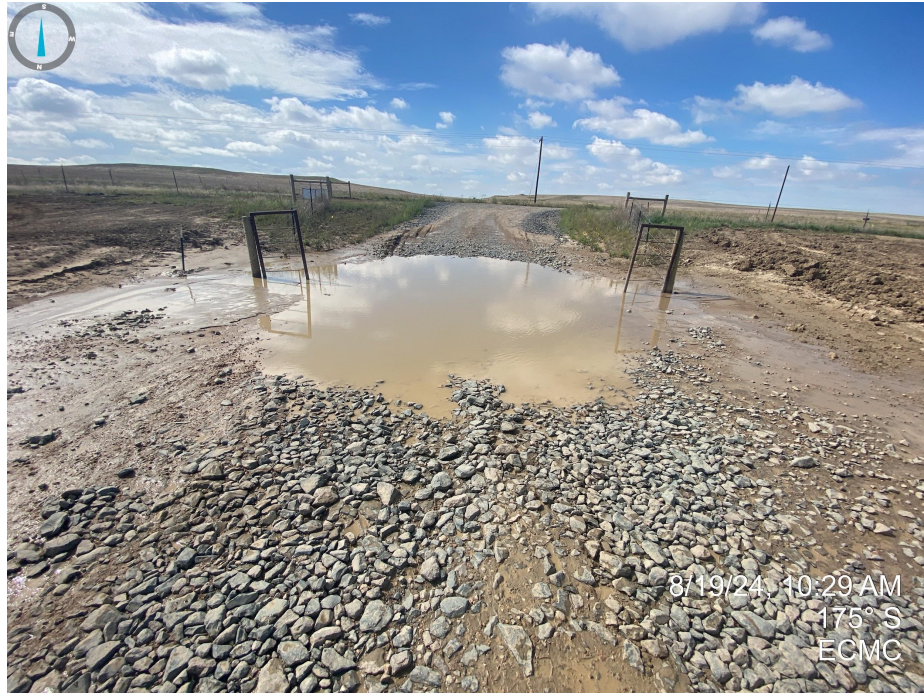
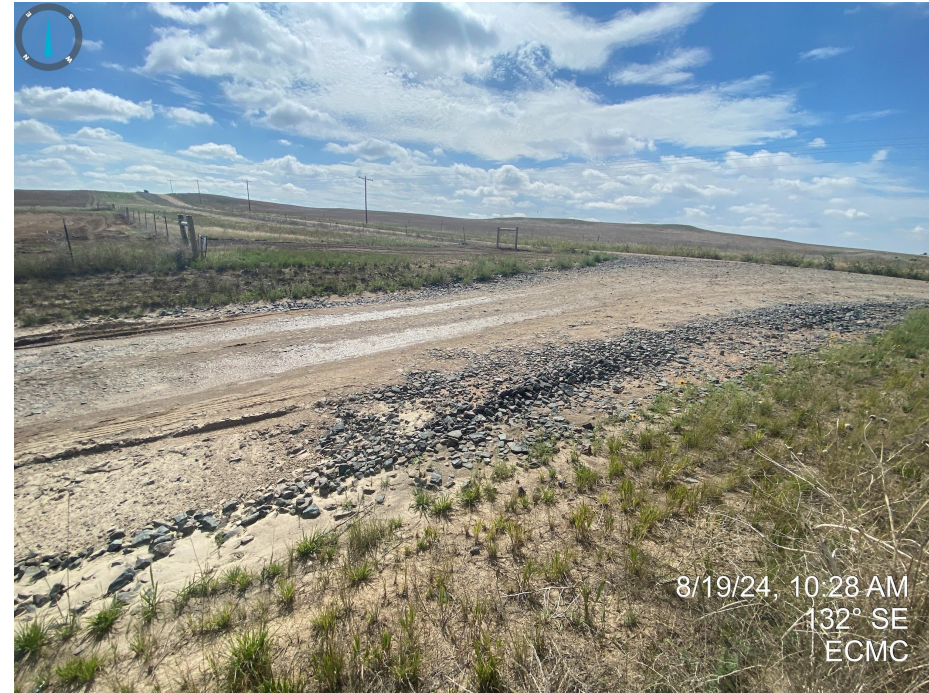
**Photos 1 & 2.** Cattle guard is submerged under stormwater and the track-out pad is filled with sediment. Additional stormwater control measures and/or maintenance required.

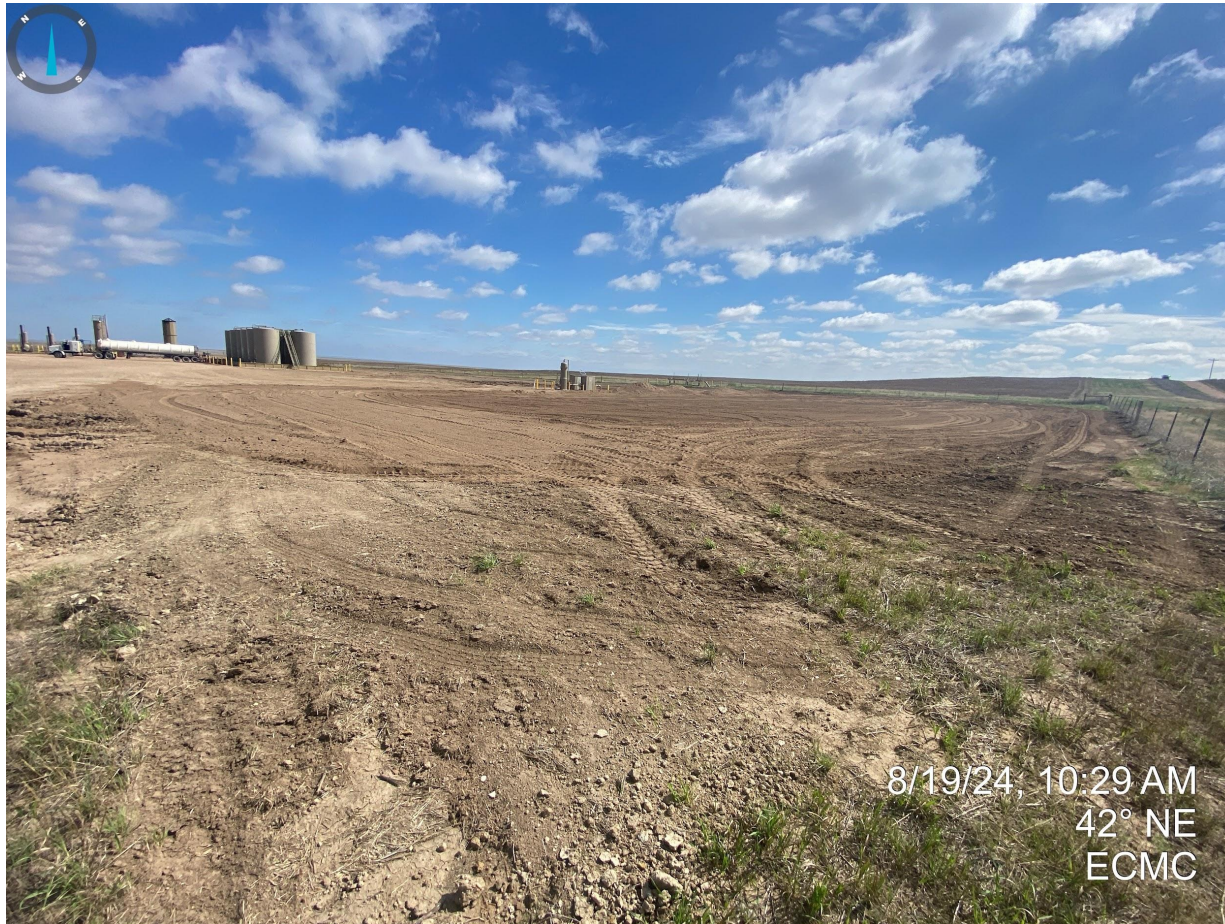
**Photo 3.** Southeast corner of location. Interim reclamation activities and topsoil importation had commenced at the time of this inspection.

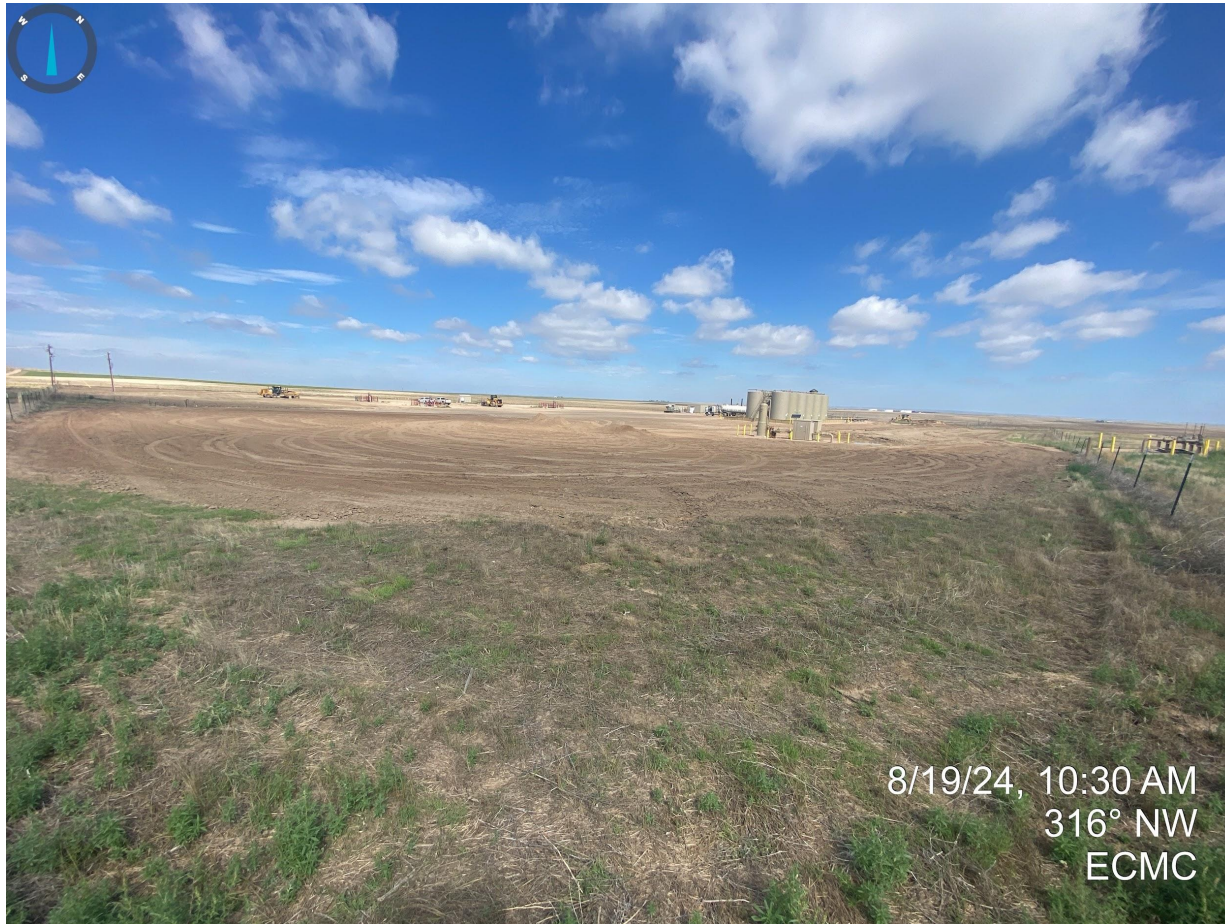
**Photo 4.** Southeast corner of location; see comments in Photo 3.

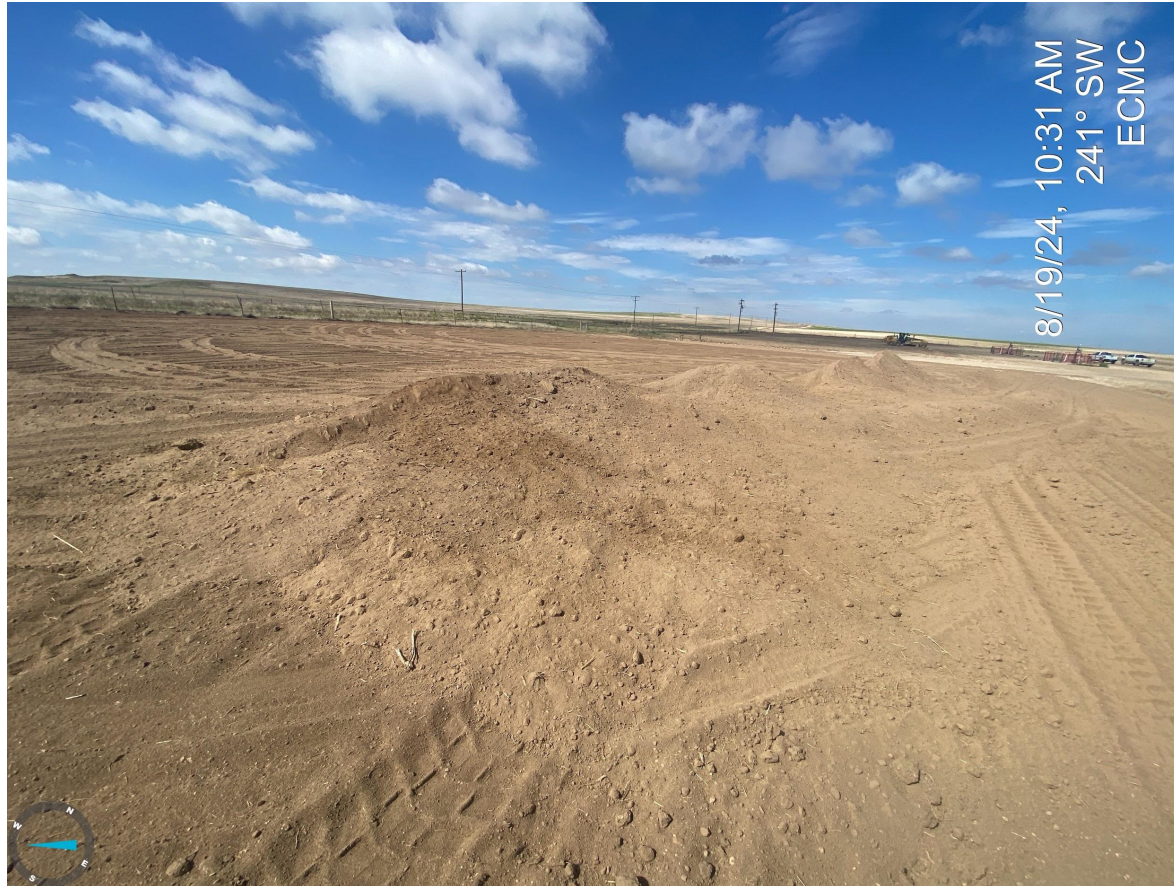
**Photo 5.** Close up photo of imported topsoil.

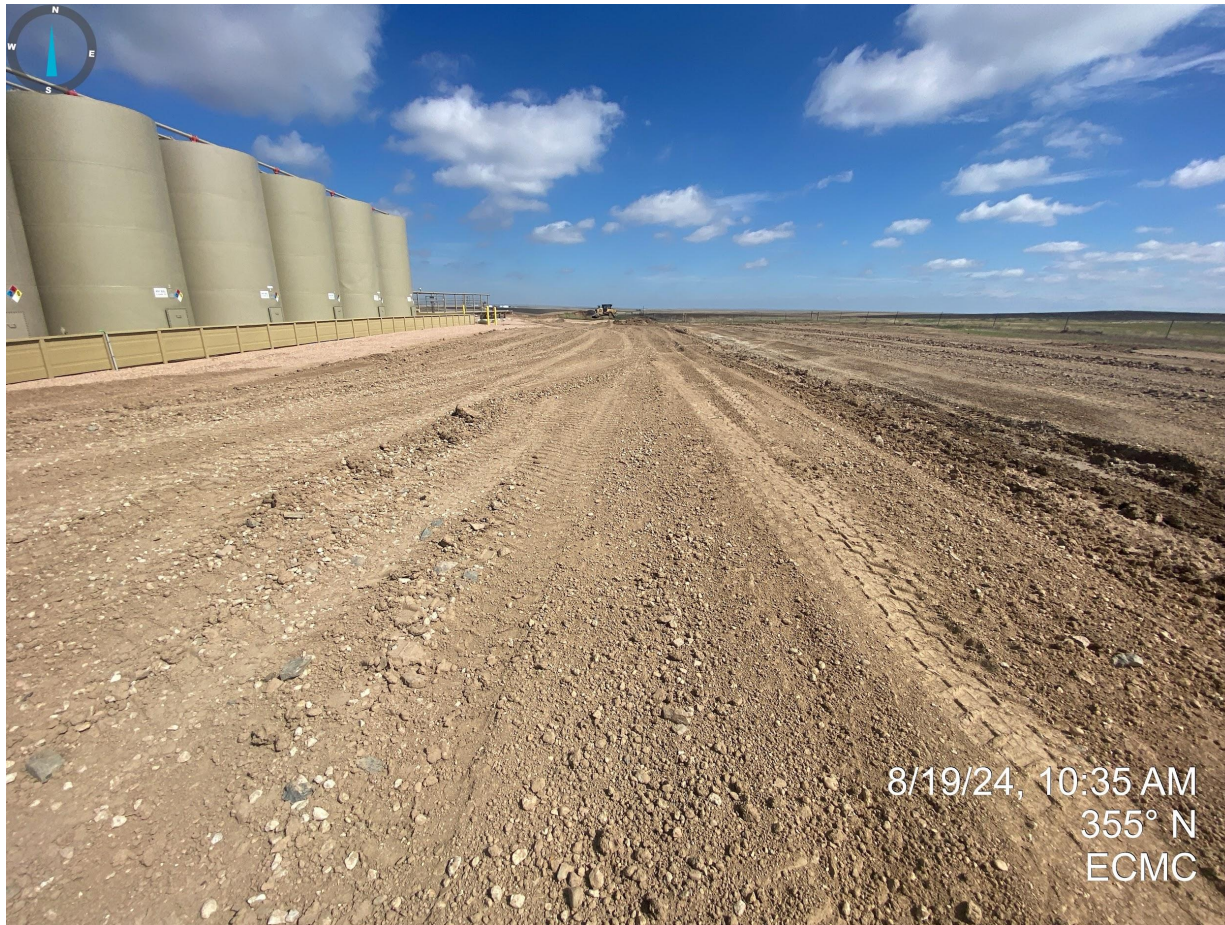
**Photo 6.** Sound wall holes have been covered up/backfilled resulting from interim reclamation activities.

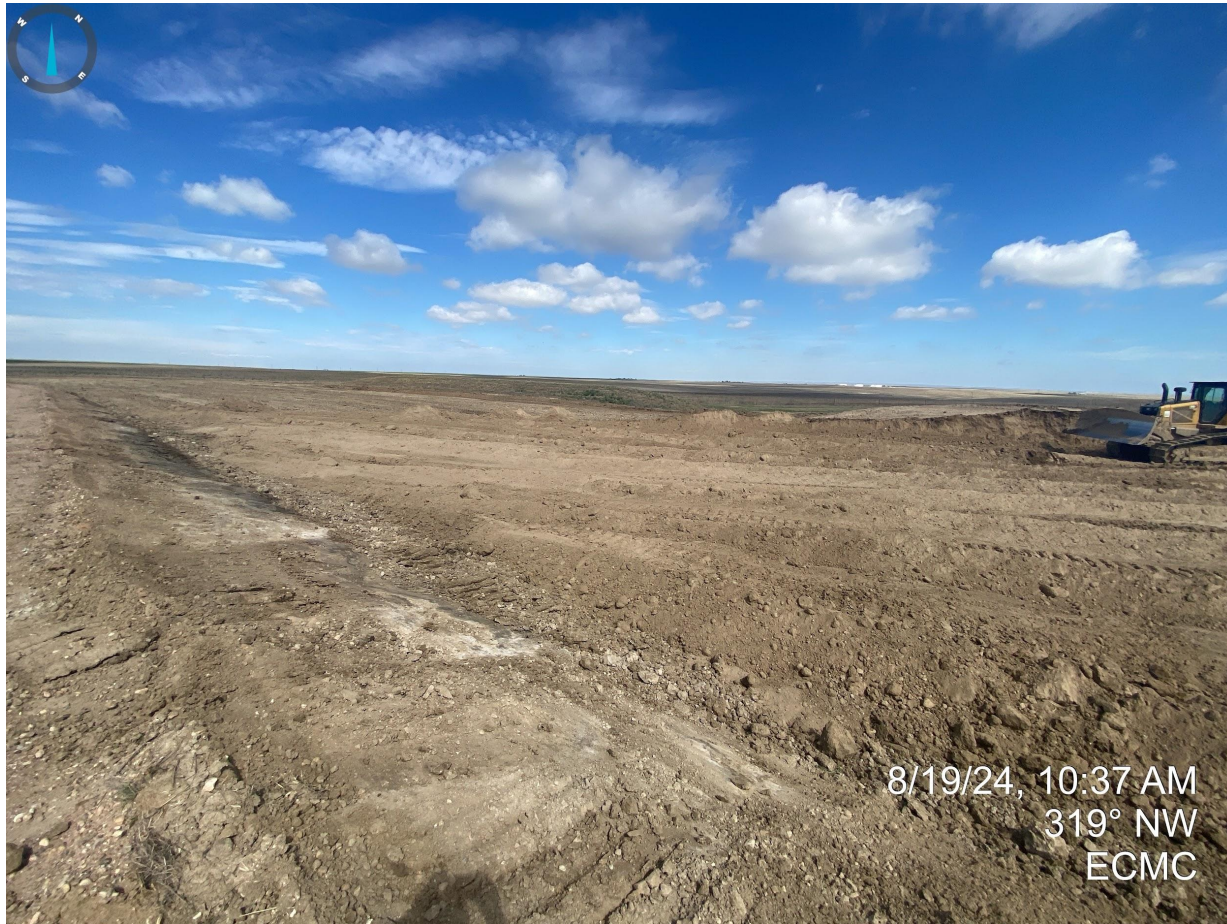
**Photo 7.** Northeast corner of production pad. Interim reclamation activities and topsoil importation had commenced at the time of this inspection.

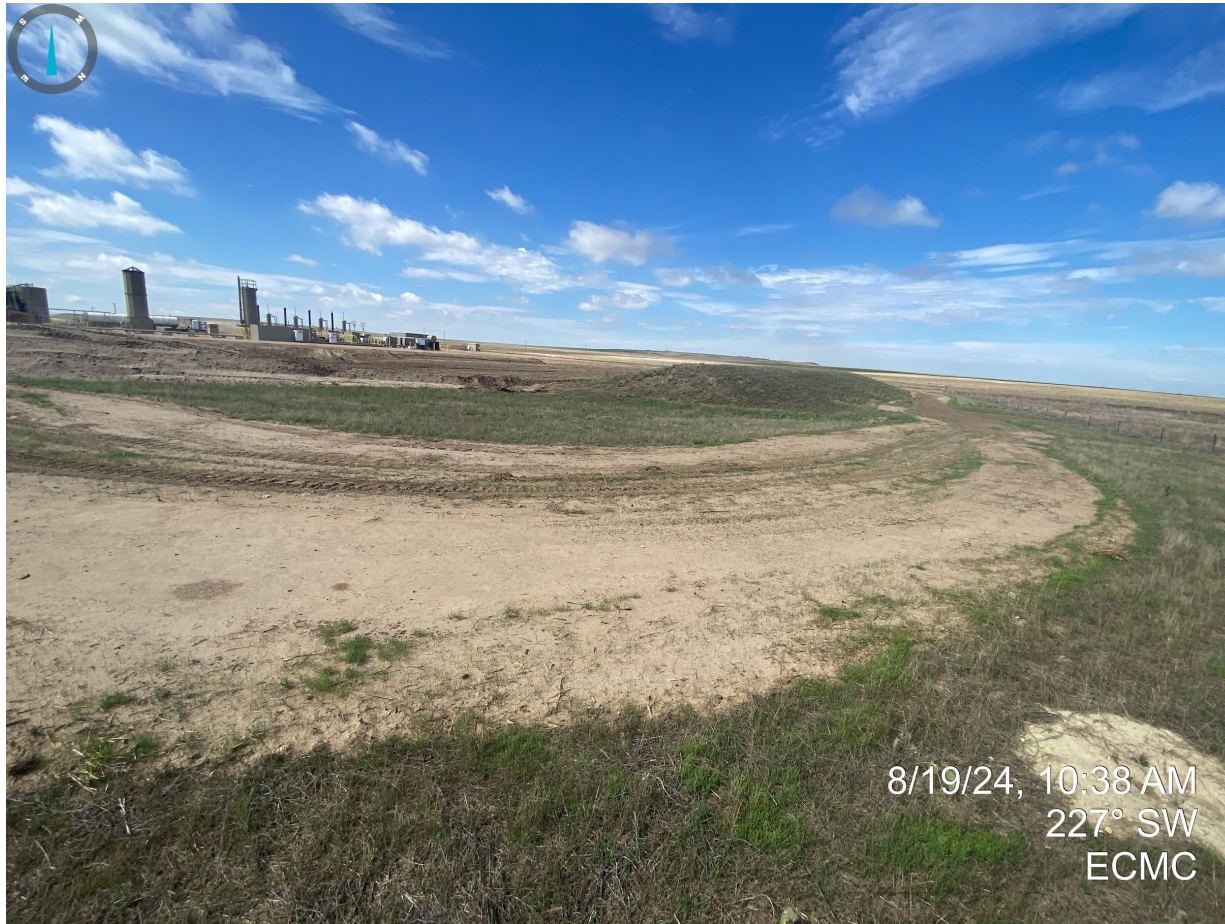
**Photo 8.** Northeast corner of the disturbance area. Photo illustrates that perimeter stormwater controls (ditch and berm) have been uninstalled/removed at the time of this inspection.

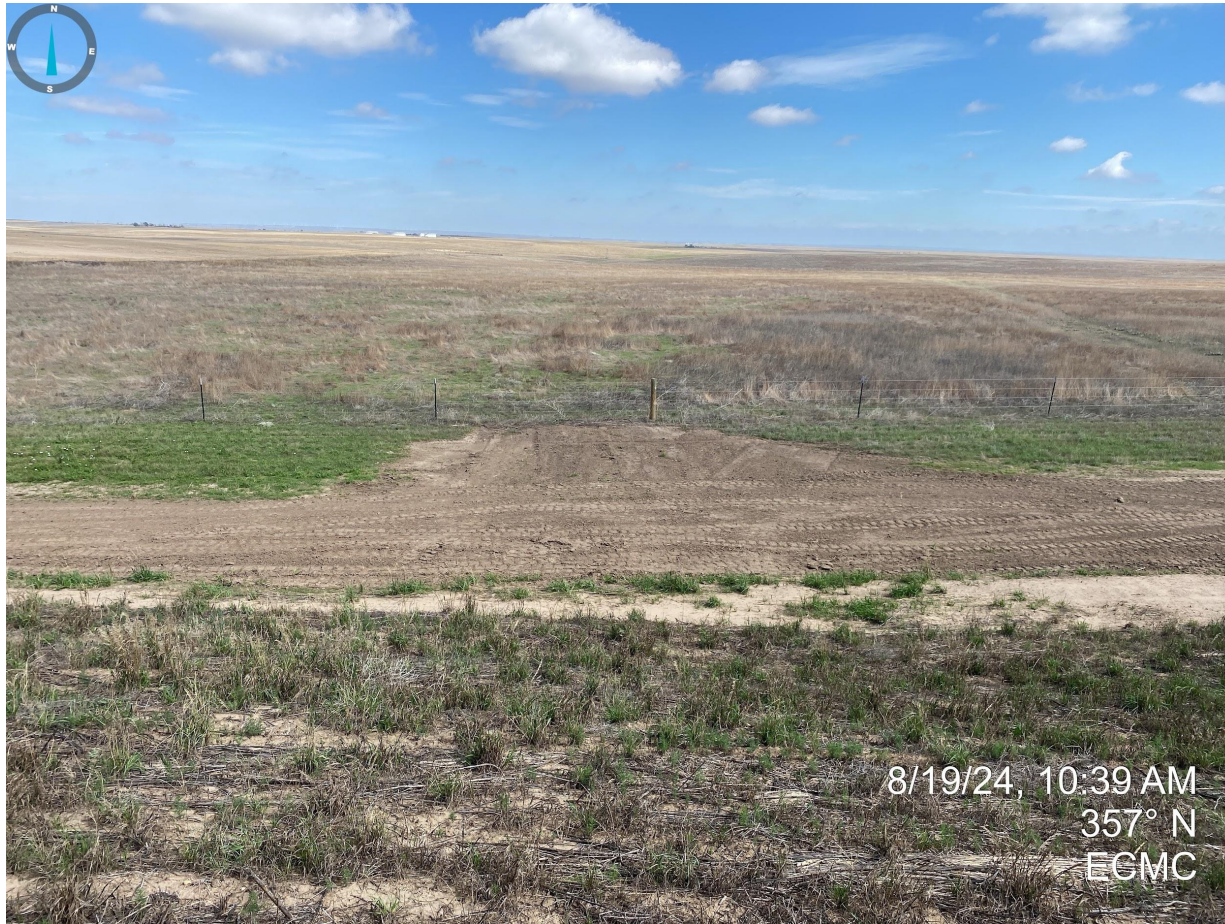
**Photo 9.** Northern/center portion of the disturbance area. Photo illustrates that stormwater control measures (ditch and berm, sediment trap) have been uninstalled/removed at the time of this inspection.

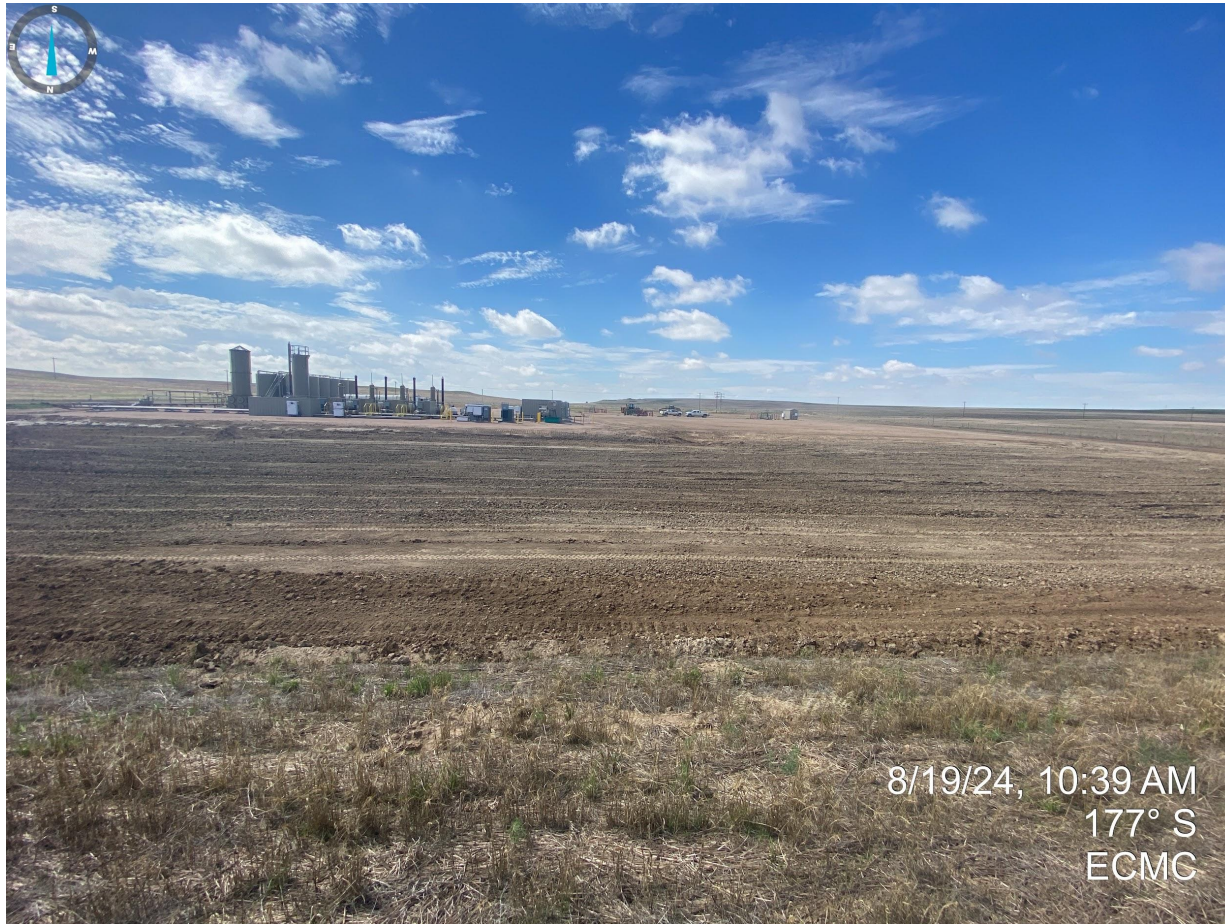
**Photo 10.** Overview of interim reclamation areas; photo taken from top of existing topsoil stockpile.

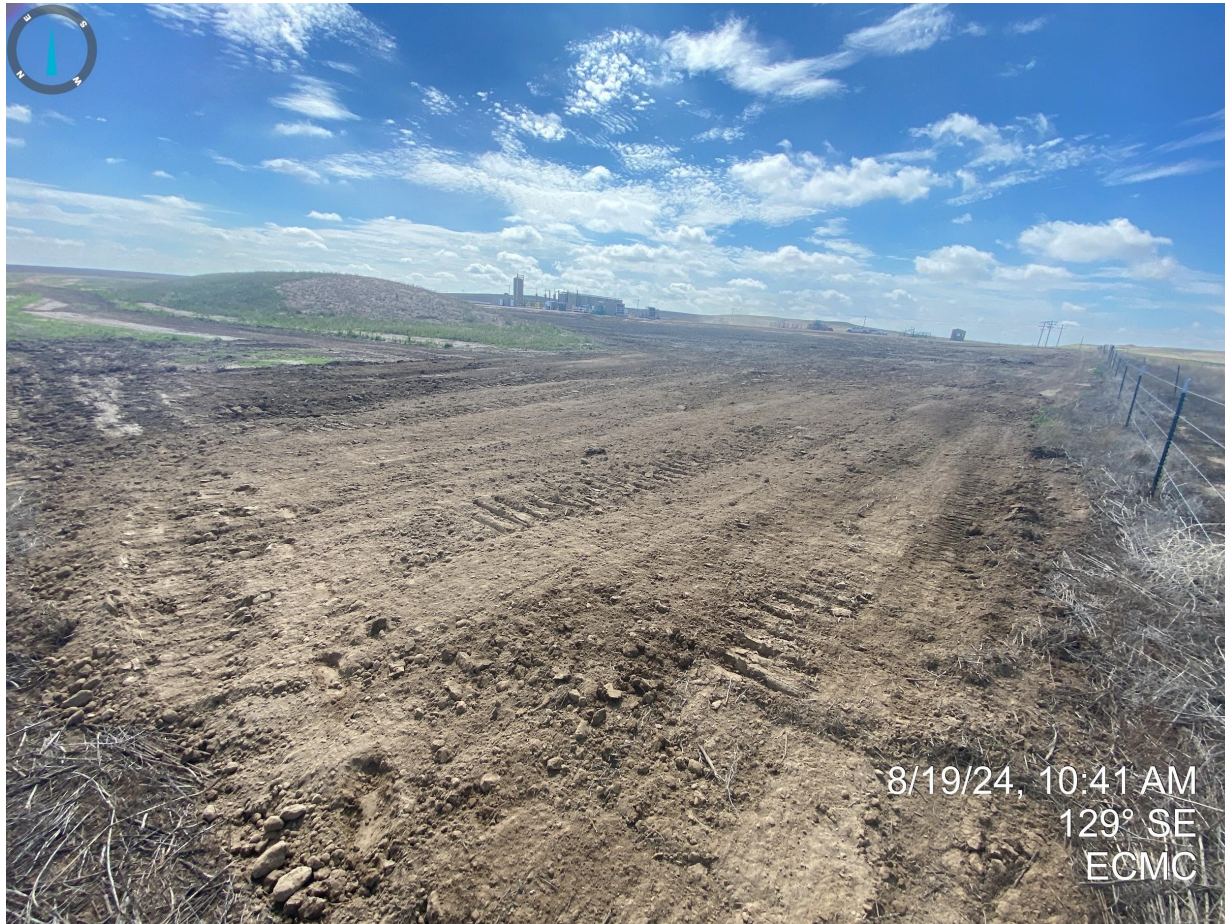
**Photo 11.** Taken from the northwest corner of the disturbance area. Photo illustrates that the sediment trap has been uninstalled/removed.

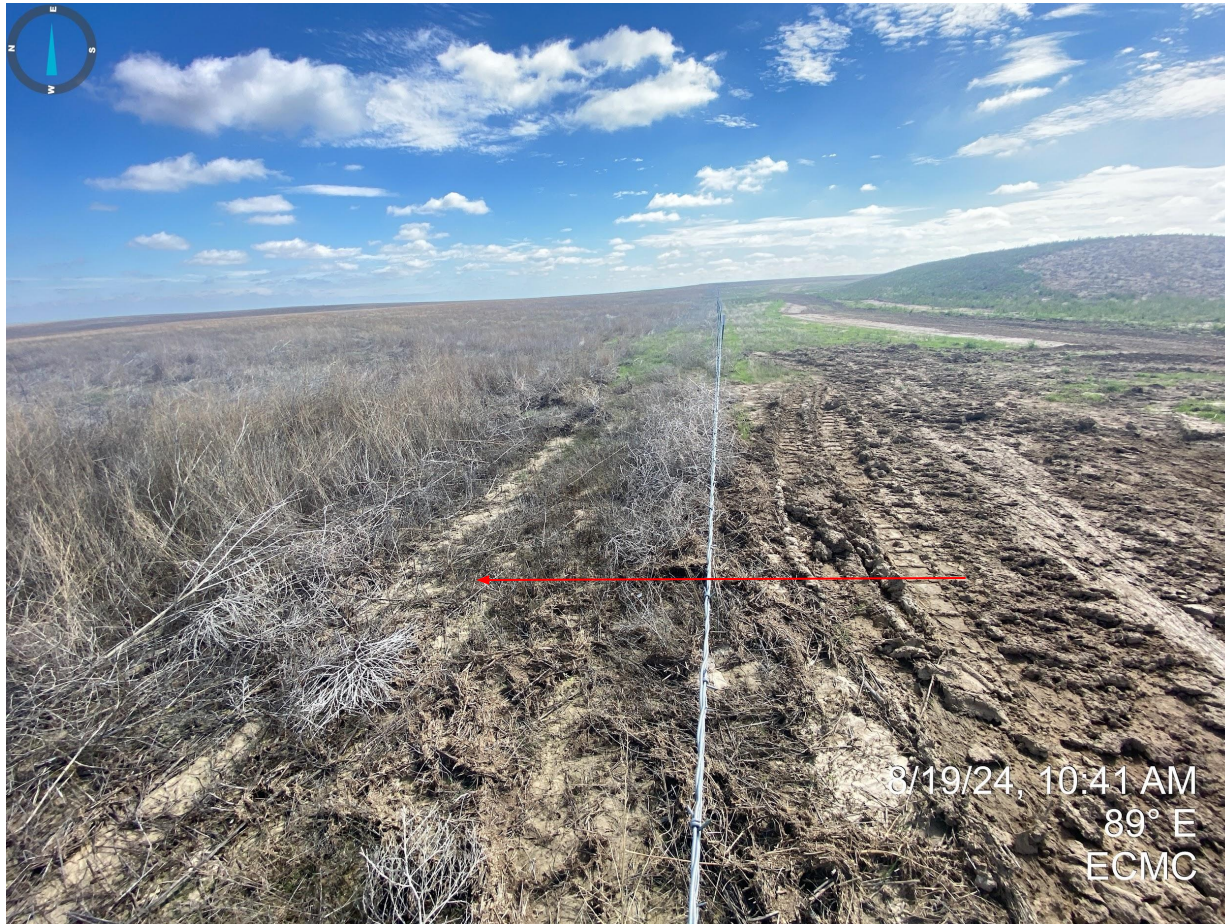
**Photo 12.** Continued from Photo 11. Photo illustrates off-location sediment transport into adjacent lands, immediately north of the former sediment trap.

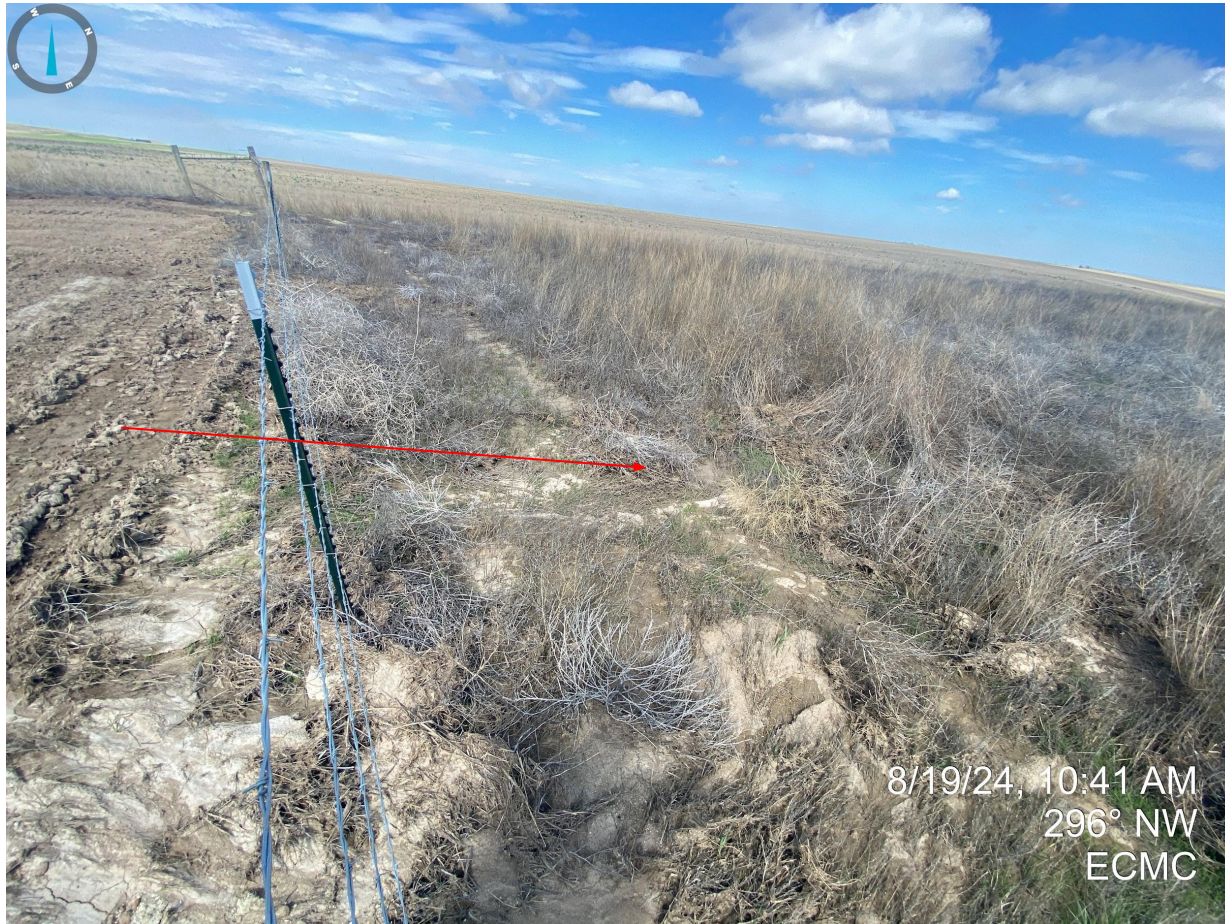
**Photo 13.** Continued from Photos 11 & 12; off-location sediment transport with no apparent stormwater control measures observed that would prevent sediment laden stormwater from exiting off location.

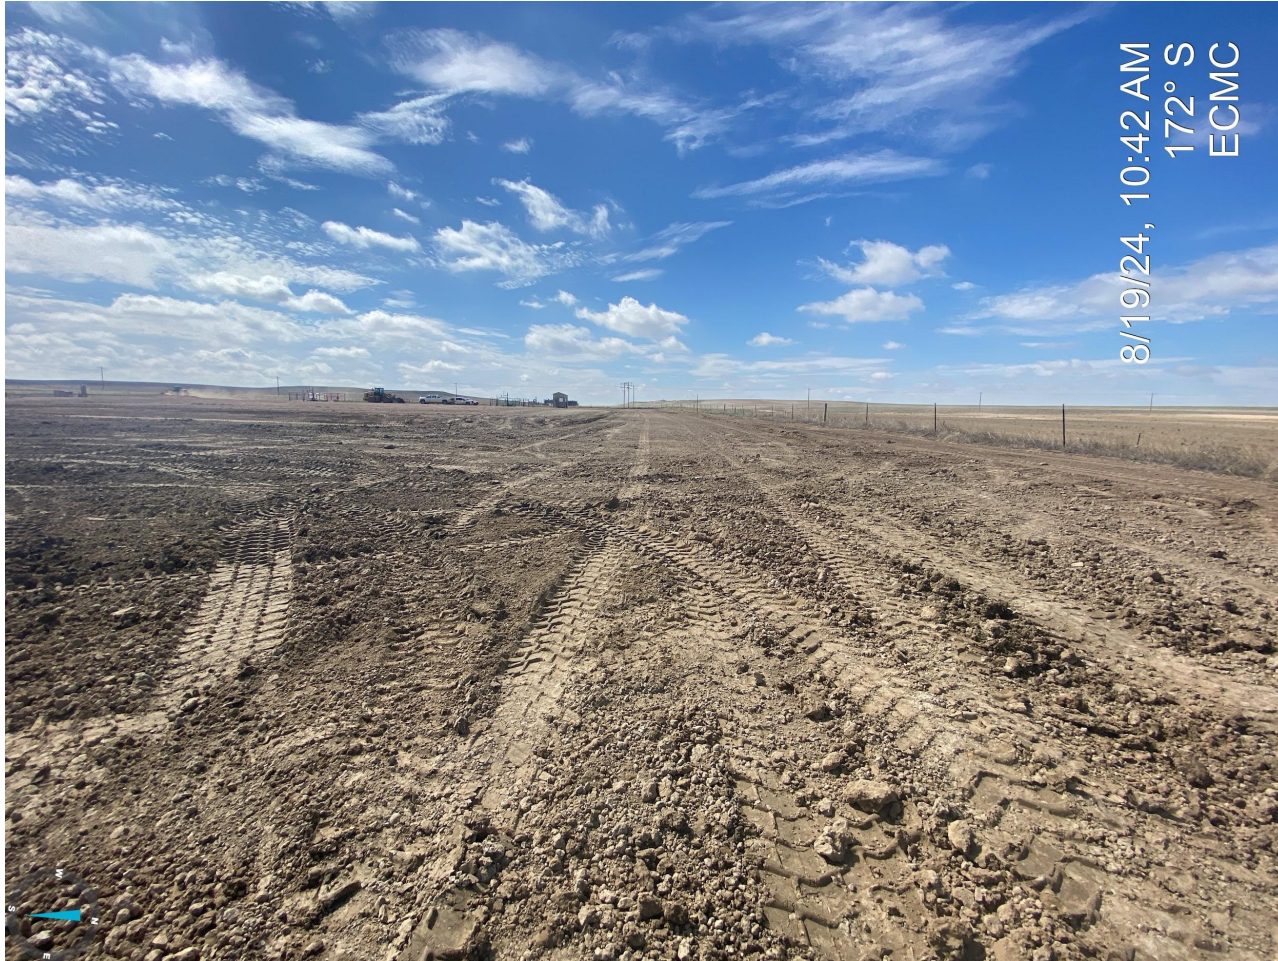
**Photo 14.** Taken from the western portion of the disturbance area. Photo illustrates that stormwater controls measures (perimeter ditch and berm, and sediment traps) have been removed/uninstalled.

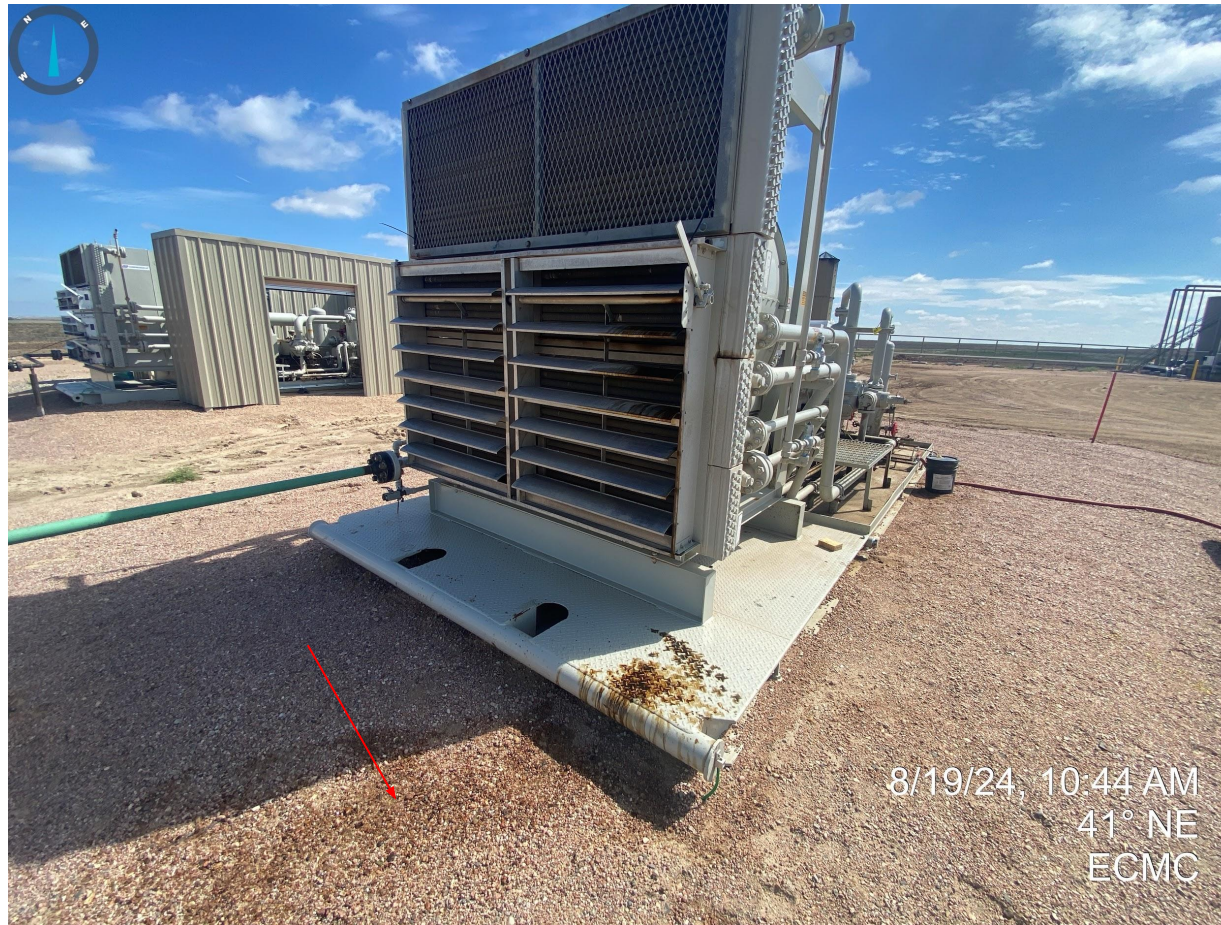
**Photo 15.** Stained soil observed at compressor station; leak appears to be coming from compressor fan/coils.

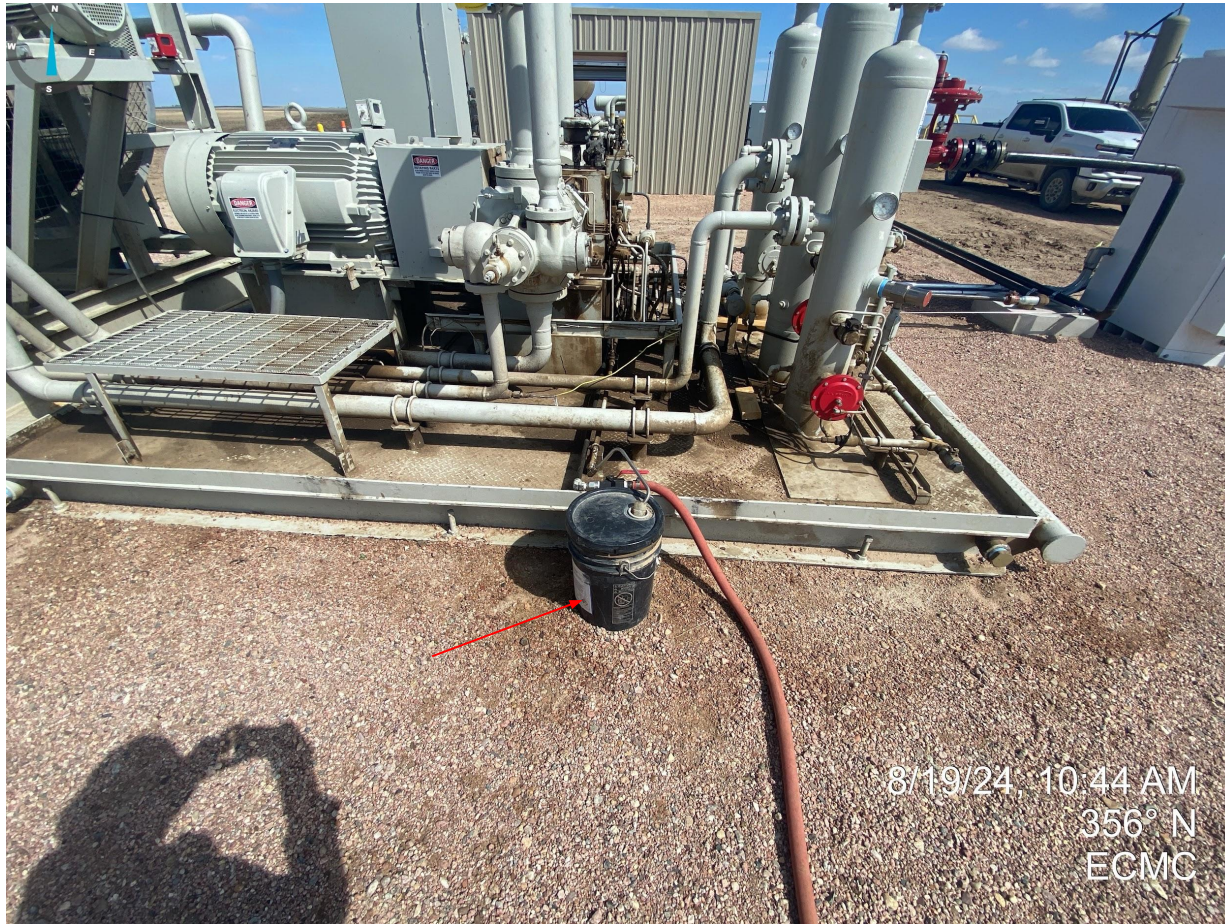
**Photo 16.** 5 gallon bucket outside of secondary containment.

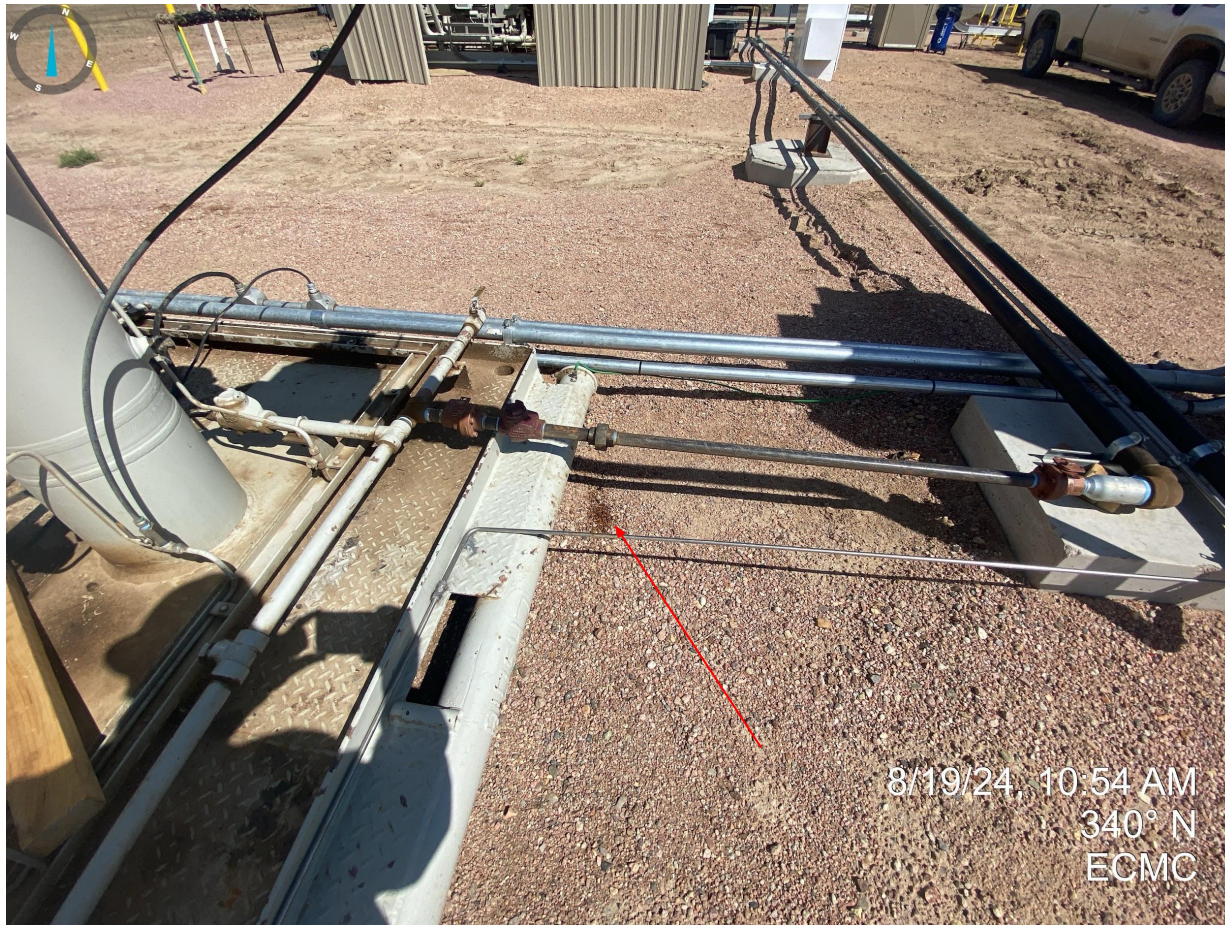
**Photo 17.** Stained soil observed at compressor skid.

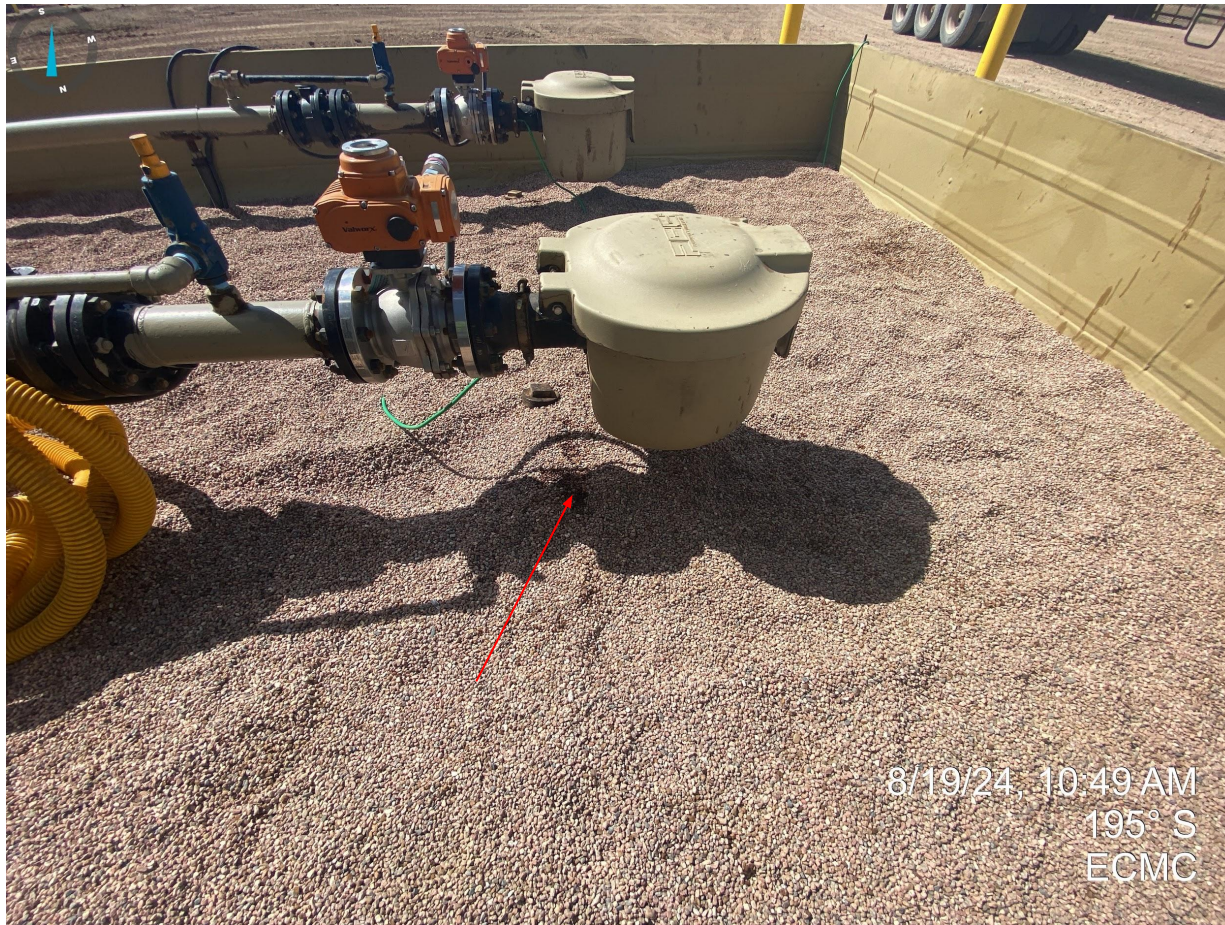
**Photo 18.** New discovery of stained soil at loadout lines.

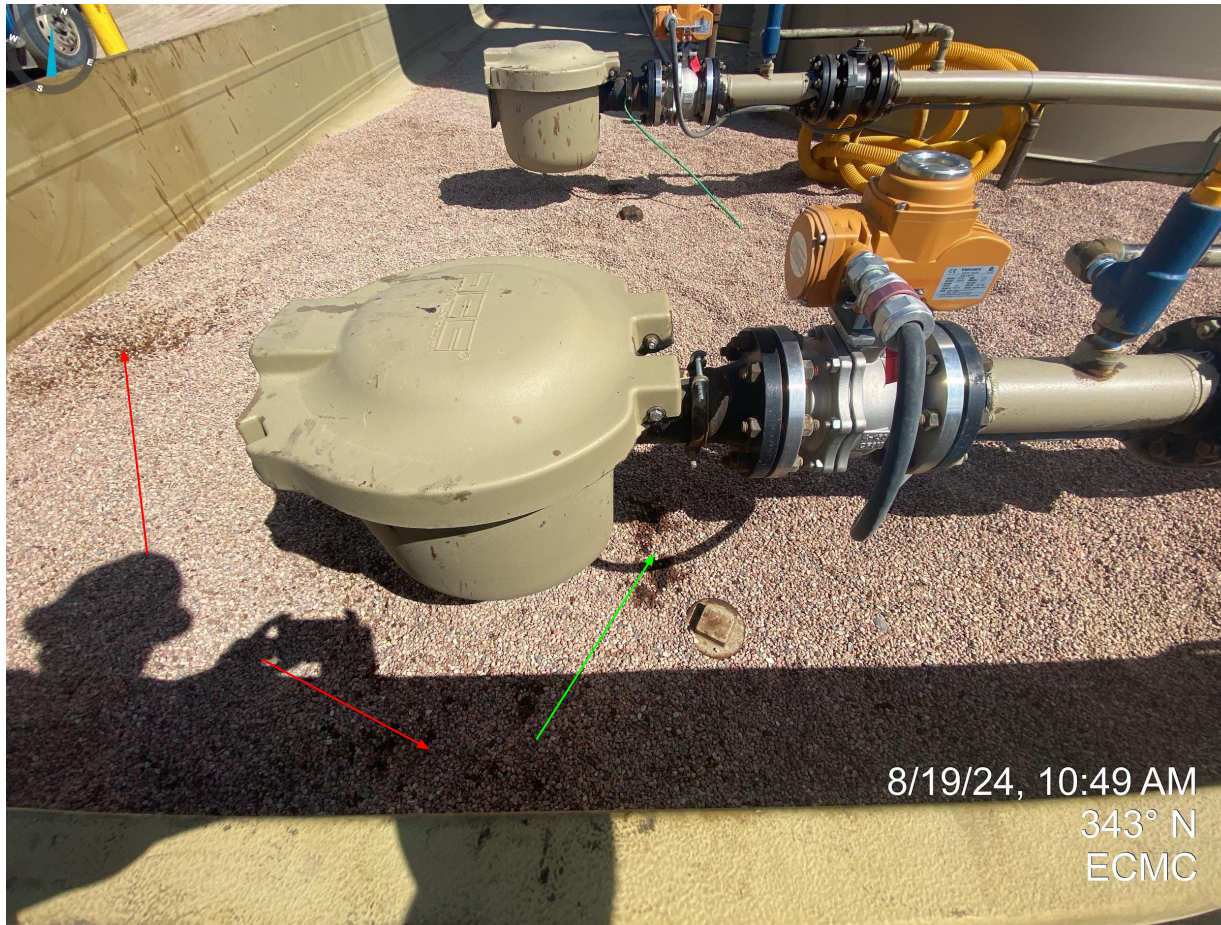
**Photo 19.** Green arrow indicates previous discovery of stained soil observed on FIR doc# 708201482 (Photo 5 of inspection photos) which does not appear to have been removed. Red arrows indicate stained soil observed at time of this inspection.

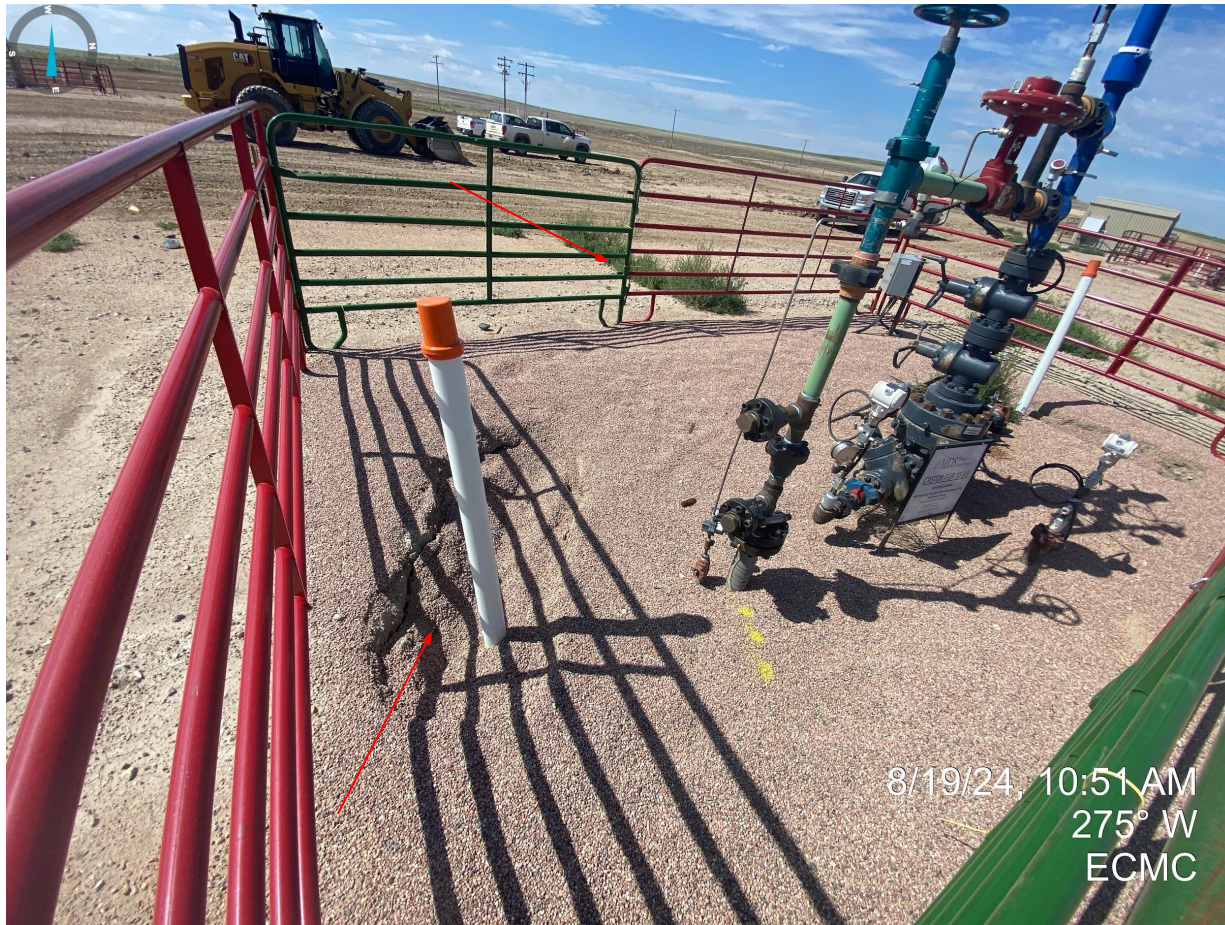
**Photo 20.** Subsidence observed at Well API 123-50751. Also pictured, undesirable vegetation (kochia and russian thistle).
