# Interim Reclamation and Stormwater Inspection

Operator: MDS ENERGY DEVELOPMENT - 10814

Location ID: 471039

Location Name: Castor 7-59 10

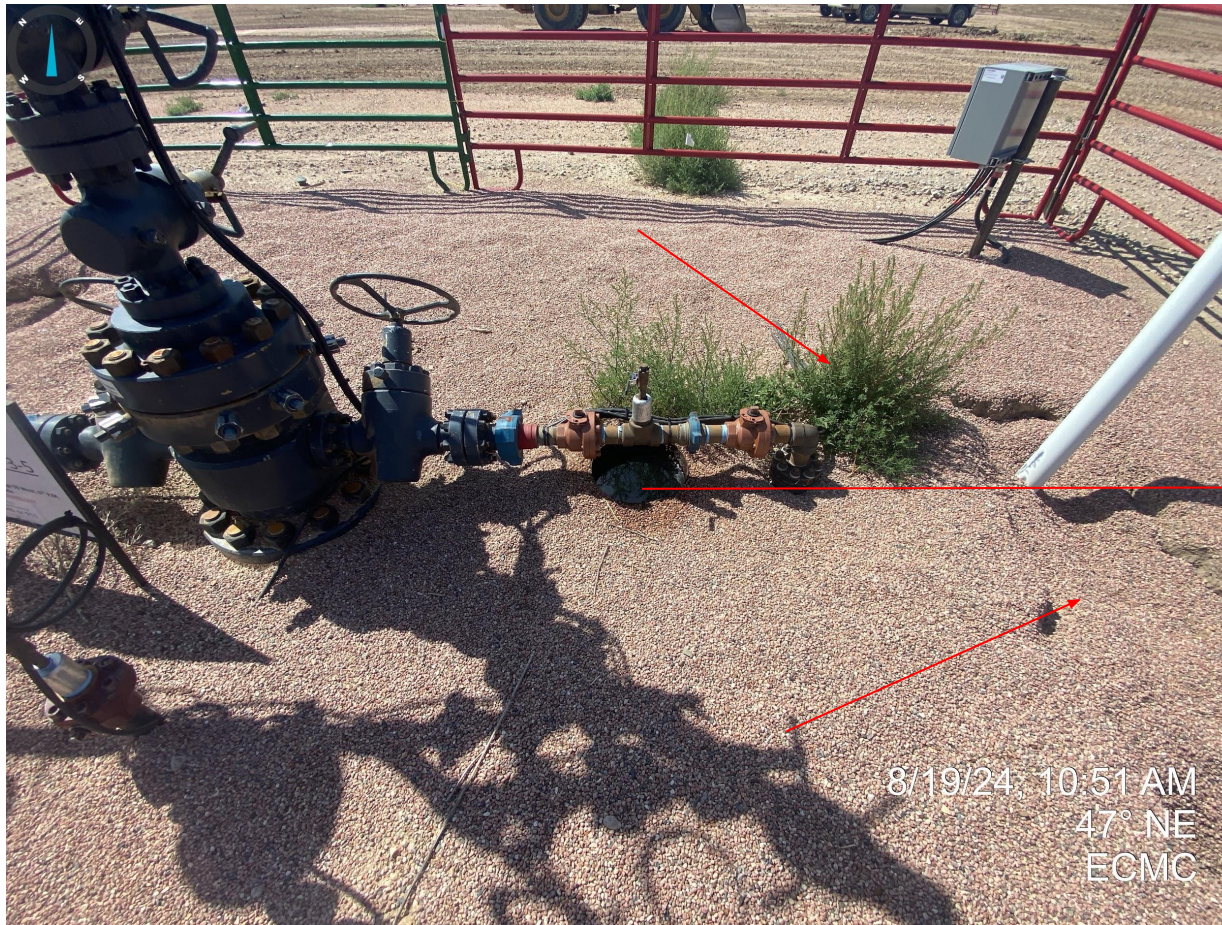
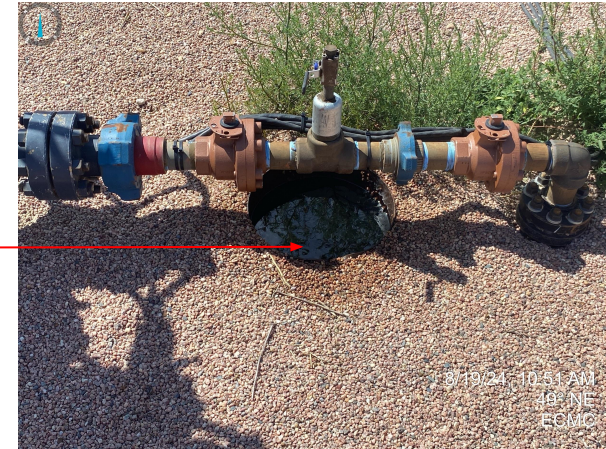
**Photo 21.** Continued from Photo 20. Undesirable vegetation, subsidence and unidentified fluid within mouse/rat hole.

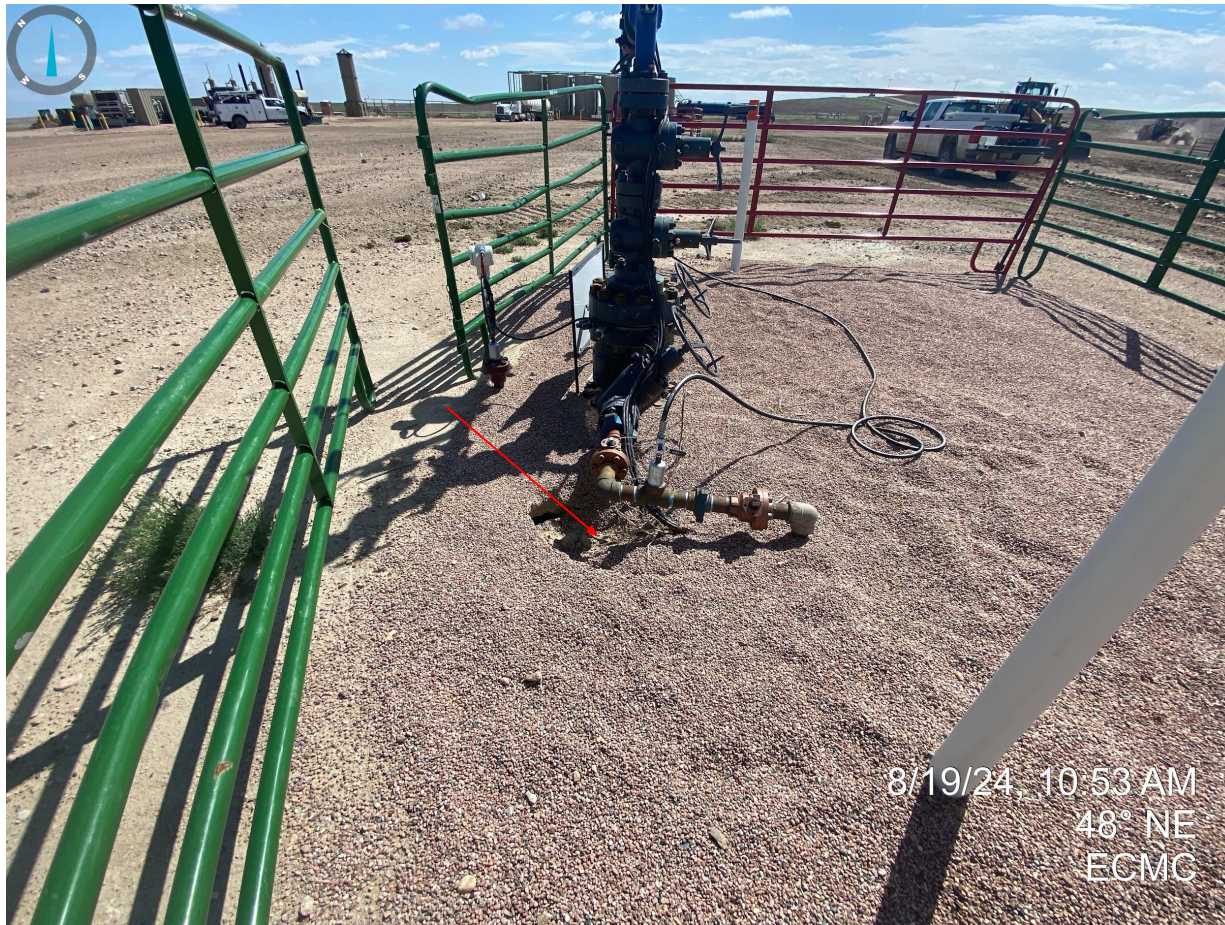
**Photo 23.** Subsidence observed at Well API 123-50750.

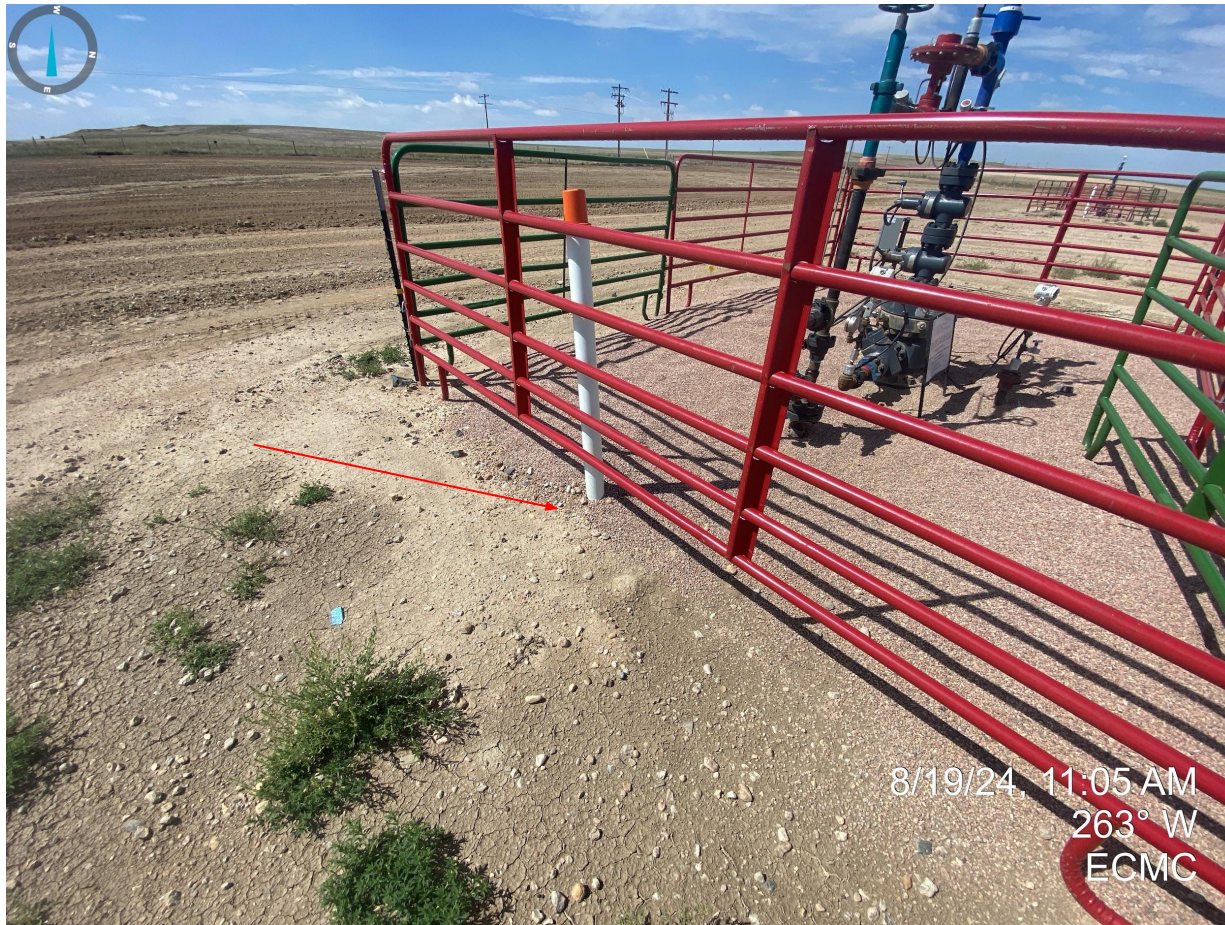
**Photo 24.** Previous subsidence at Well API 123-50755 appears to have been backfilled and repaired.
