Interim Reclamation and Stormwater Inspection

Date: 08/19/2024

Operator: RED HAWK PETROLEUM LLC - 10503

Location ID: 433082

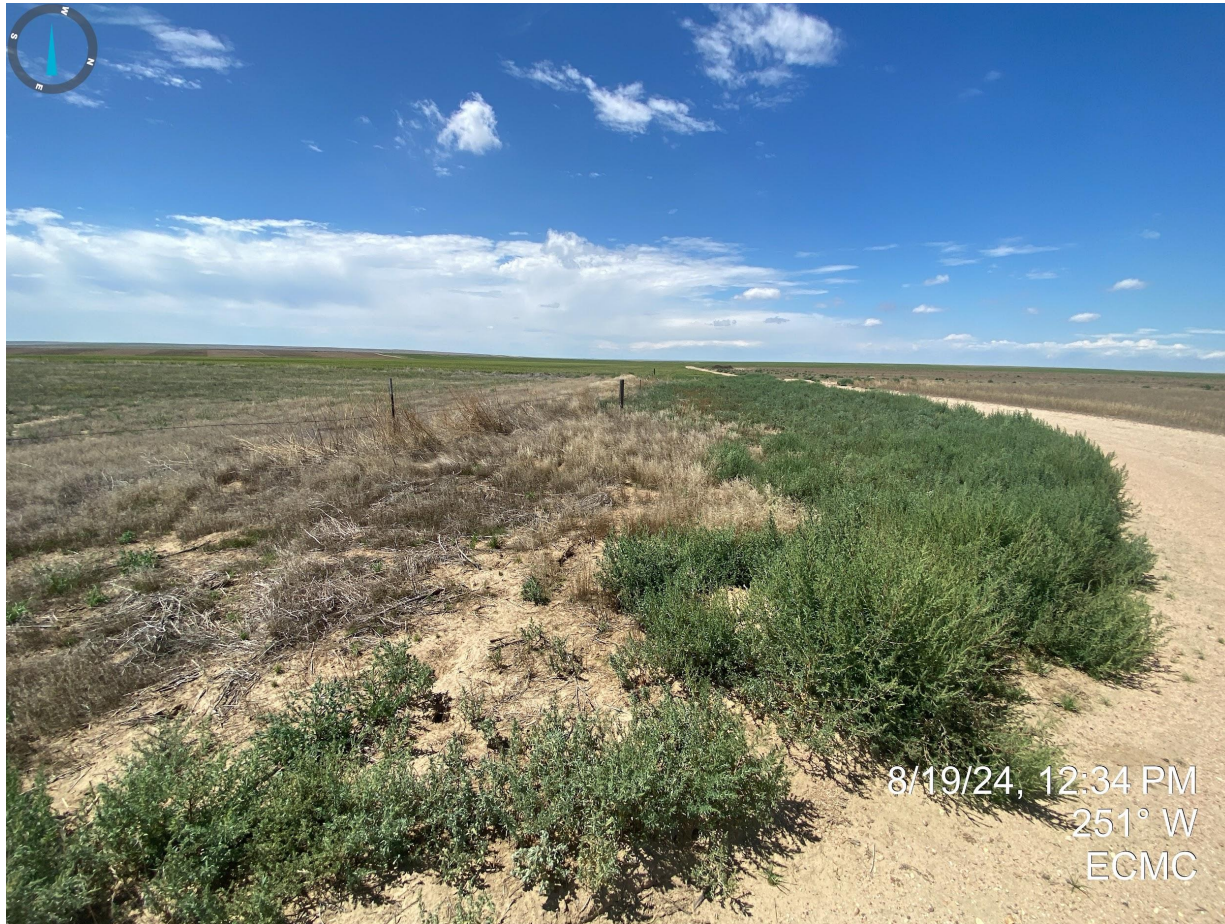
Photo 1. Facing west at the location entrance. Undesirable vegetation (kochia) growing along location and access road.

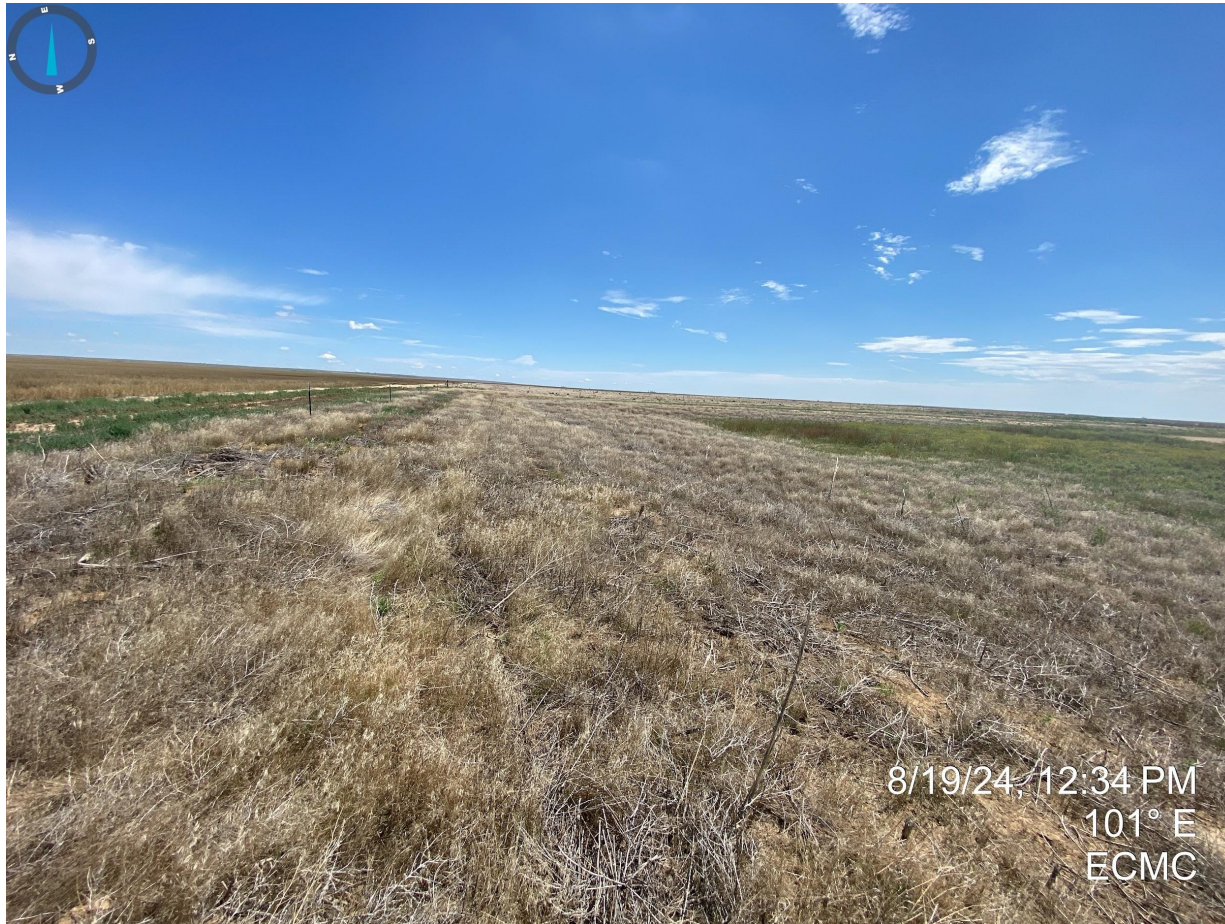
Photo 2. Northern interim areas are comprised of mainly CO List C Noxious Weed - cheatgrass; it appears that cheatgrass has already seeded out at the time of this inspection.

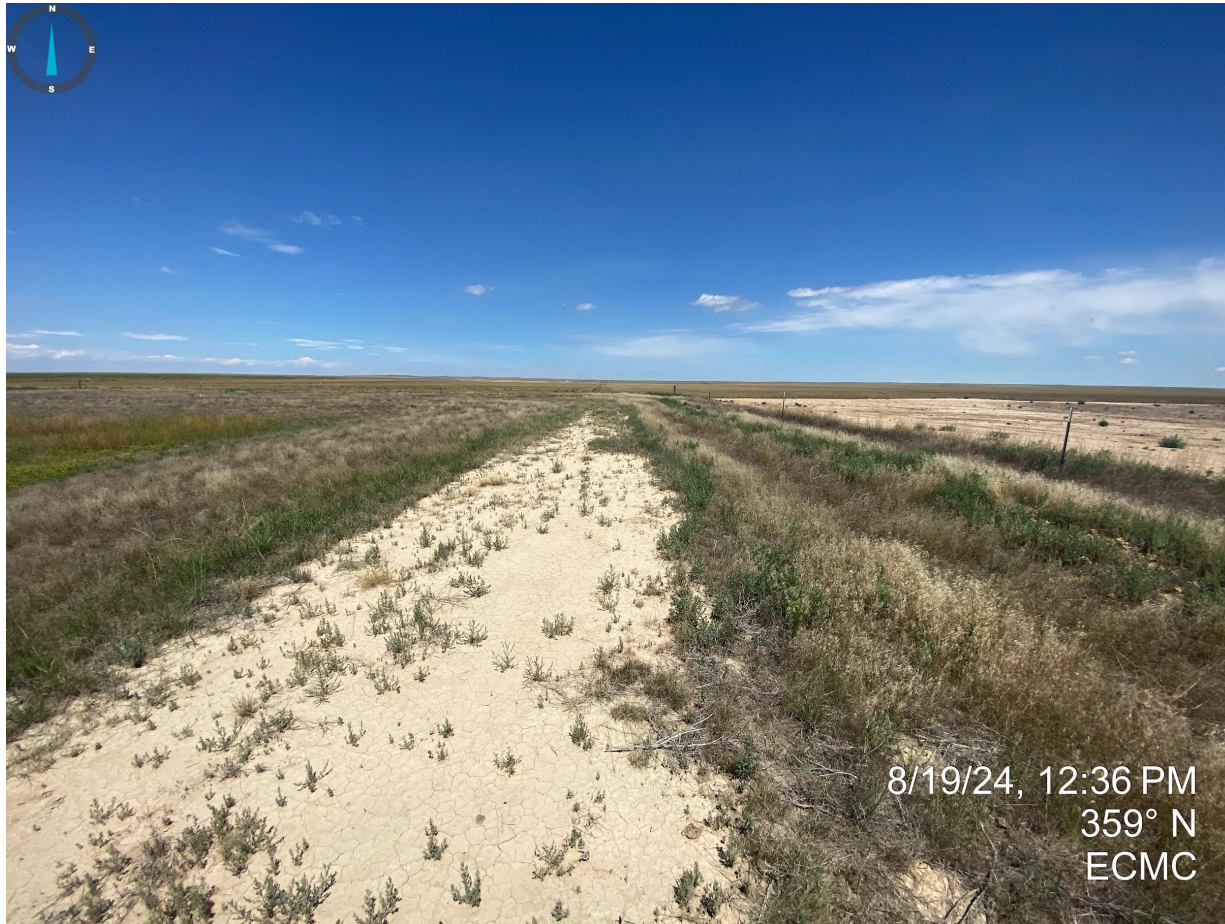
Photo 3. Eastern interim areas have evidence of non-uniform vegetation cover resulting in bare soil and CO List C Noxious Weed - cheatgrass.

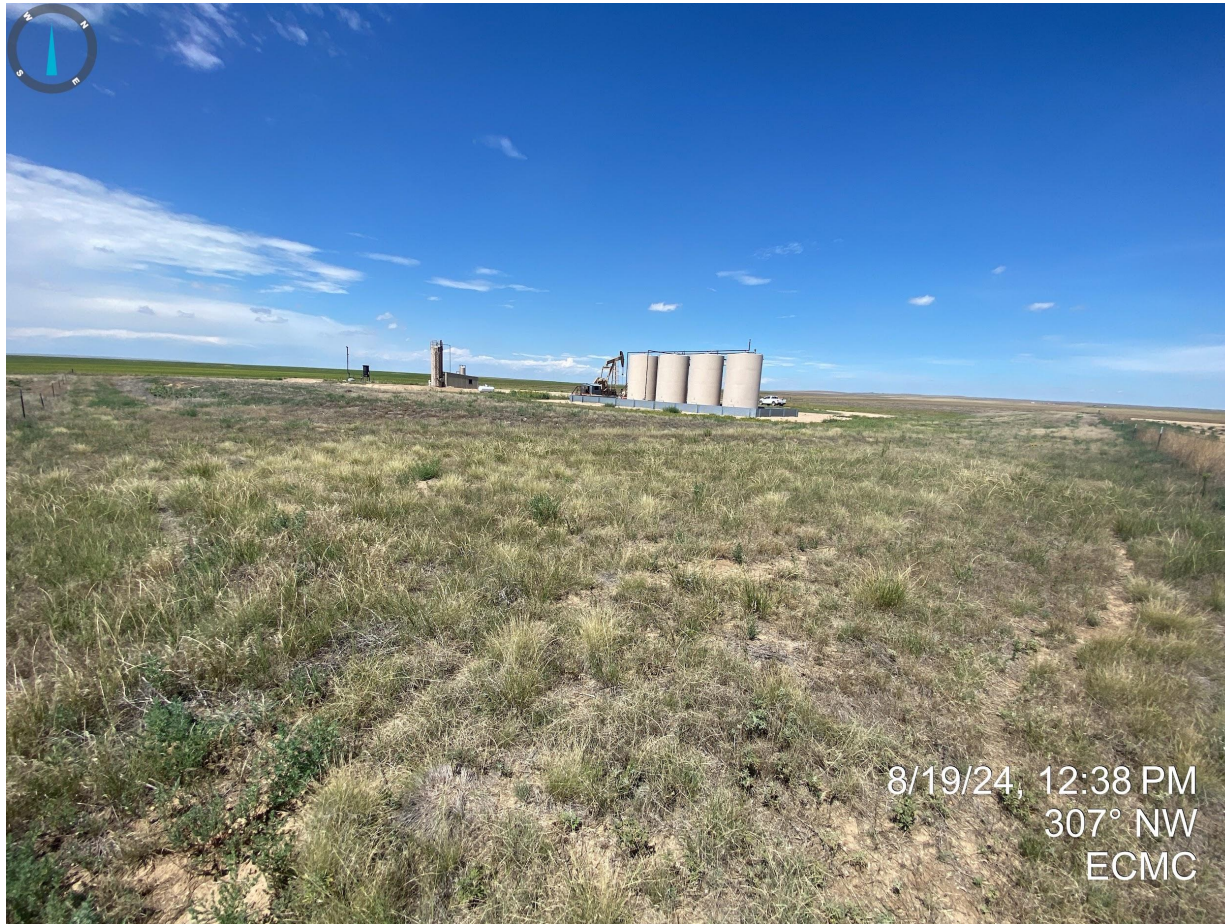
Photo 4. Some desirable vegetation cover was observed in the southeast corner of the interim areas.

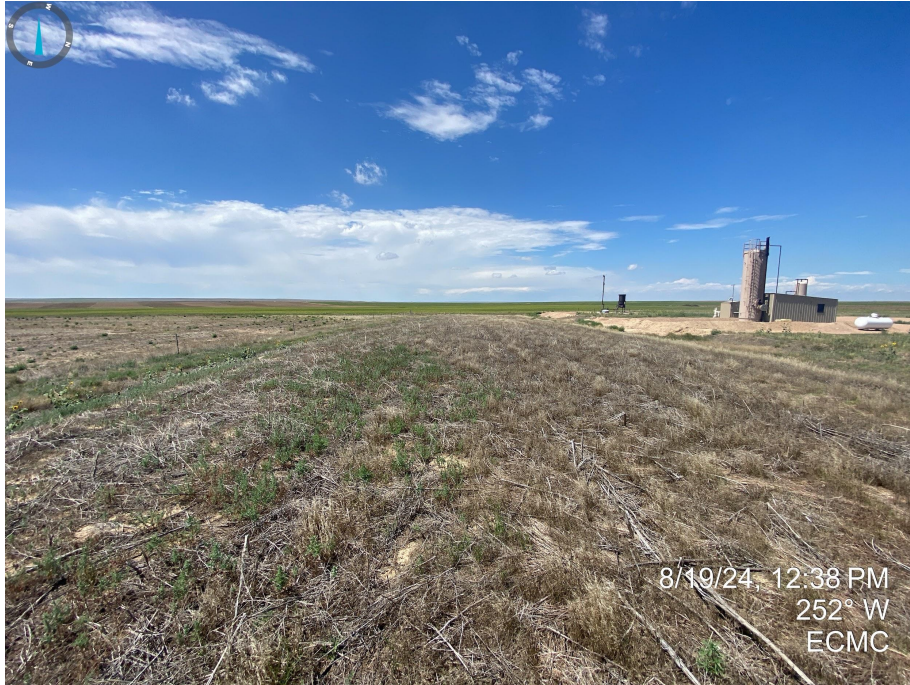
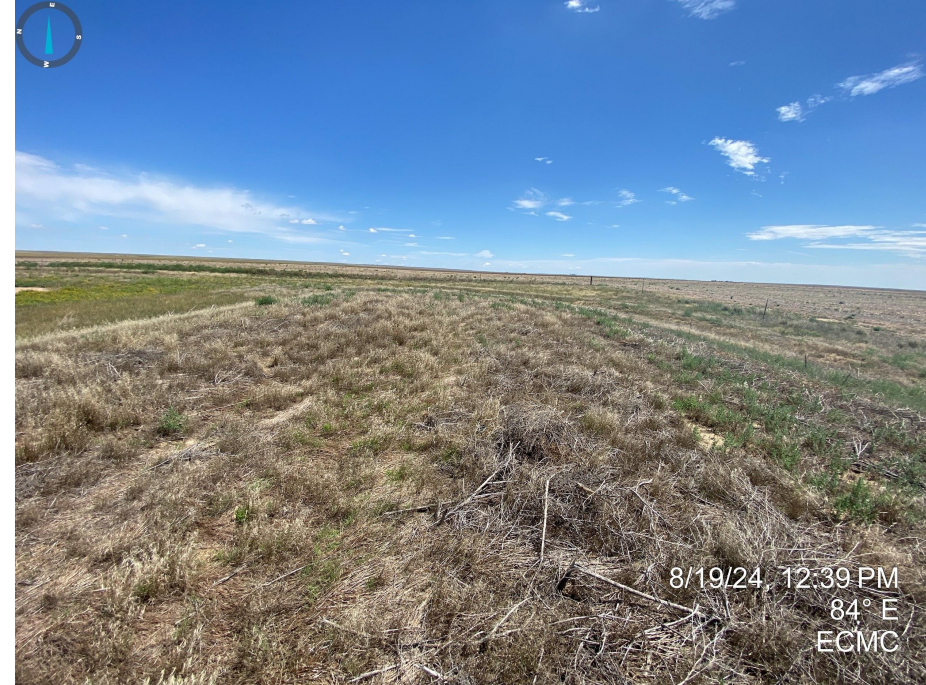
Photos 5 & 6. Taken on the topsoil stockpile. The stockpile is predominantly undesirable vegetation (e.g. kochia, russian thistle and CO List C Noxious Weed- cheatgrass).

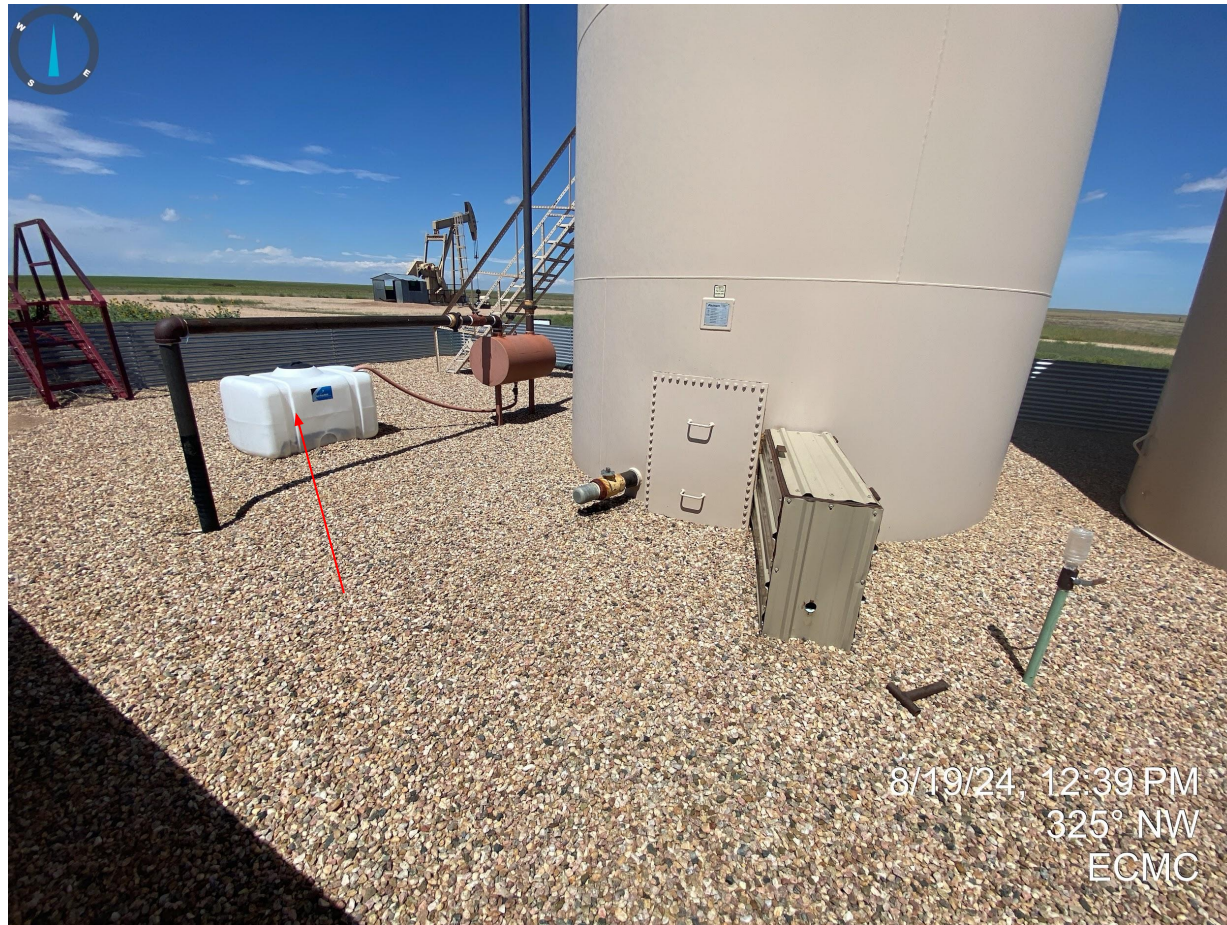
Photo 7. Tank/Container within battery does not appear to be properly labeled.

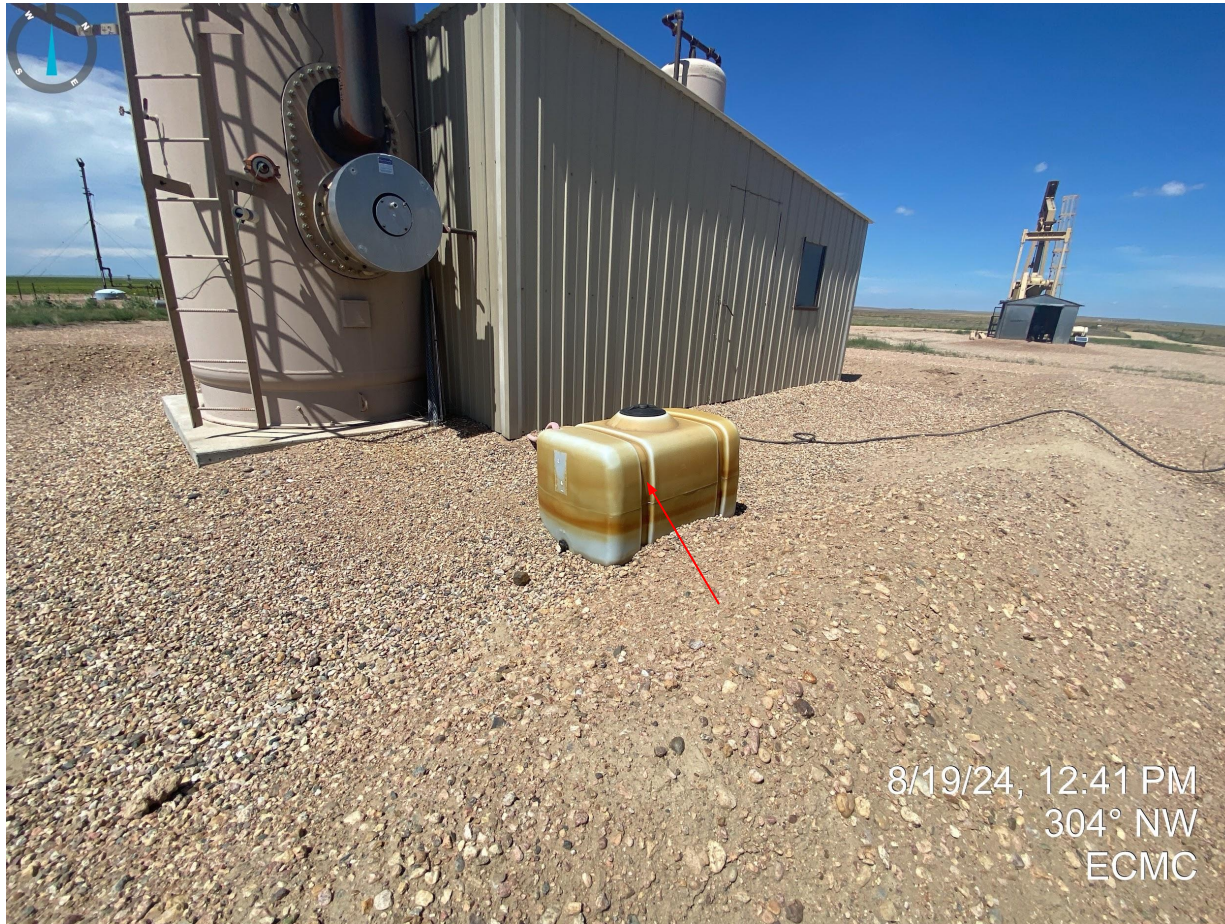
Photo 8. Tank/Container at separator does not appear to be properly labeled.

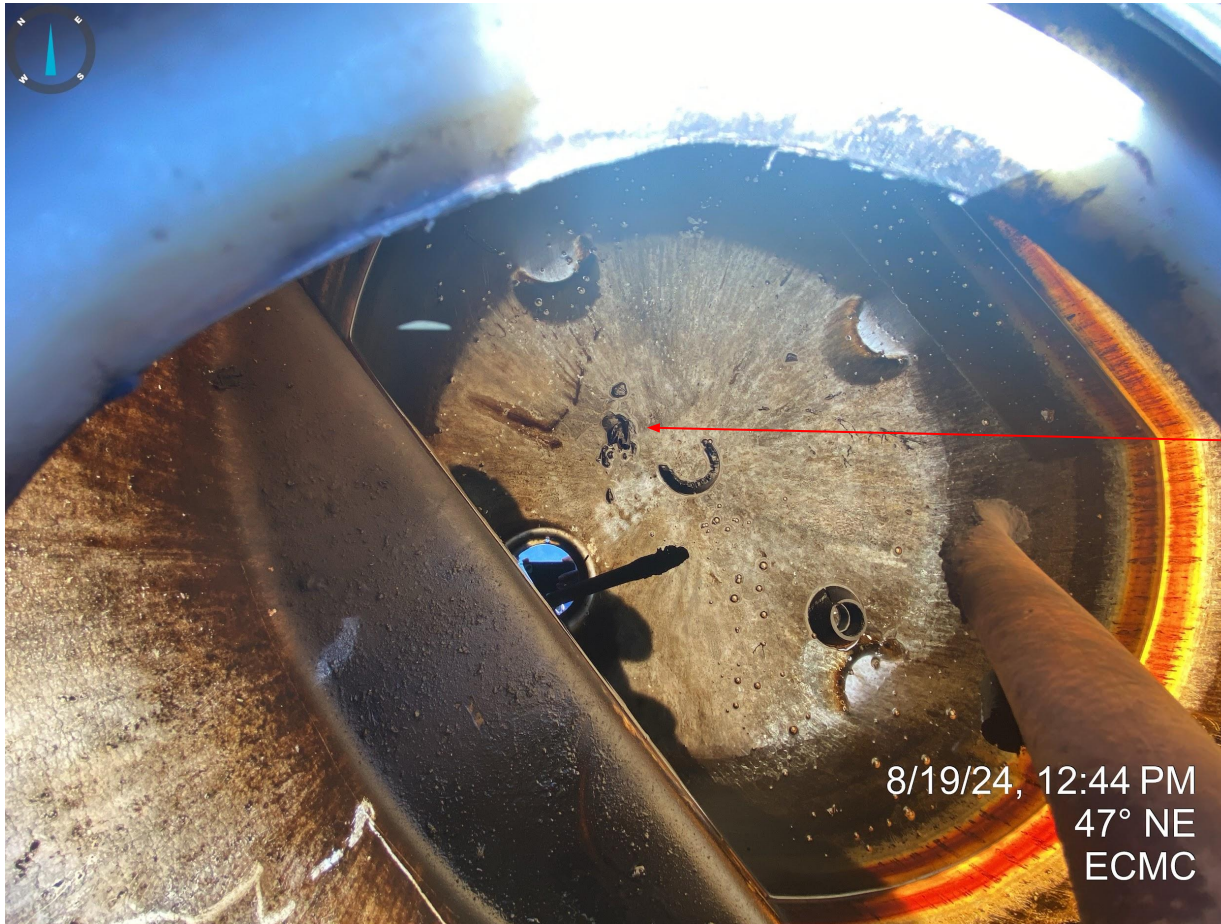
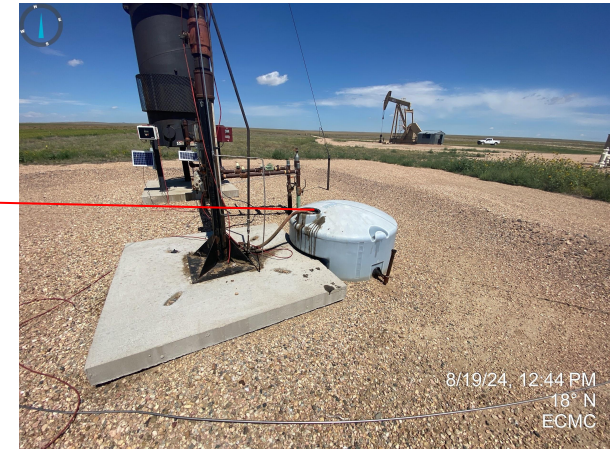
Photo 9. Tank/Container at flare unit does not have adequate wildlife BMPs to prevent or exclude entry by wildlife. Red arrow indicates wildlife mortality (unidentified bird) within container contents. Oily waste shall be removed and wildlife BMPs installed.

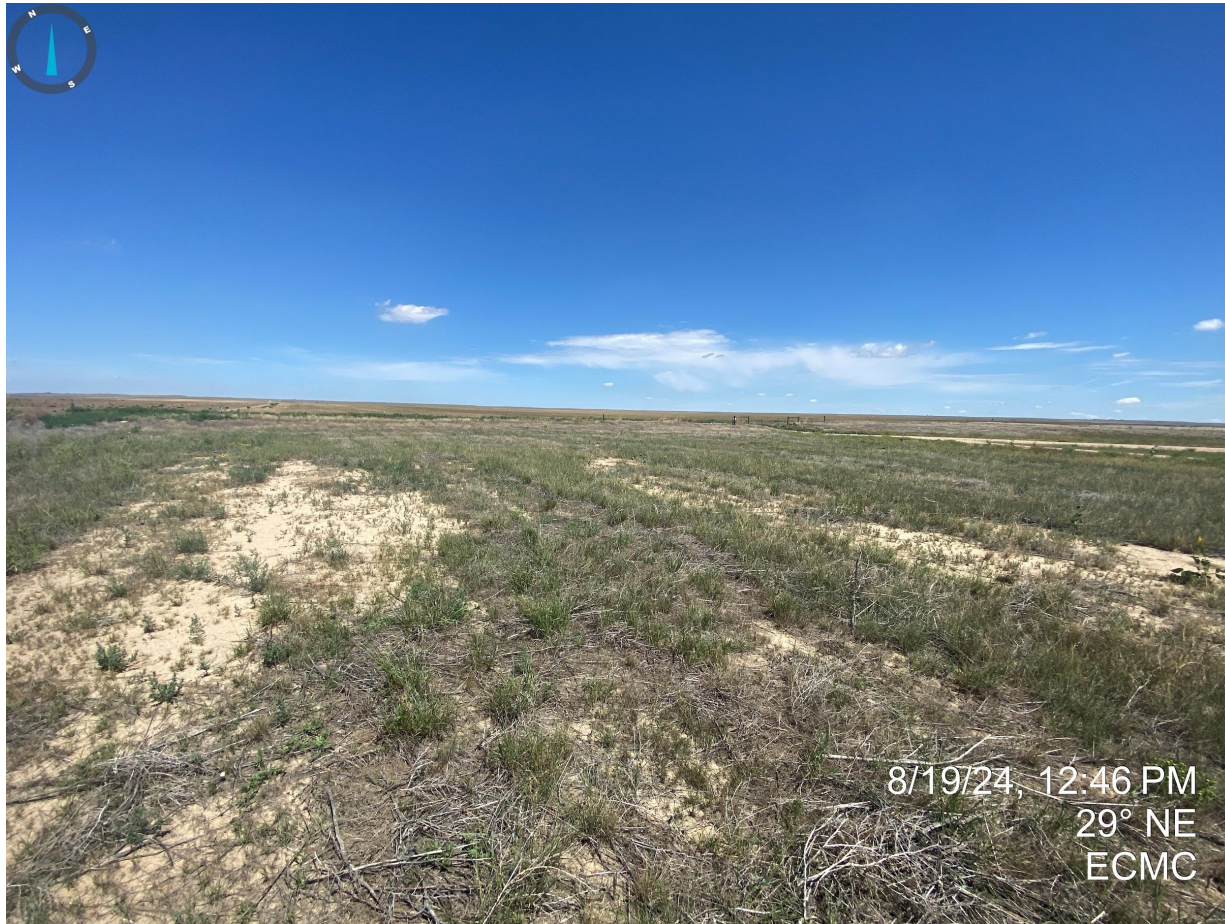
Photo 10. Western interim areas have evidence of non-uniform vegetation cover resulting in bare soil.

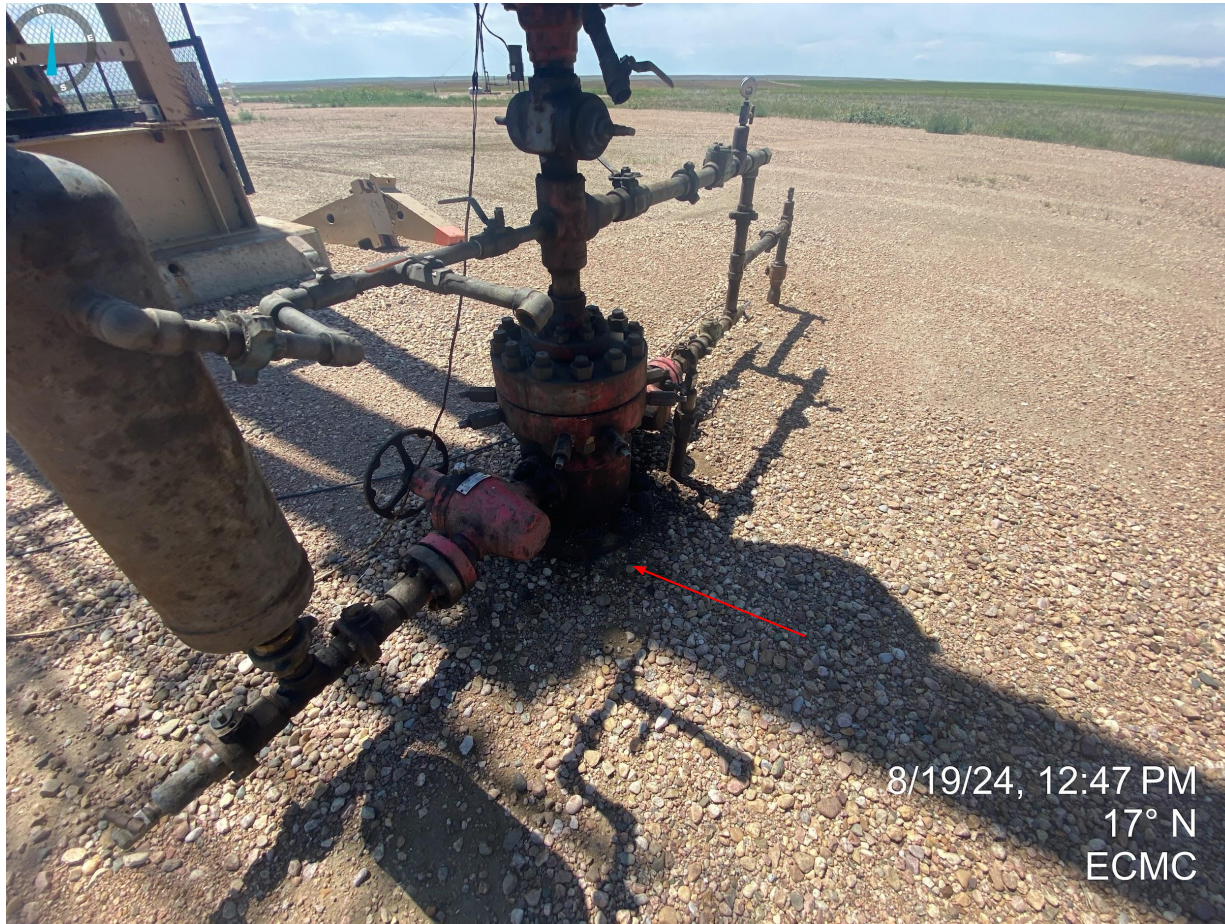
Photo 11. Stained soil around wellhead.

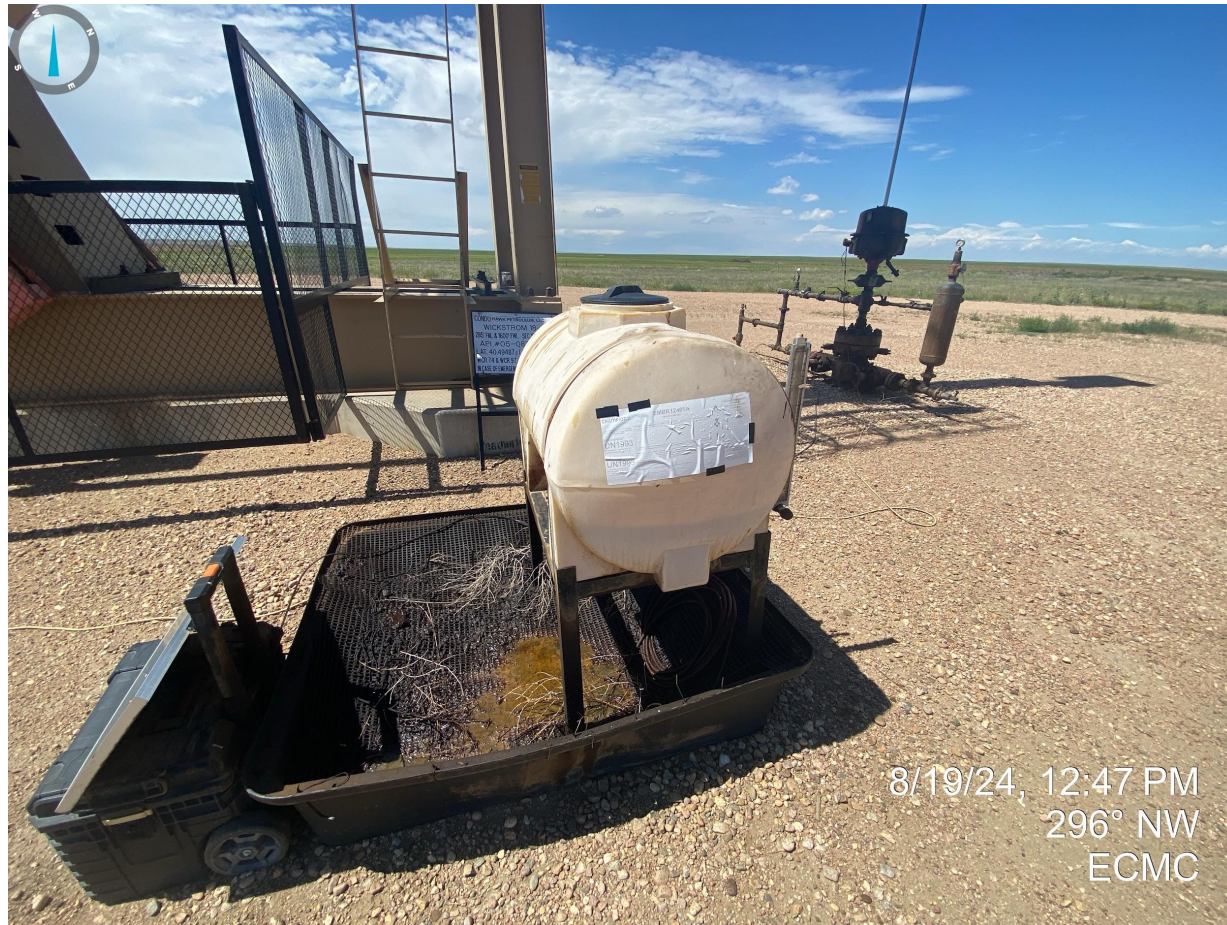
Photo 12. Wildlife BMPs (netting) inadequate, tank labels are not legible, and oily waste within secondary containment needs to be properly disposed of.

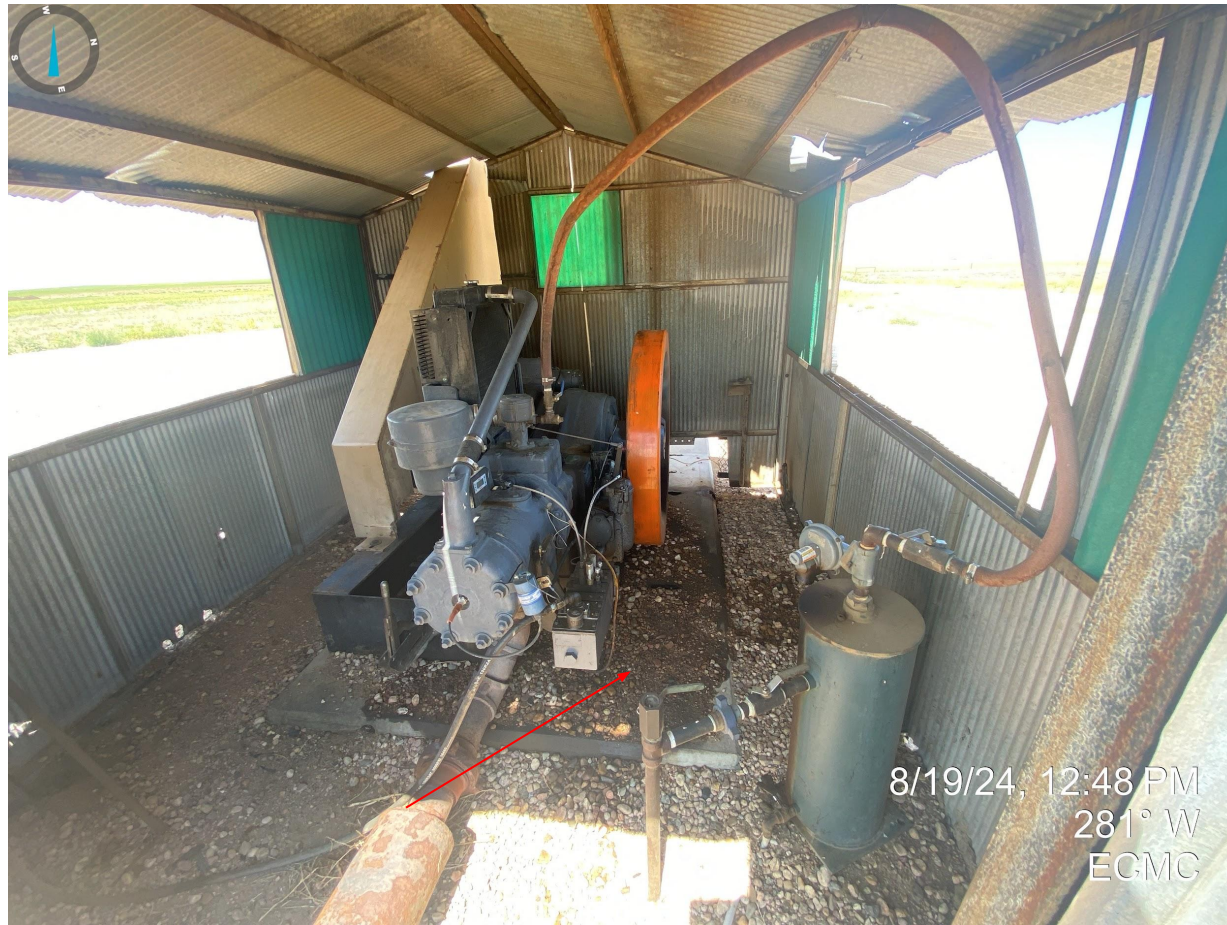
Photo 13. Hydrocarbon staining at pumpjack motor.

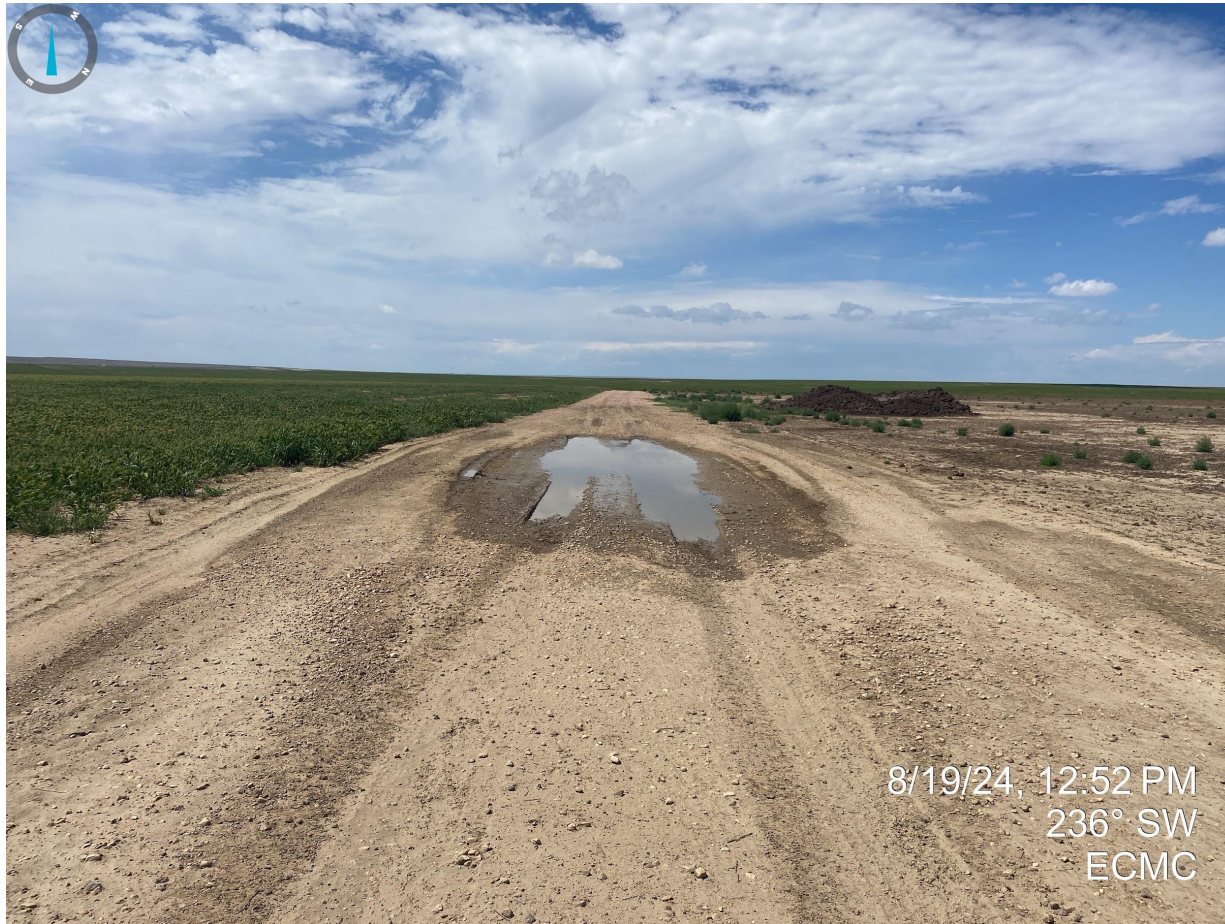
Photo 14. Maintenance advised along access road to manage stormwater and prevent trackout, and to reduce access road expansion.
