# Inspection Photos

API: 055-06278

Operator: EVERGREEN NATURAL  
RESOURCES LLC

Inspection Date: 8/22/2024

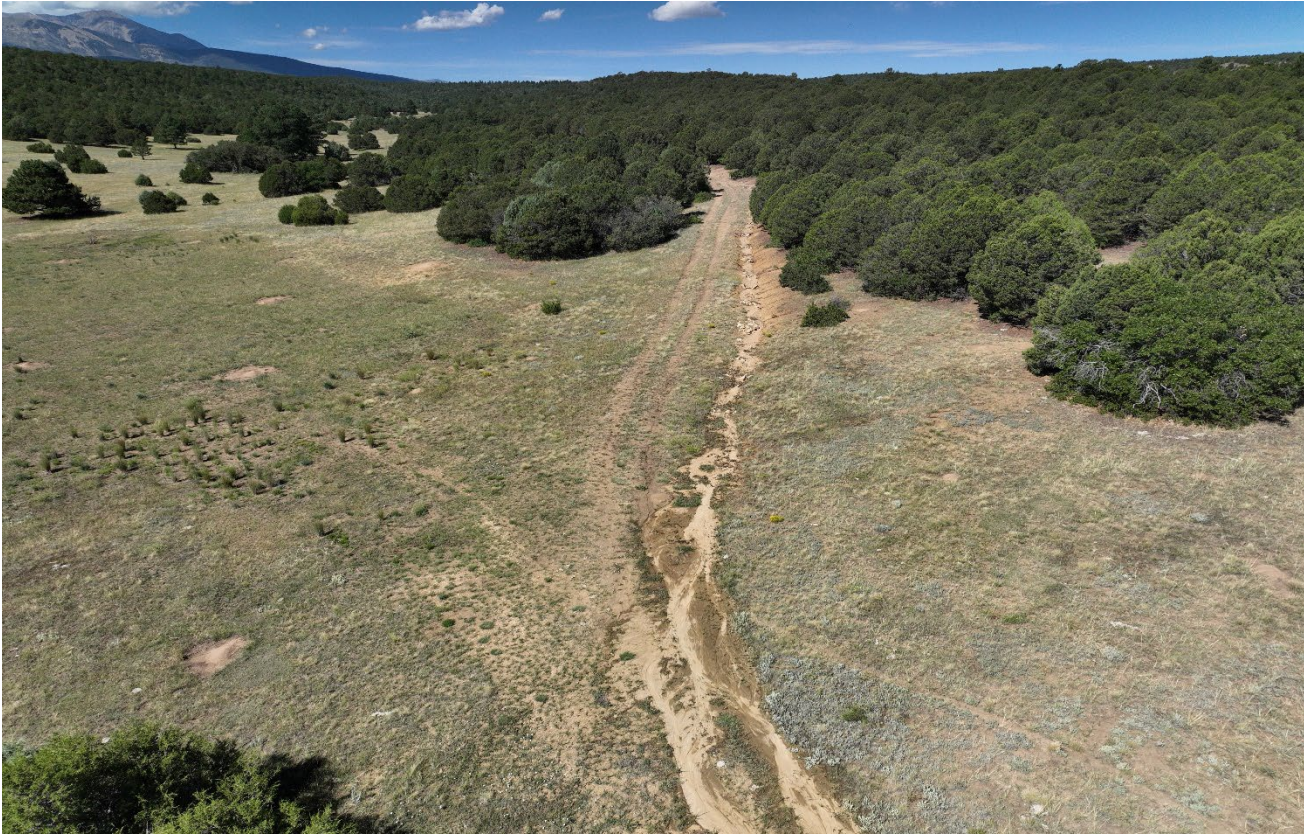
**Photo 1.** Drone aerial photo facing west toward the access road. There is sediment being deposited on the road from the ditch along the road side further up the road.

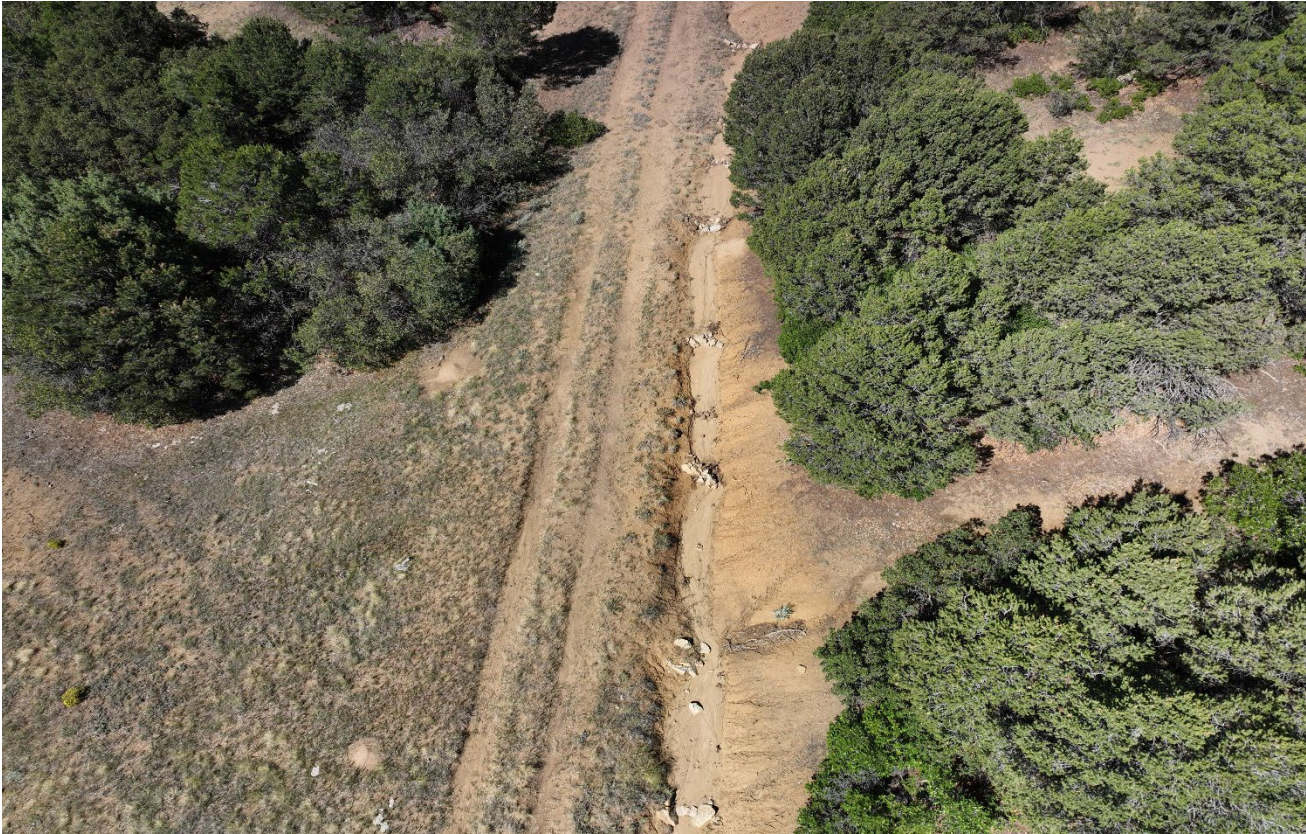
**Photo 2.** Drone aerial photo facing down toward the ditch along the access road. The check dams have fallen apart and the ditch is not stabilized.

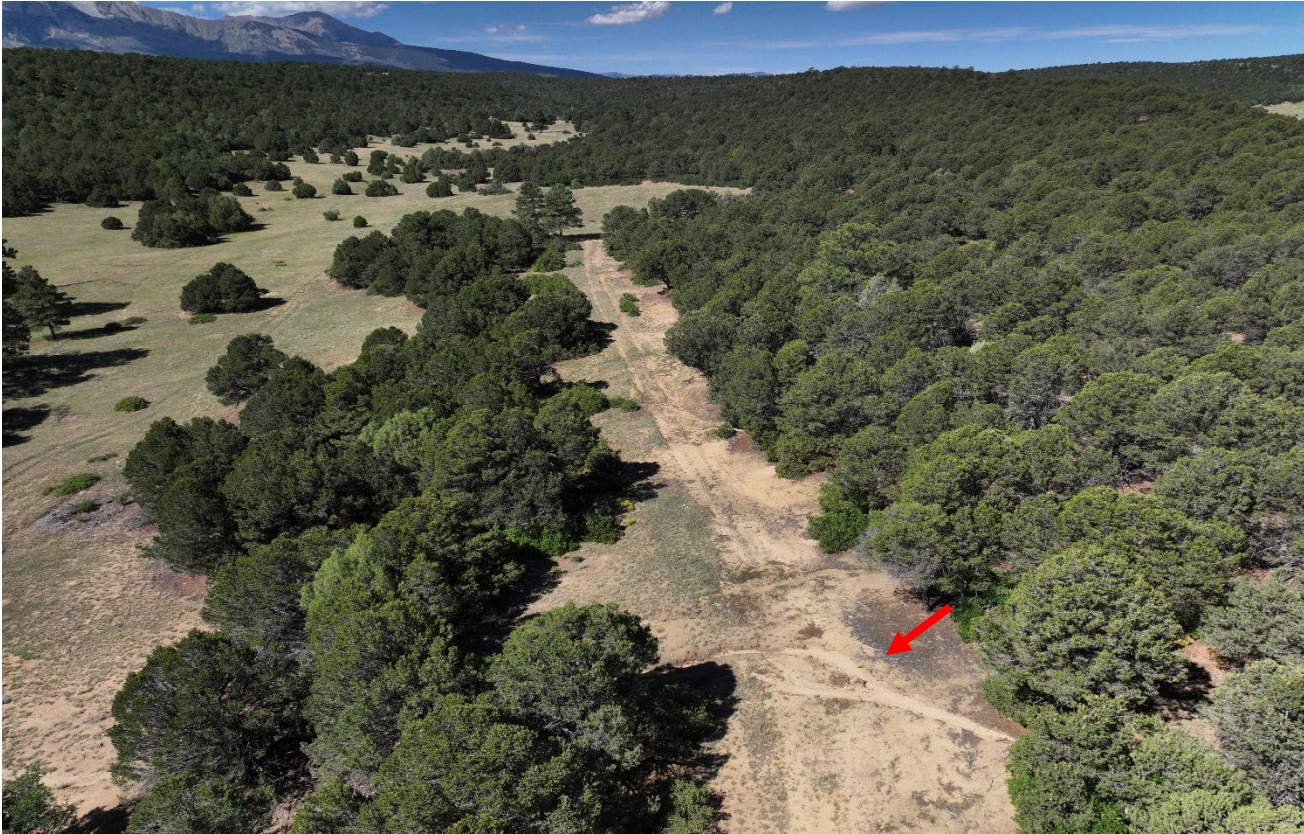
**Photo 3.** Drone aerial photo facing southwest along the access road. The area at the red arrow appears to have erosion issues.

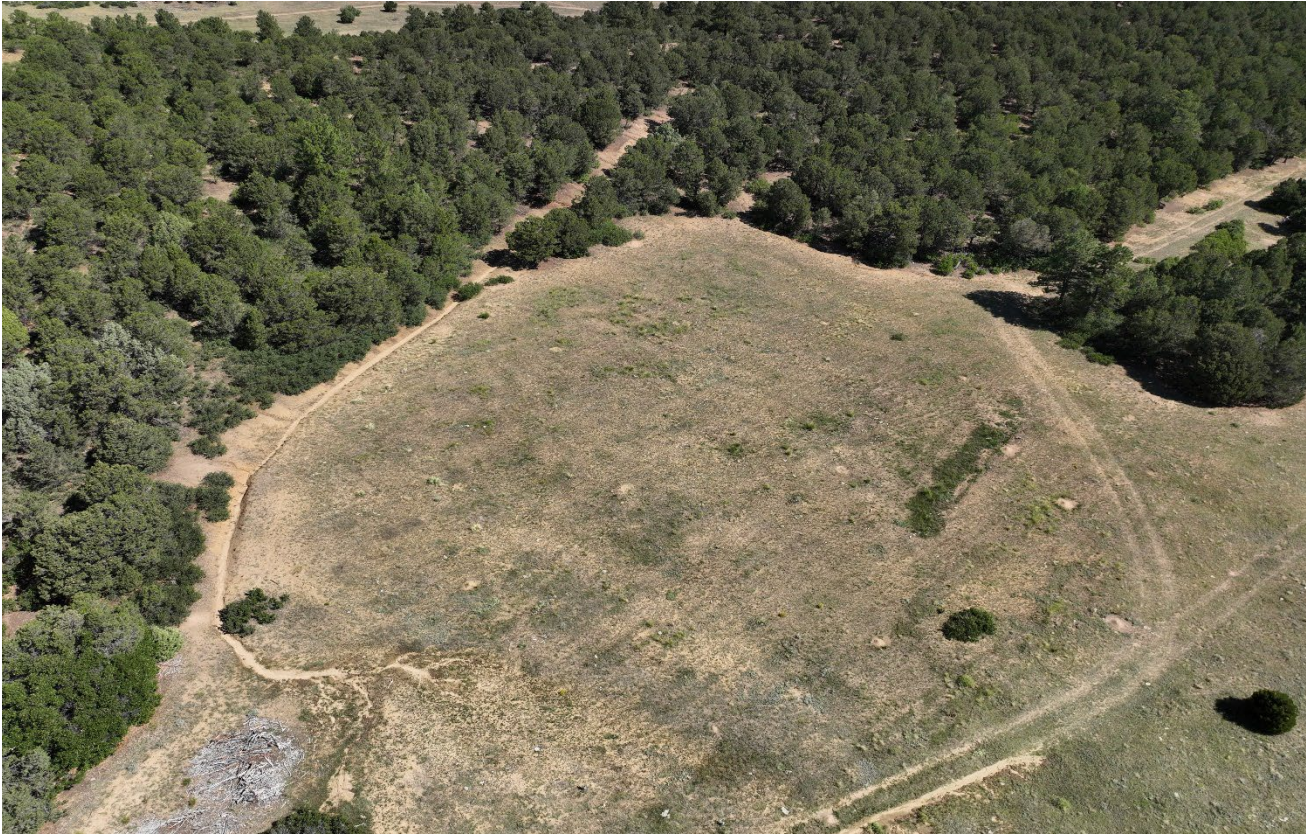
**Photo 4.** Drone aerial photo facing northeast toward the location. There is a perimeter run-on ditch along the northwest side of the pad that appears to be causing erosion.
