Inspection Photos

API: 055-06190

Operator: EVERGREEN NATURAL
RESOURCES LLC

Inspection Date: 8/22/2024

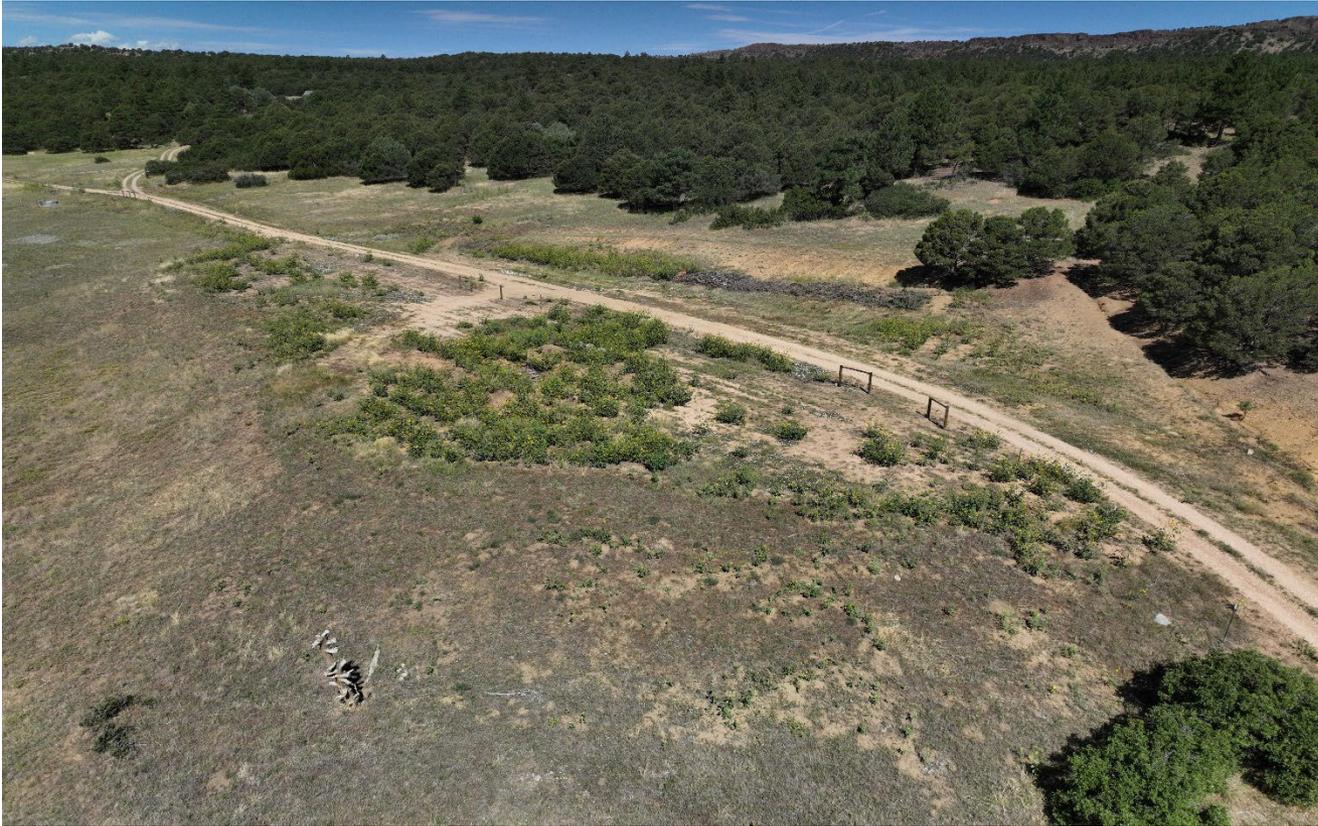
Photo 6. Drone aerial photo facing northwest toward the location.

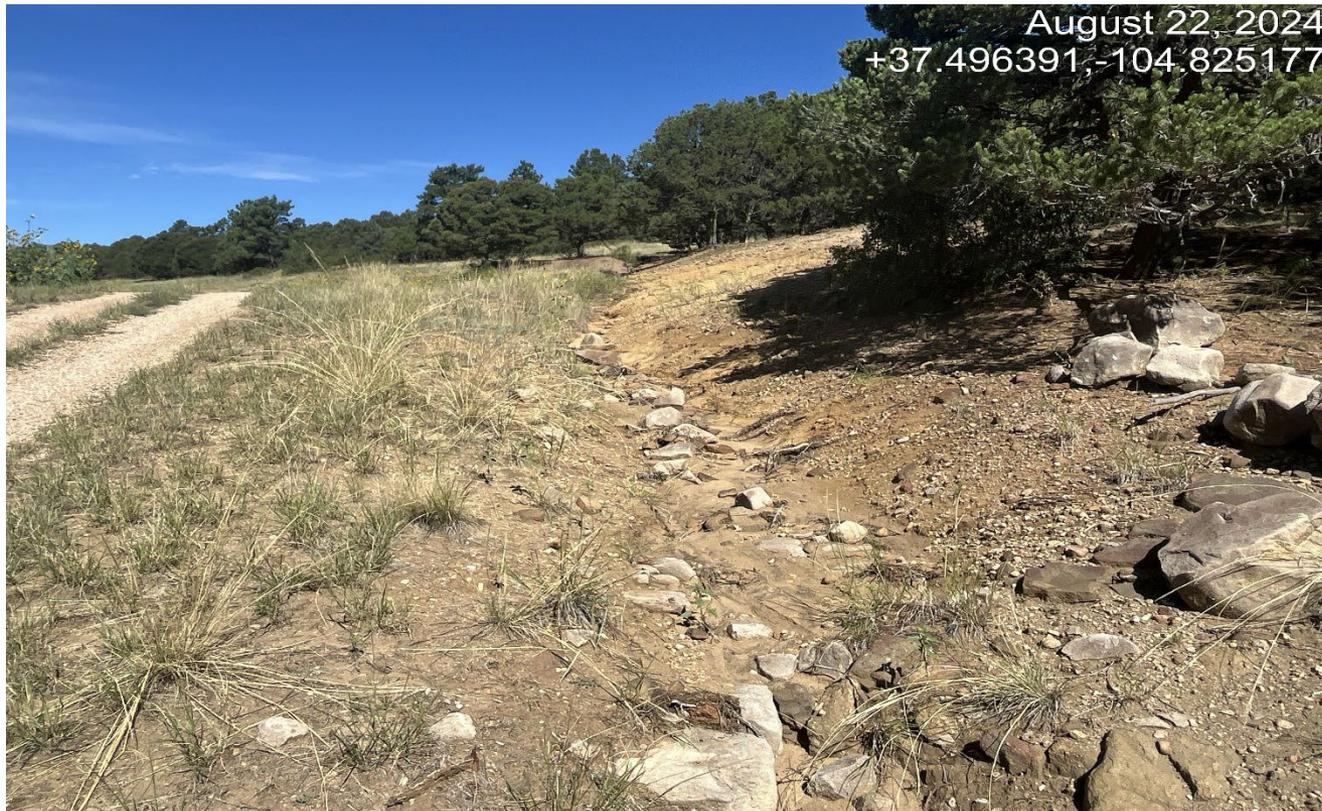
Photo 2. Facing northwest. The cut slope is not stabilized and has signs of erosion.

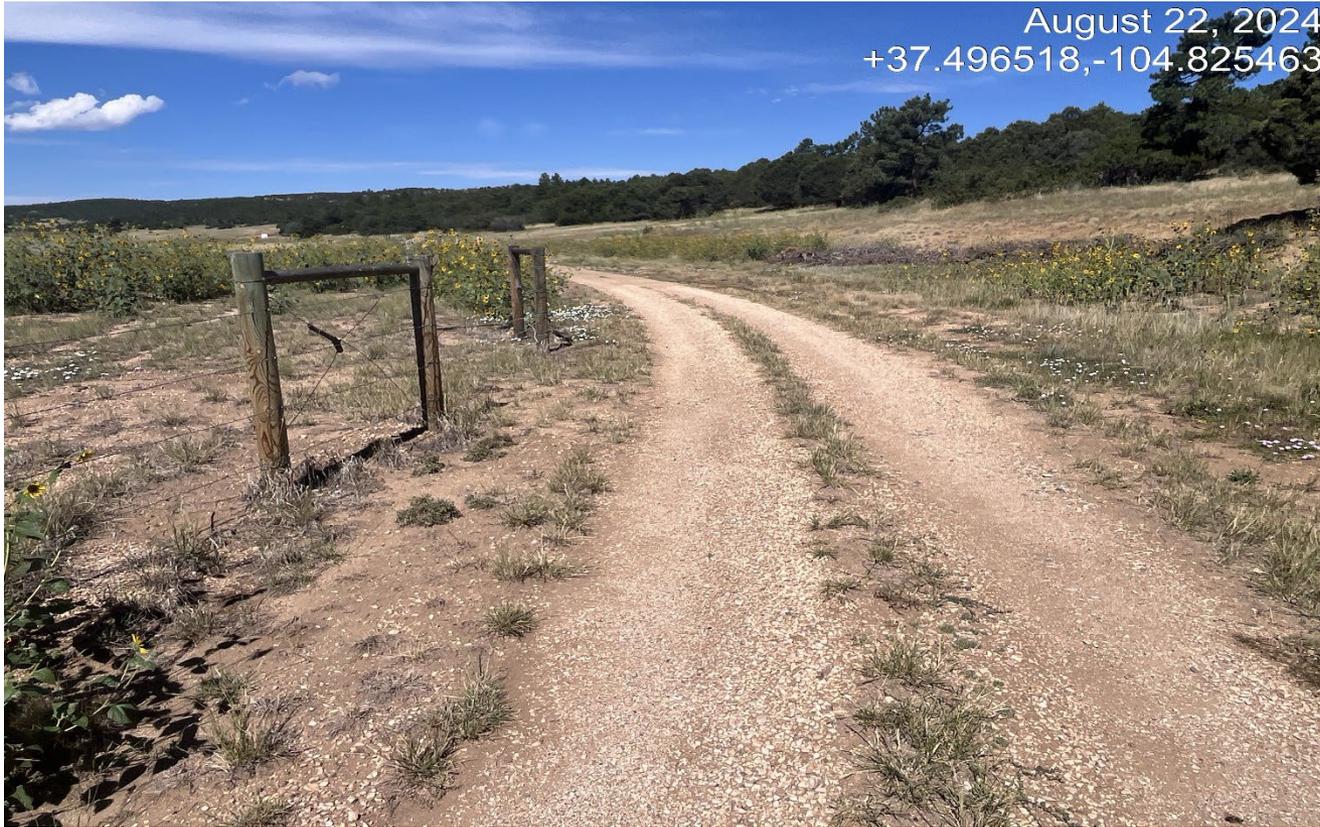
Photo 3. Facing west toward the location. The road continues on past the location.

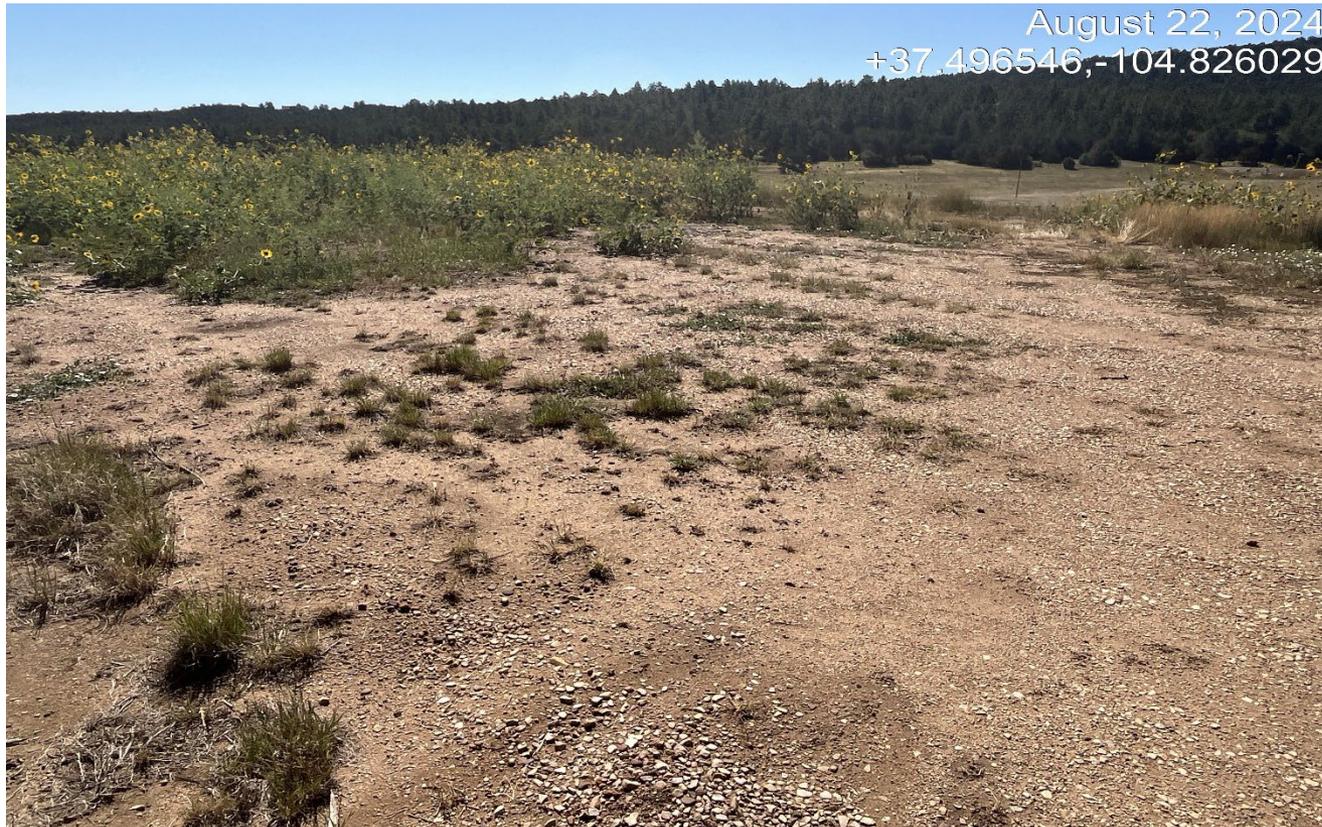
Photo 4. Facing southeast at the location.

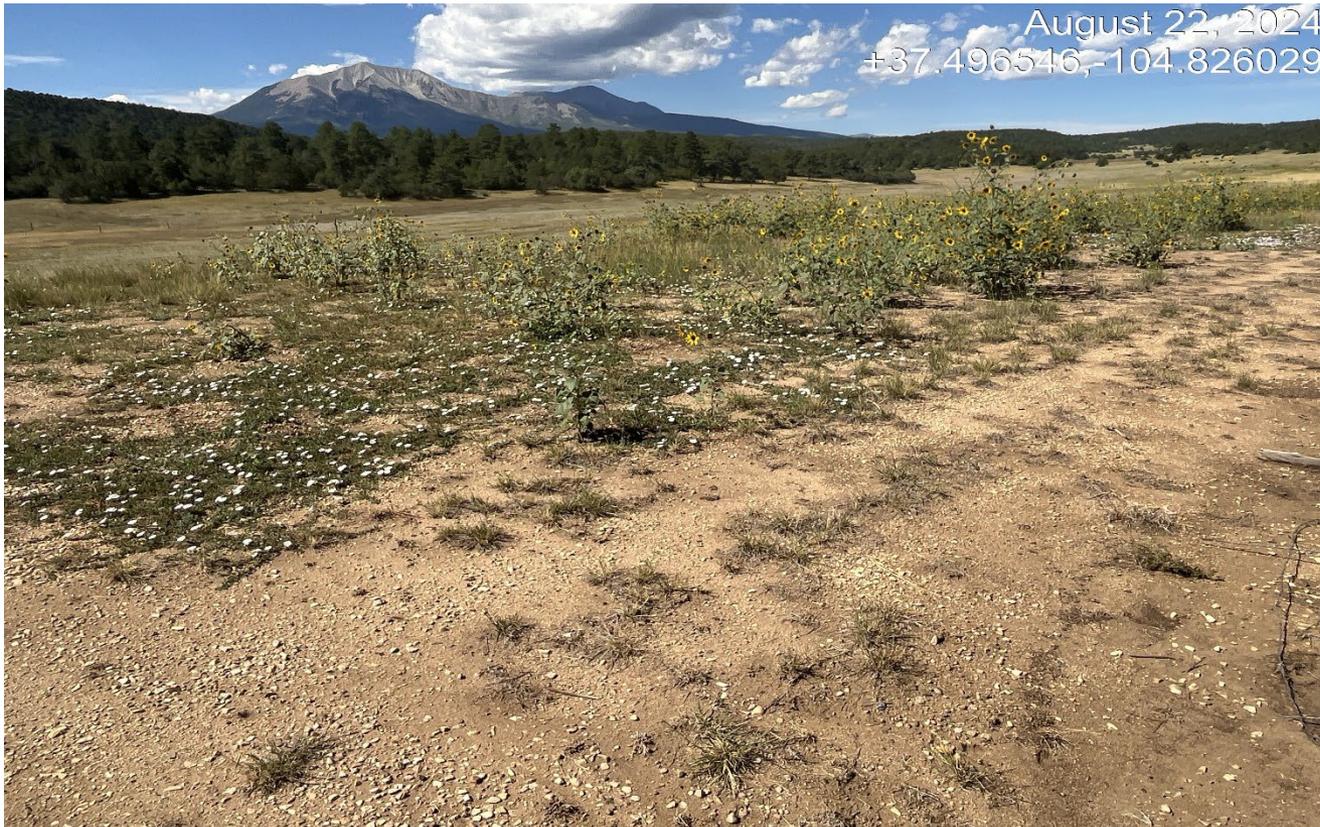
Photo 5. Facing southwest at the location.

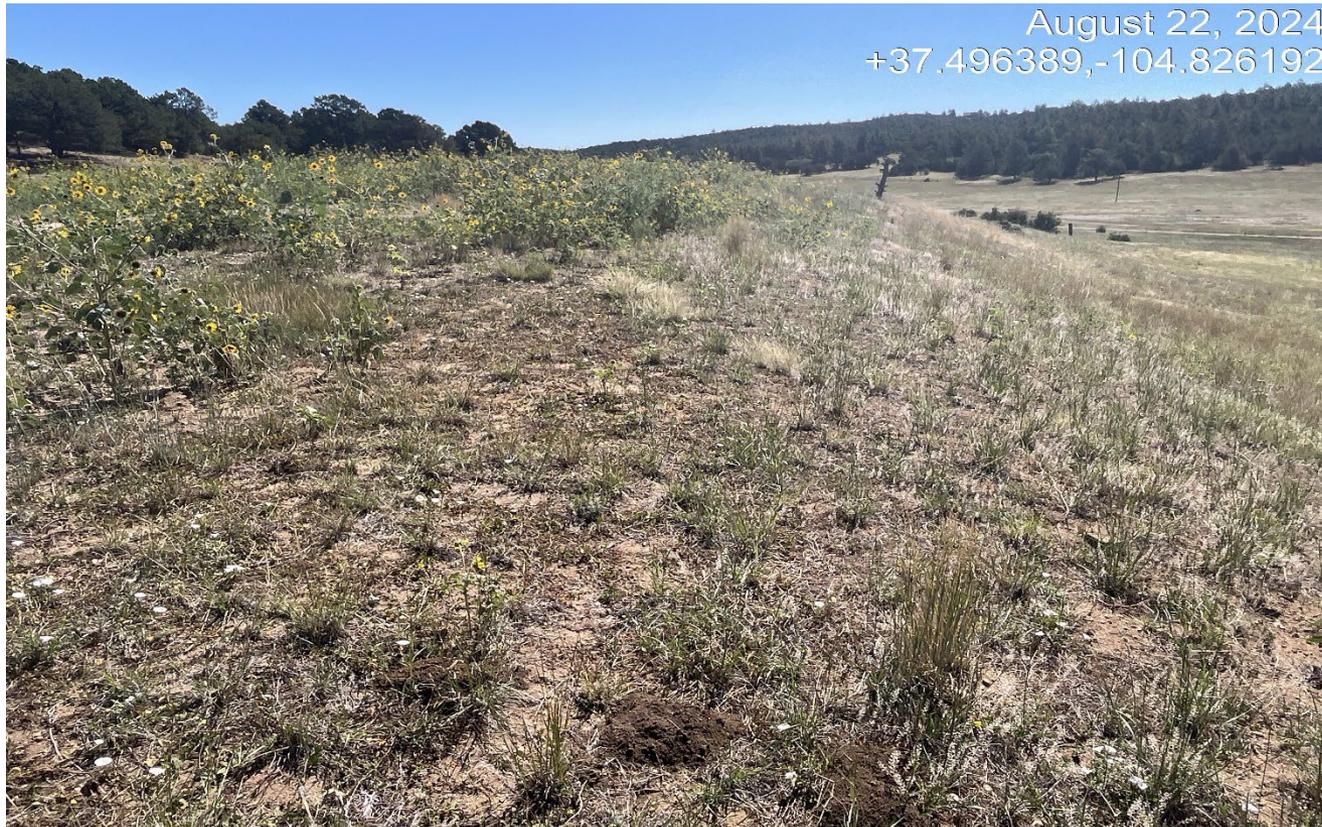
Photo 6. South side of the location facing east along the fill slope.

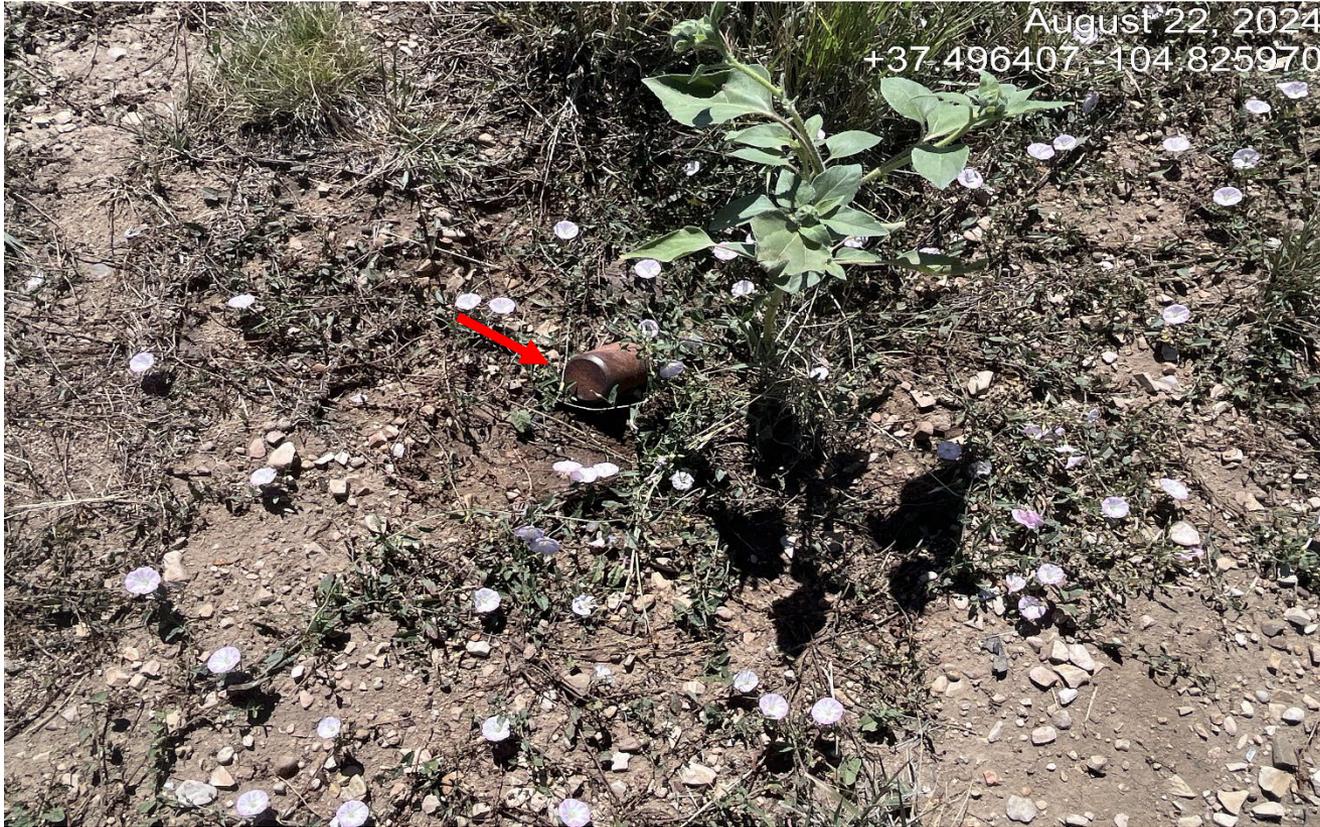
Photo 7. There is field bindweed throughout the location that will need to be controlled. There is a capped flowline riser that needs to be removed or cut 3' below the surface.
