**Inspection Photos**  
**Location Name: Henderson 1**  
**Location ID: 331730**

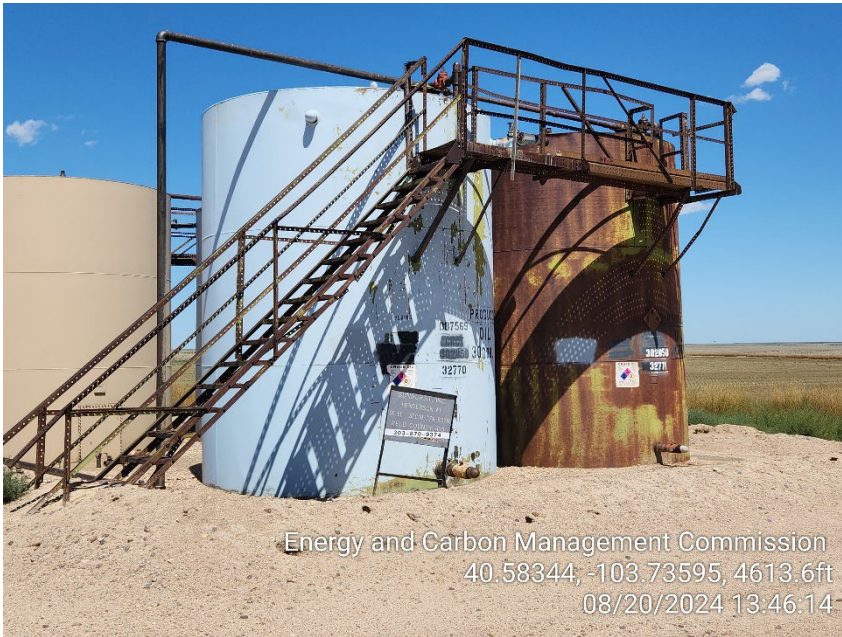
**Photo 1 – Tank Battery**

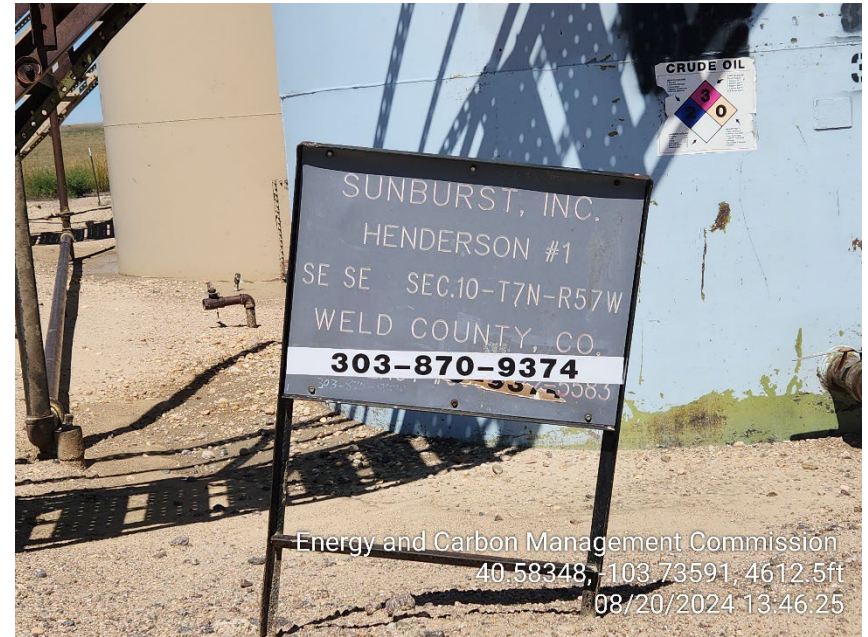
**Photo 2 – Tank Battery Sign**

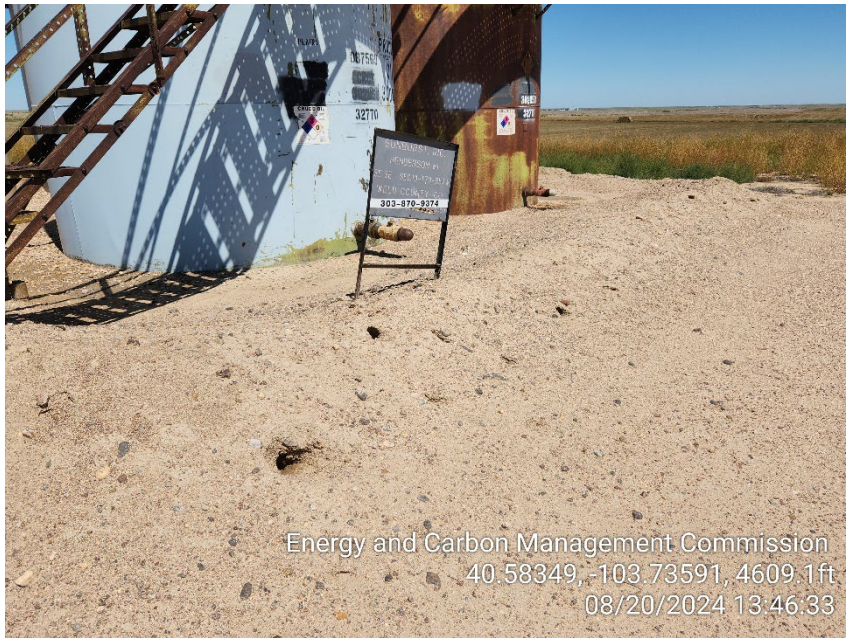
**Photo 3 – Tank Berm**

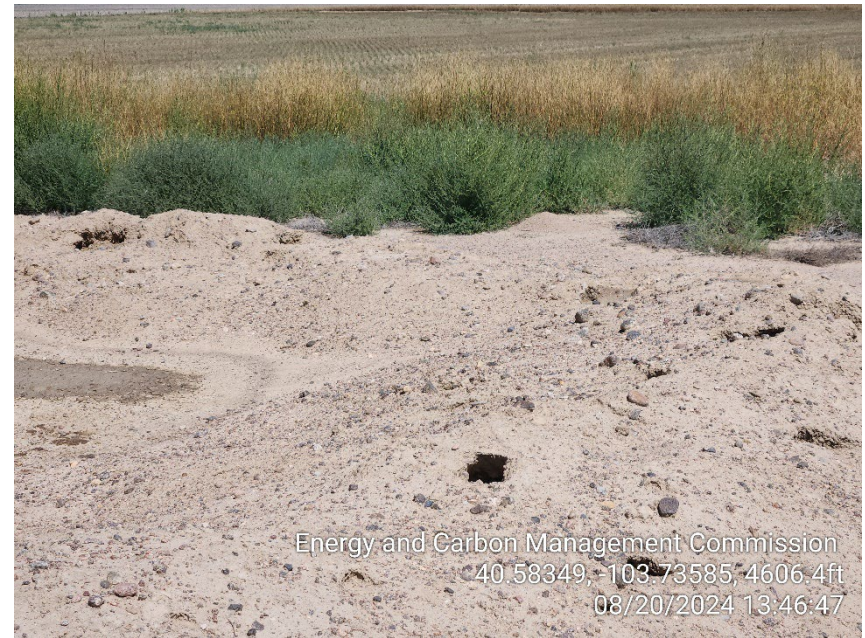
**Photo 4 – Tank Berm**

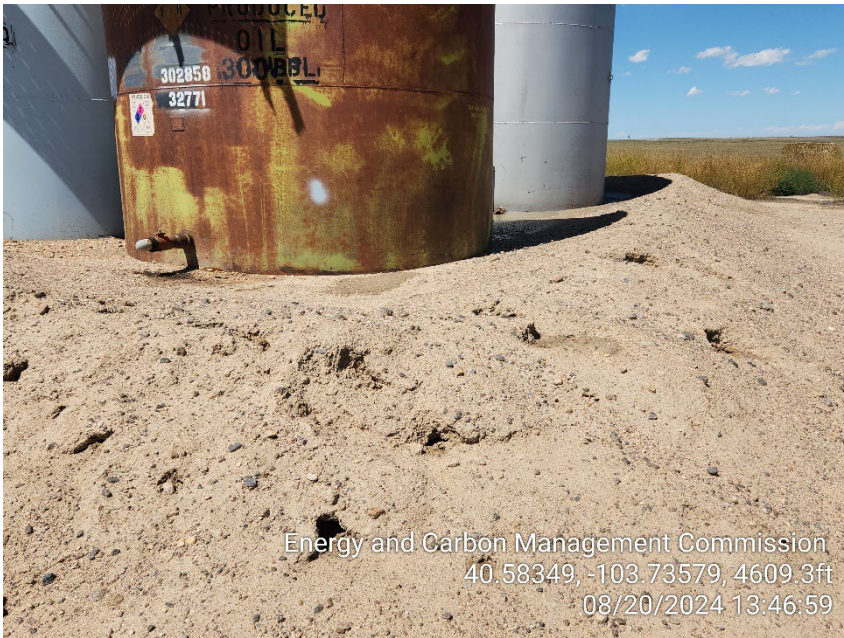
**Photo 5 – Tank Berm**

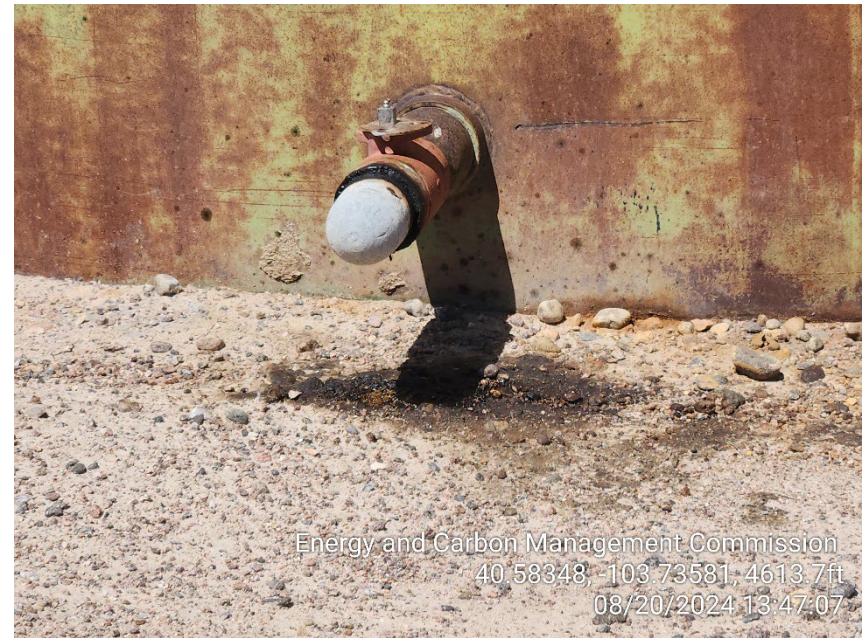
**Photo 6 – Stained Soil at Southeast Tank Loadline Valve**

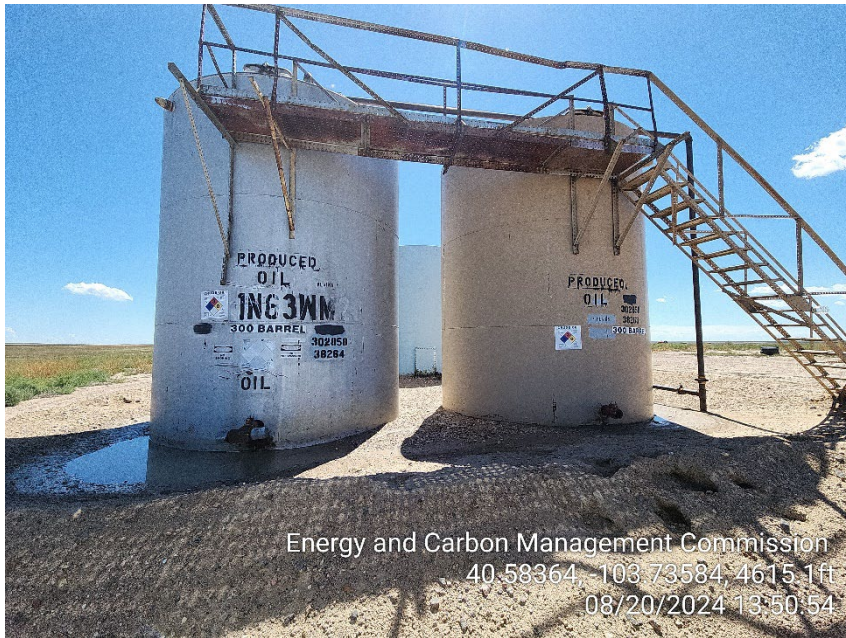
**Photo 7 – Tank Battery – North Tanks – Berms**

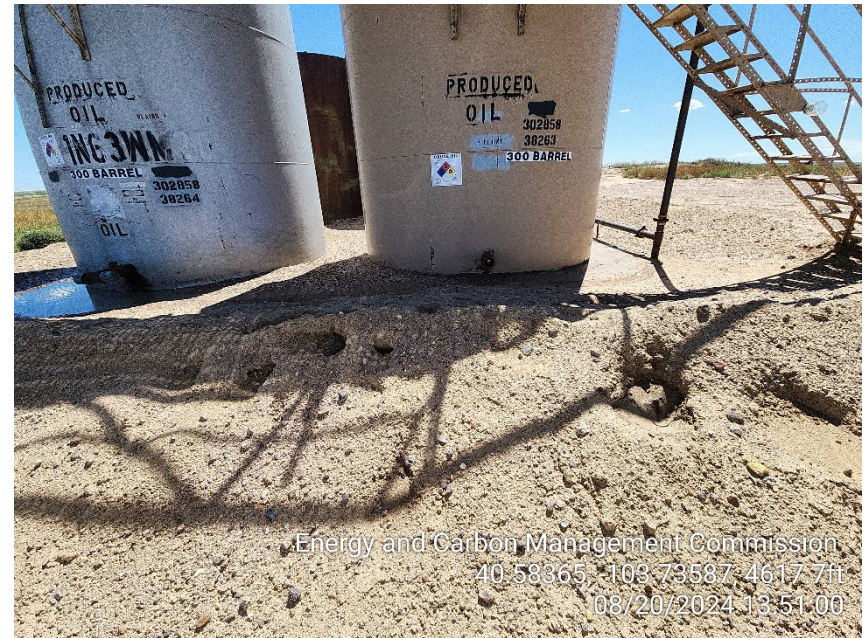
**Photo 8 – Tank Berm**

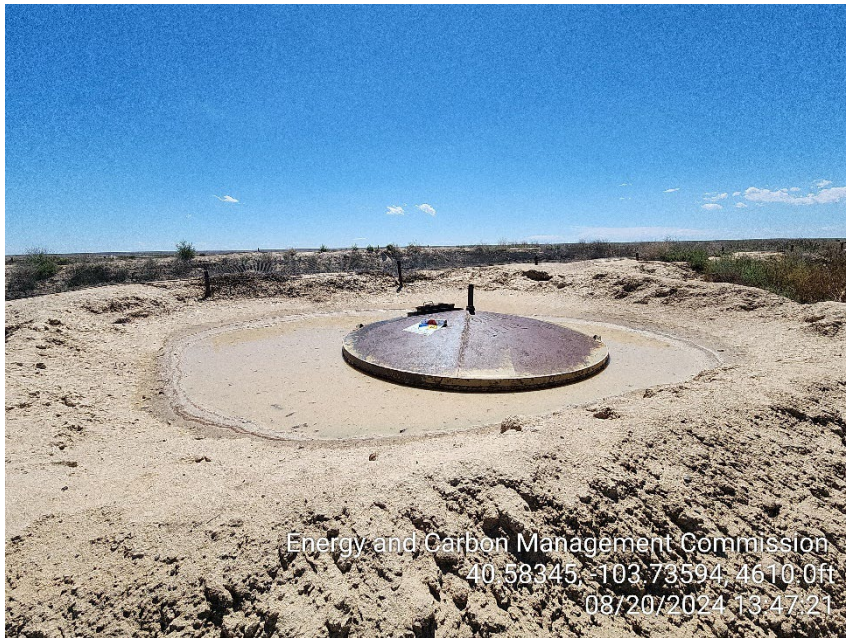
**Photo 9 – Skim Tank**

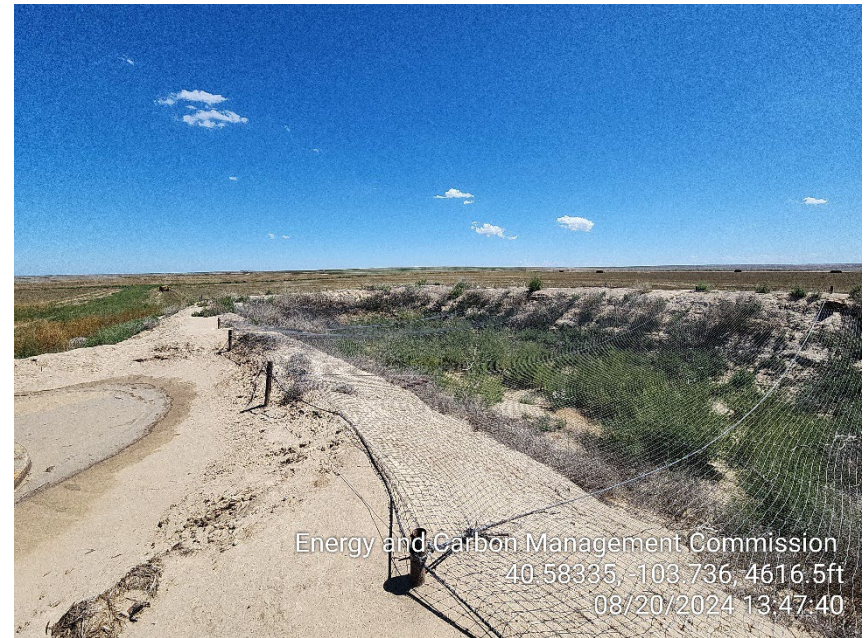
**Photo 10 – Pit Area – Looking East**

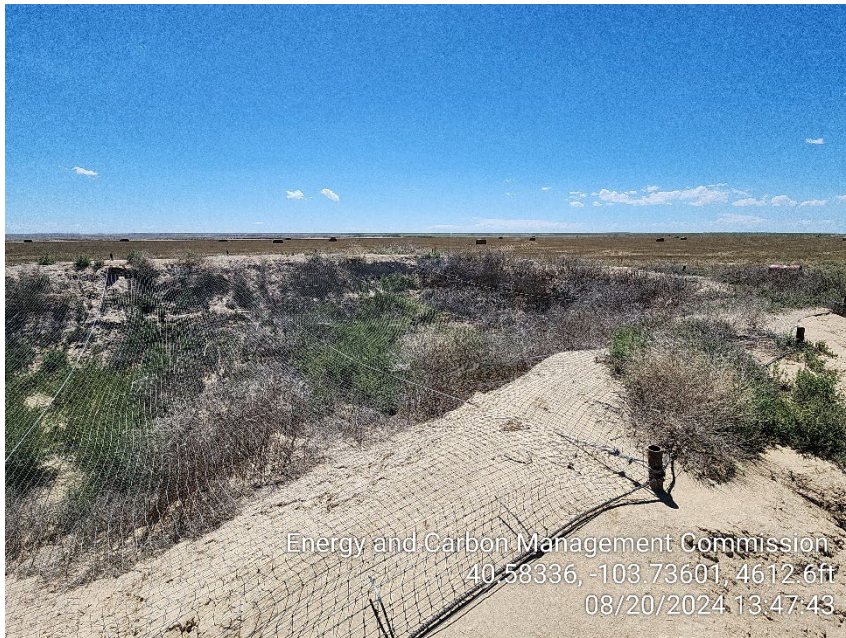
**Photo 11 – Pit Area – Looking West**

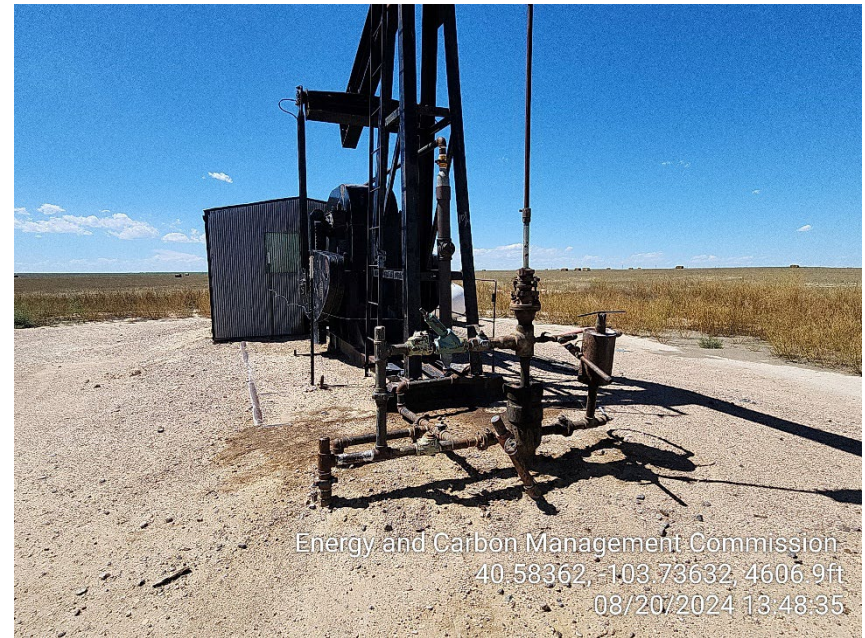
**Photo 12 – Wellhead**

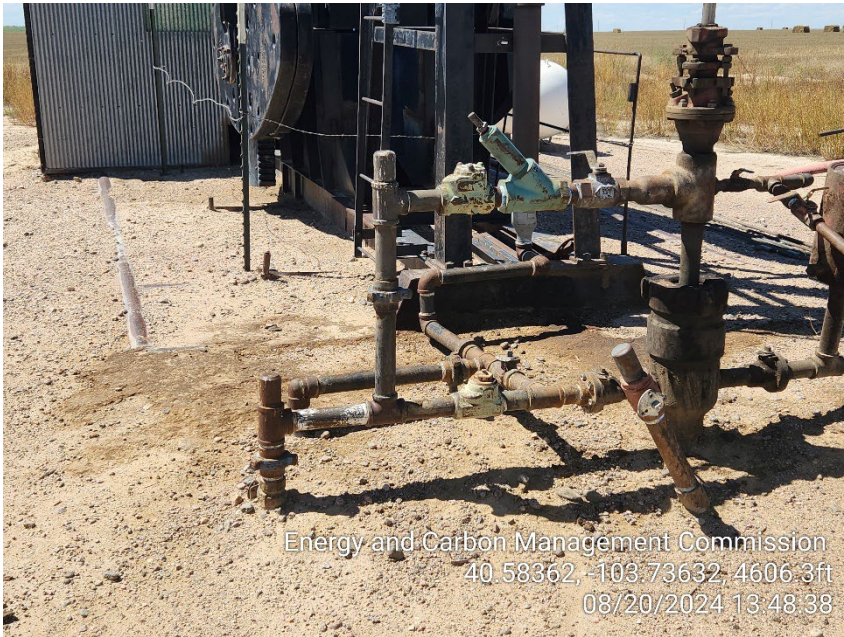
**Photo 13 – Wellhead – Stained Soil**

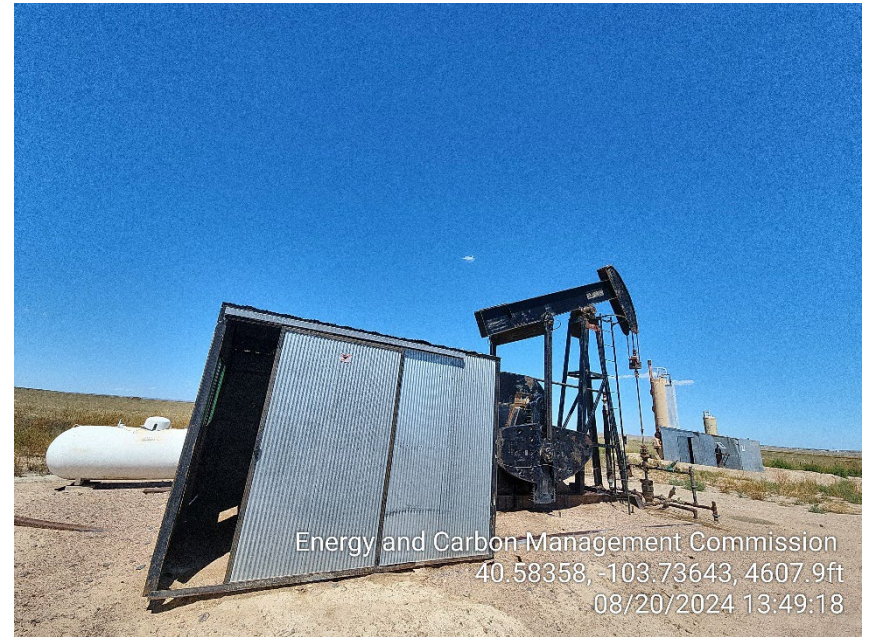
**Photo 14 – Pumping Unit**

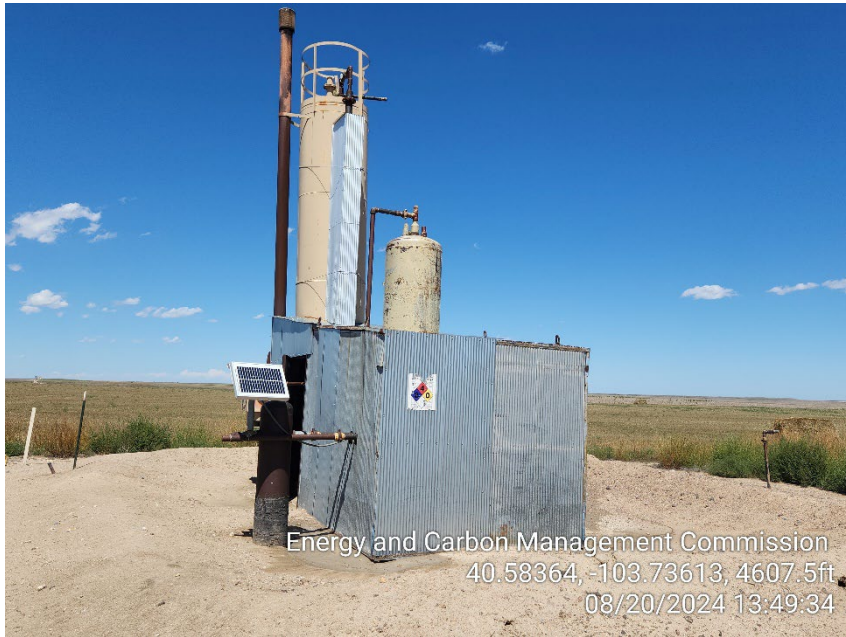
**Photo 15 – Heater Treater**

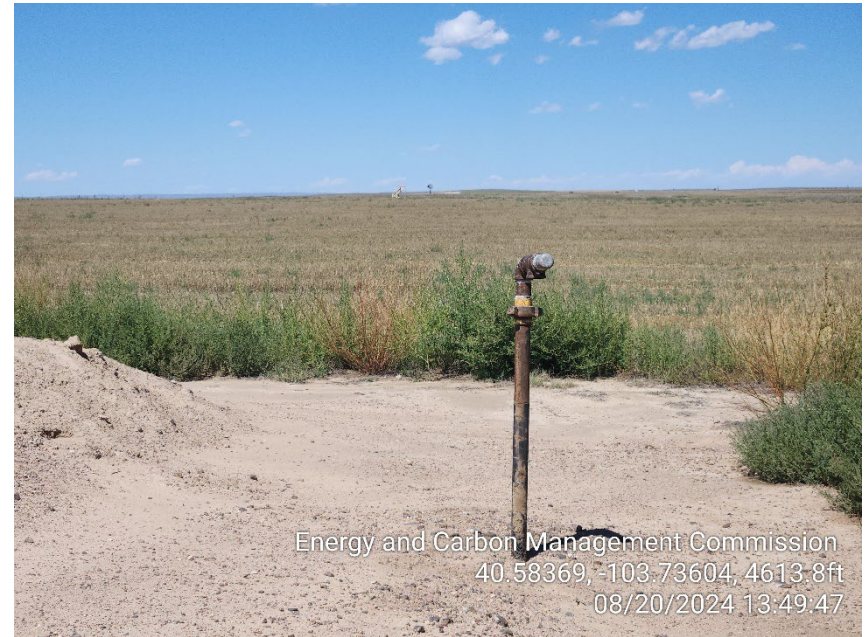
**Photo 16 – Unmarked Riser**

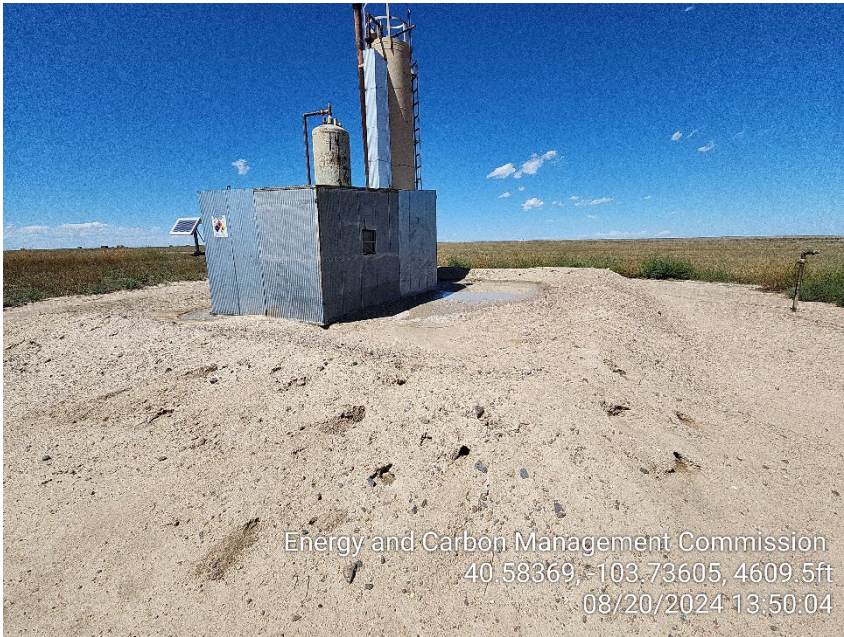
**Photo 17 – Heater Treater Berms**

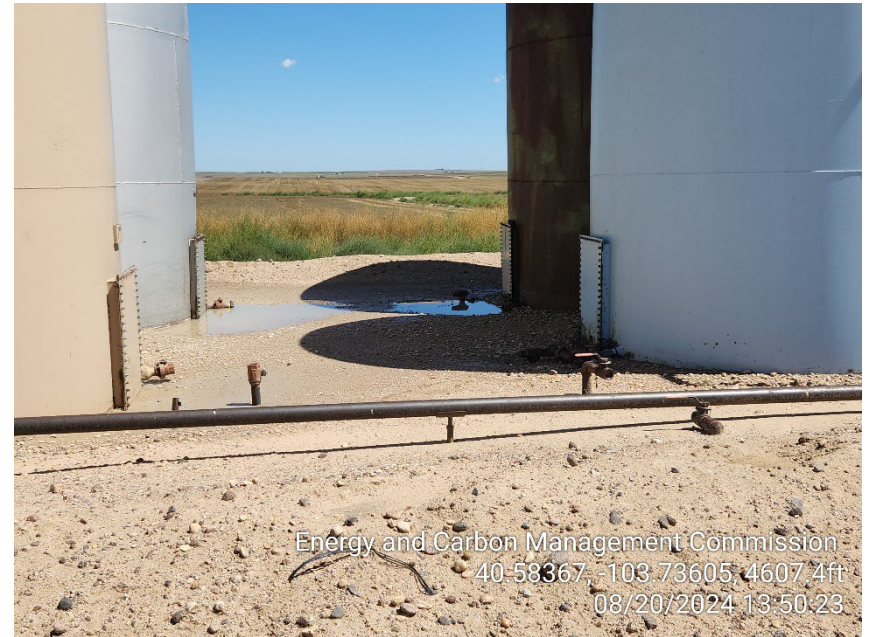
**Photo 18 – Unmarked Risers at Tanks**
