Inspection Photos

Location: CHEVRON USA INC SKR-66S98W/9SENE

Location ID: 336050

Date: 8/21/2024

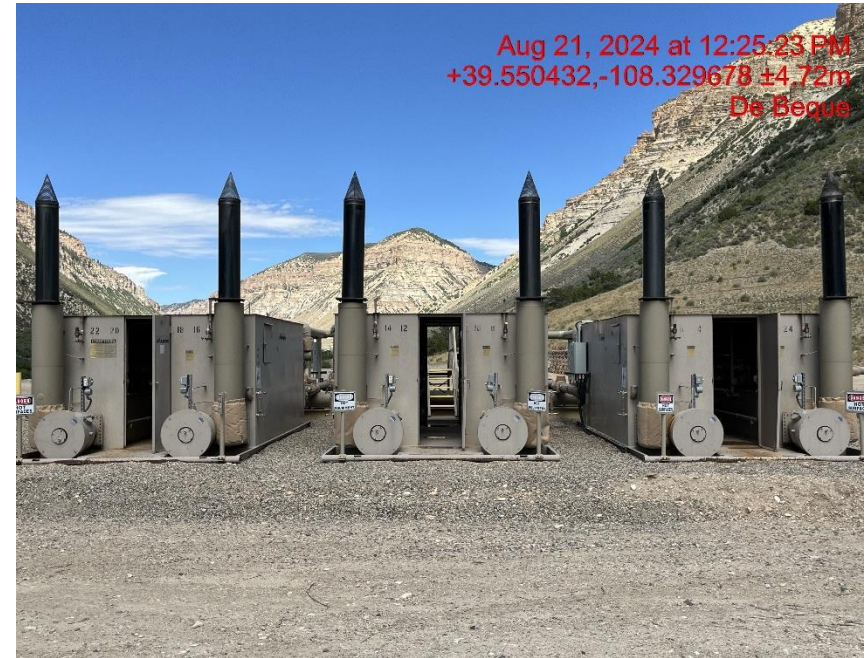
Doors open/Wildlife hazard - Photo #04852

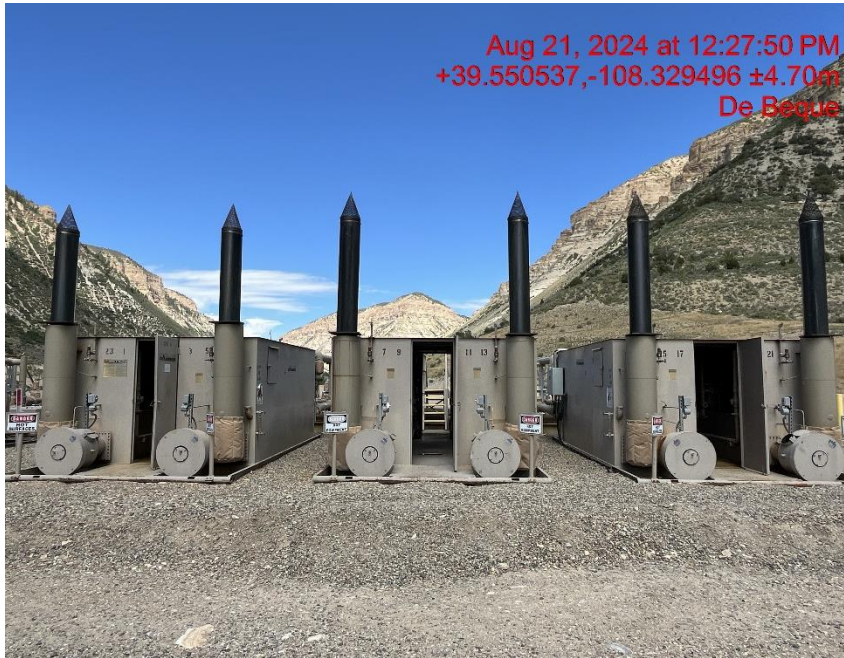
Doors open/Wildlife hazard - Photo #04854

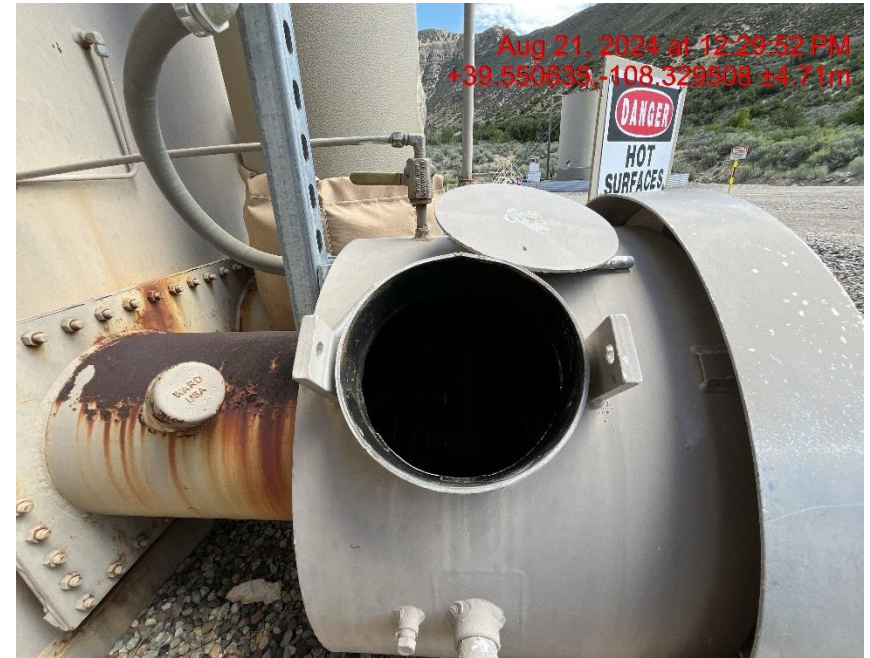
Wildlife hazard - Photo #04855

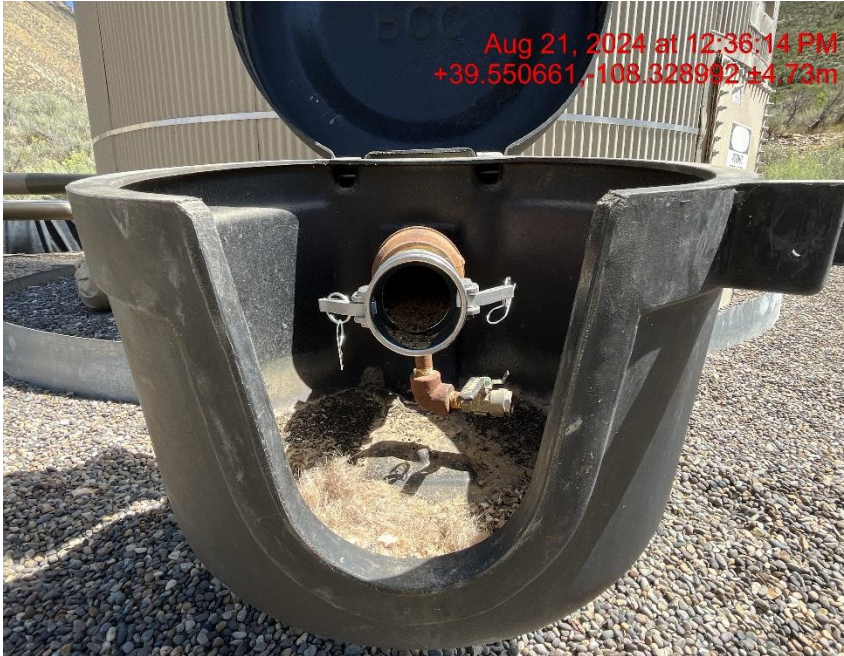
Open ended load line - Photo #04859

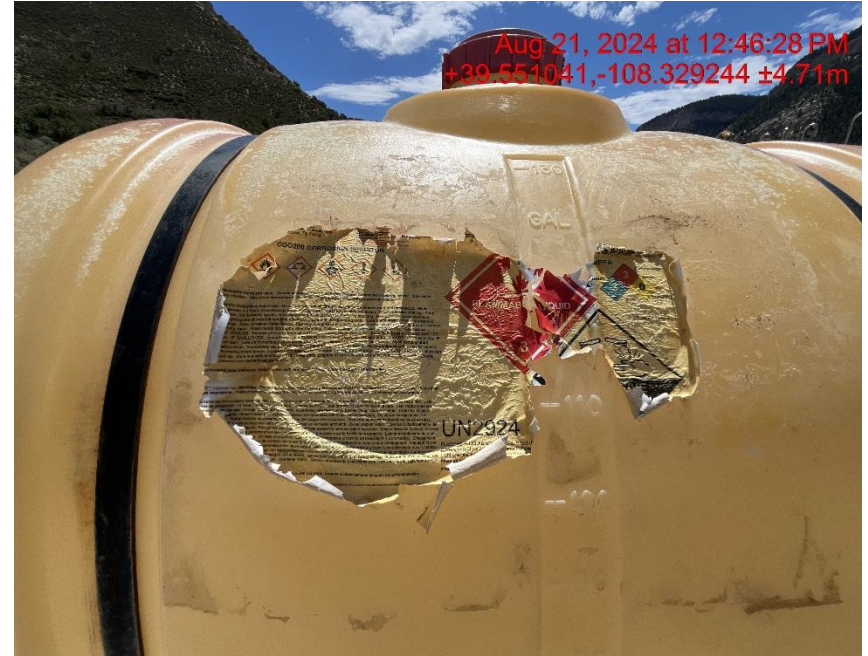
Label is weathered and peeling - Photo #04871
