Report of Work Completed – SVE Remediation

ECMC Location Name (ID)	PICEANCE CREEK UNIT-62S96W18NESW (315347)
Client Location Name	PCU F23-18G
ECMC Spill/Release Point ID	9186
Legal Description	NESW Sec. 18 T2S-R96W
Coordinates (Lat/Long)	39.876360 / -108.212270
County	Rio Blanco County, Colorado

Remediation Investigation

PCU F23-18G (ECMC Location ID: 315347)

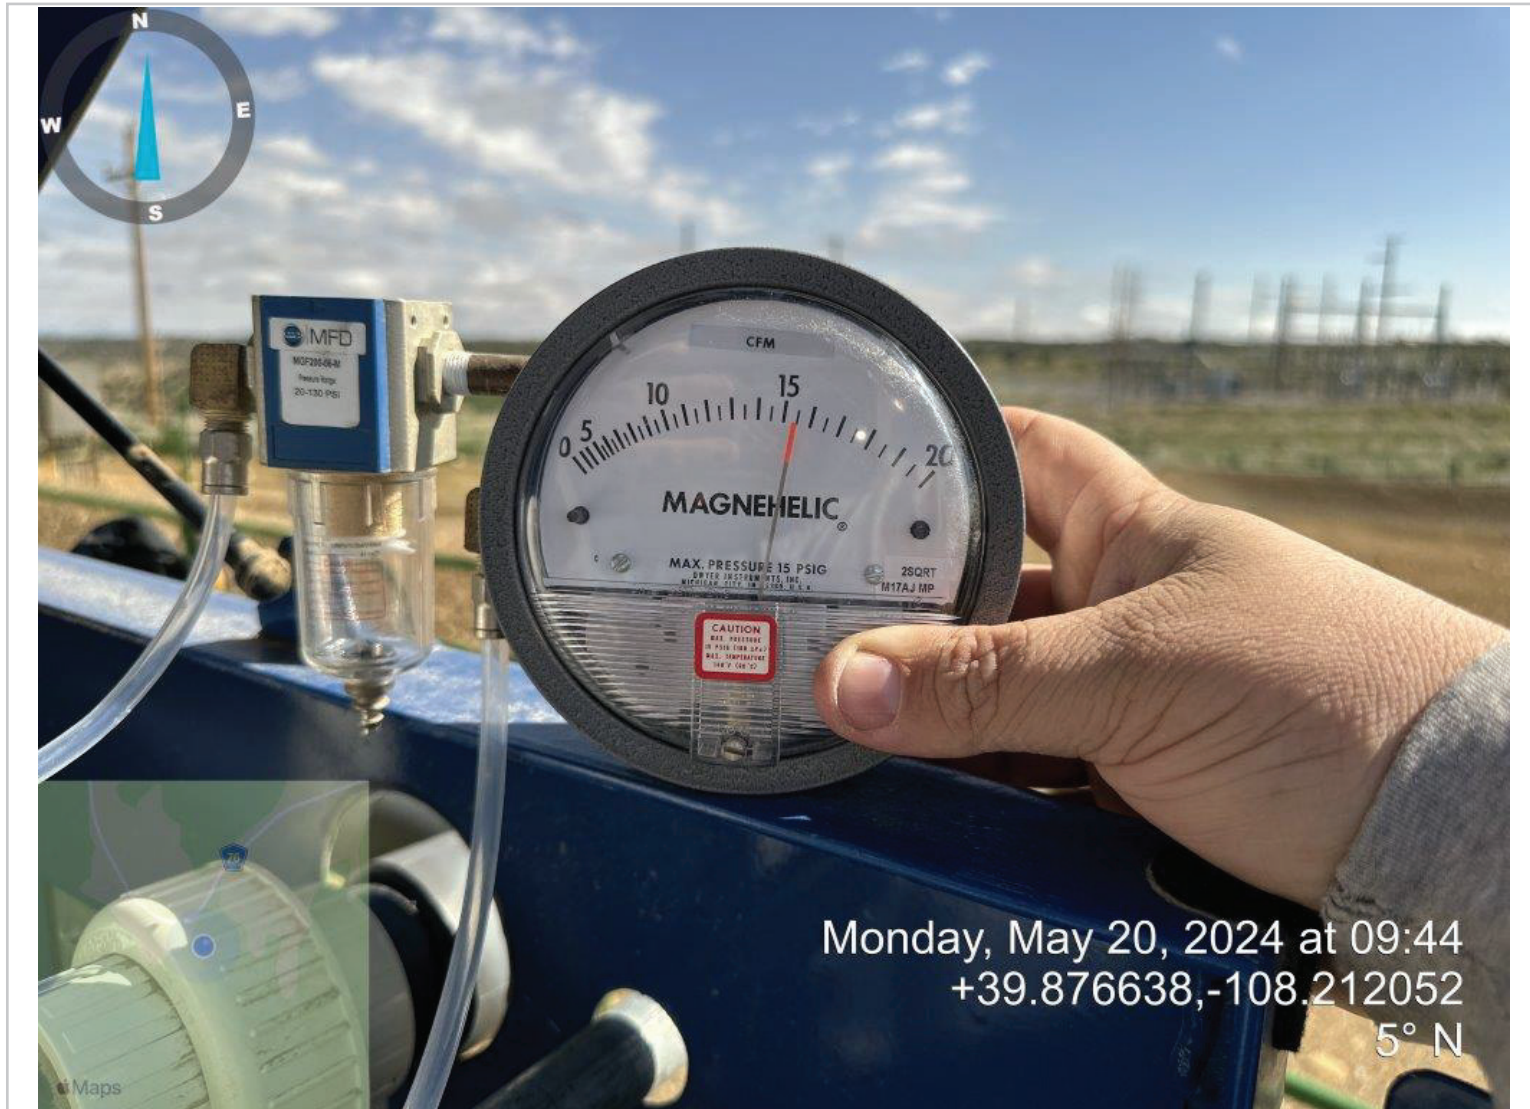
Updated Flow Meter

On May 20, 2024, Confluence personnel were onsite at the Location to perform quarterly SVE O&M activities. Using a photoionization detector (PID), the exhaust stack and SVE wells were field screened. Based on PID measurements, adjustments were made to the SVE system flow and vacuum in order to optimize volatilization of organic compounds within the impacted area. As part of O&M activities, a new flow gauge was installed with a lower range to more accurately document SVE system flow rates.

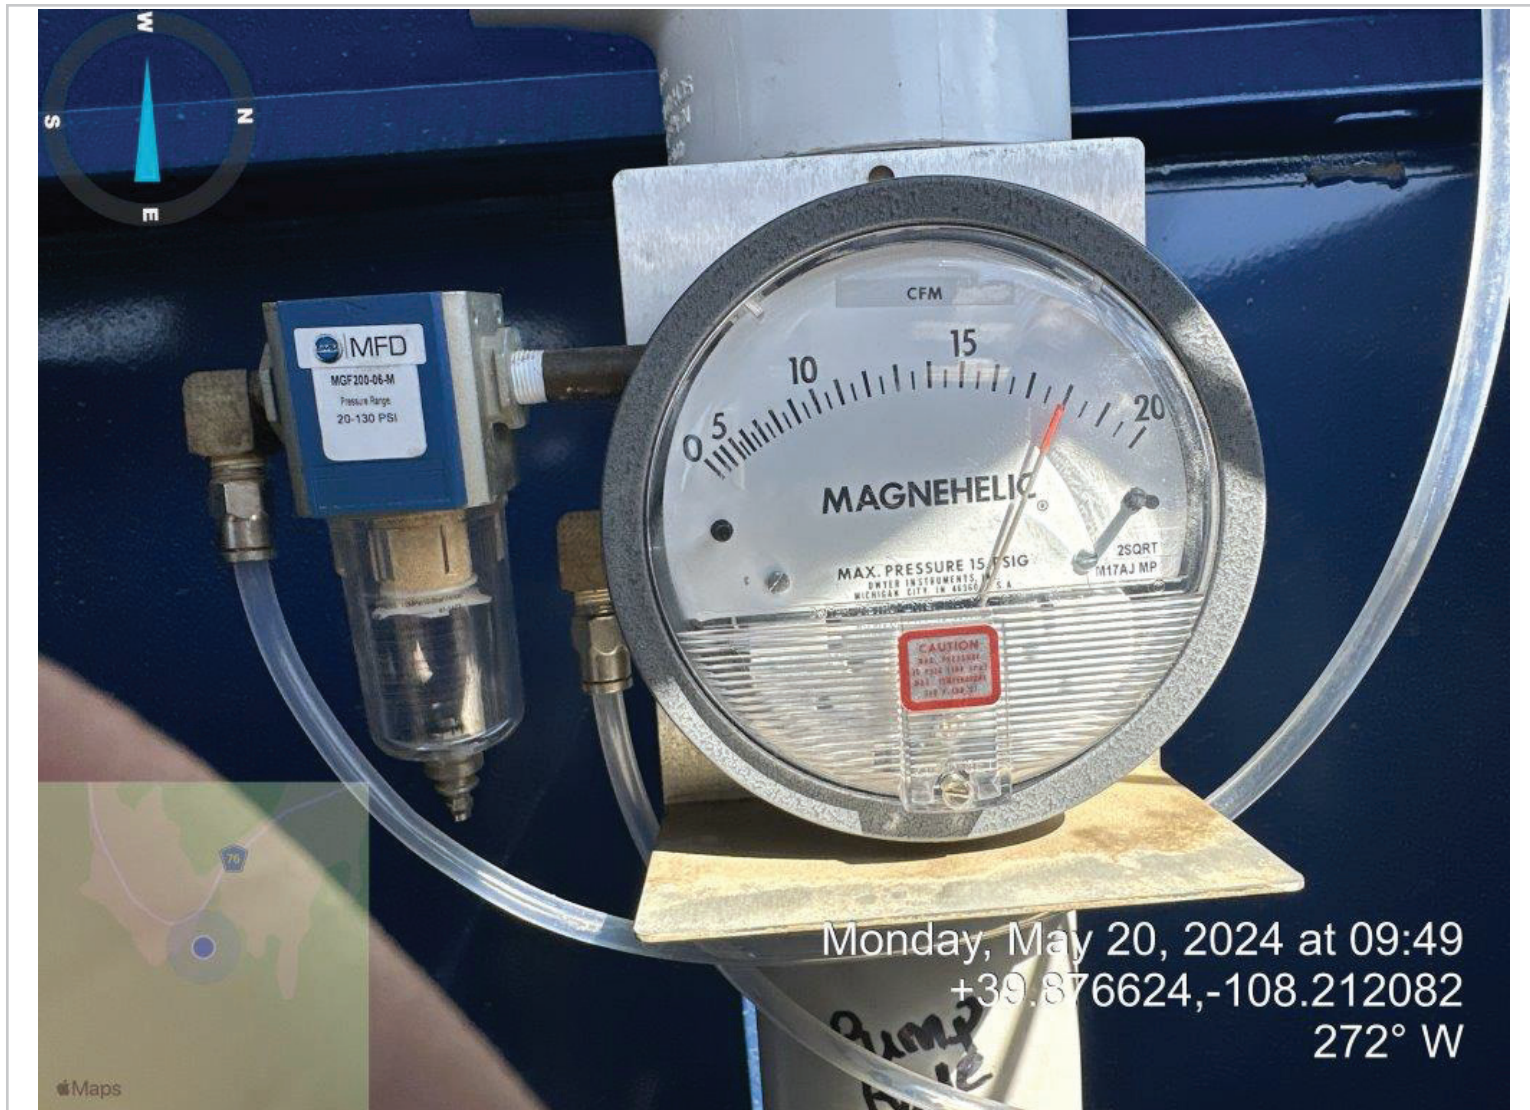
Updated Flow Meter Installed

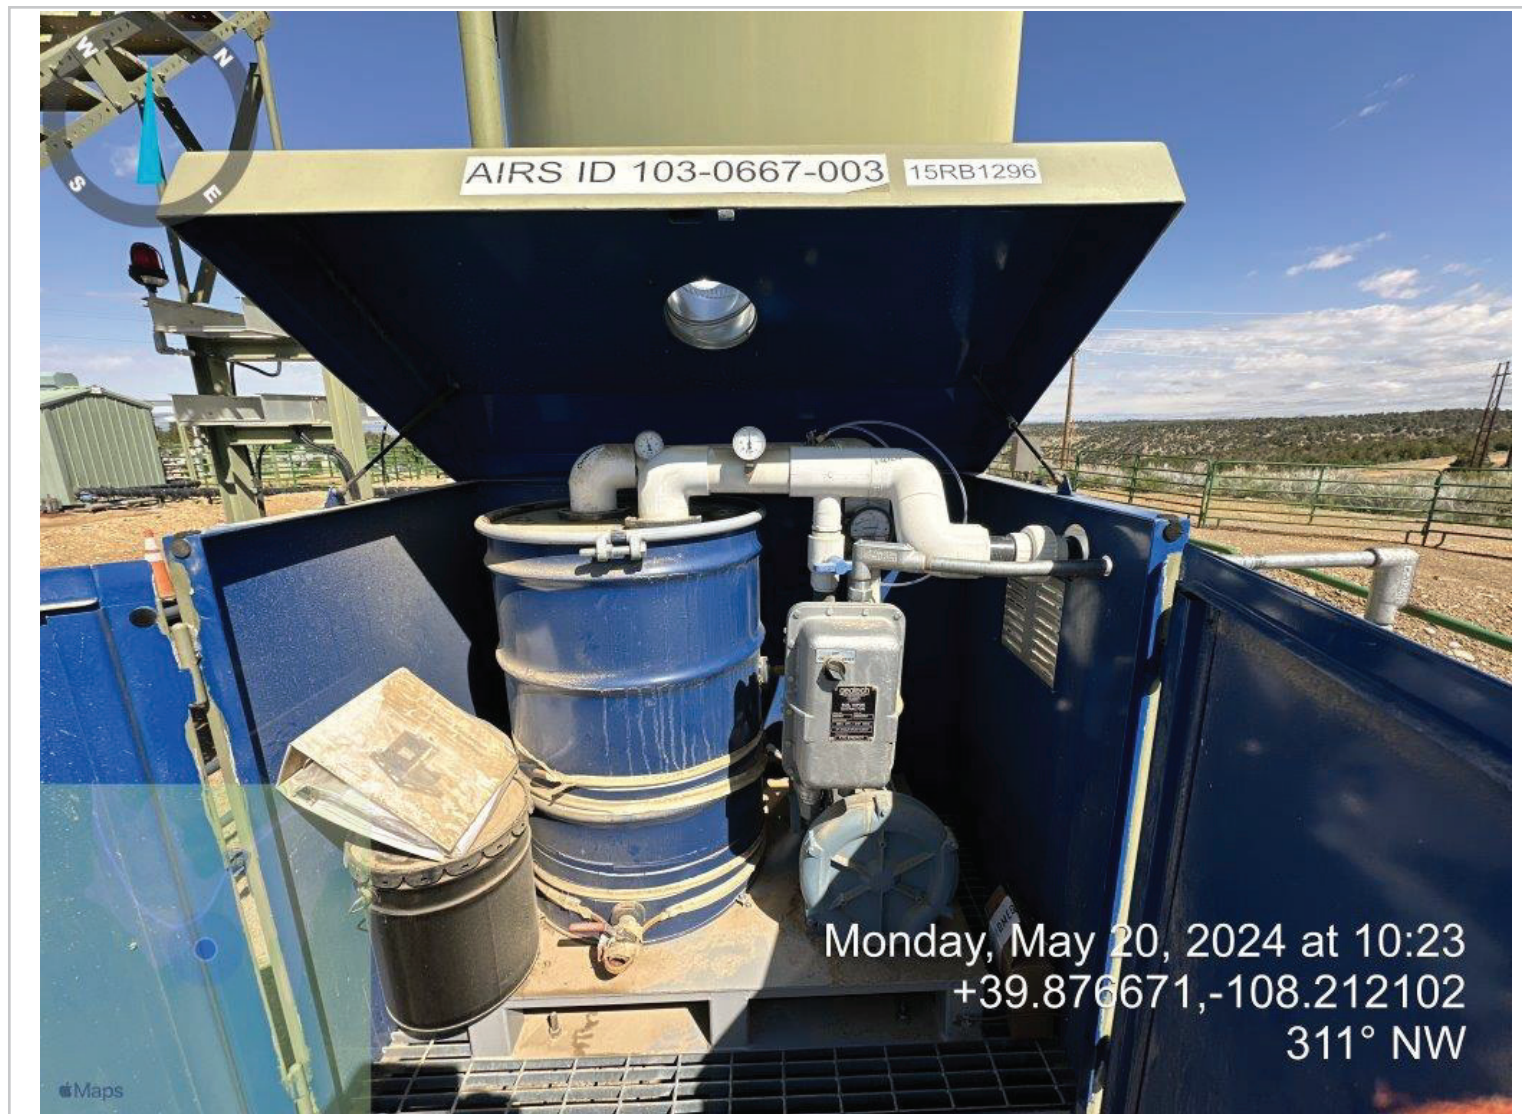
Operating SVE System Stack

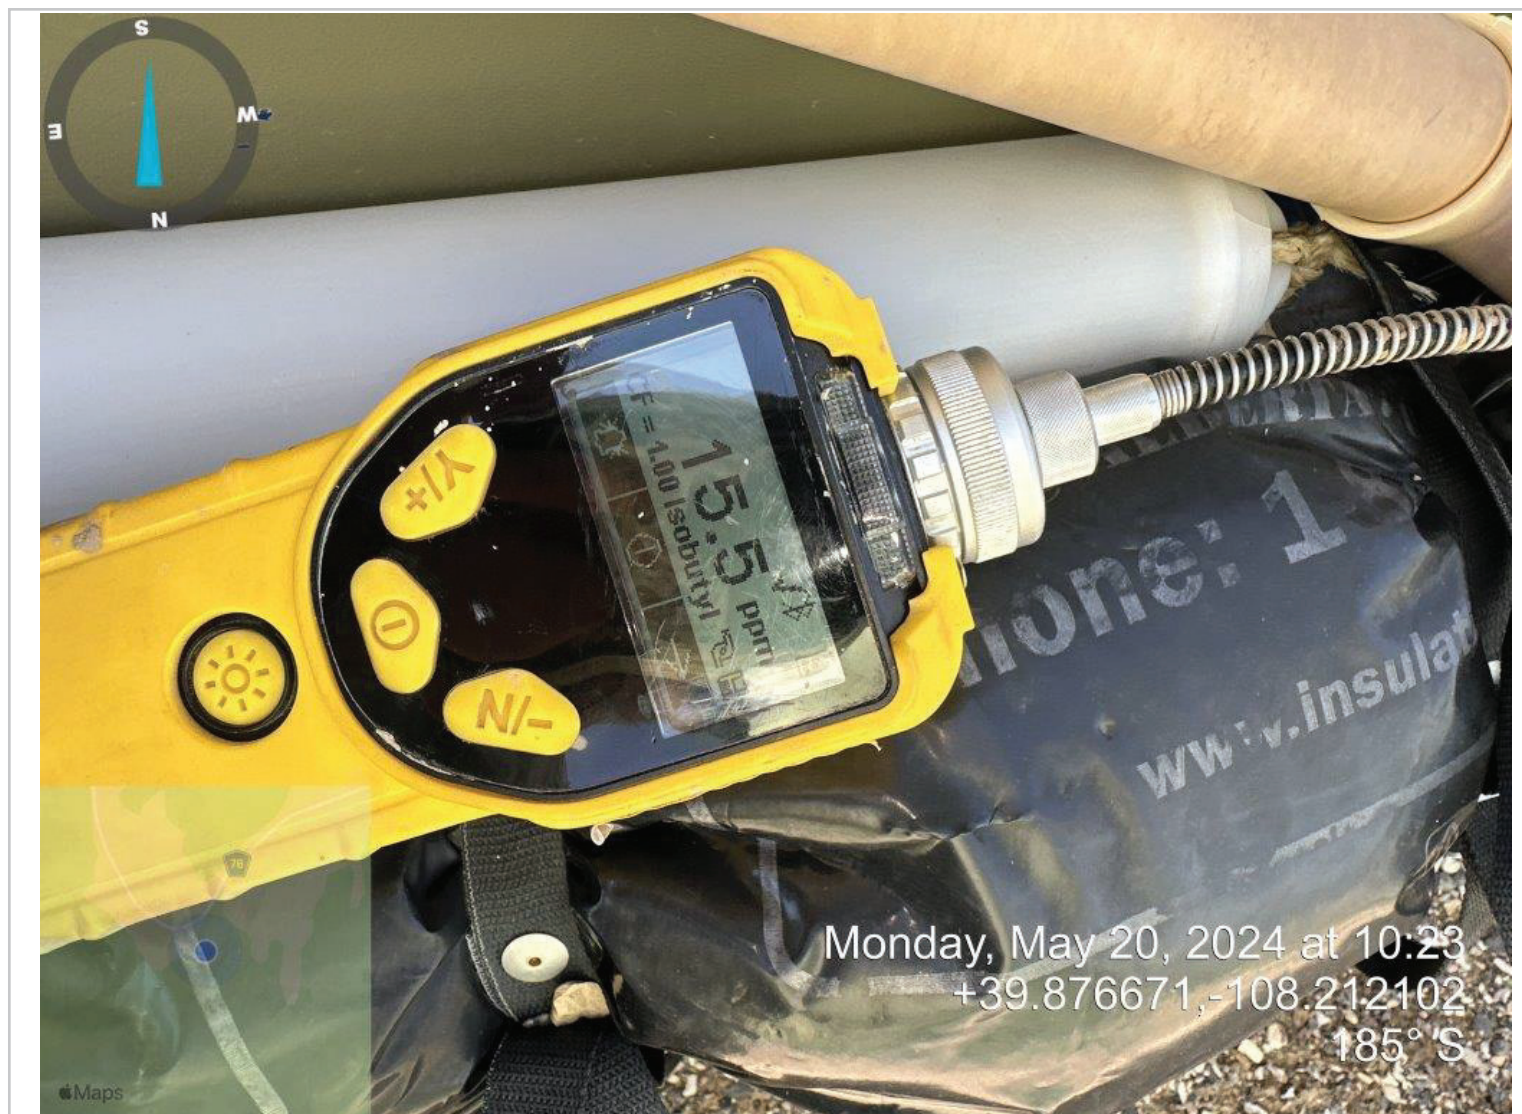
Airflow was measured at a rate of 18 standard cubic feet per minute (SCFM), and the PID measurement from the exhaust stack was 12.1 parts per million (ppm) with SVE04 25 percent (%) open, SVE07 at 100% open, and SVE06 closed. During system adjustments, PID measurements of the exhaust stack and isolated SVE wells ranged from 1.6 to 25.3 ppm. The optimal valve configuration for maximizing remedial potential was found to be as follows: SVE04 30% open, SVE06 closed, and SVE07 100% open. After system adjustments were made, the final exhaust stack PID measurement was 15.5 ppm.

Stack PID reading
