## Inspection Photos

Location Name: CAERUS PICEANCE LLC HMU Federal 24-13A1 (D25W) Pad

Location #: 334618

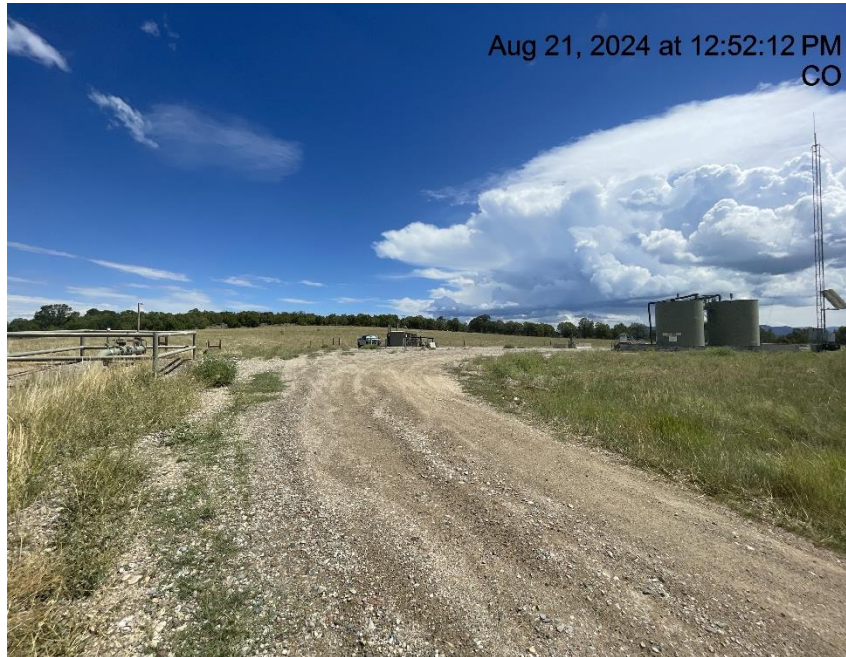
Photo # 5851 From entrance to location

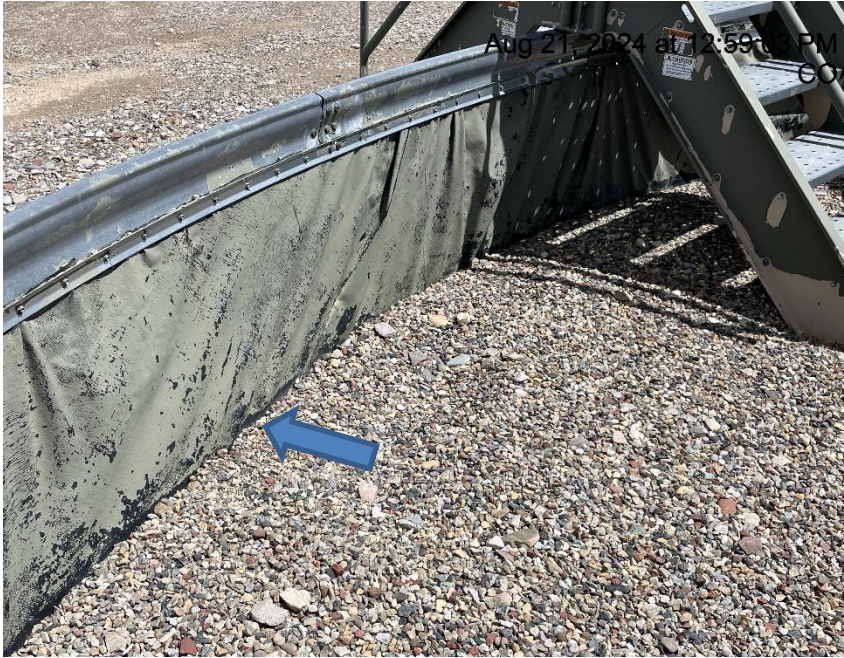
Photo # 5857 Hole in liner/liner needs maintenance

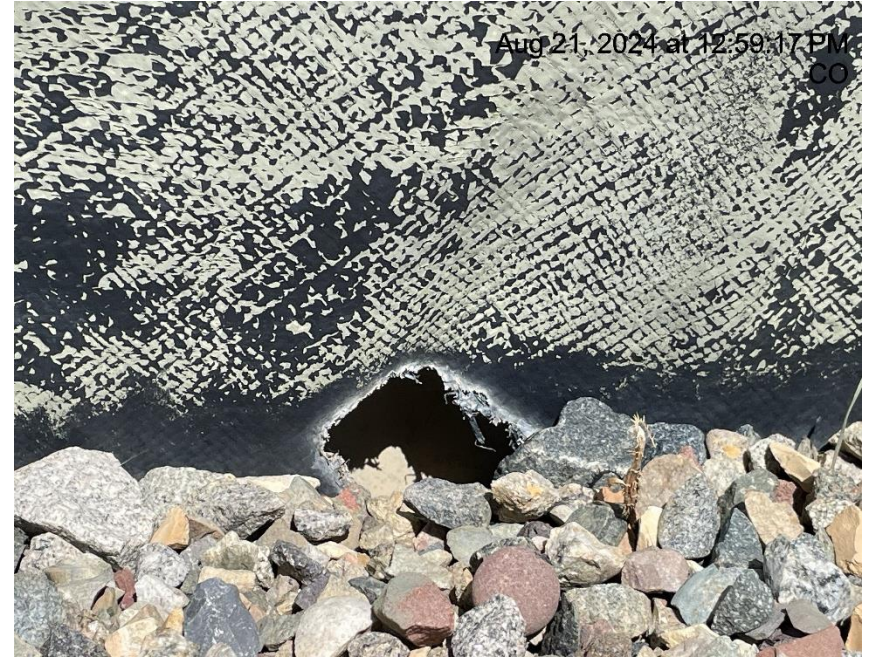
Photo # 5858 Hole in liner/liner needs maintenance

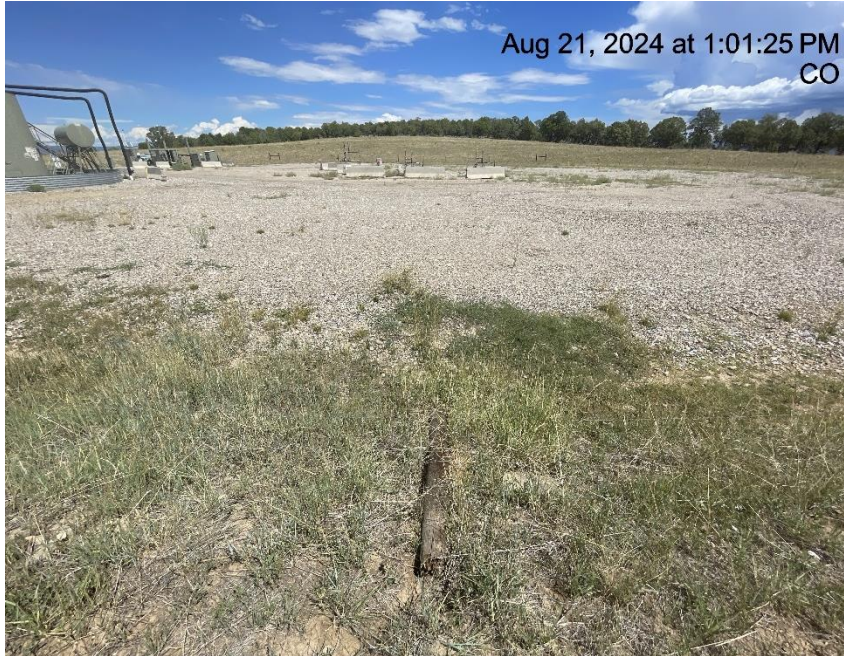
**Photo # 5859 Barbed wire fence needs maintenance/wildlife hazard**

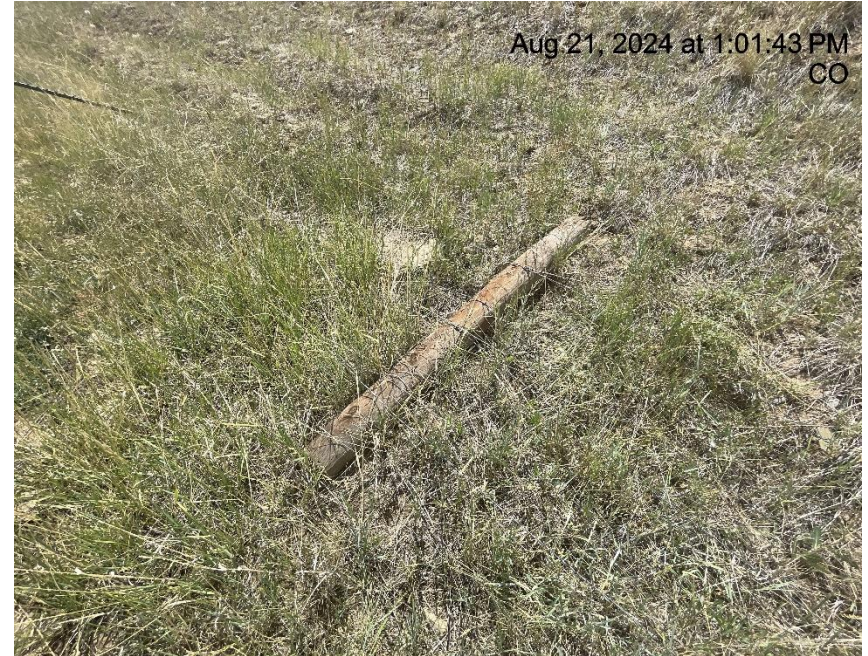
**Photo # 5860 Barbed wire fence needs maintenance/wildlife hazard**

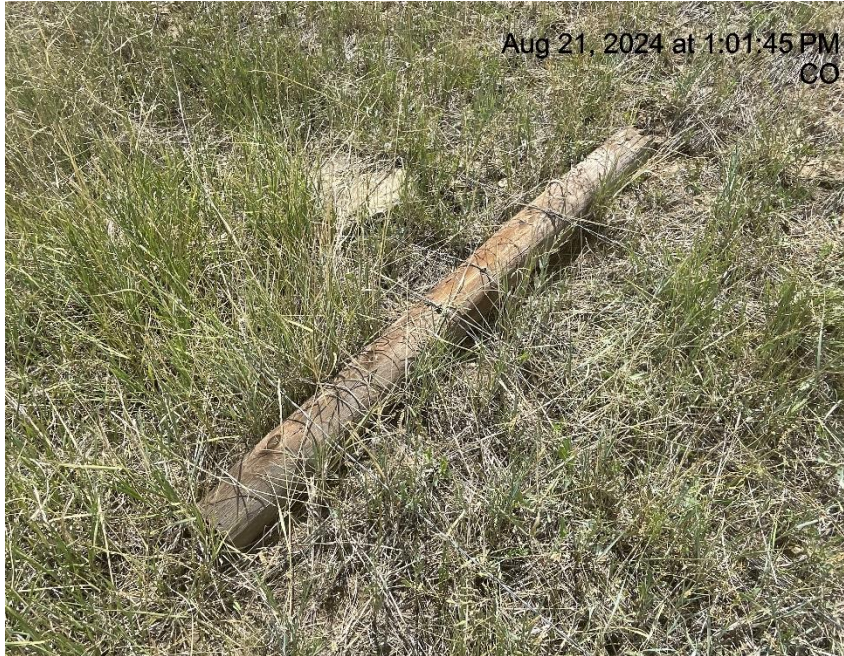
**Photo # 5861 Barbed wire fence needs maintenance/wildlife hazard**

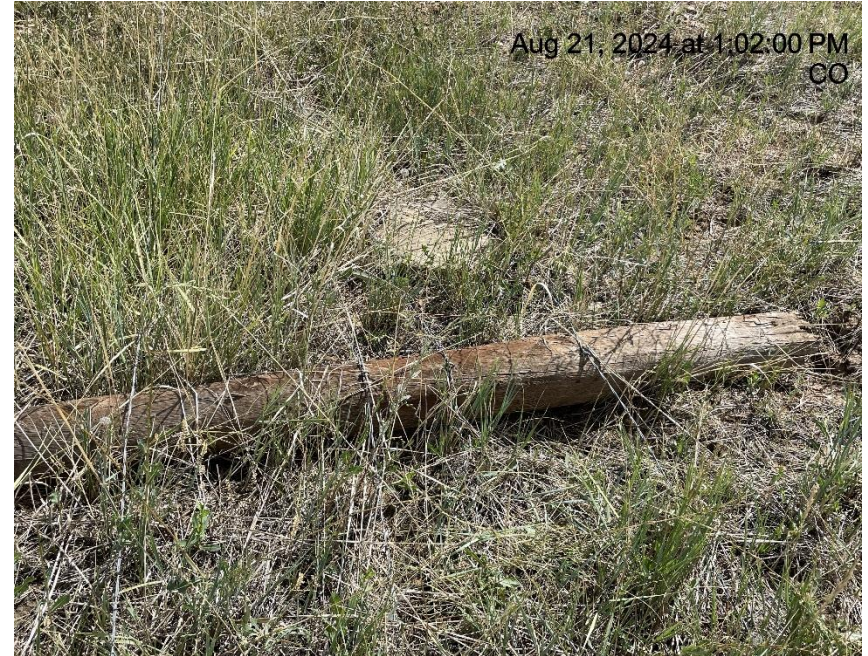
**Photo # 5862 Barbed wire fence needs maintenance/wildlife hazard**

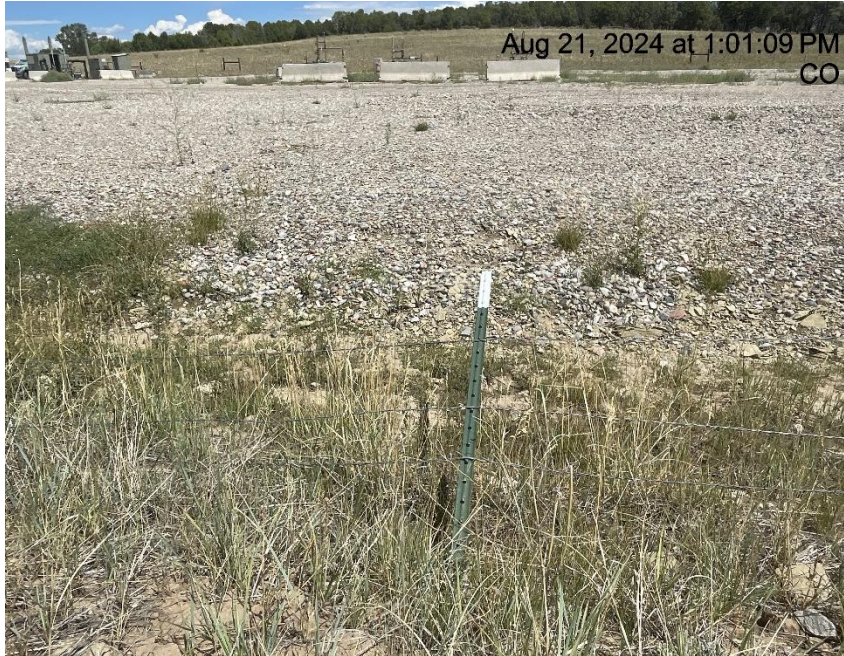
**Photo # 5863 Barbed wire fence needs maintenance/wildlife hazard**

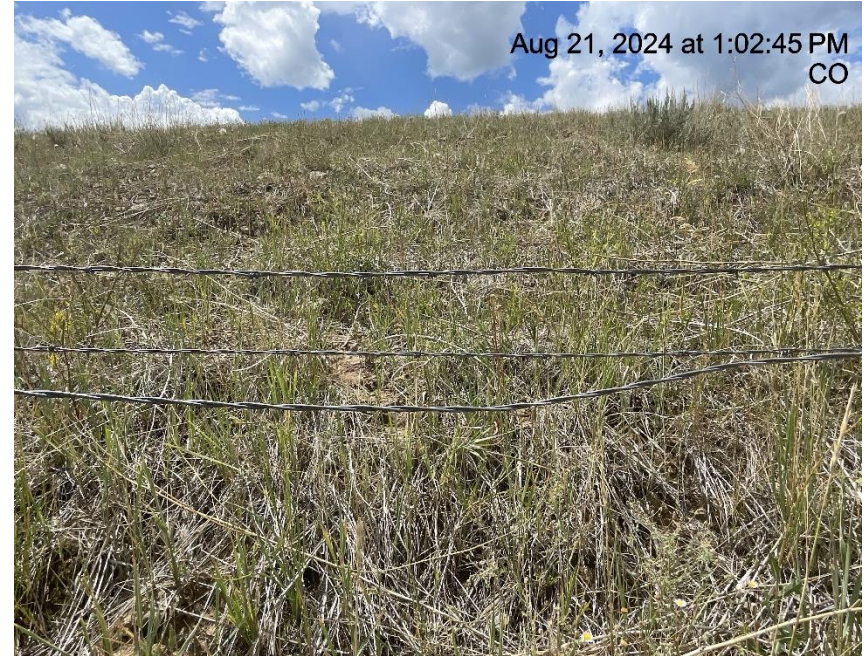
**Photo # 5864 Barbed wire fence needs maintenance/wildlife hazard**

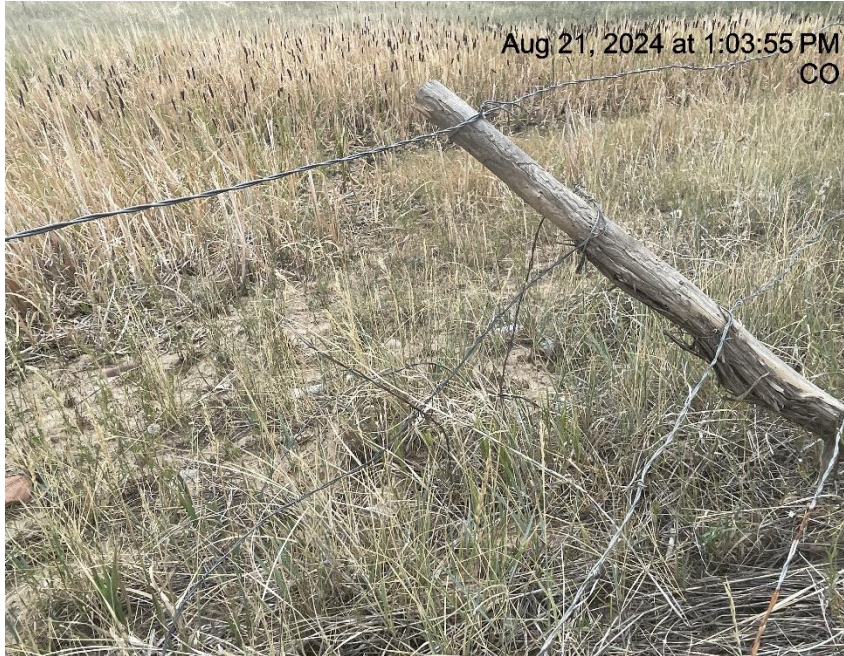
**Photo # 5865 Barbed wire fence needs maintenance/wildlife hazard**

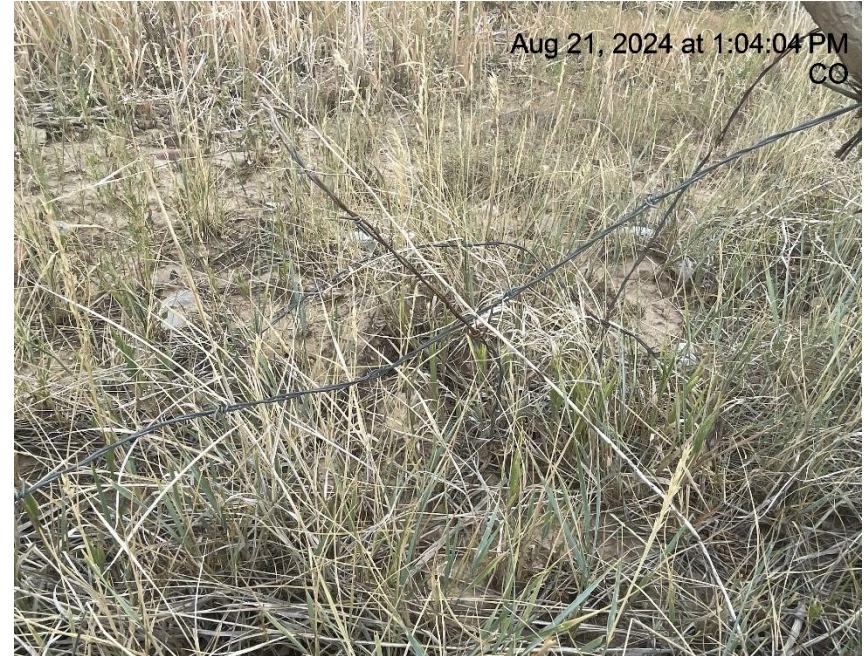
**Photo # 5866 Barbed wire fence needs maintenance/wildlife hazard**

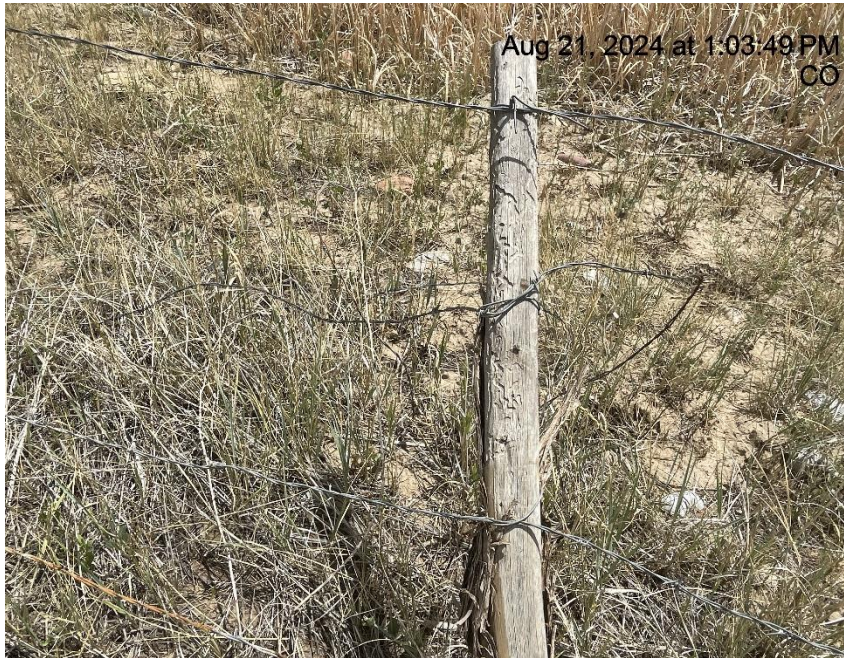
**Photo # 5867 Barbed wire fence needs maintenance/wildlife hazard**

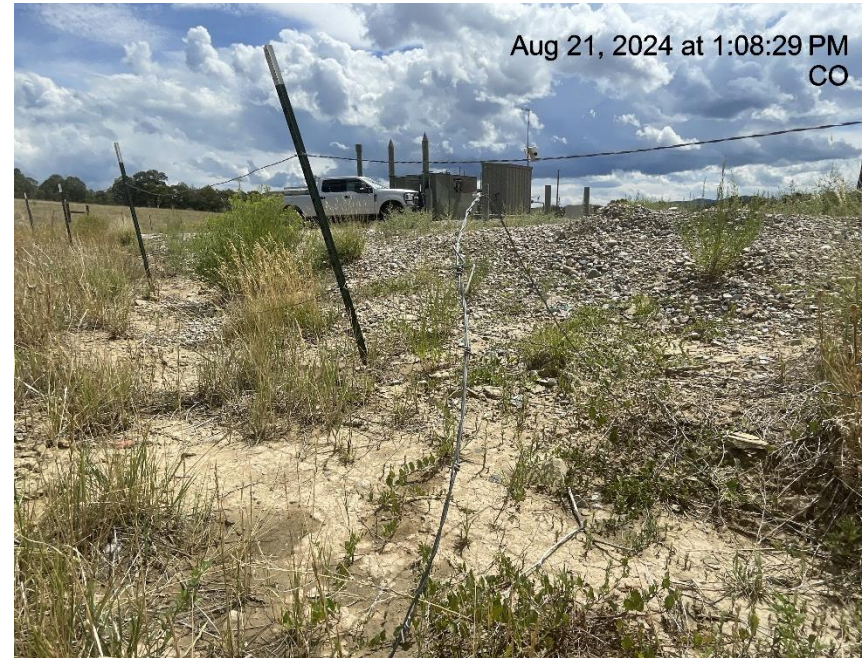
**Photo # 5868 Barbed wire fence needs maintenance/wildlife hazard**

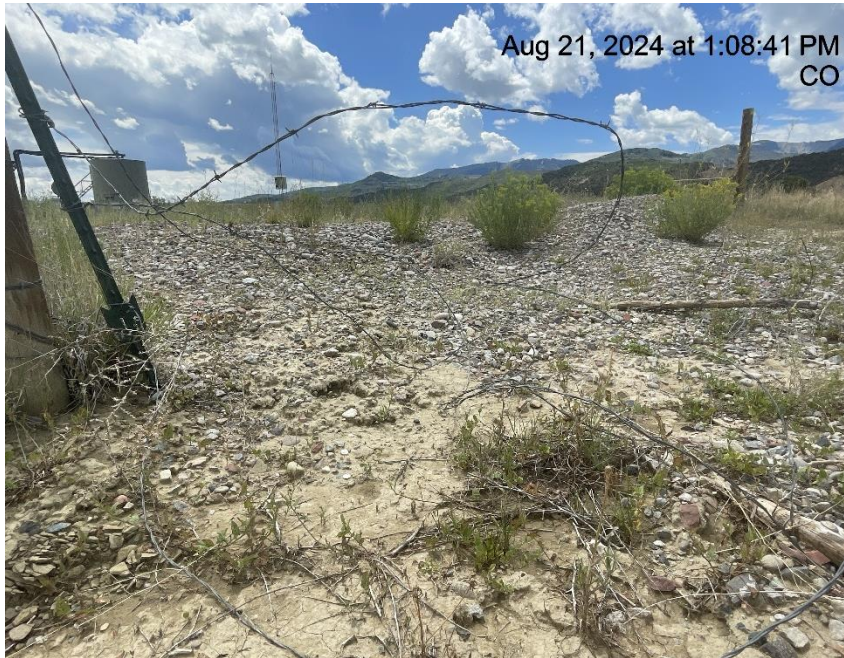
**Photo # 5869 Barbed wire fence needs maintenance/wildlife hazard**

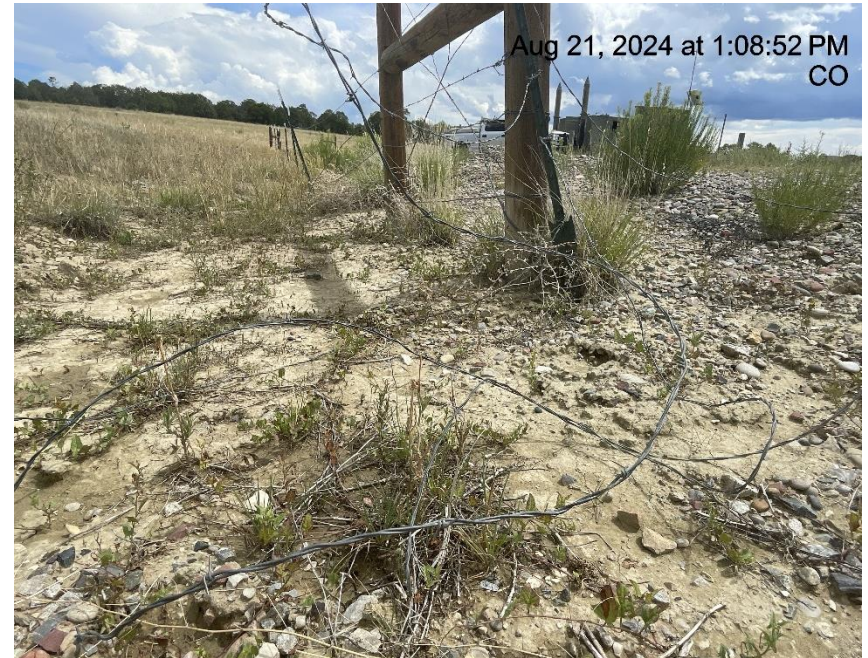
**Photo # 5870 Barbed wire fence needs maintenance/wildlife hazard**

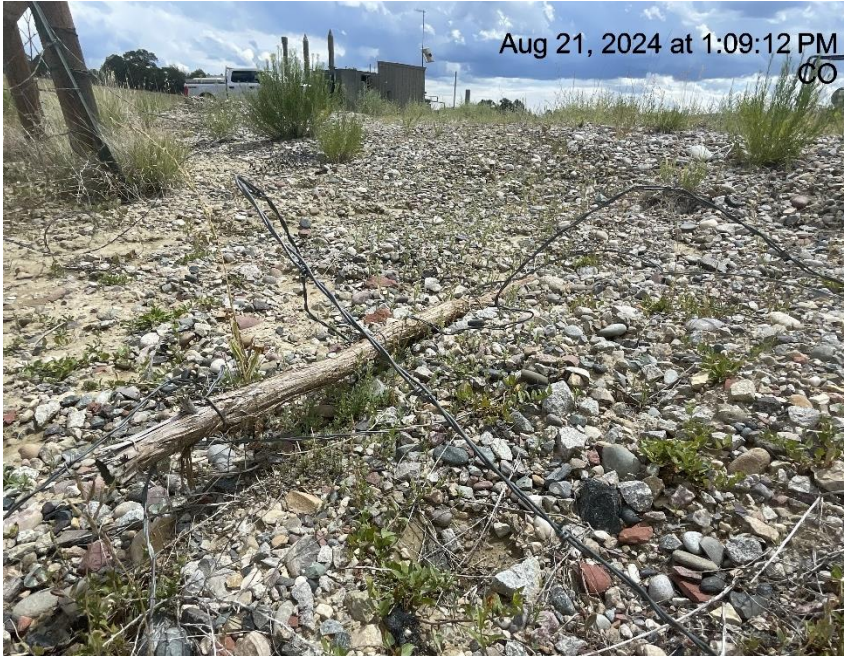
**Photo # 5871 Barbed wire fence needs maintenance/wildlife hazard**

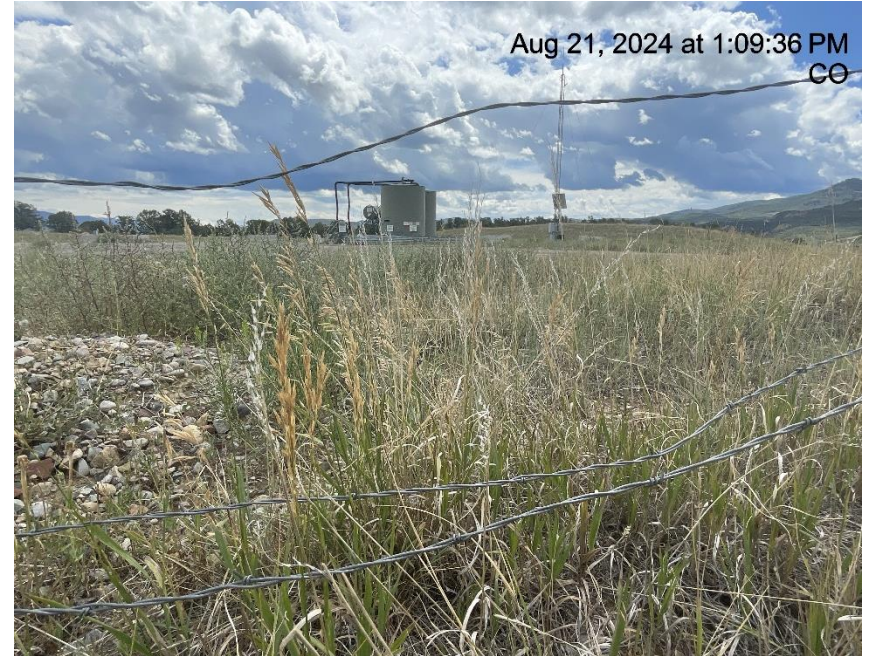
**Photo # 5872 Barbed wire fence needs maintenance/wildlife hazard**

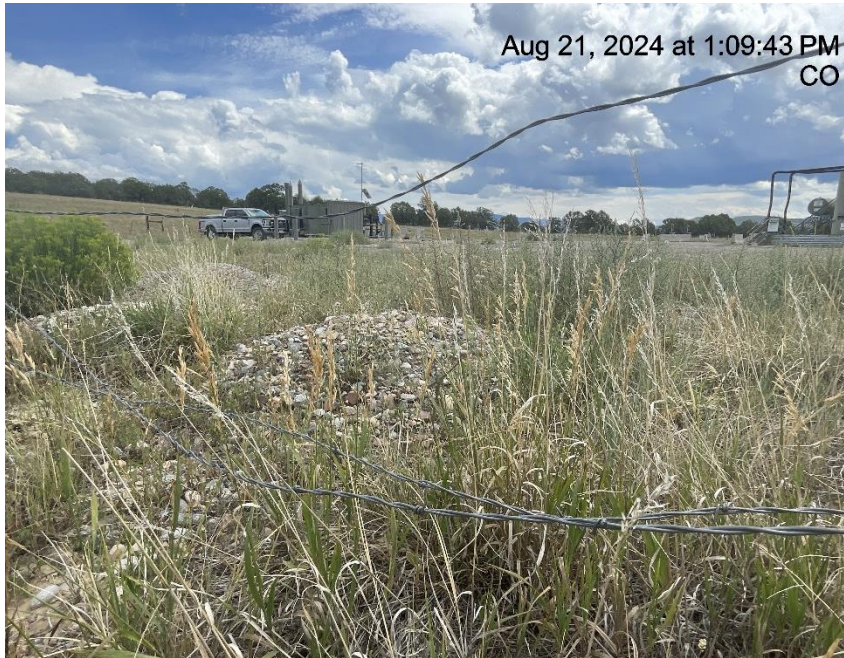
**Photo # 5873 Barbed wire fence needs maintenance/wildlife hazard**

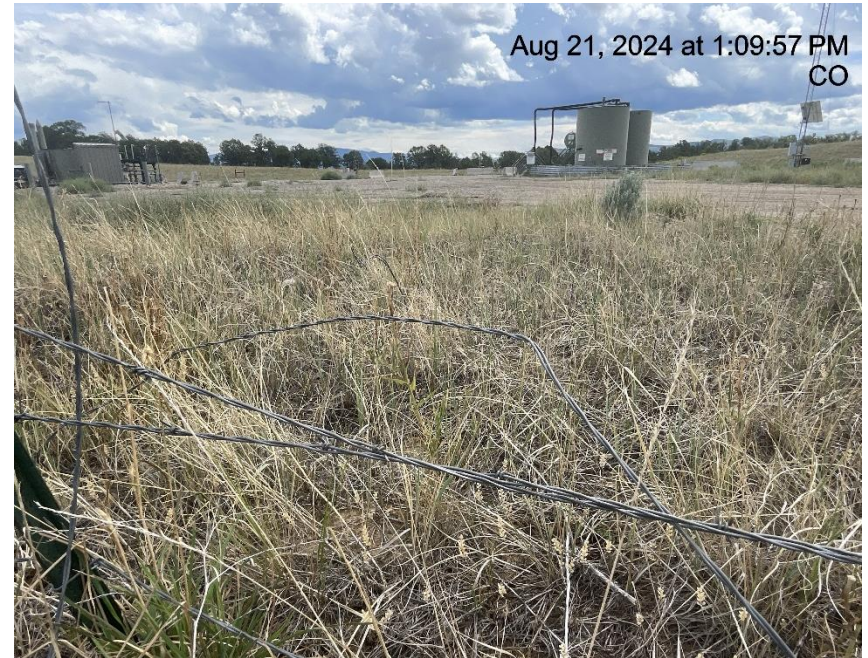
**Photo # 5874 Barbed wire fence needs maintenance/wildlife hazard**
