## Inspection Photos

Location: CHEVRON USA INC SKINNER RIDGE-65S98W/25SESW

Location ID: 336054

Date: 8/21/2024

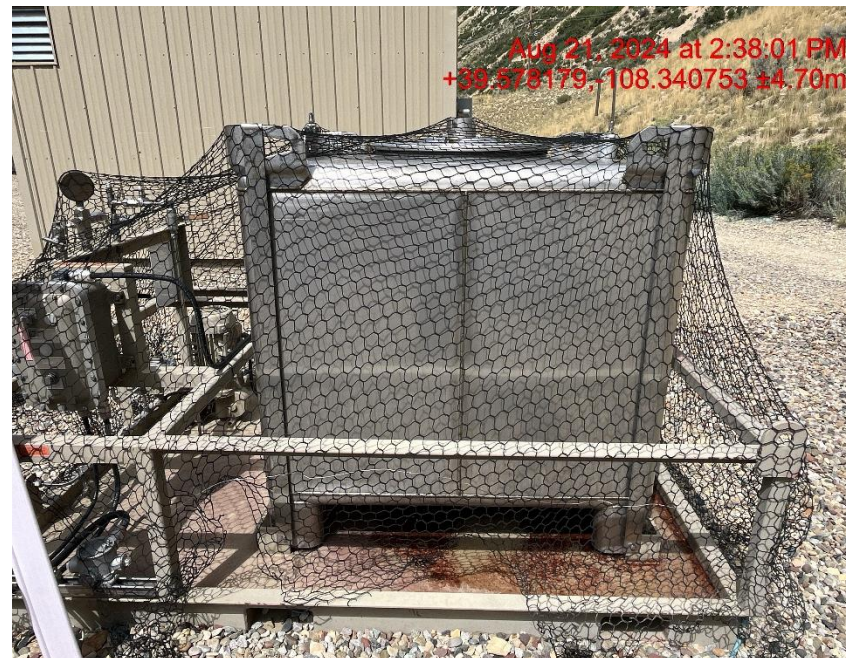
No tank labeling - Photo #04891

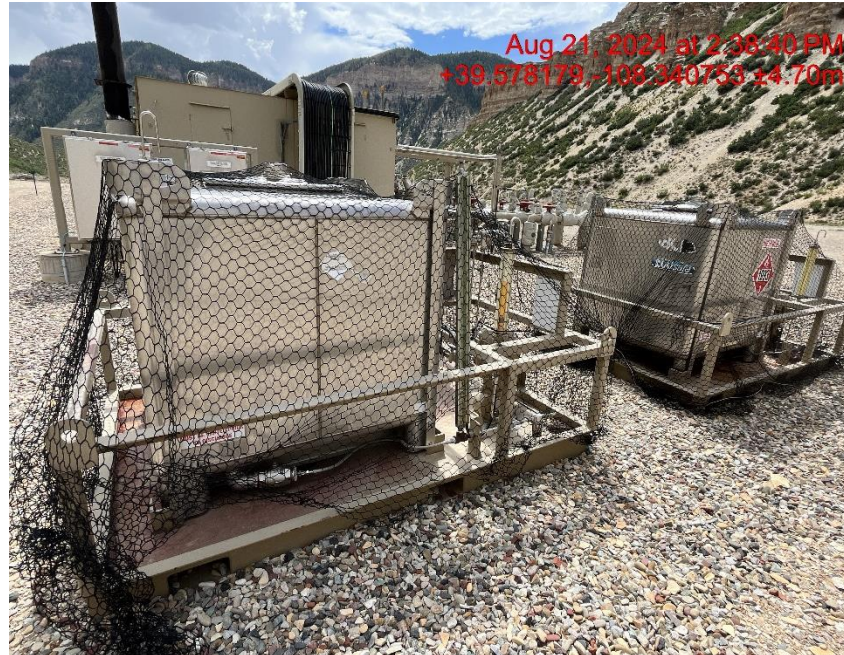
No tank labeling - Photo #04892
