Operator: 8 North

Location Name: GALLEGOS PC GJ 13-99HZ

Loc ID: 417344

Inspection: 684905115

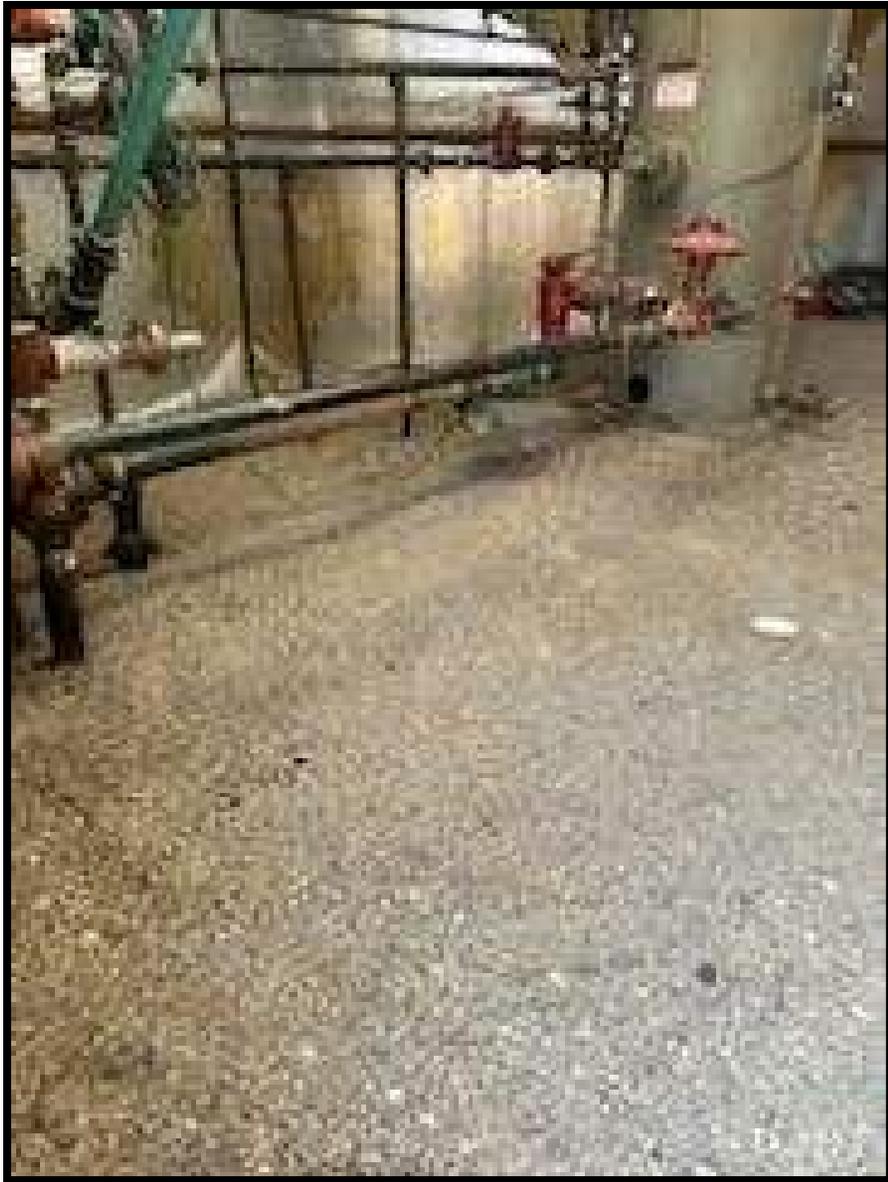
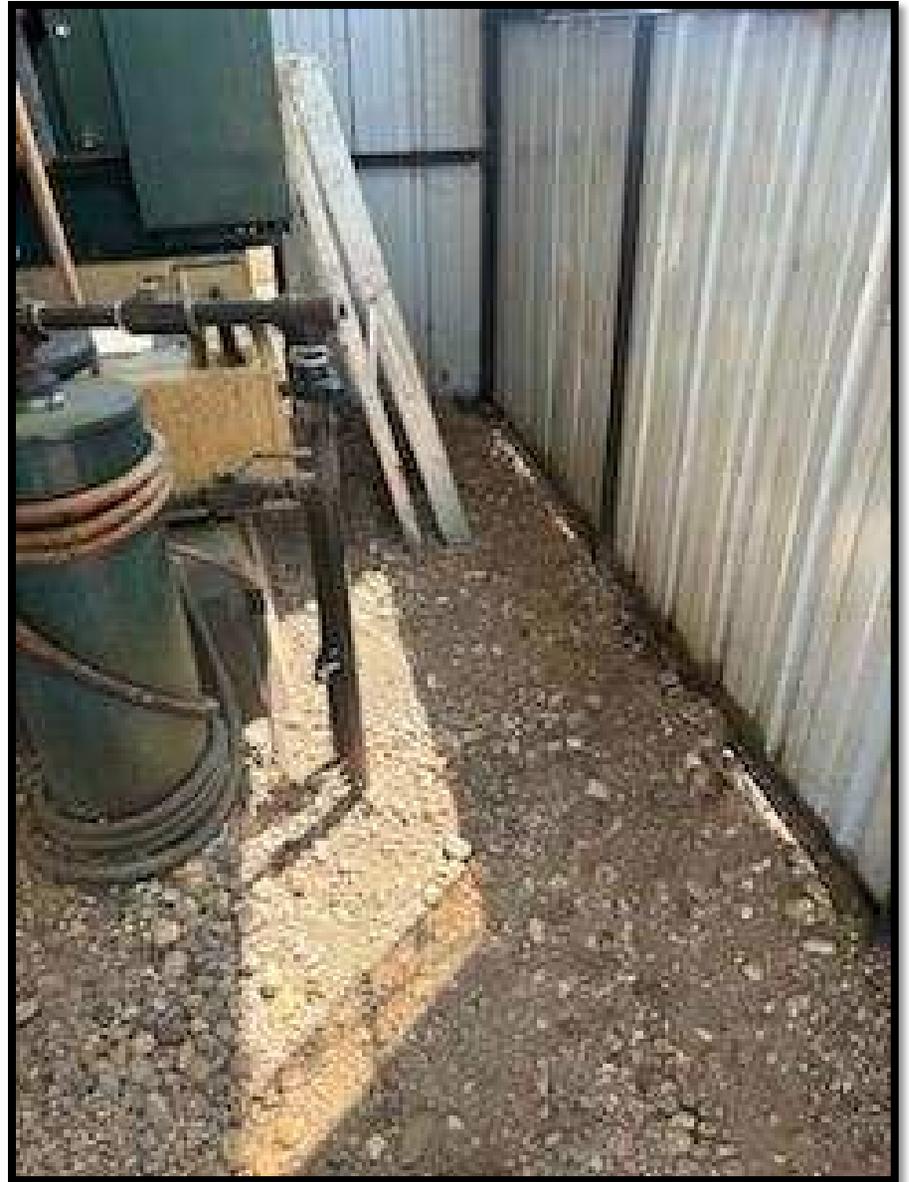
CA: Debris in treater house. Comply with rule 603.f.

CA Resolution: Operator has addressed identified debris and it has been removed from the location to comply with the 600 series.

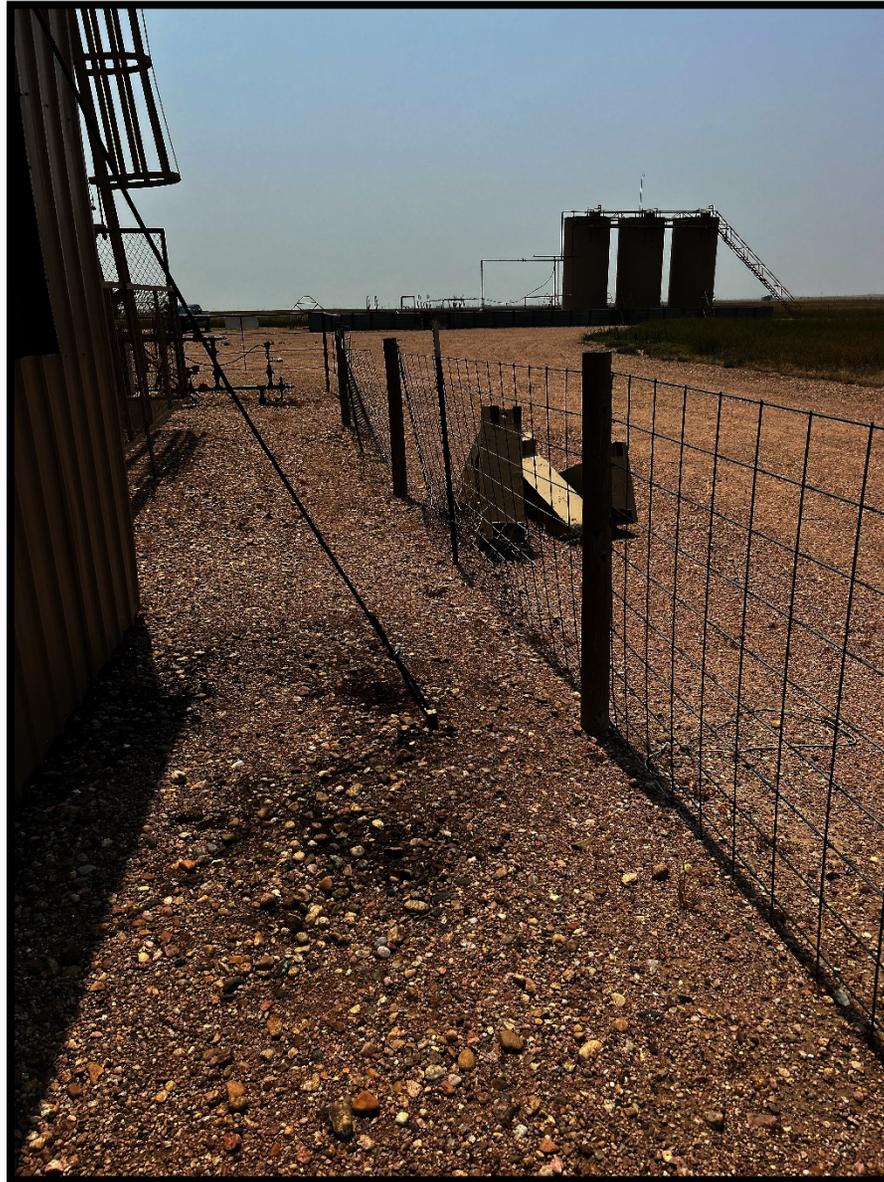
CA: Gas engine; stained soil at engine. Properly treat or dispose of oily waste in accordance with Rule 907.e. Securely fasten all valves, pipes, and fittings to ensure good mechanical condition, inspect at regular intervals and maintain in good mechanical condition per Rule 605.d.

CA Resolution: Operator has provided photo evidence showing that the stained soil has been addressed, and the location is currently in compliance with the 900 and 600 series.
