Final Reclamation Complete Notice – Cropland Drone Imagery

PERMIT CLOSURE REPORT – CROPLAND

Location Name KAMMERZELL-65N66W/29SWNW

16 Aug 2024

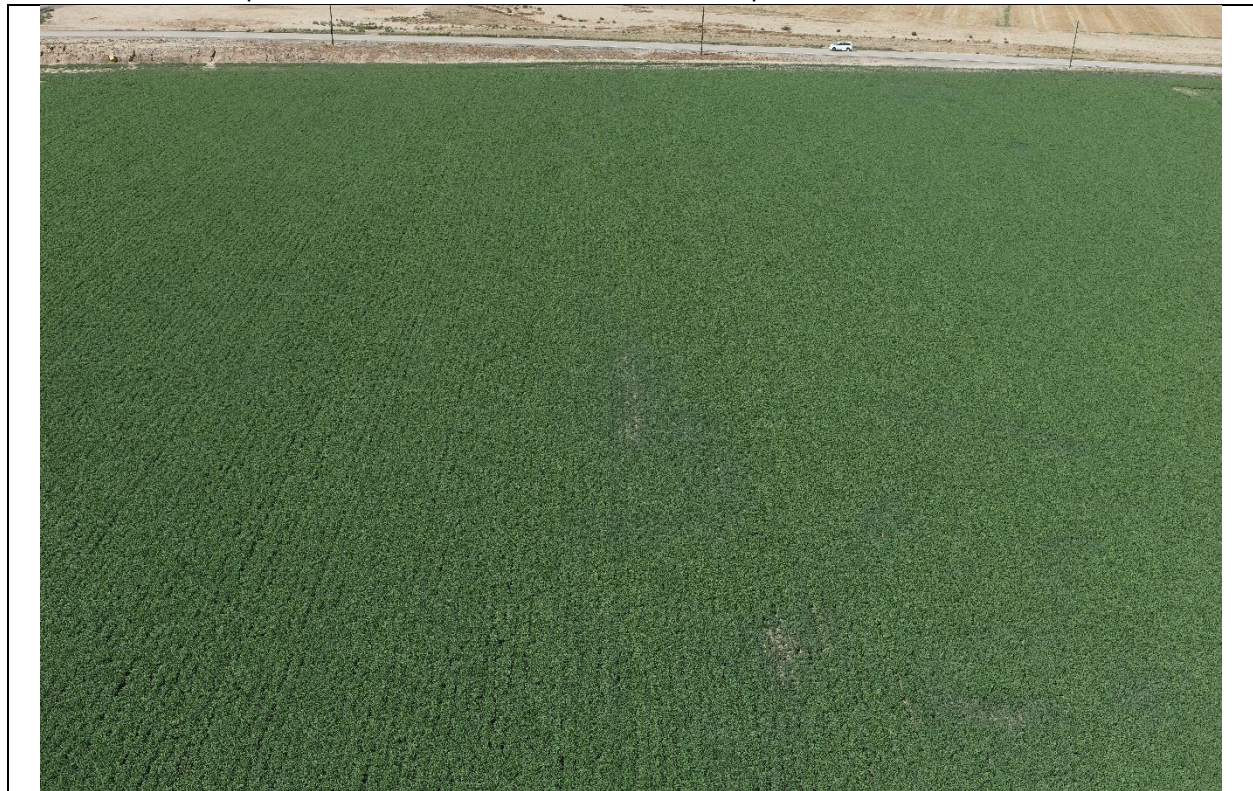
NORTH – 40.375360/-104.811280

In View – Well, Access Road, Flowlines

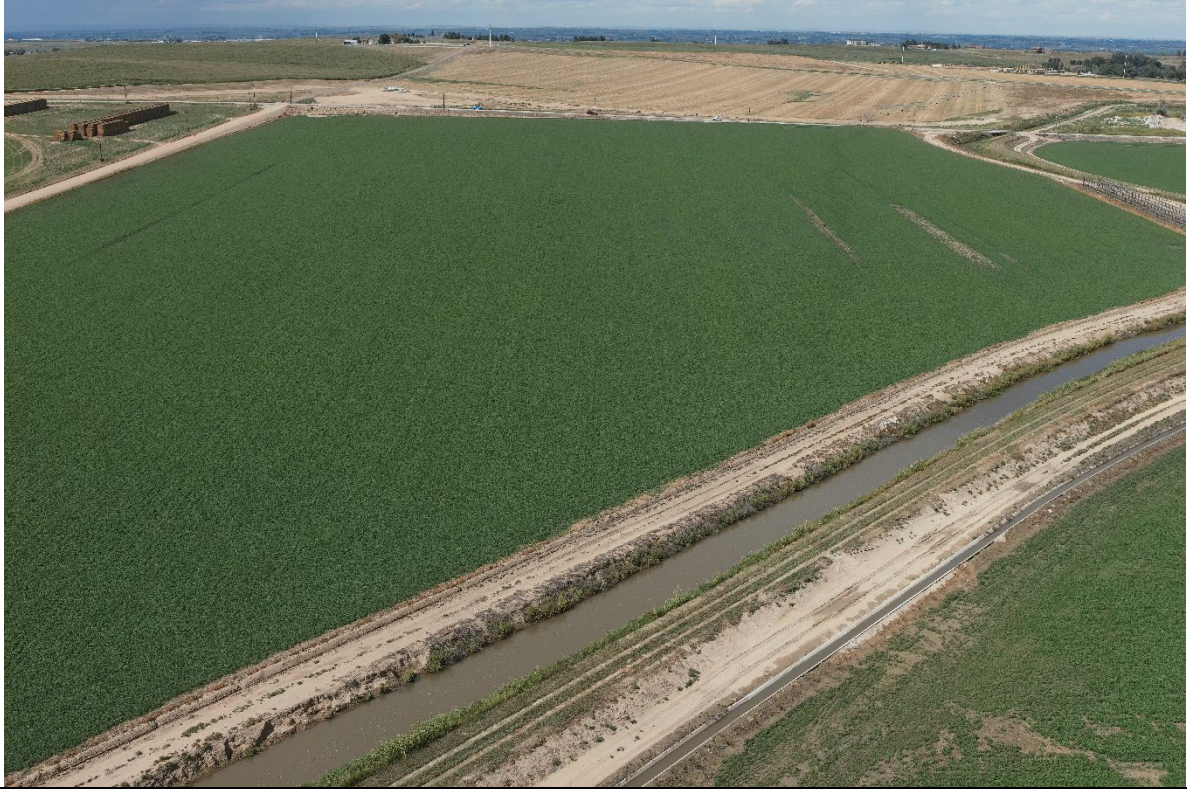
NORTH – 40.372094/-104.810902

In View – Well, Access Road, Flowline

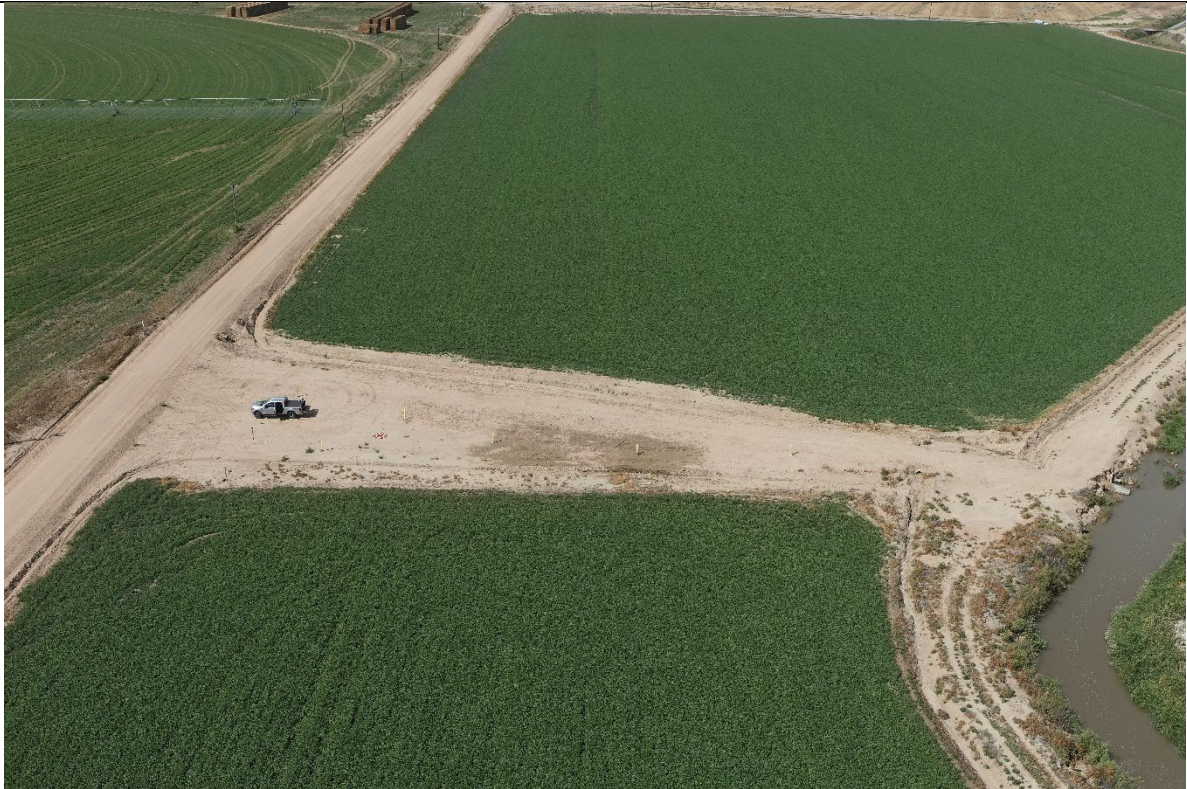
NORTH – 40.371417/-104.812191

In View – Tank Battery (Location ID [448598](#))

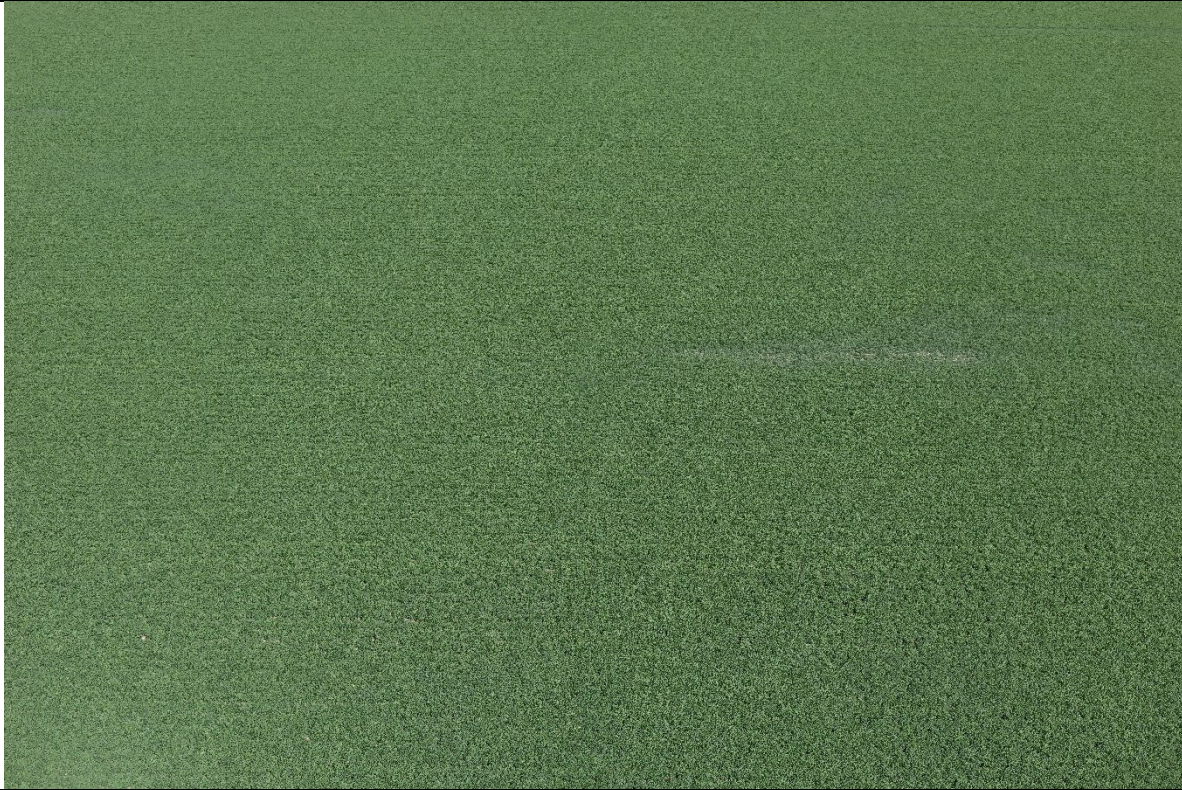
EAST – 40.376352/-104.812192

In View – Well, Access Road, Flowlines

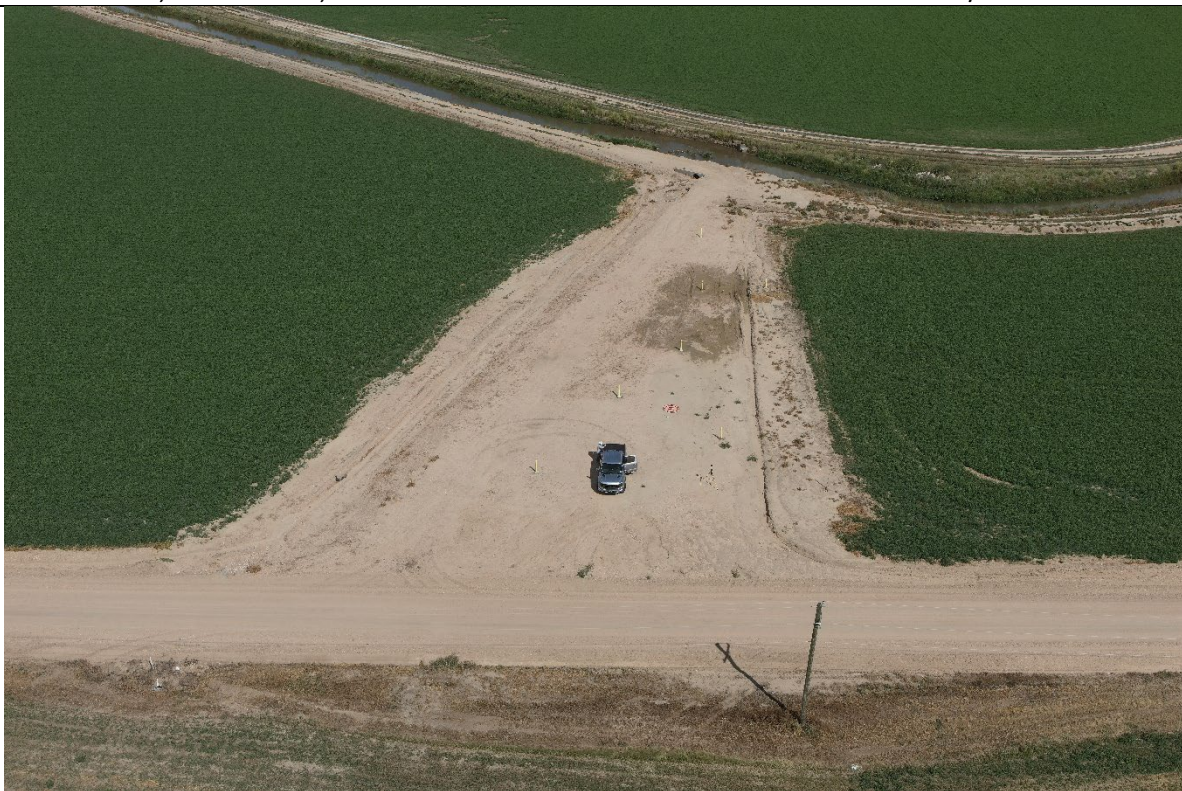
EAST – 40.372449/-104.813546

In View – Tank Battery (Location ID [448598](#))

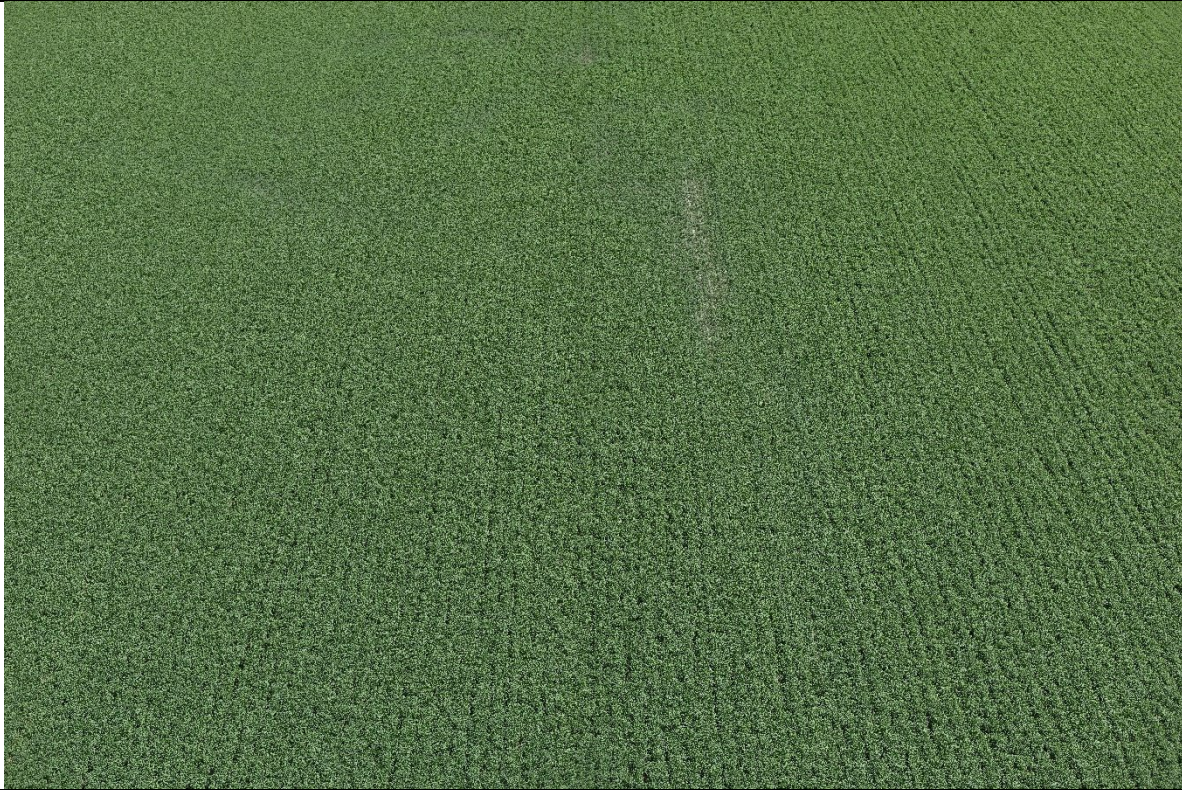
SOUTH – 40.376856/-104.811205

In View – Well, Access Road, Flowlines

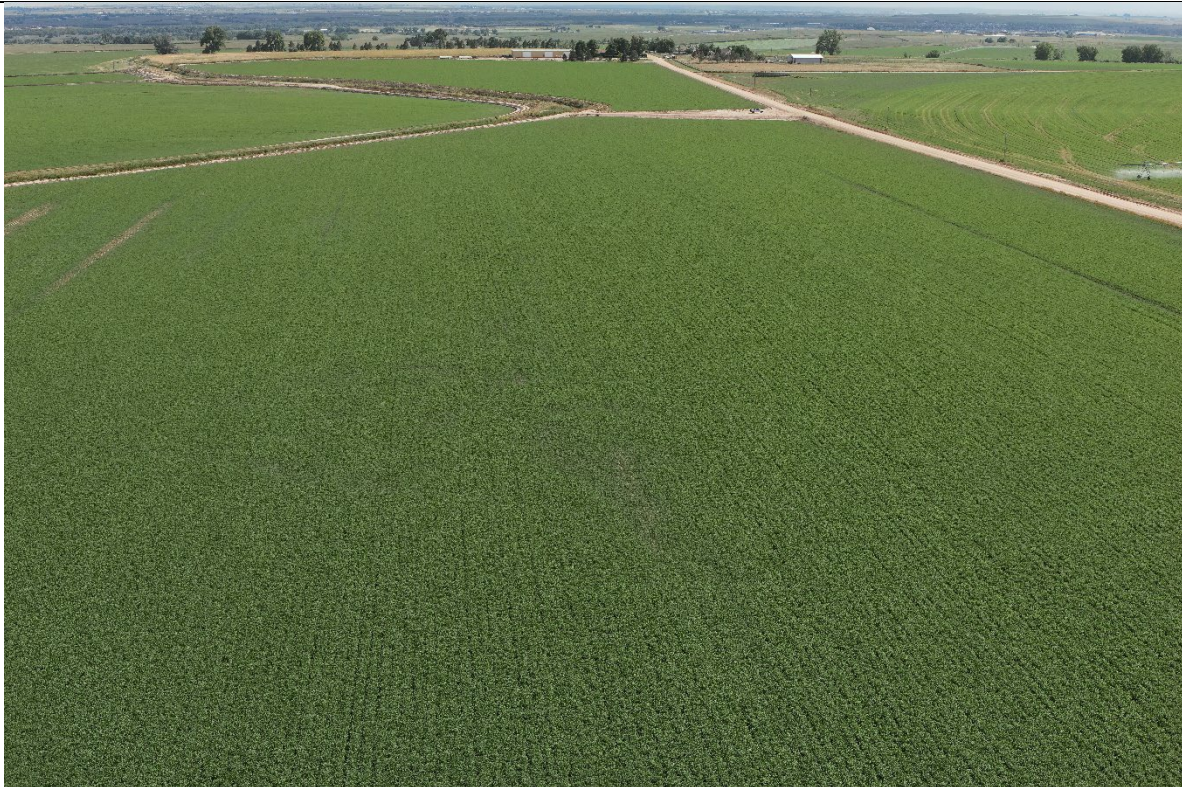
SOUTH – 40.377098/-104.811095

In View – Well, Tank Battery, Access Road, Flowline

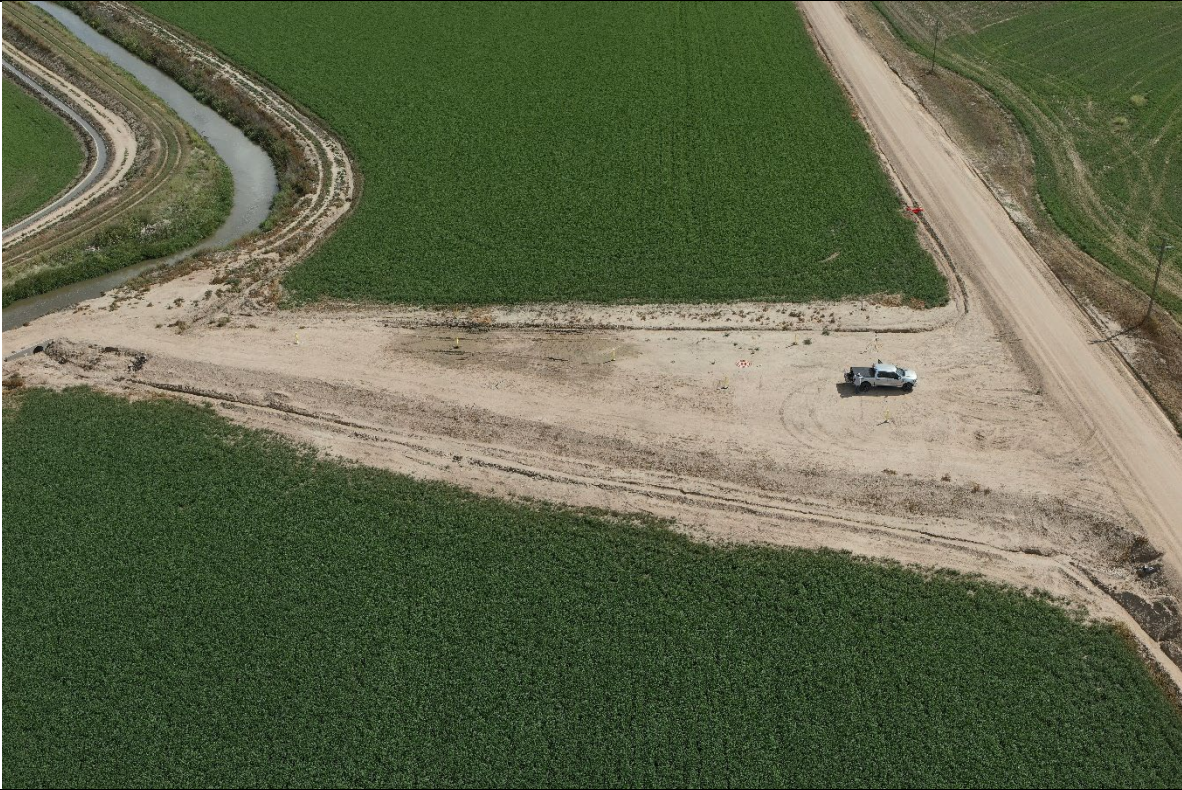
SOUTH – 40.373320/-104.812388

In View – Tank Battery (Location ID [448598](#))

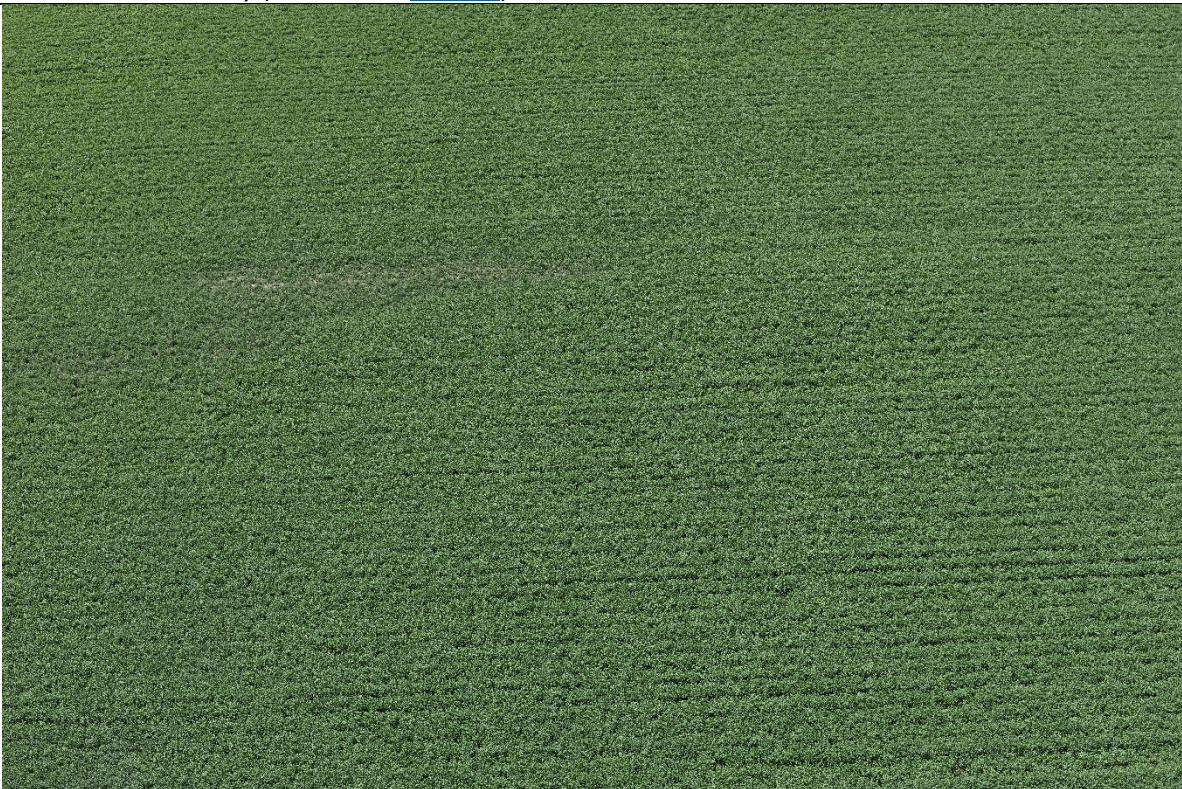
WEST – 40.376311/-104.810628

In View – Well, Access Road, Flowlines

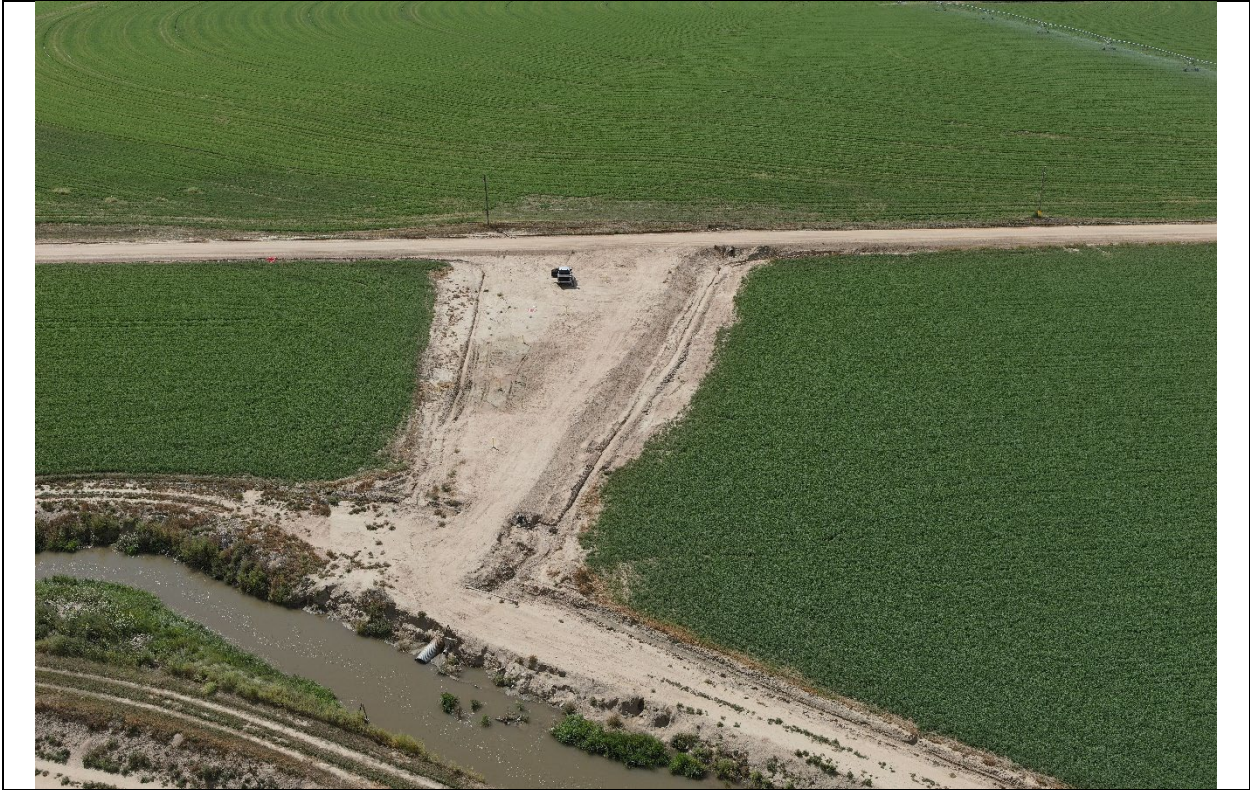
WEST – 40.372475/-104.810708

In View – Tank Battery (Location ID [448598](#))

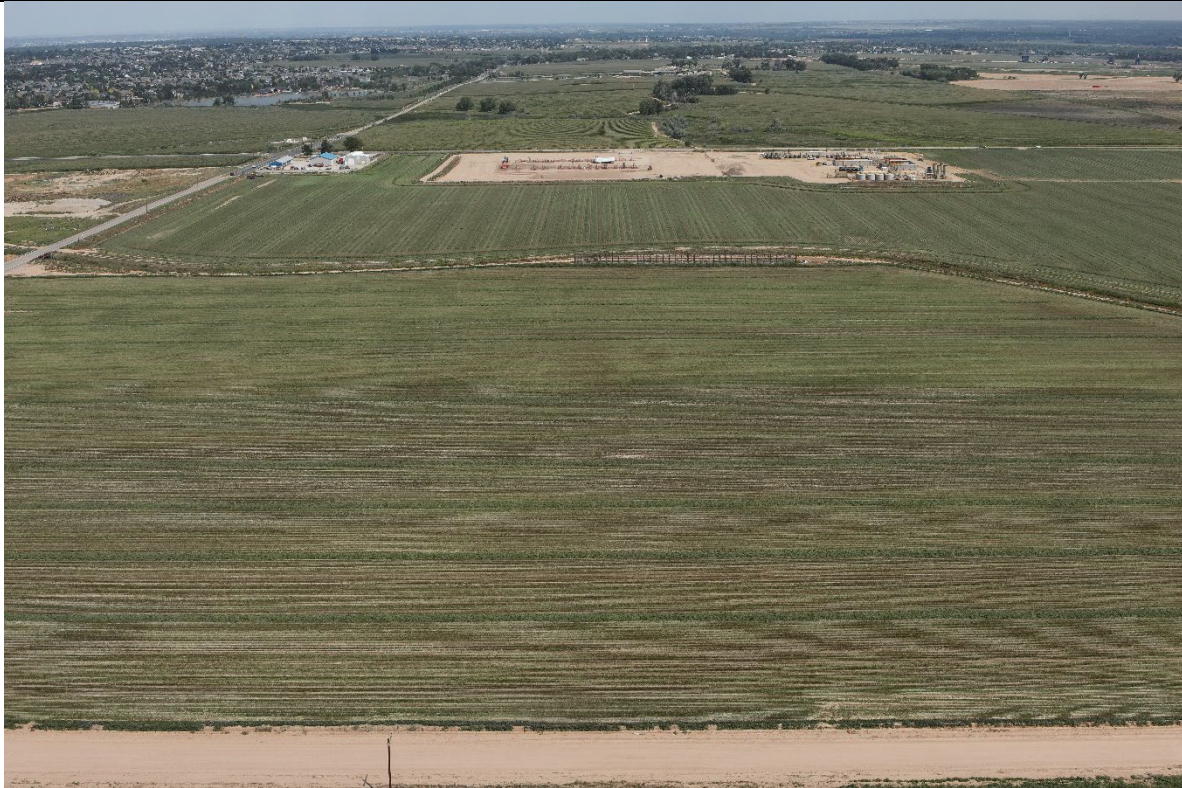
EAST – 40.375541/-104.814427

In View – Well, Access Road, Flowline

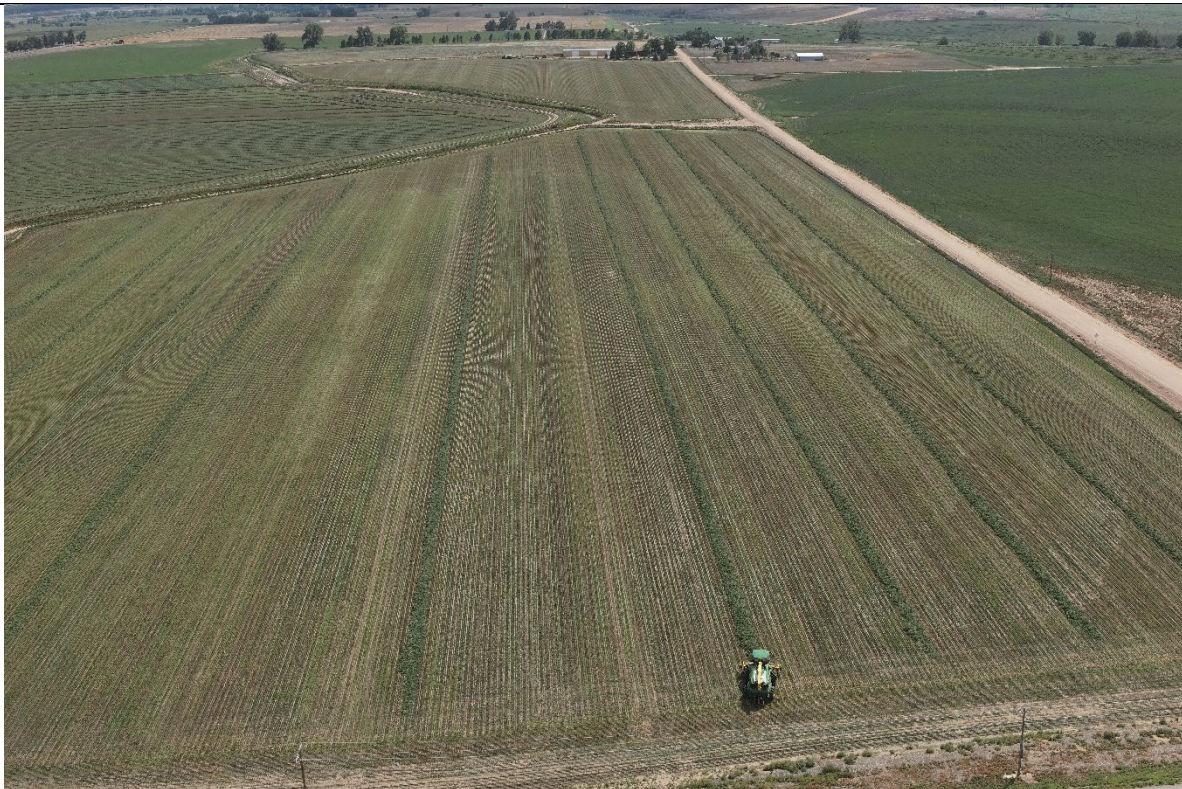
SOUTH – 40.378574/-104.811416

In View – Well, Access Road, Flowline, Tank Battery

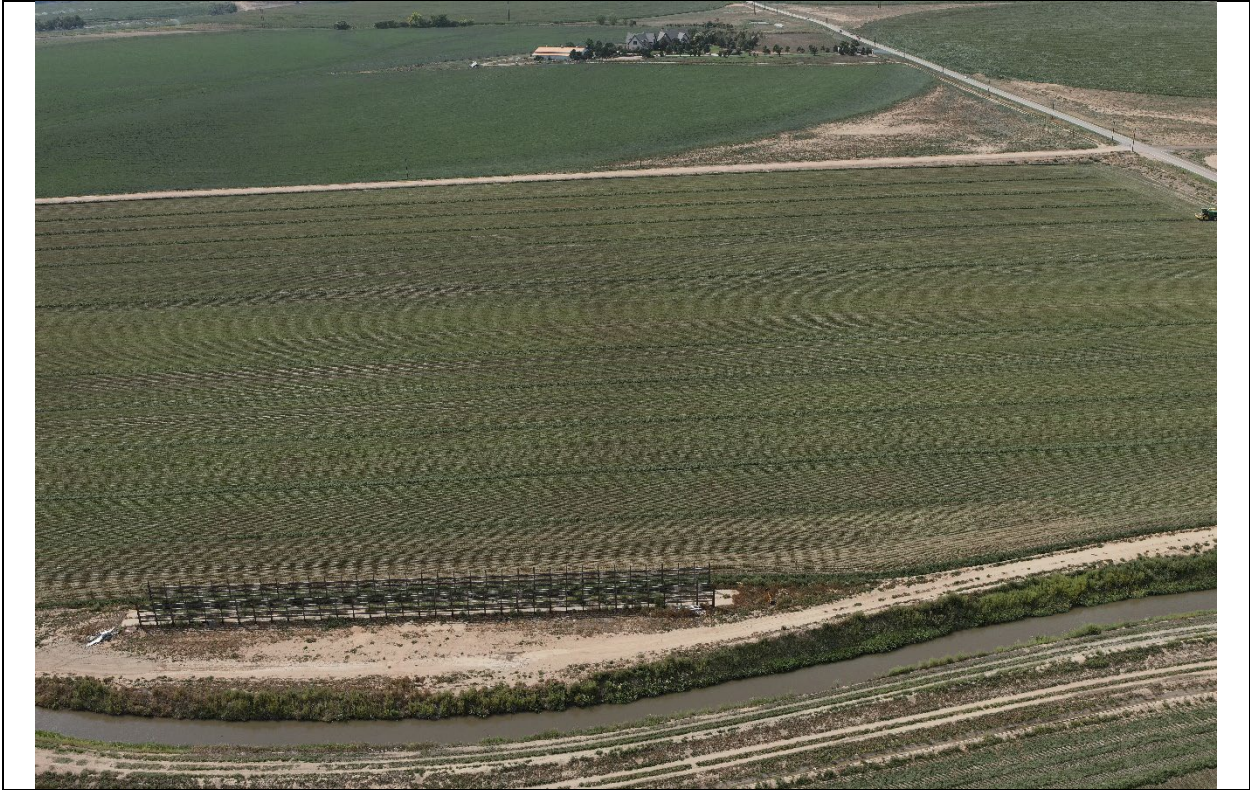
WEST – 40.375453/-104.807256

In View – Well, Access Road, Flowline
