# Inspection Photos

Operator: Hilcorp Energy Company - 10133

Location ID: 326204

Location Name: Huber SPC Federal 2-14

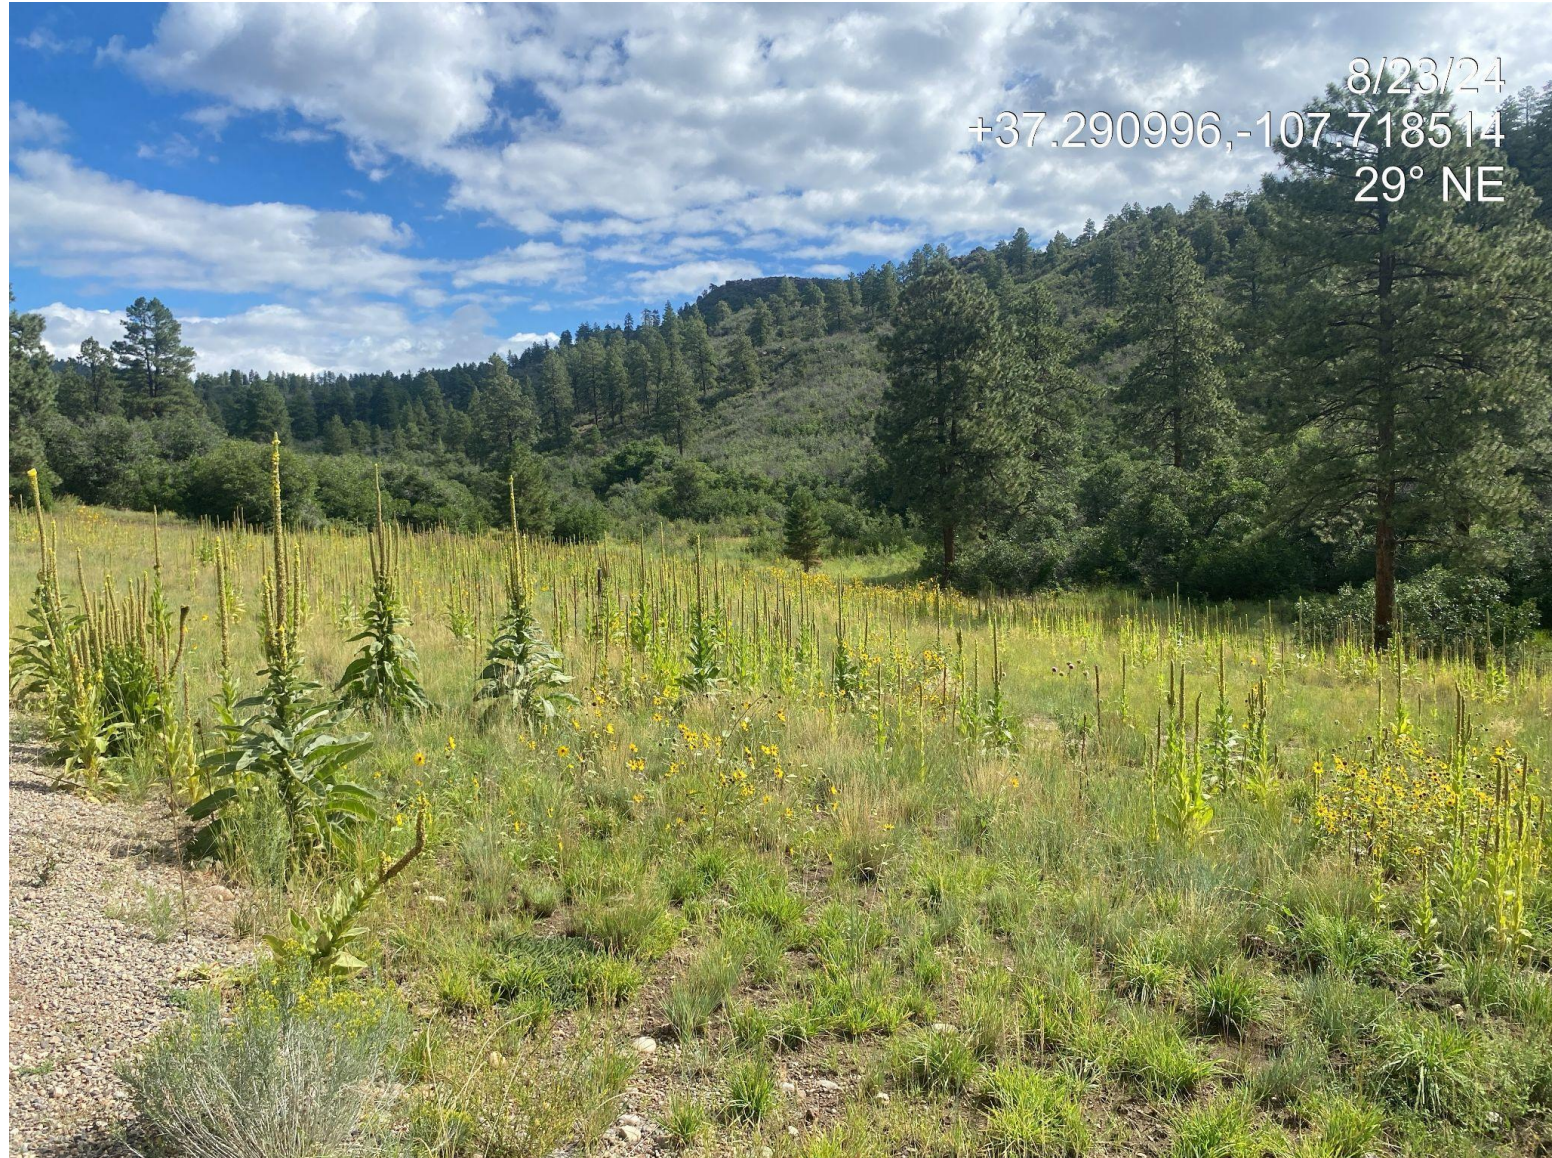
**Photo 1.** View of the project area taken from the southern edge facing center. Note: Infestation of noxious weeds dominating the project area. Noxious weeds include Mullein and Musk thistle.

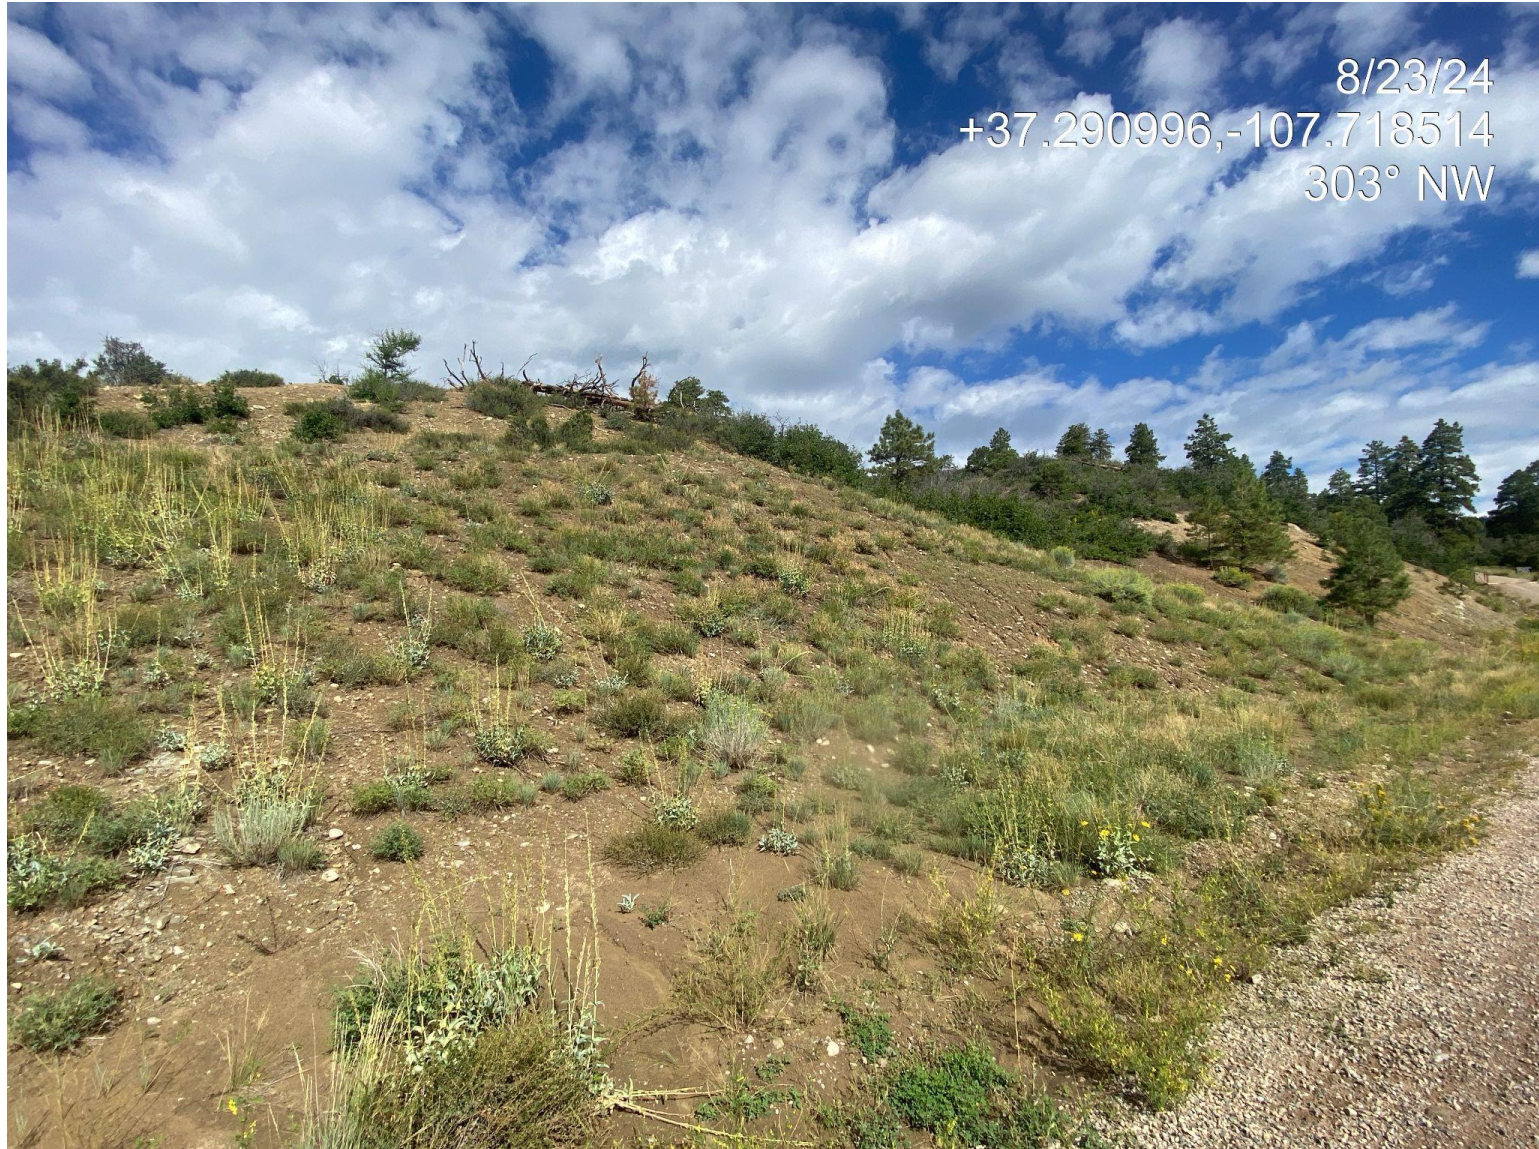
**Photo 2.** View of the western cut slope. Vegetation is progressing in this area with perennial grasses and Penstemon observed establishing on the cut slope.

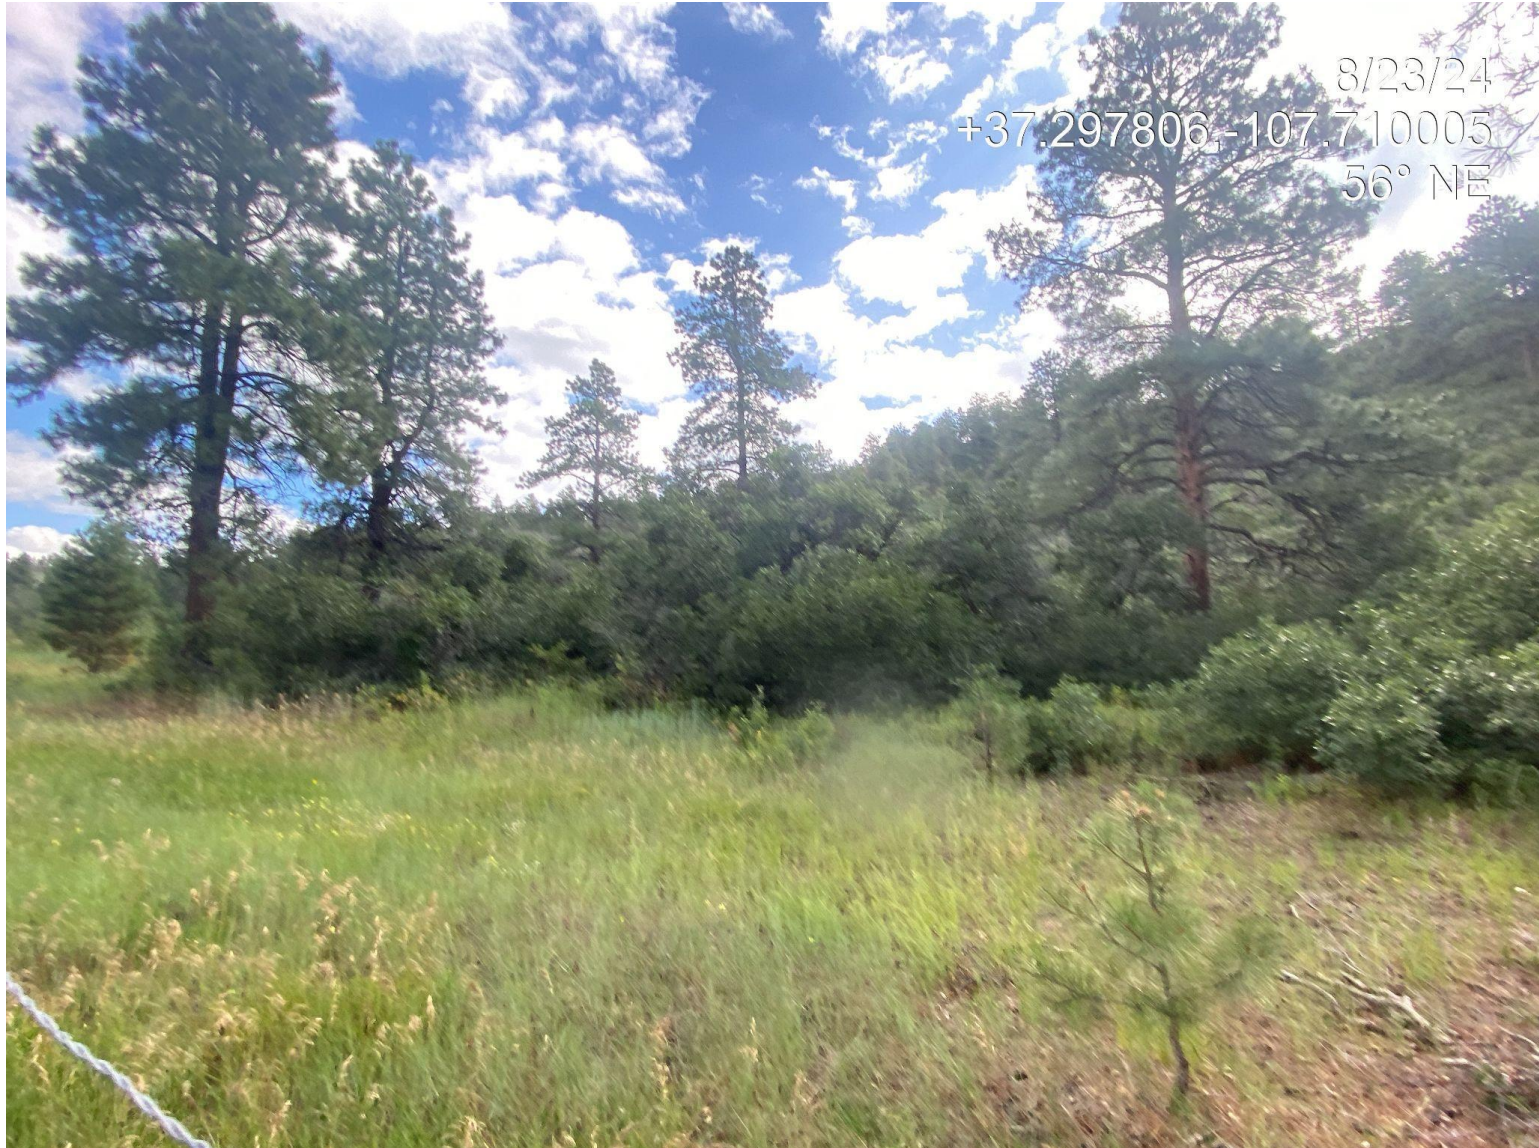
**Photo 3.** Reference area comprised of Gambel oak, Pine and Smooth brome.
