Operator: 8 North

Location Name: MARICK 1061-6-41

Loc ID: 410175

Inspection: 684904645

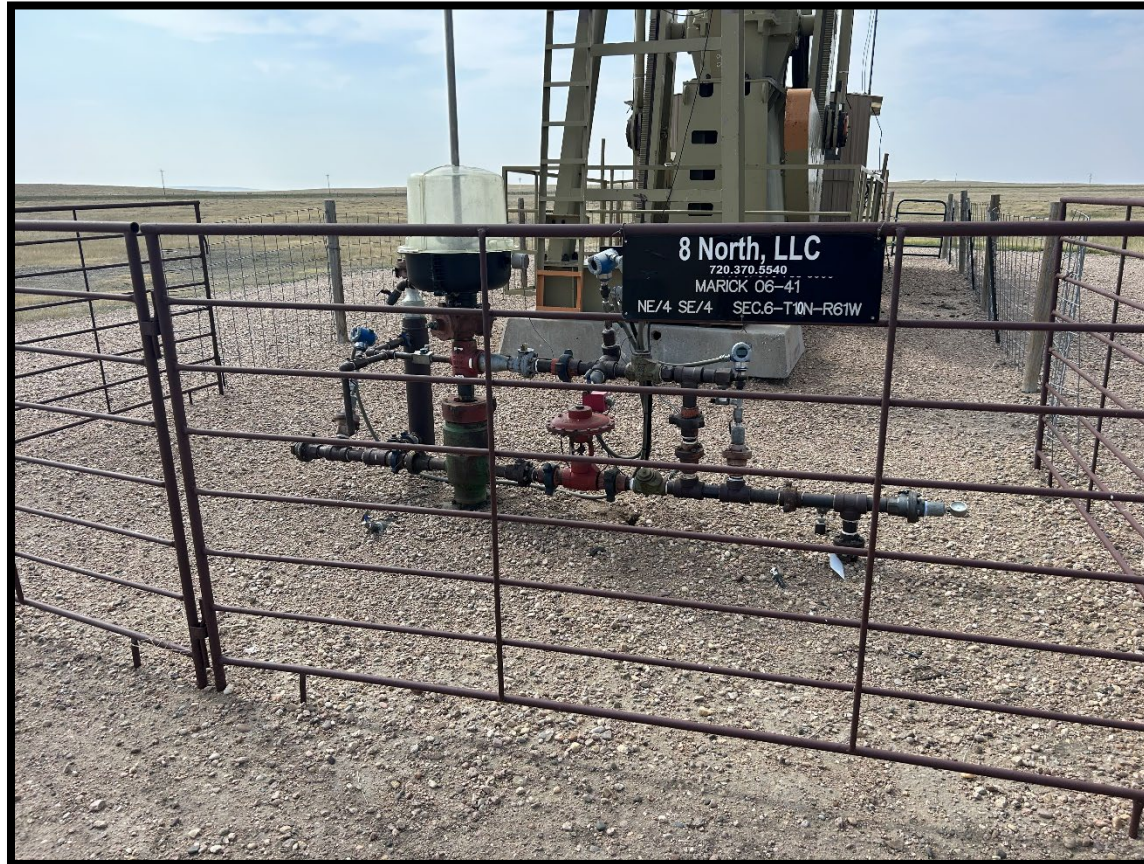
CA: Stained soil at wellhead. Remove or remediate stained soil; Securely fasten all valves, pipes, and fittings to ensure good mechanical condition, inspect at regular intervals and maintain in good mechanical condition per Rule 605.d.

CA Resolution: Operator has provided photo evidence to show that the stained soil has been appropriately removed/cleared and mechanical issues leading to the leak have also been addressed to comply with the 600 and 900 series.
