**Operator: 8 North**

**Location Name: RASMUSSEN-611N61W 29SWSW**

**Loc ID: 302796**

**Inspection: 691400032**

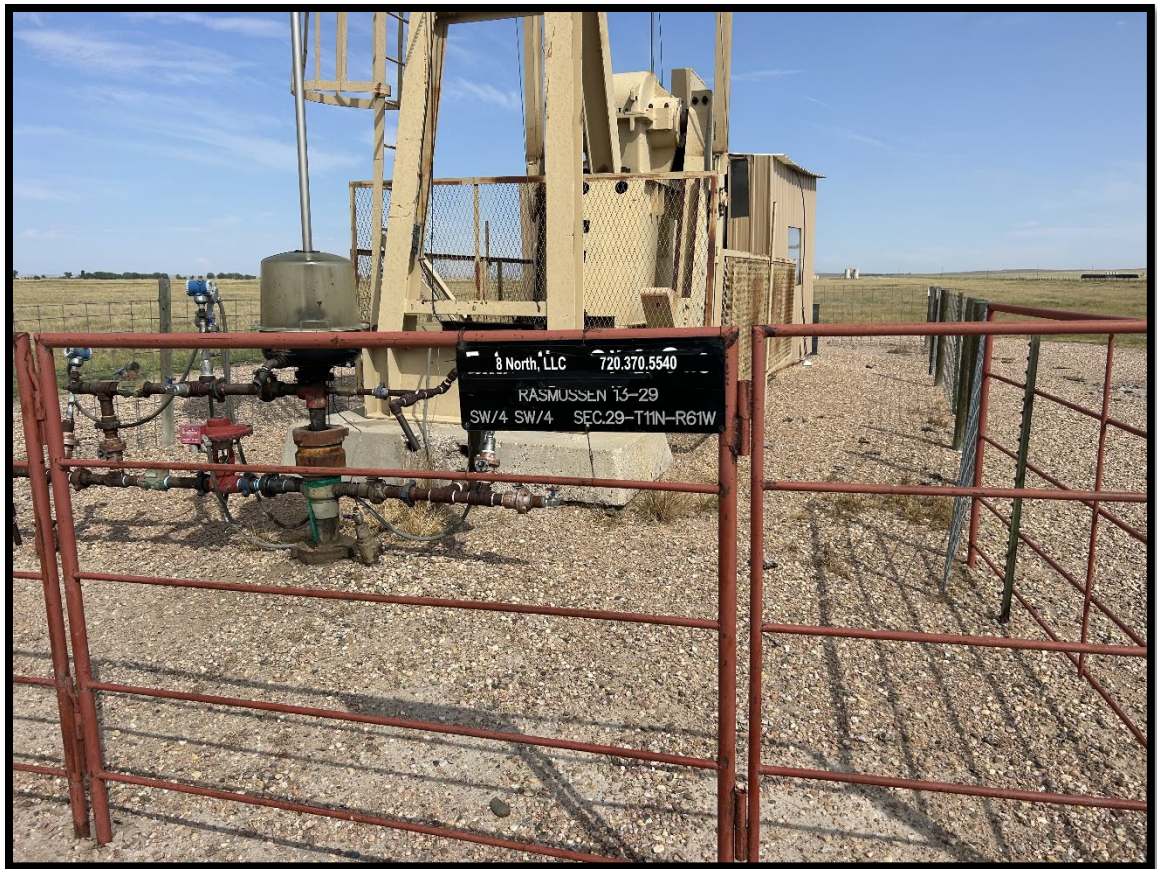
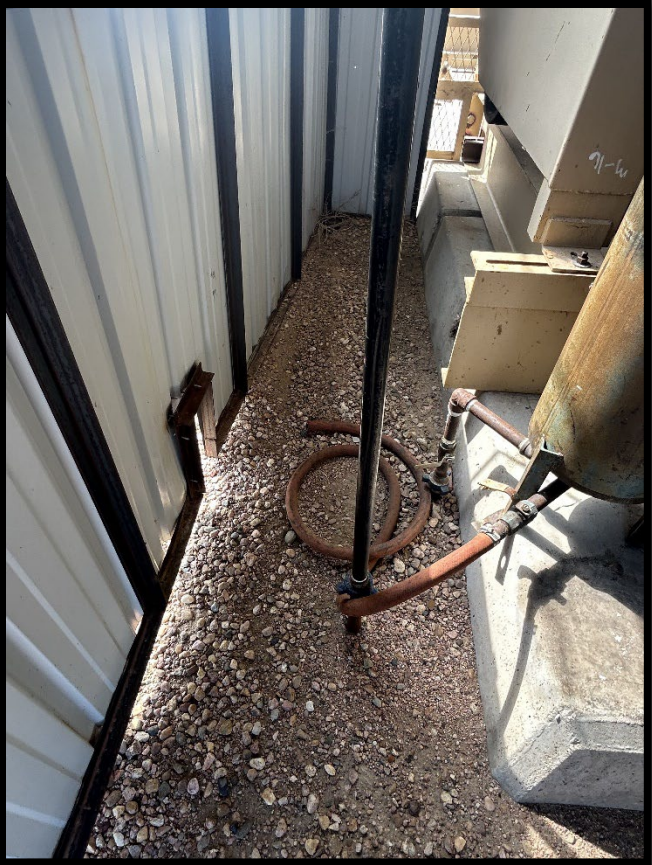
**CA:** Wellhead sign is for prior operator. Install sign to comply with Rule 210.e.

**CA Resolution:** Wellhead sign displays the current operator and provides contact number in the event of an emergency.

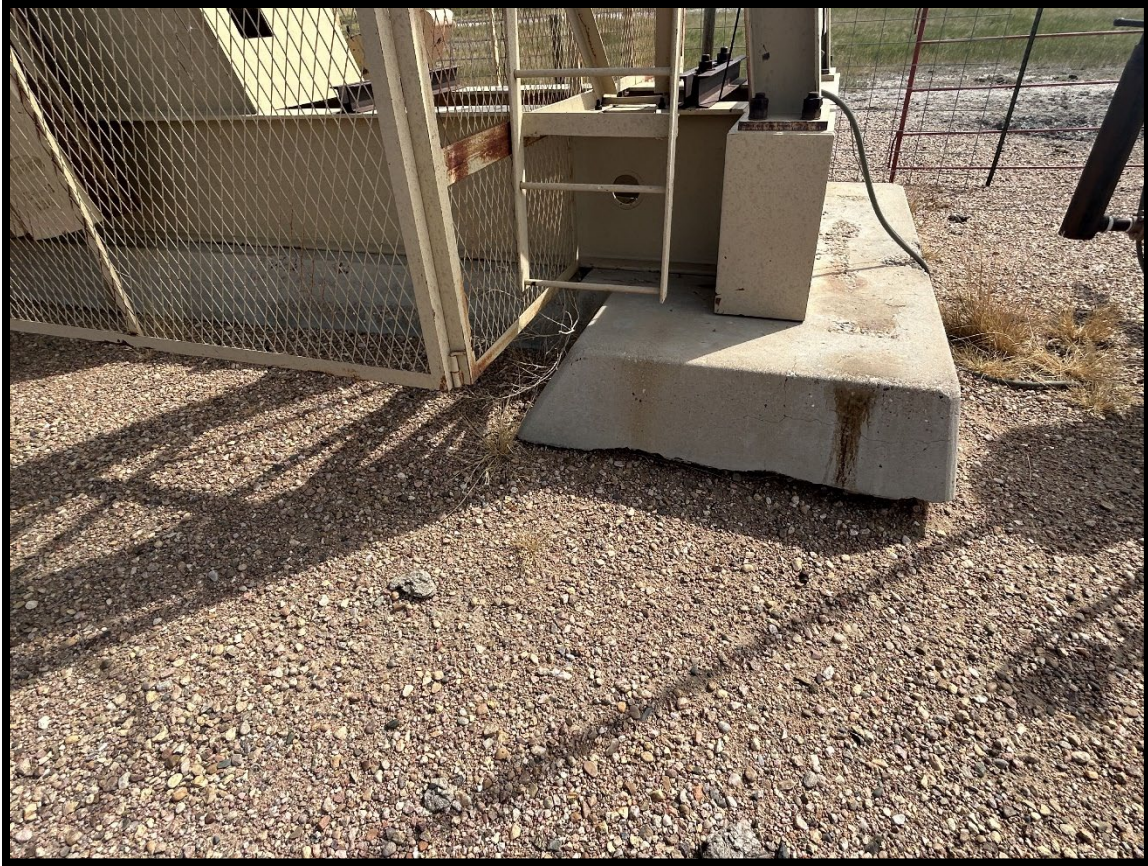
**CA:** UNUSED EQUIPMENT -Flywheel guard is off, unknown object on pumpjack base leaking fluid to the ground. Comply with Rule 603.f .

**CA Resolution:** Unused equipment was removed from the location to comply with the 600 series.

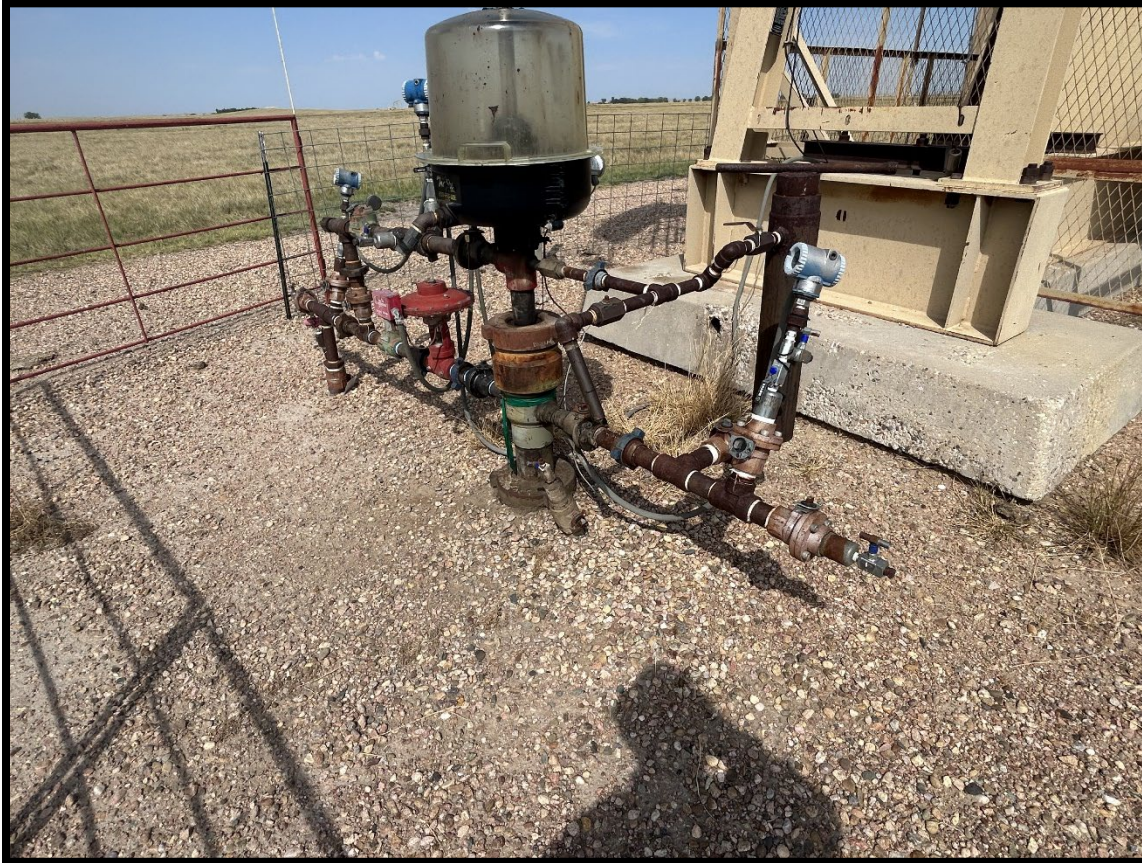
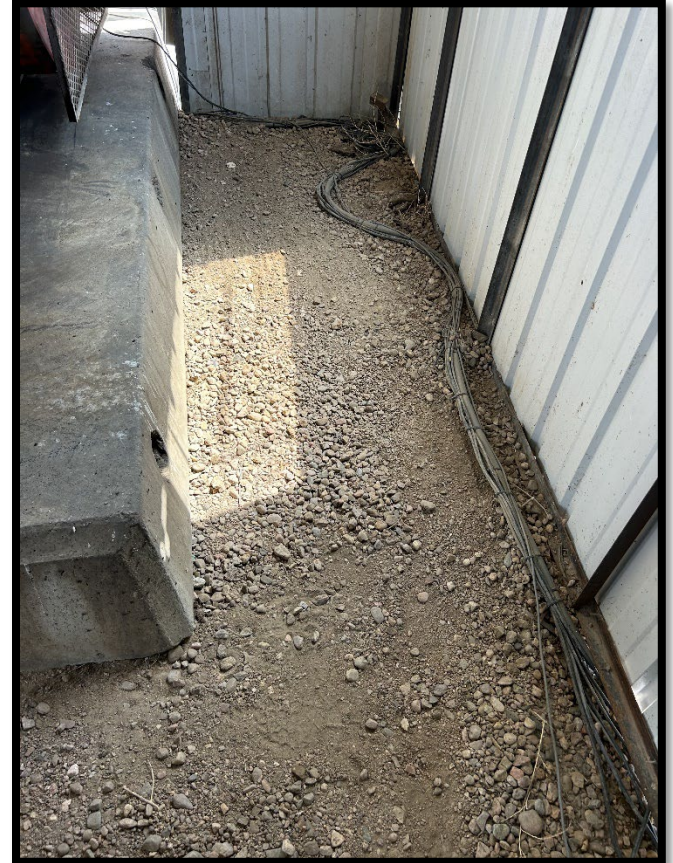
**CA:** DEBRIS-Miscellaneous debris in motor room. Comply with Rule 603.f .

**CA:** Stained soil around wellhead and at the north side of motor room. Comply with Rule 603.f .

**CA Resolution:** Identified debris has been addressed and removed to comply with the 600 series.

**CA Resolution:** Operator has provided photo evidence to show that the stained soil has been appropriately removed/cleared and mechanical issues leading to the leak have also been addressed to comply with the 600 and 900 series.
