Operator: CPR

Location Name: Prosper Farms 4-65 2-1-6

Loc ID: 443722

Inspection: 713900897

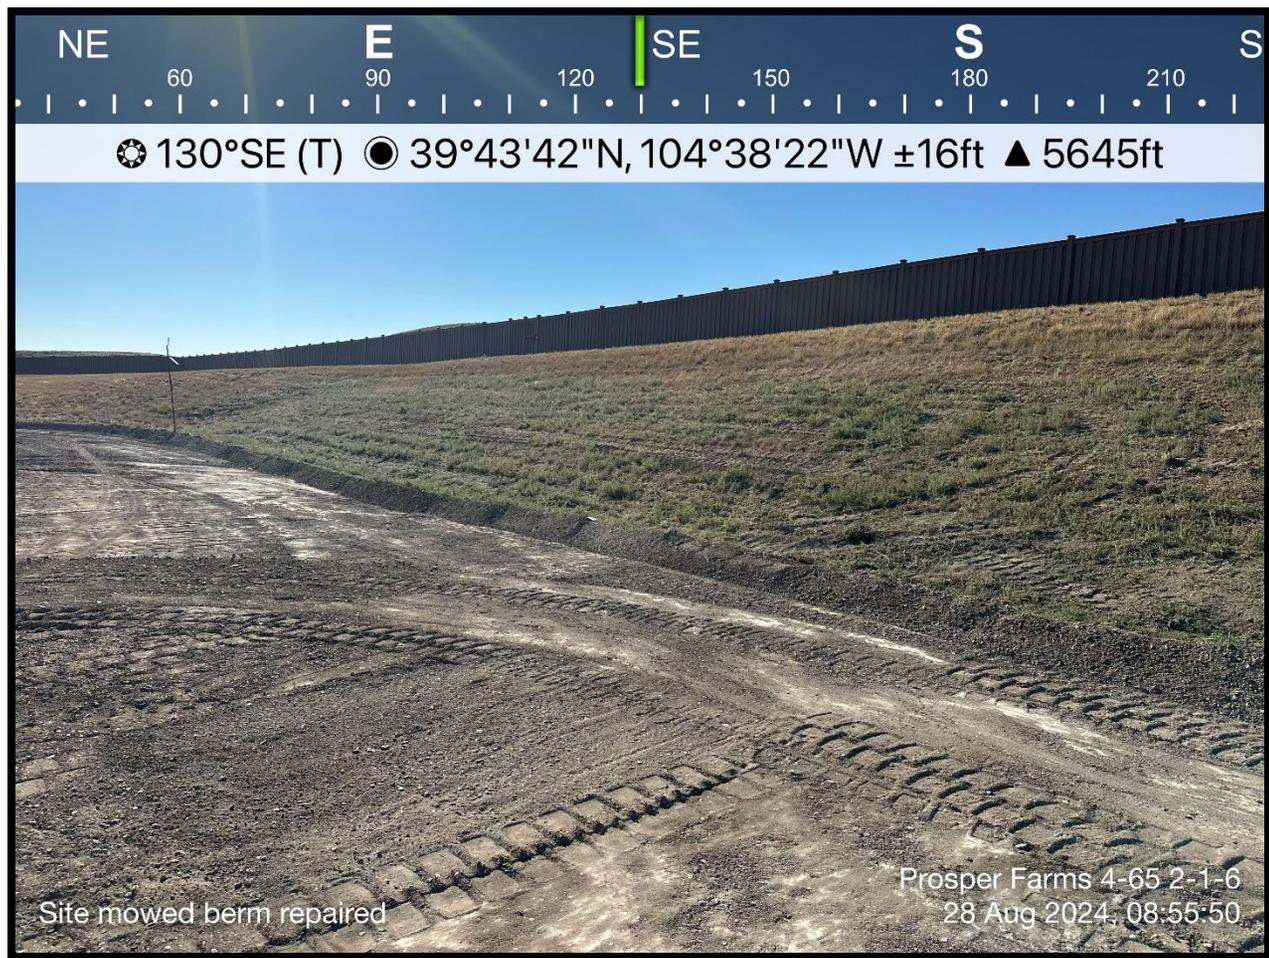
Site mowed berm repaired

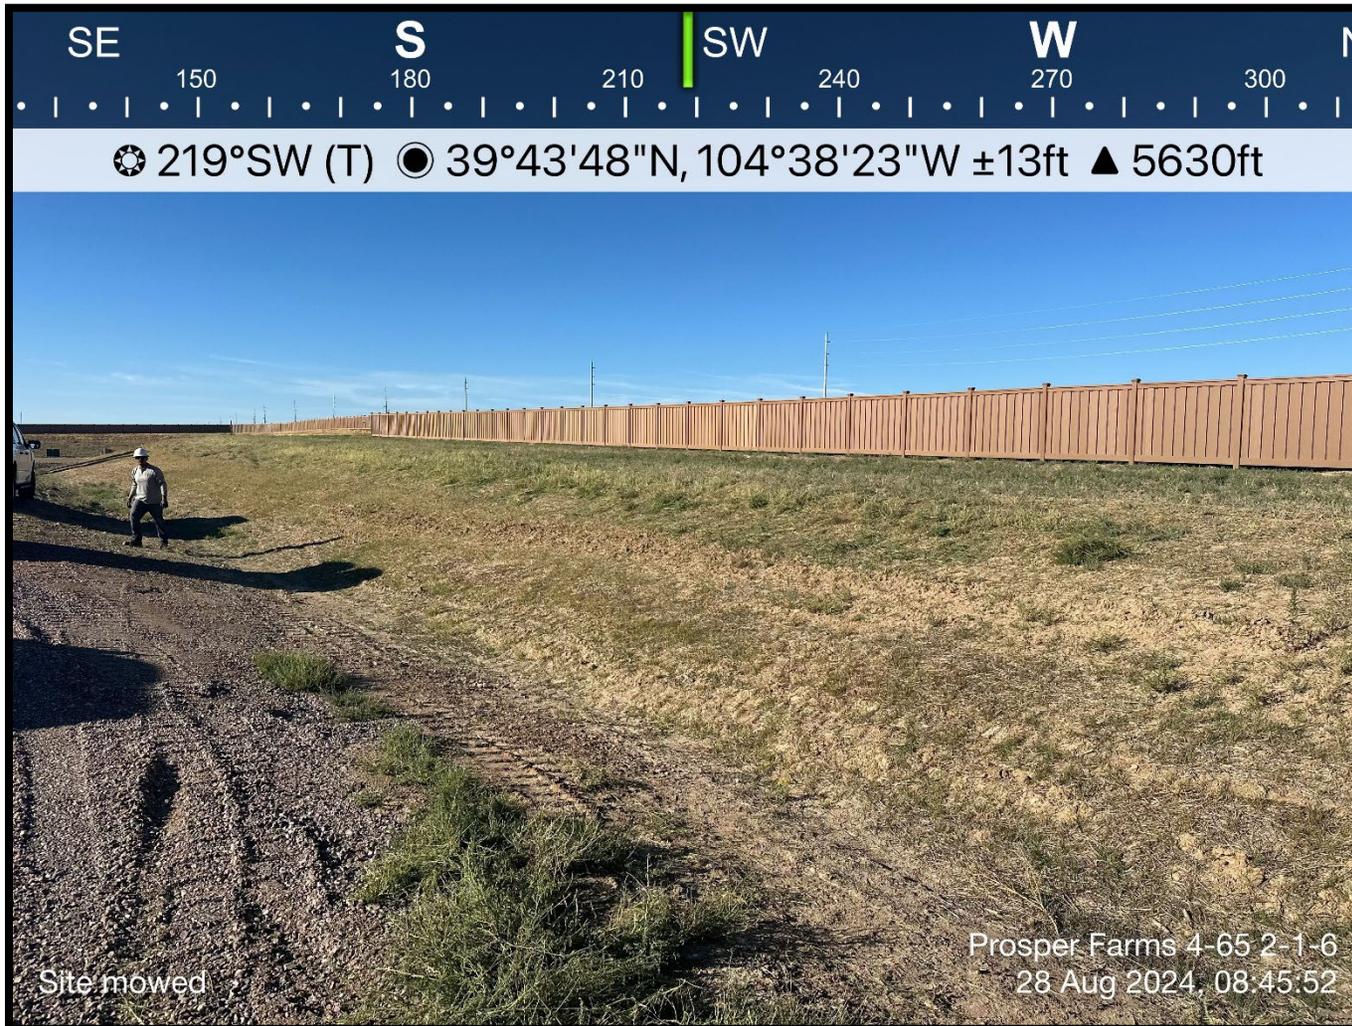
Prosper Farms 4-65 2-1-6
28 Aug 2024, 08:55:50

CA: Weed debris in the form of tumbleweeds, new germination and full stature plants were observed throughout interim areas within the permanent location fence as well as outside along topsoil stockpiles. Tumbleweeds are a troublesome annual non-native weed that easily breaks off at the stem. Operator failed to control and manage weeds to prevent weed waste and prevent the spread of seeds onto adjacent lands. See inspection photos for details. Comply with Rule 606 to remove weed debris.

CA Resolution: Operator has reported that the location has been appropriately mowed and weeds have been mitigated to comply with the 600 series.

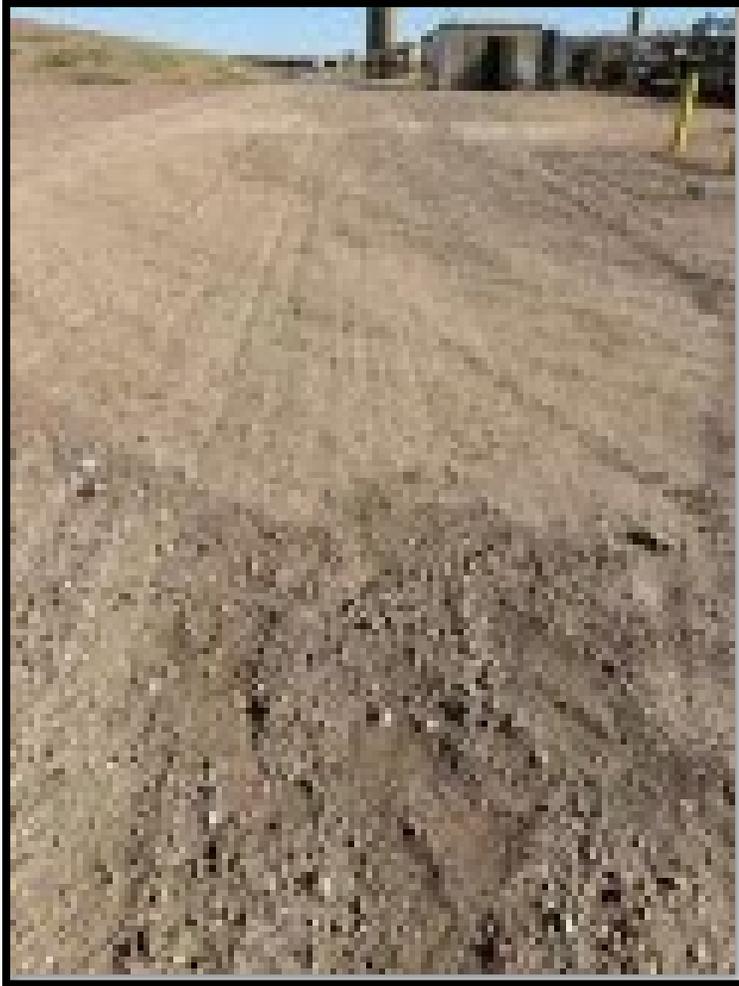
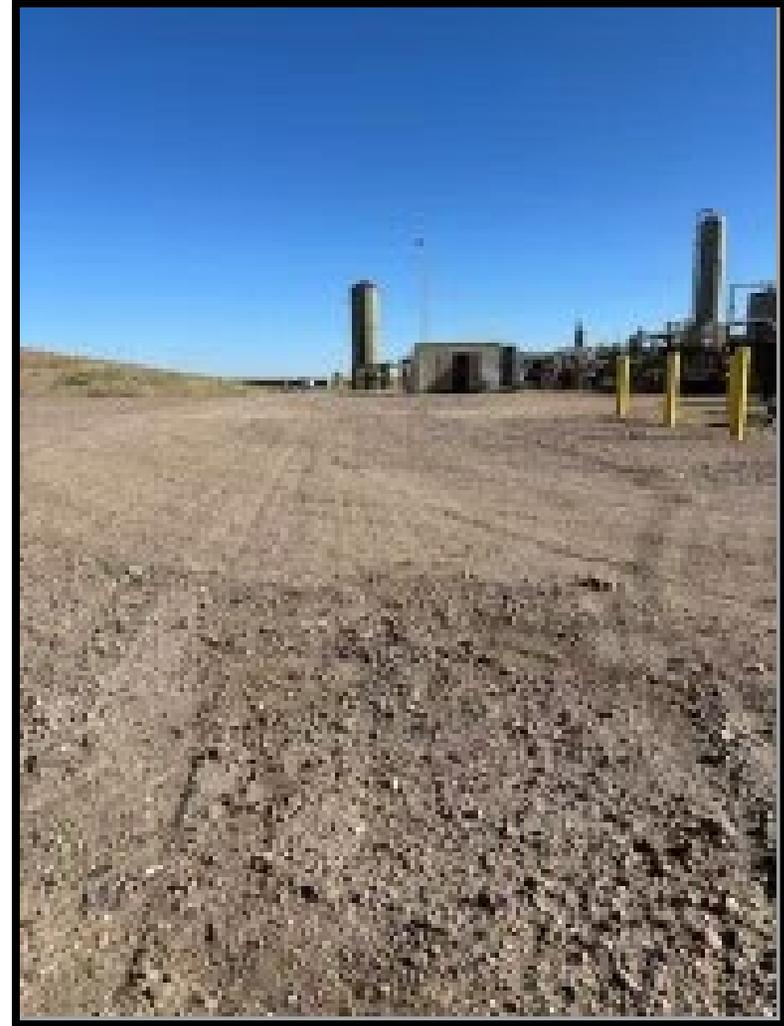
CA: Unused debris such as t-posts and loose pipe were observed around the porta john area at the entrance to the well location. See inspection photos for details. Comply with Rule 606 to remove debris.

CA: Loose wires were observed daylighting at the Southwest corner of the production facility. See inspection photos for details. Comply with Rule 606 to remove debris.

CA Resolution: Operator has reported that the identified unused equipment on location has been removed to comply with the 600 series.
