Inspection Photos
Location Name: Anschutz Equus Farms 3-62-4-2532C2
API # 05-123-43429

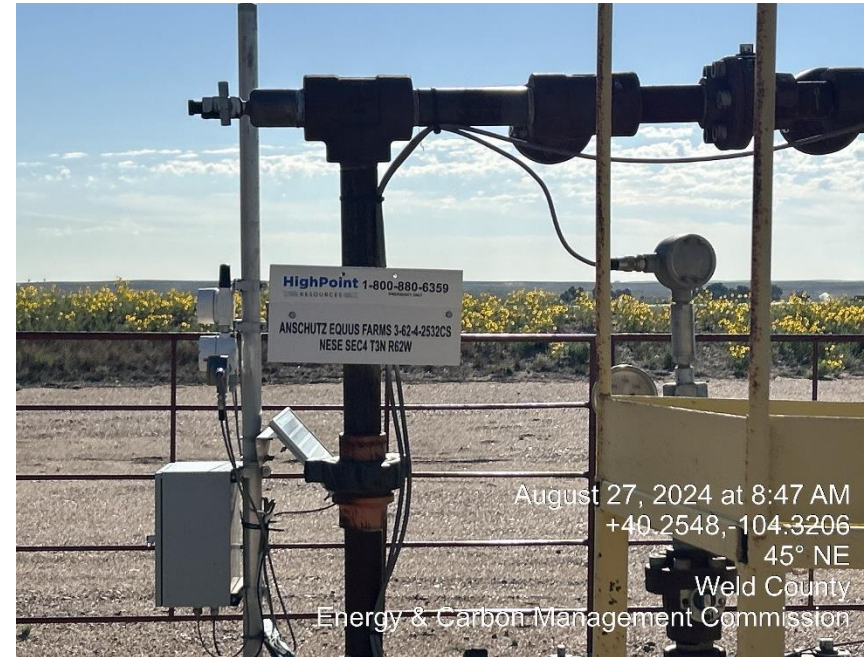
Appears to not match ECMC data base
