CORRECTIVE ACTION REPSONSE

DOCUMENT NUMBER: 696205961
FACILITY ID: 210835
API # 045-06593
FACILITY NAME: CHEVRON SHALE 1-25A

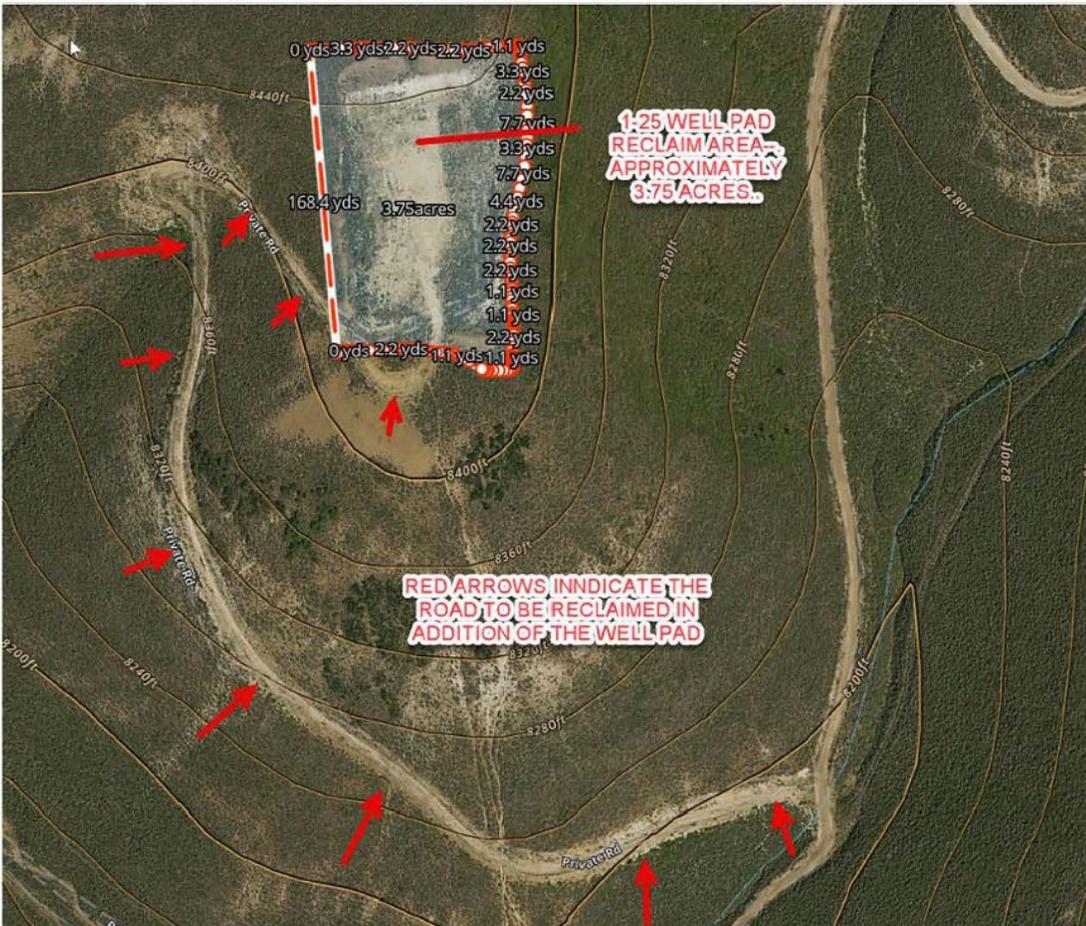
It was observed in this inspection that the Location remains out of compliance with ECMC Rules and Corrective actions: Location and access road have not been recontoured/regraded reclaimed in accordance with Rule 1004.a. Cut and fill slopes remain apparent. Additionally, topsoil remains bare and stockpiled on the north, west and southeastern ends of the location, and has not been replaced.

Reclamation of the CHEVRON SHALE 1-25A in accordance with Rule 1004.a will commence in the 2025 season. The pad will be recontoured to match pre-existing contours and topsoil will be redistributed after the pad is recontoured. After 1-25A is recontoured the pad will be seeded with the appropriate seed mix with soil supplements added to encourage quick plant growth.

At the same time the well pad is reclaimed the road to the pad will be reclaimed, recontoured, and seeded with additional soil supplements.

The following is the proposed footprint of the reclaimed area:

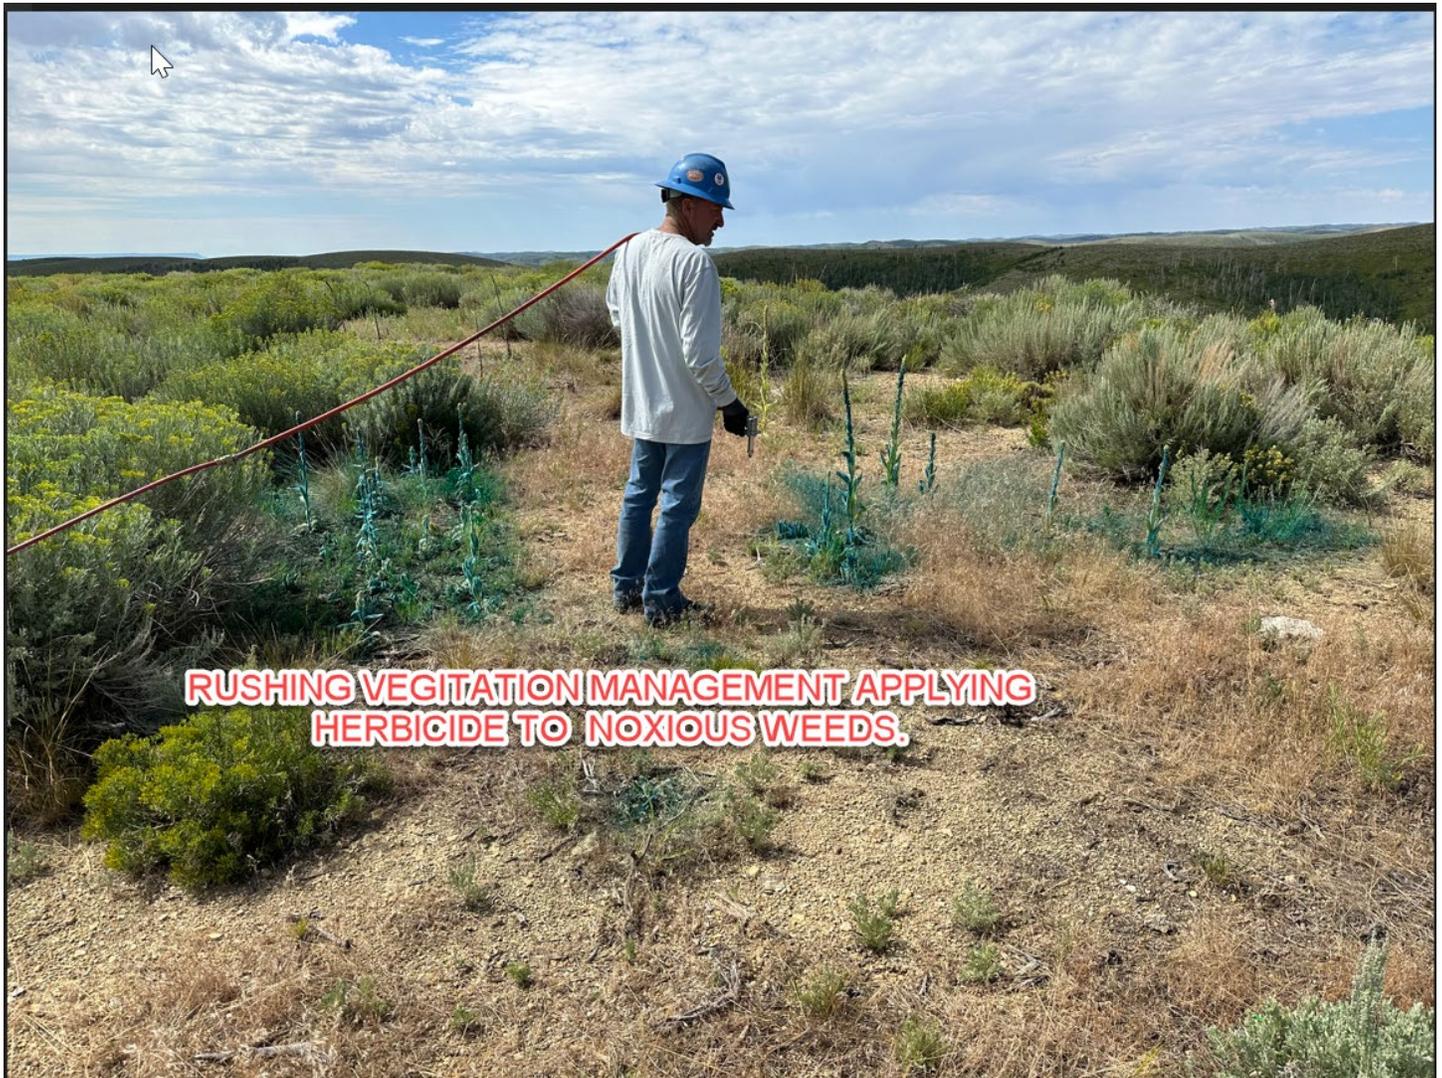
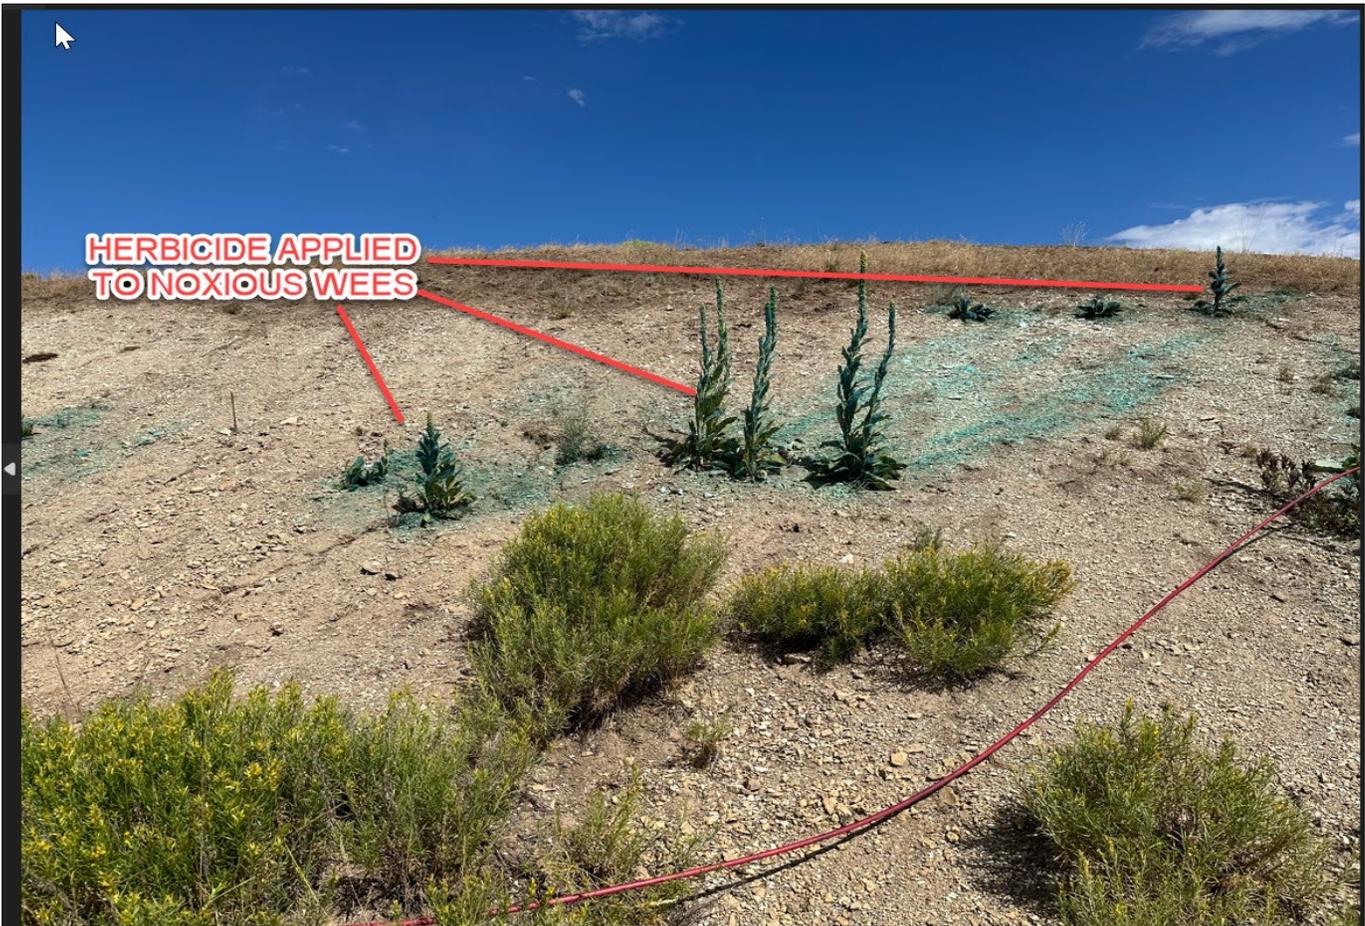
Undesirable Plant Species (Mullein) have continued to establish and spread on the location and access road.

**HERBICIDE APPLIED
TO NOXIOUS WEEDS**

Rushing Vegetations Management was escorted to the 1-25A well on 7 August 2024 pad and all noxious weeds were sprayed with herbicide to rid the pad area of all noxious weeds. Mullen was evident as the above comment indicates and was sprayed with herbicide as noted in the following pictures.

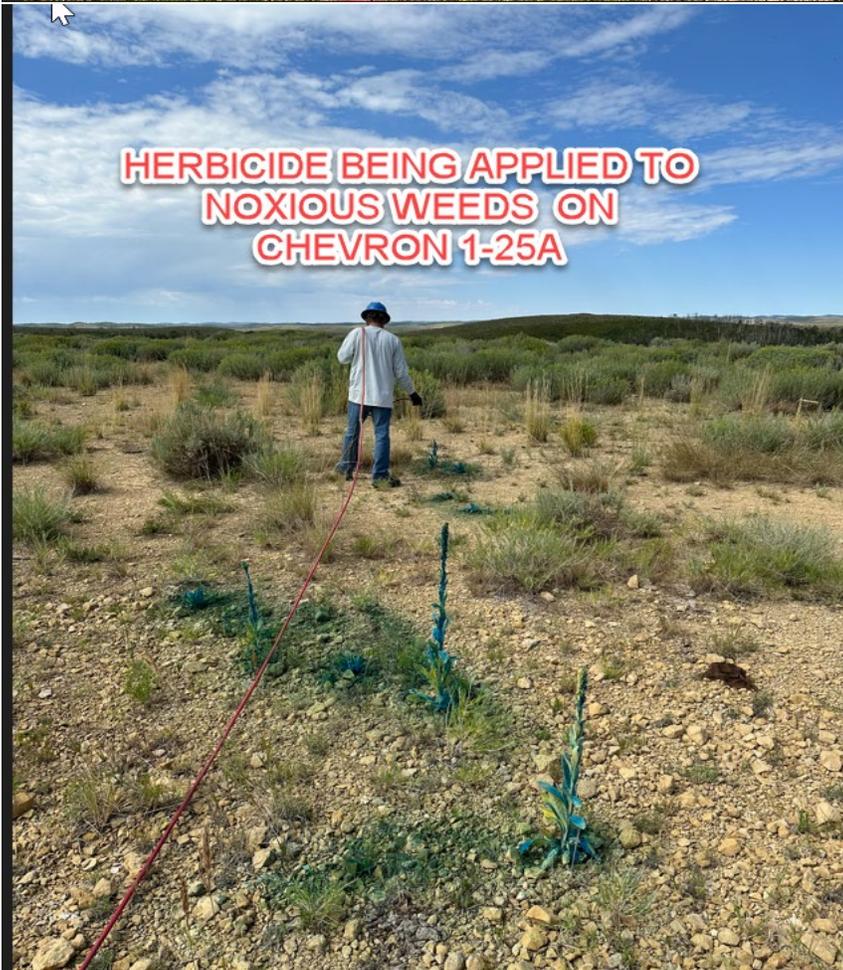
**HERBICIDE BEING APPLIED TO
NOXIOUS WEEDS ON
CHEVRON 1-25A**
