KP Kauffman - ECMC Inspection Photos
Location: Lanson Farms 15 Flowline Release
Spill ID #487675 Date 08/22/2024

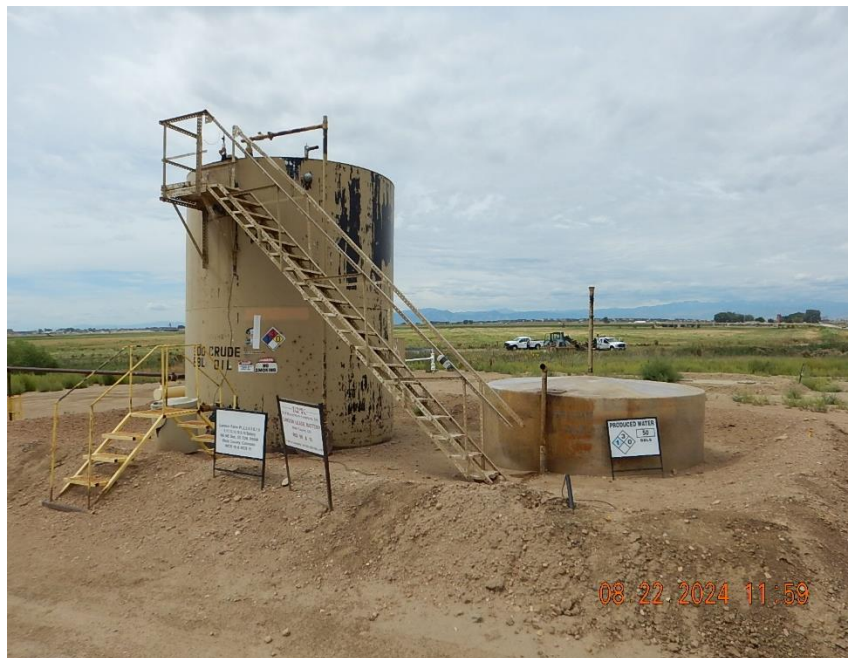
Signage at Tank Battery; view west to release/ excavation.

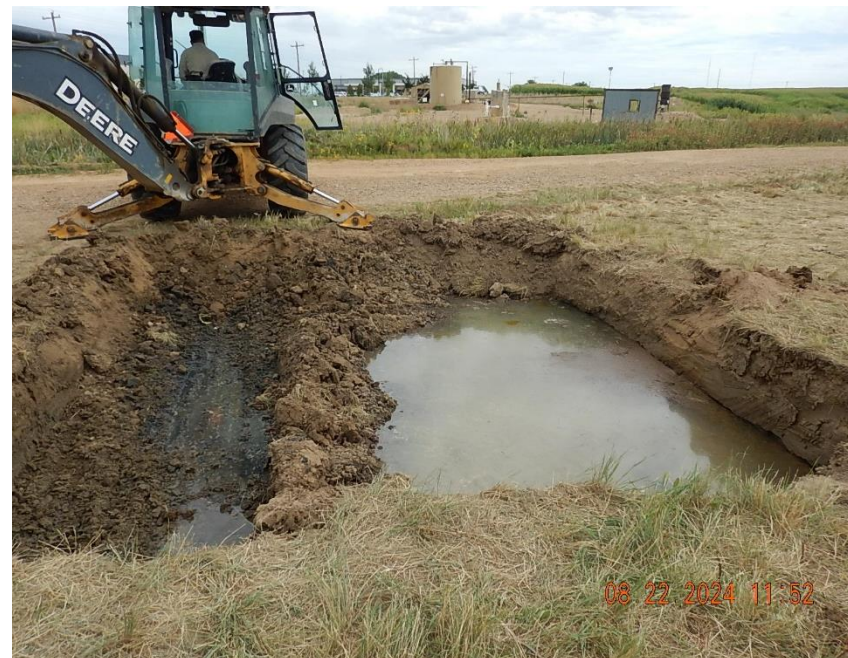
Excavation at flowline release point; view east to battery.

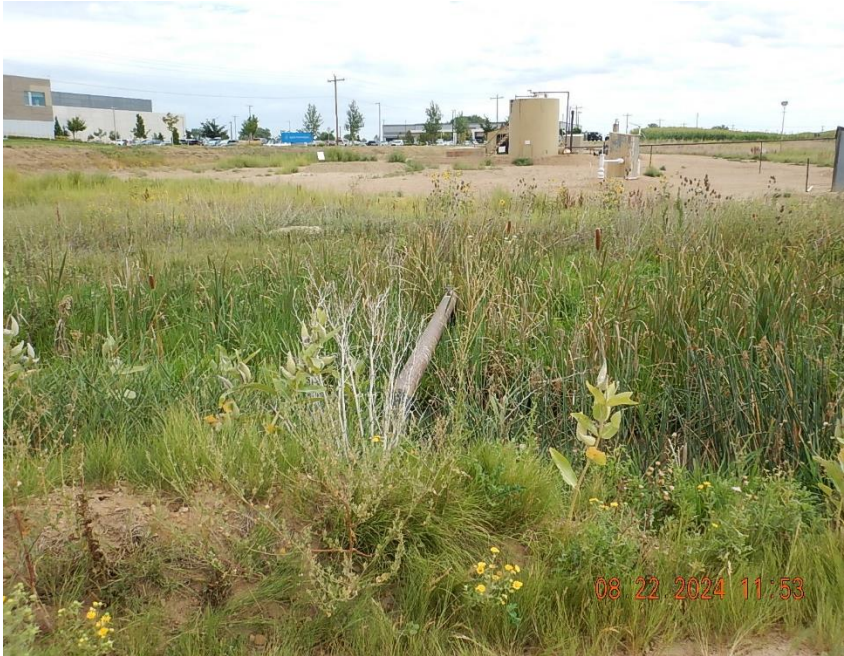
Above ground section of flowline at irrigation ditch crossing.
Note: 3" CS flowline is inside 6" CS casing pipe shown.

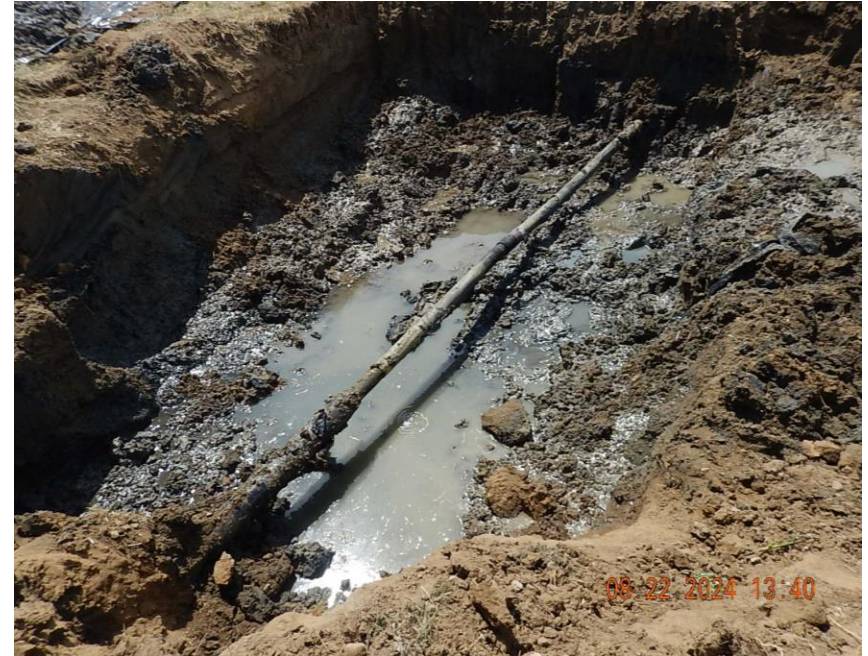
Failed flowline segment exposed in excavation.
Note: Corrosion pinhole is above ripple in water (7 o'clock)

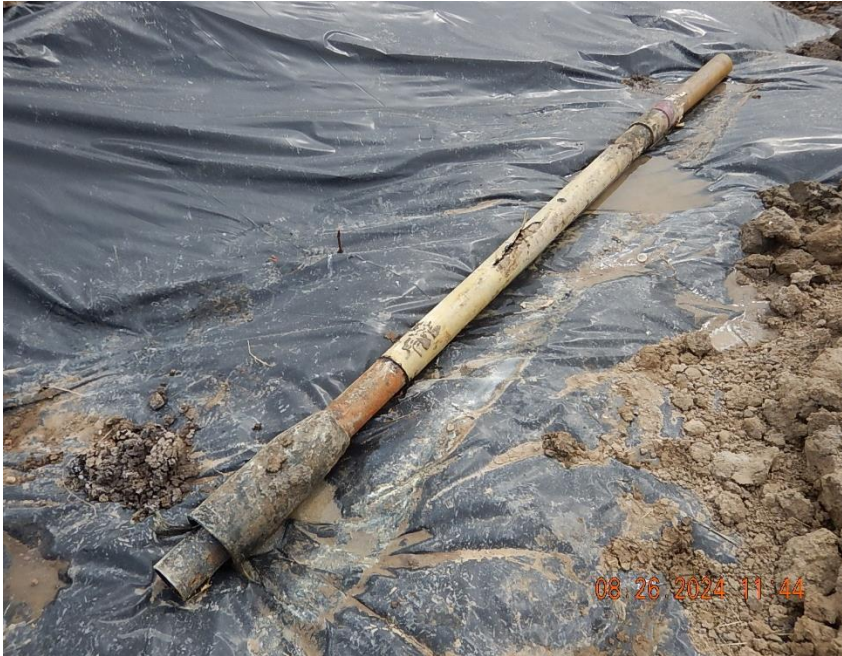
**Failed flowline segment cut out and removed;
The transition from fiberglass to carbon steel can be seen
(top); the corrosion failure is located between the yellow
coating and flowline pipe entry into casing pipe.**

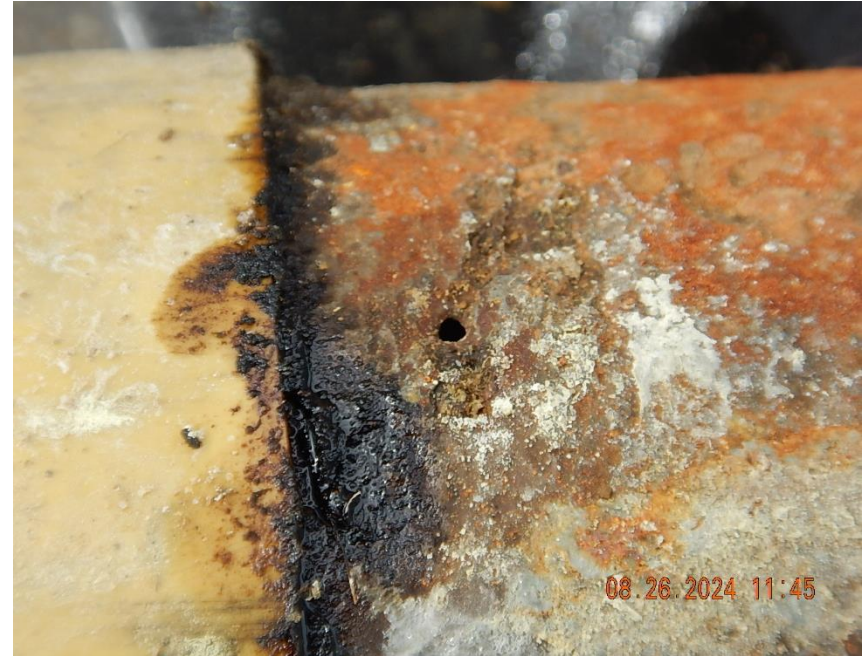
**Close up view of corrosion pinhole found on 3" CS pipe;
Failure appears to be result of external corrosion in area of
uncoated/ poorly coated pipe.**
