Operator: 8 North

Location Name: DF RANCH 1161-10-13

Loc ID: 415381

Inspection: 696300858

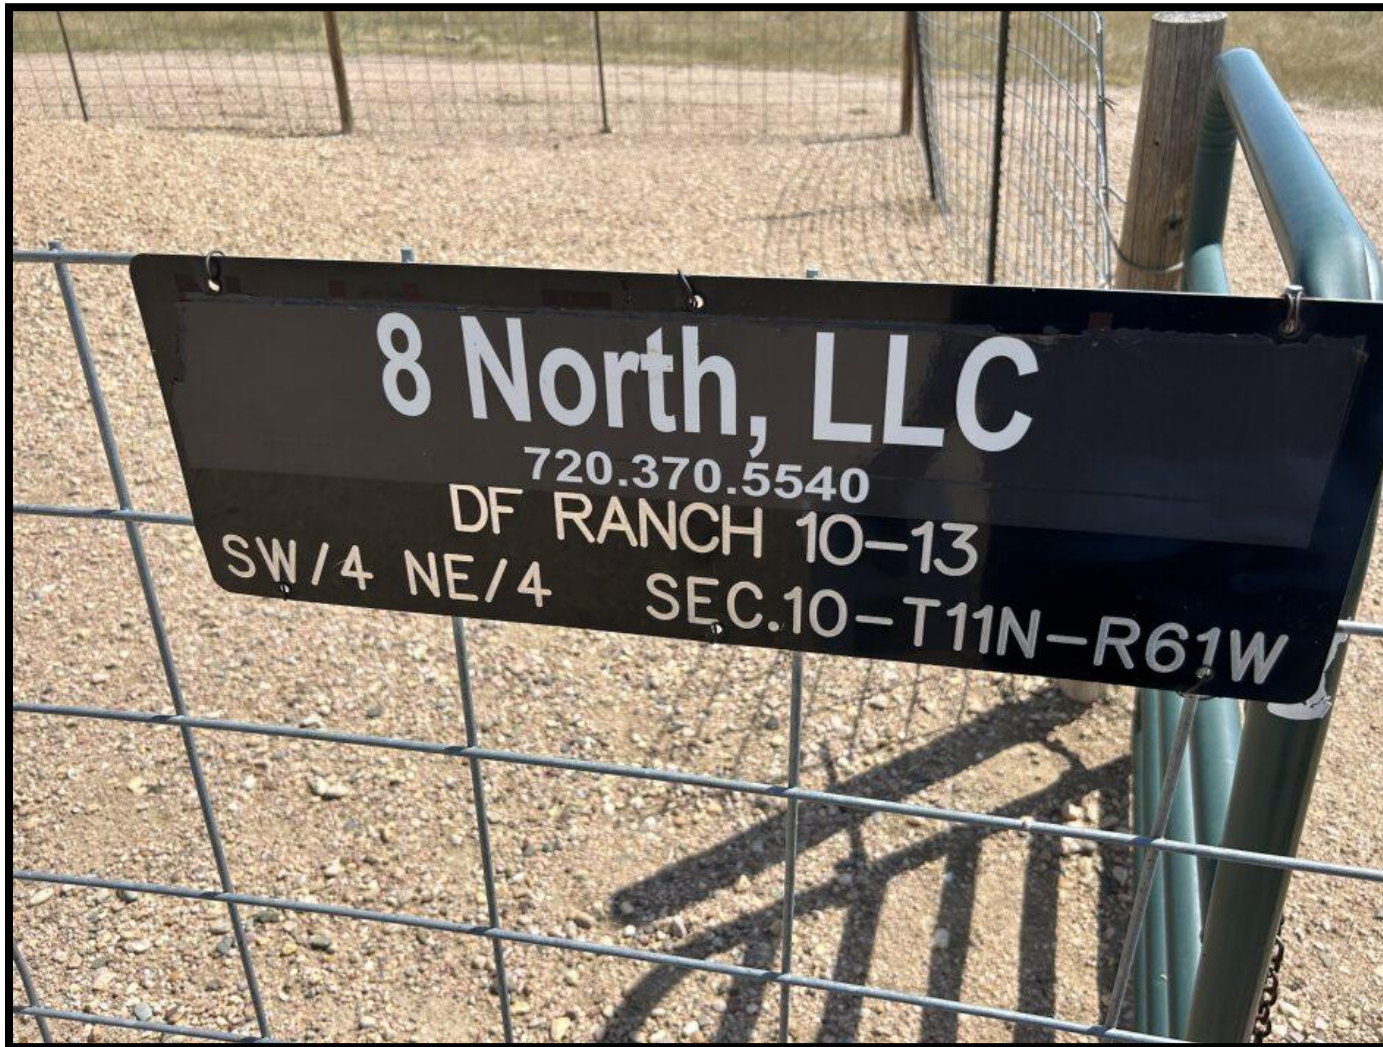
Exhibit A

CA: Stained Soil at Engine, see photos Corrective Action: Properly treat or dispose of oily waste in accordance with 907.e

CA Resolution: Operator has properly treated or disposed of oily waste at engine in accordance with the 900 series.
