Operator: 8 North

Location Name: DF RANCH-611N61W 15NWSE

Loc ID: 410055

Inspection: 696300875

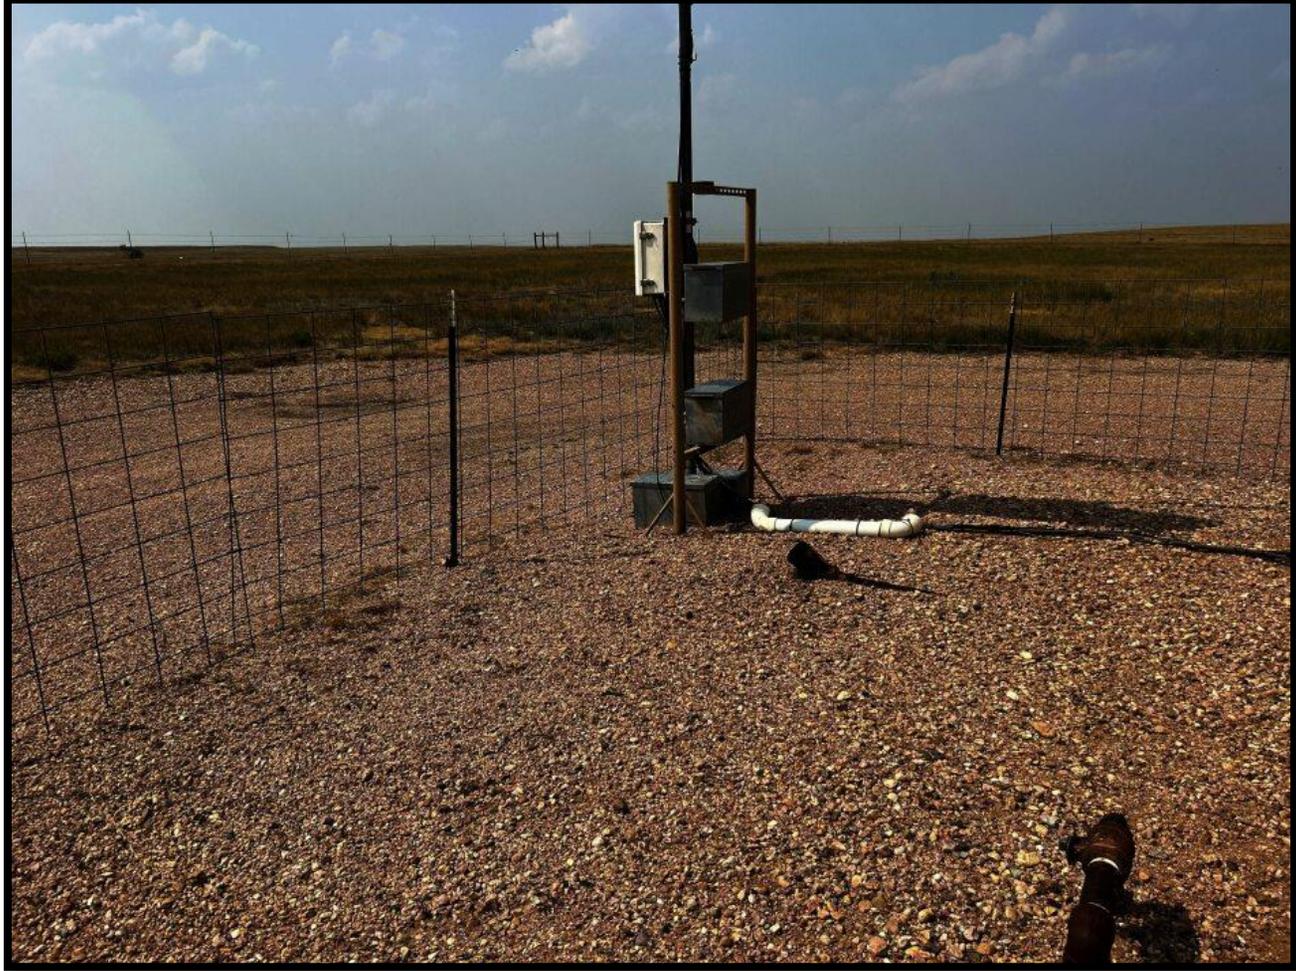
Exhibit B

CA: Stained Soil at Exhaust and Gas Engine, see photo 2. Corrective Action: "Properly treat or dispose of oily waste in accordance with 907.e

CA Resolution: Operator has provided photo evidence that the stained soil at exhaust and gas engine area has been addressed in accordance with the 900 series.
