Inspection Photos

Location Name: CAERUS PICEANCE LLC HMR FEDERAL 18-11 (N18) Pad

Location #: 334933

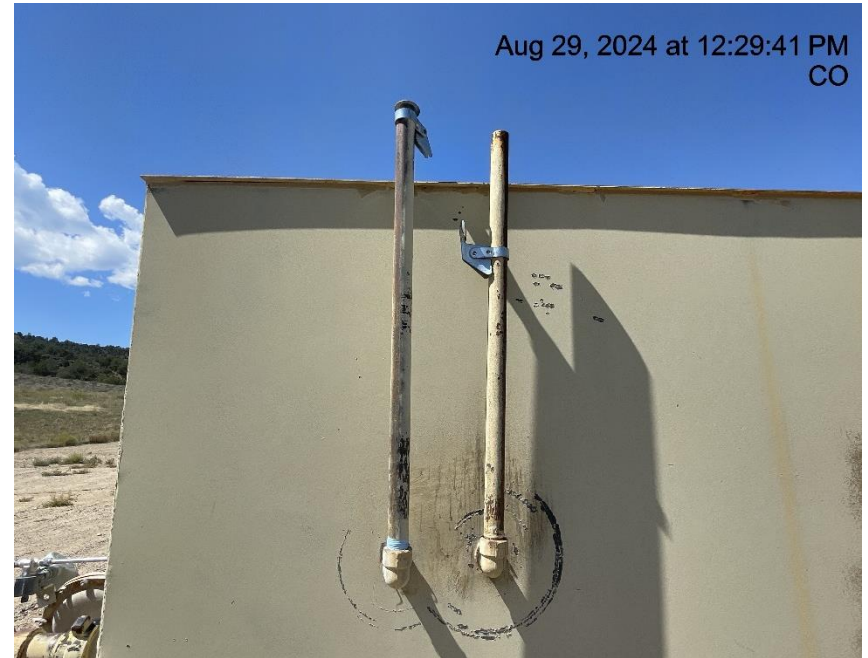
Photo # 7543 Rupture disc vent line does not comply with CECMC pressure safety device rules

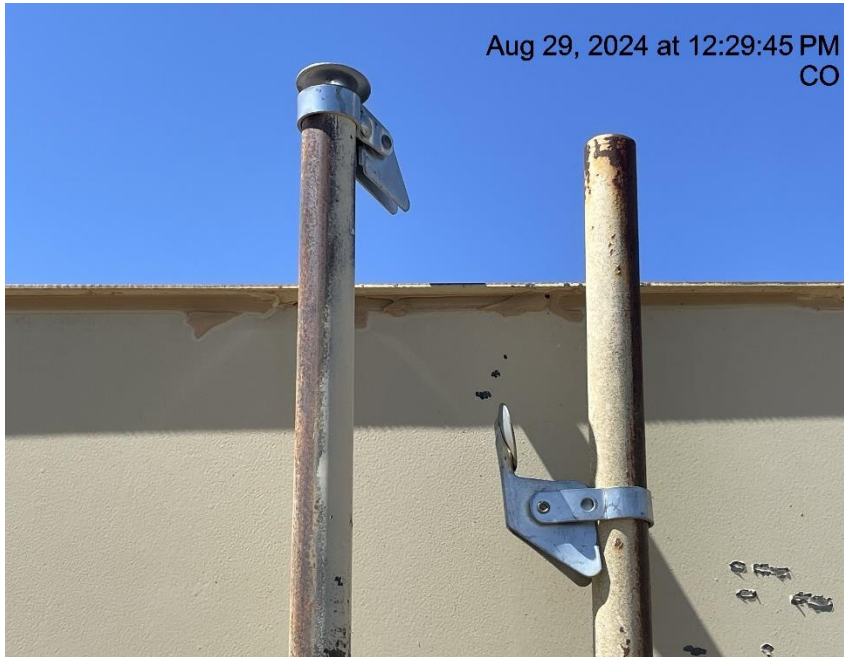
Photo # 7544 Rupture disc vent line does not comply with CECMC pressure safety device rules

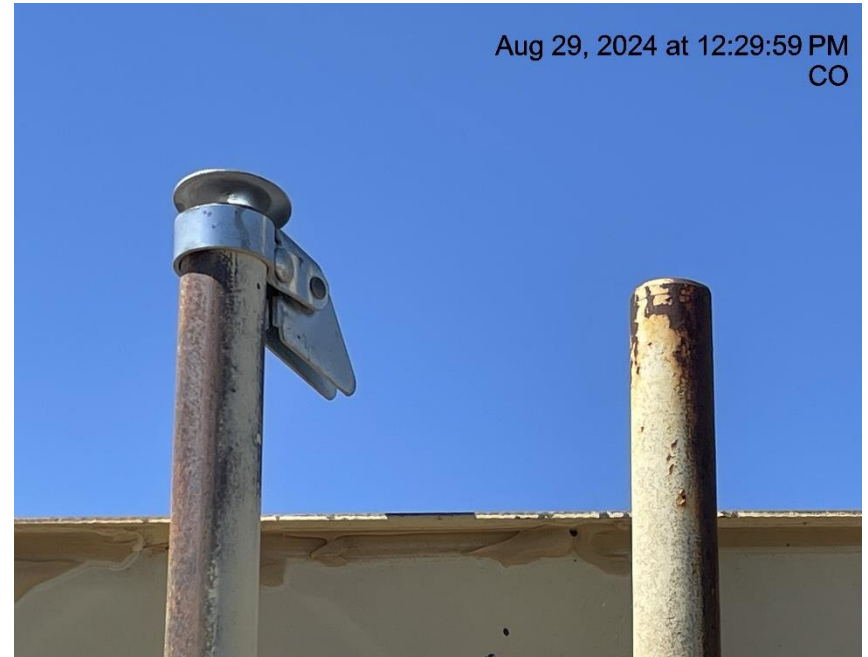
Photo # 7545 Rupture disc vent line does not comply with CECMC pressure safety device rules
