Inspection Photos

Location Name: CAERUS PICEANCE LLC SHIDELER 1-7 (G1SW) Pad

Location #: 334069

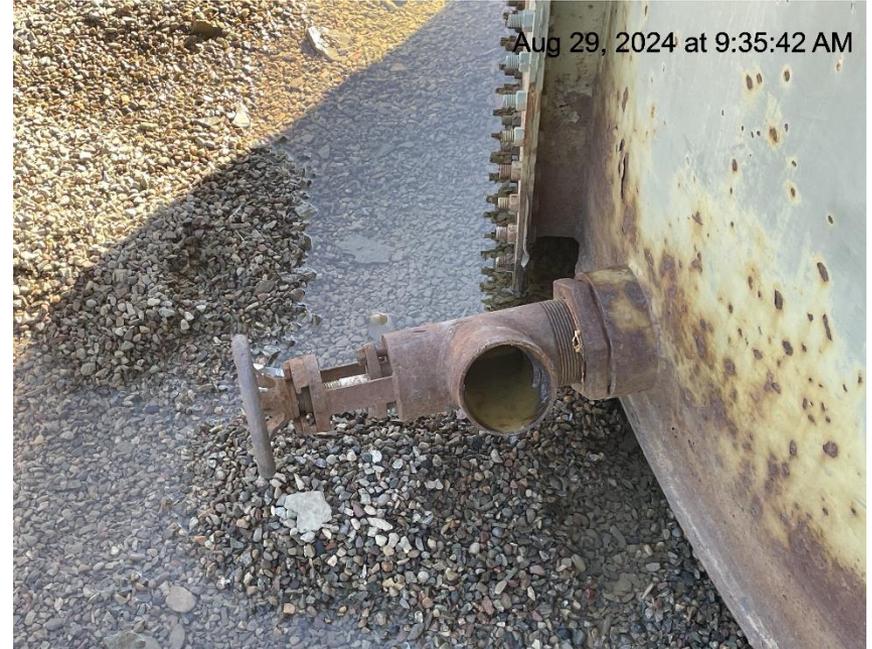
Photo # 7314 Open ended load line

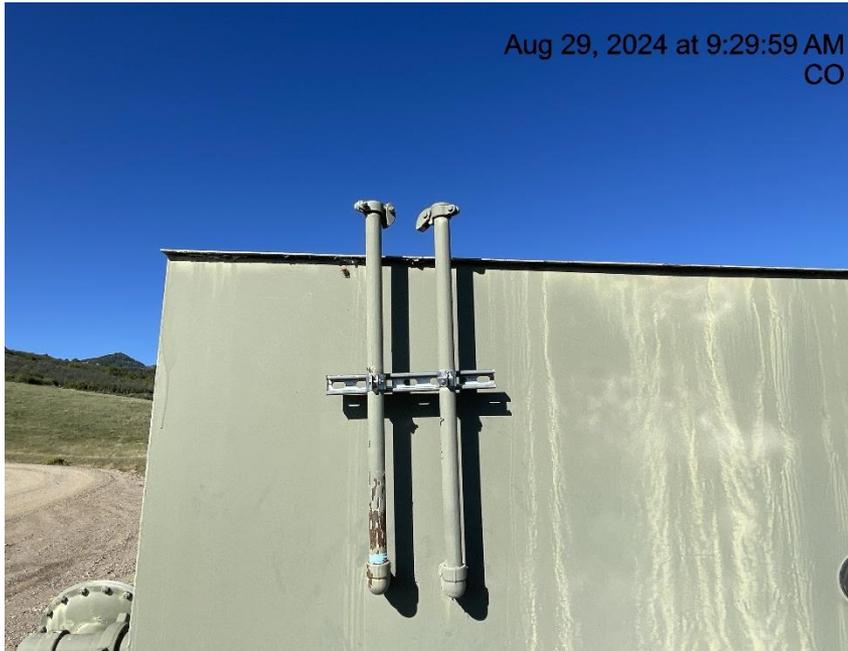
Photo # 7315 PRV vent line does not comply with CECMC pressure safety device rules

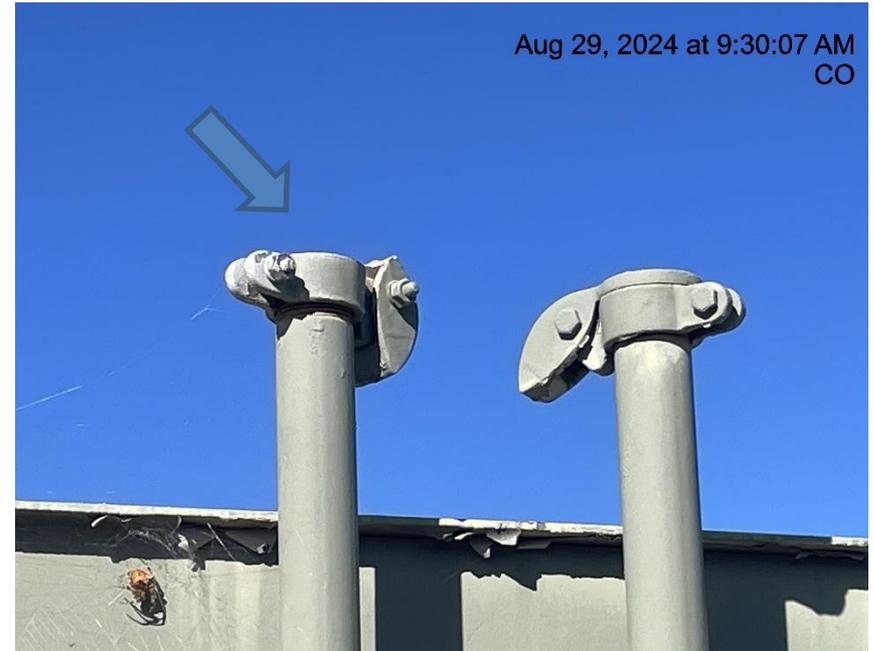
Photo # 7316 PRV vent line does not comply with CECMC pressure safety device rules

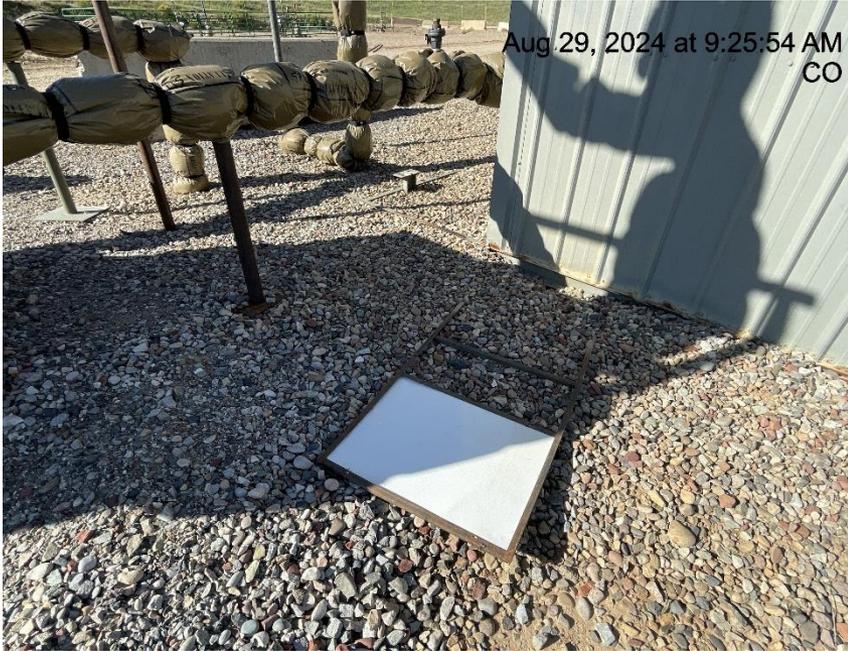
Photo # 7317 Sign laying on ground/not properly posted

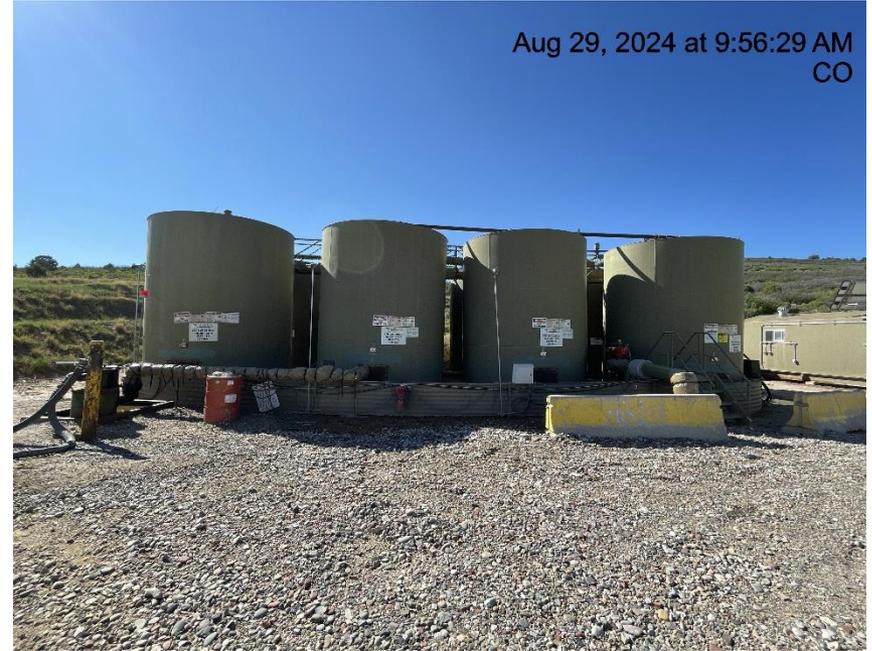
Photo # 7318 Tank battery lacks signage

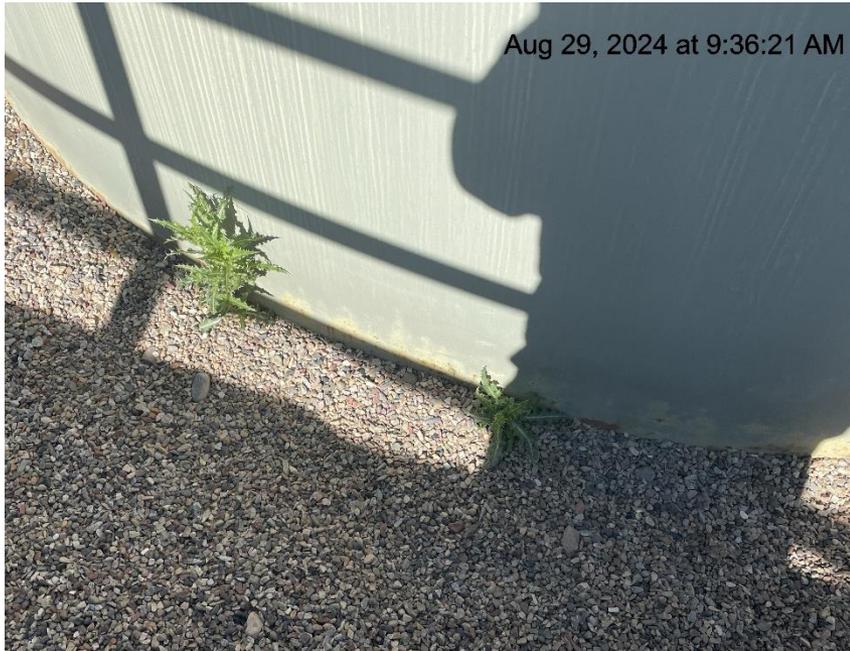
Photo # 7319 Weeds in secondary containment

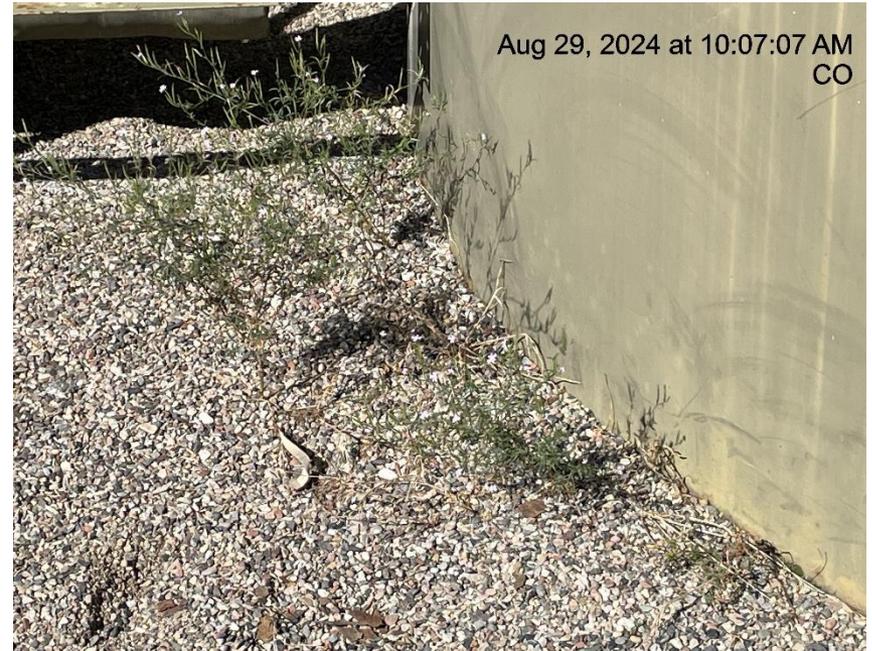
Photo # 7320 Weeds in secondary containment

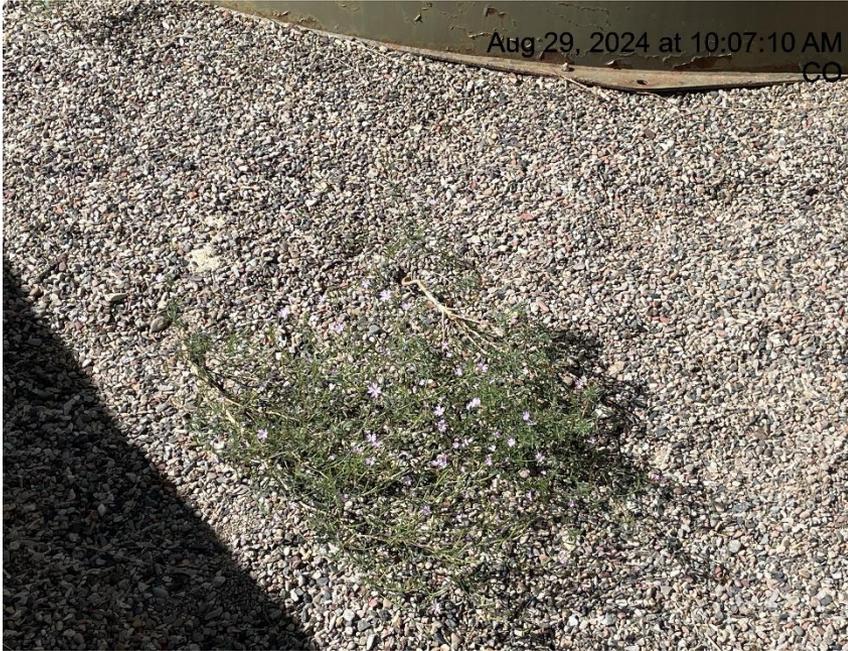
Photo # 7321 Weeds in secondary containment

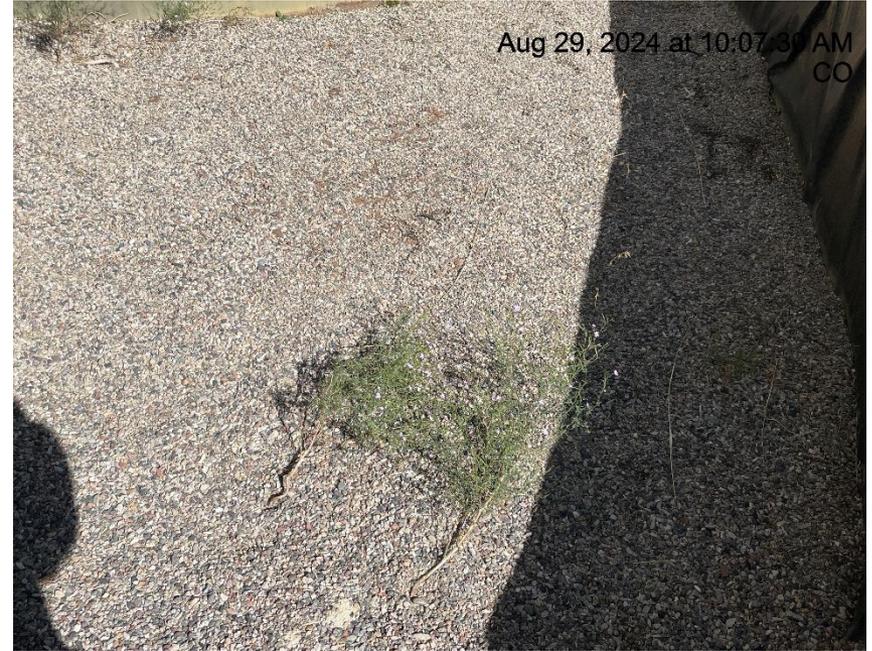
Photo # 7322 Weeds in secondary containment

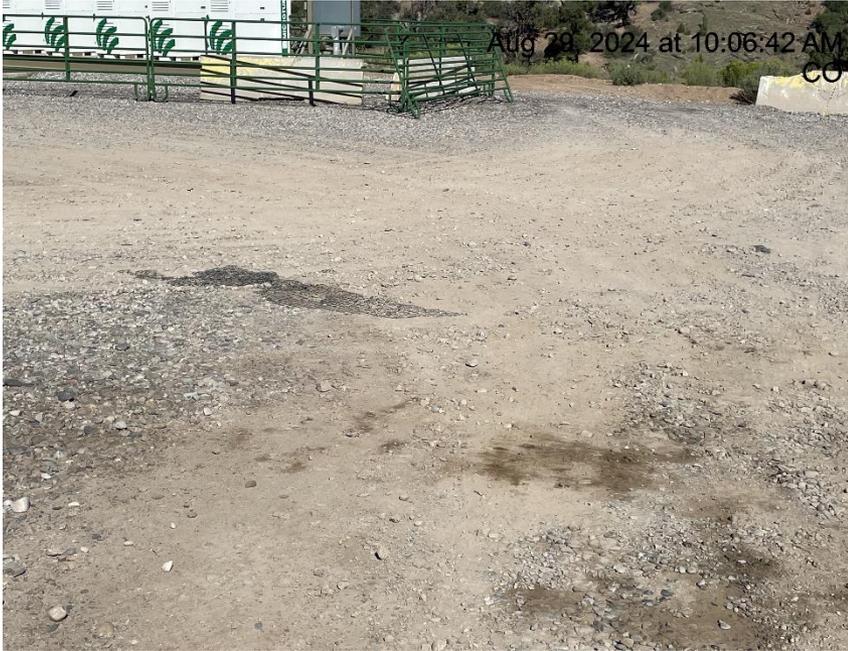
Photo # 7323 Small amount of staining & debris
