**Storm Water Management and Erosion control**  
**Location Name: CAERUS PICEANCE LLC HMU 1-11C (I2SW) Pad**  
**Location ID: 324349**

**Location Overview: Location is within High Priority/NSO/Black Bear Habitat areas. Location is approximately 80 yards from Middle Mamm Creek & drainage from location contributes to the creek.**

**Section/Township/Range: 2 8S93W**

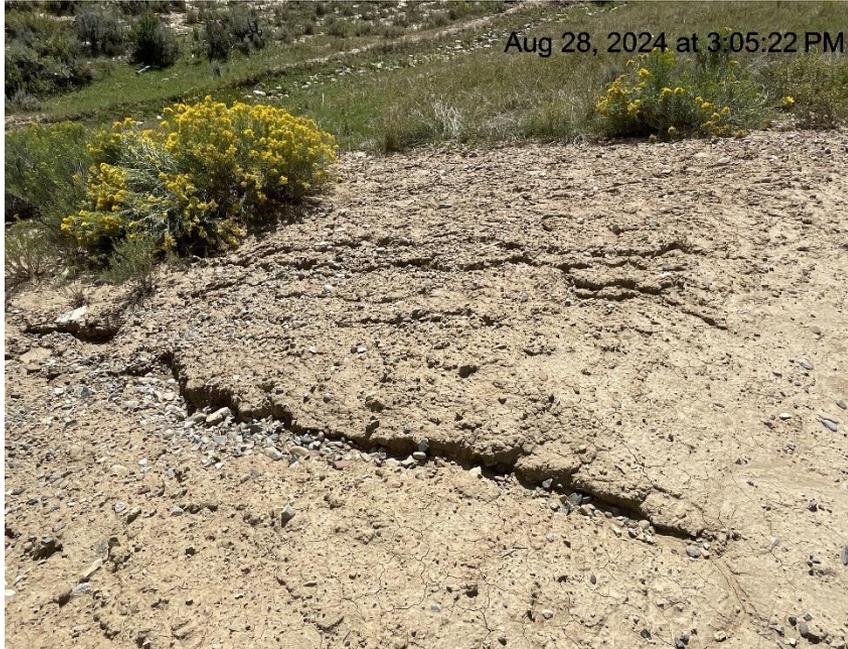
**Photo # 7174 Erosion on slope & transport of sediment off location & into a vegetated area (near separator units & Summit Midstream meter house)**

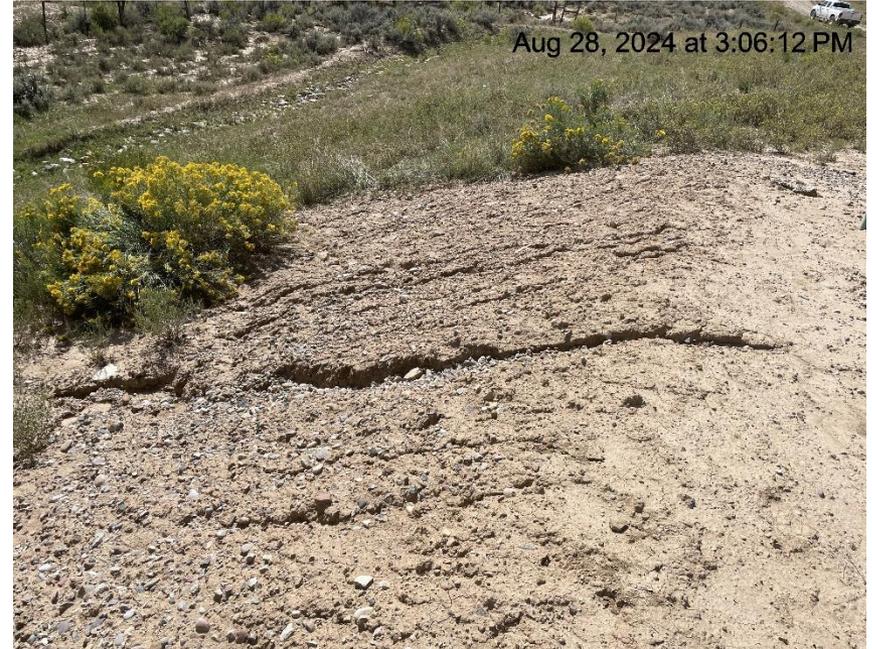
**Photo # 7175 Erosion on slope & transport of sediment off location & into a vegetated area (near separator units & Summit Midstream meter house)**

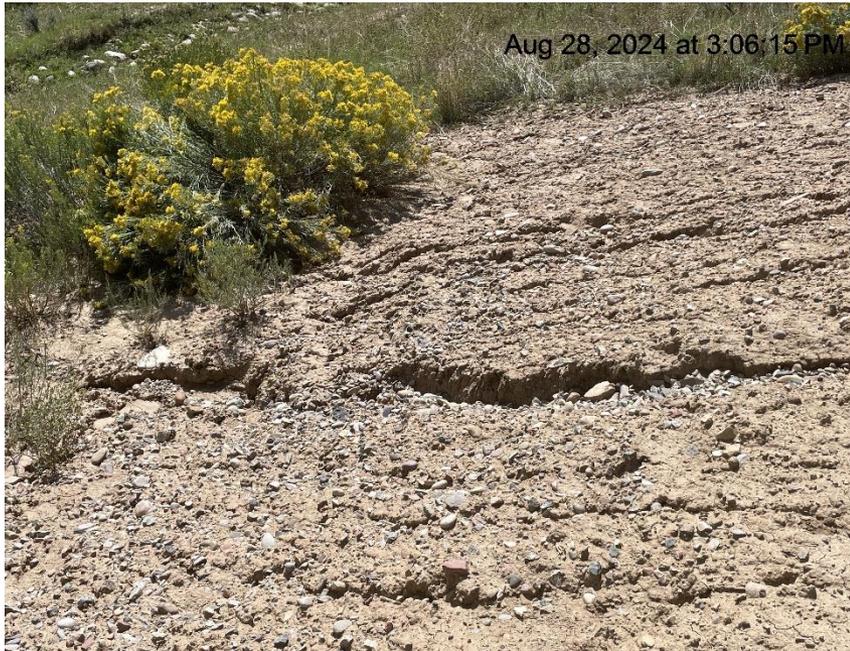
**Photo # 7176 Erosion on slope & transport of sediment off location & into a vegetated area (near separator units & Summit Midstream meter house)**

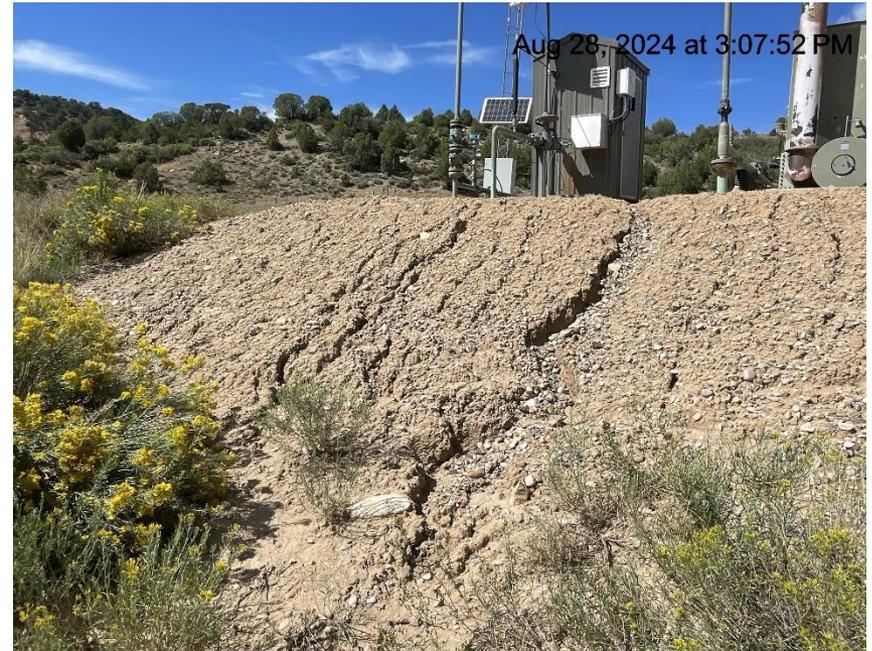
**Photo # 7177 Erosion on slope & transport of sediment off location & into a vegetated area (near separator units & Summit Midstream meter house)**

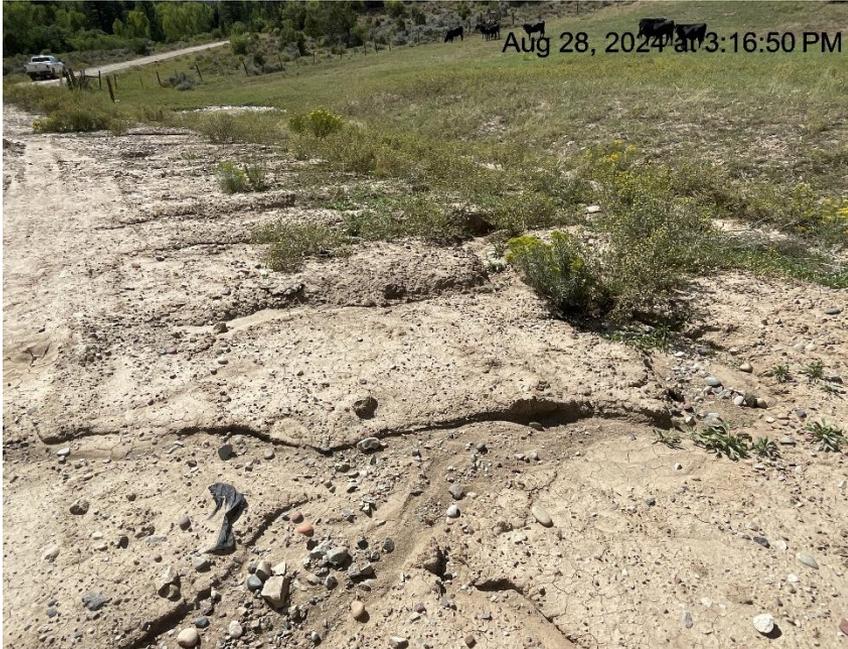
**Photo # 7178 Rill erosion & sediment transport (N/NW edge of location)**

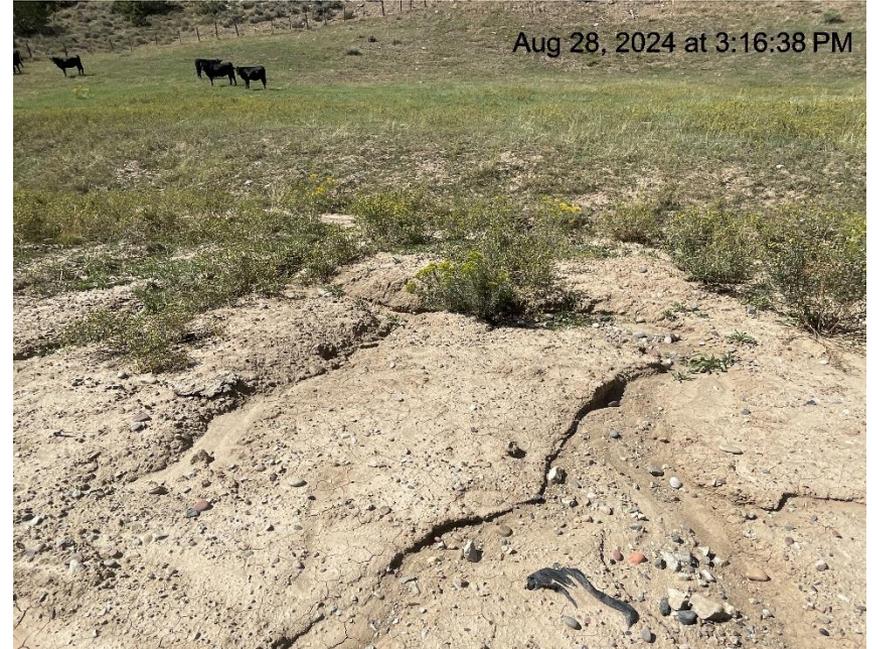
**Photo # 7179 Rill erosion & sediment transport (N/NW edge of location)**

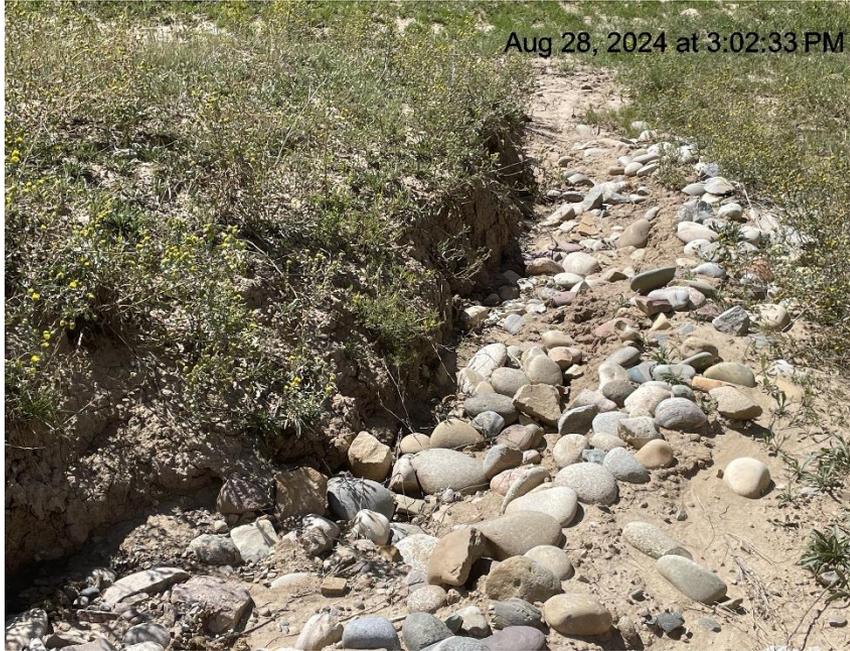
**Photo # 7180 Rip Rap Run showing some erosion & sediment buildup (SW corner of location near pig launcher)**

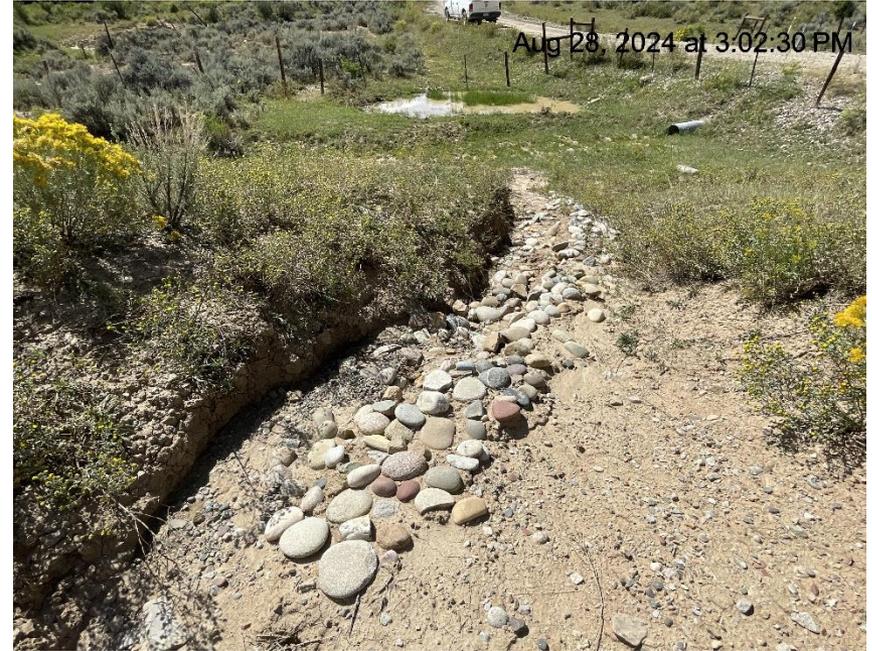
**Photo # 7181 Rip Rap Run showing some erosion & sediment buildup (SW corner of location near pig launcher)**

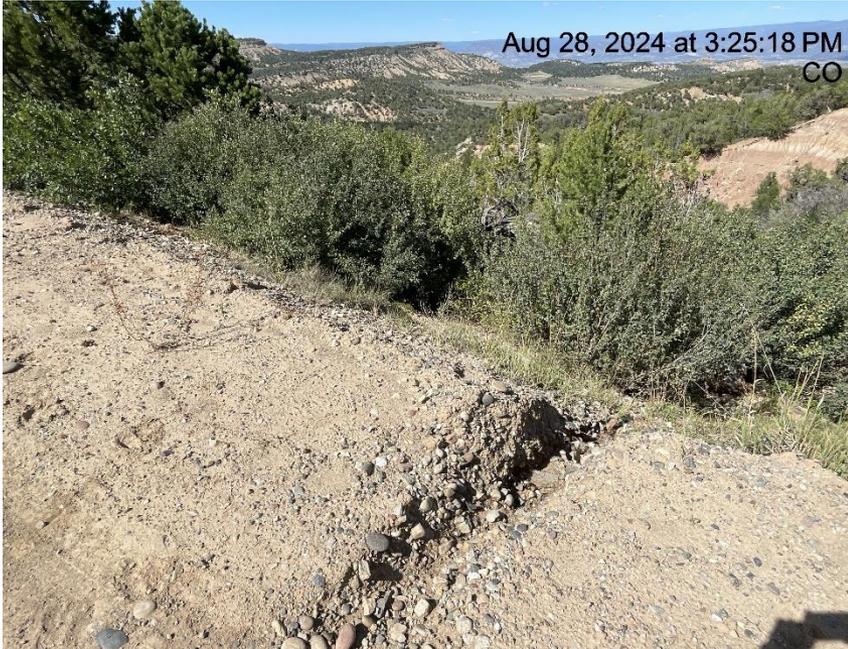
**Photo # 7182 Erosion on lease road & transport of sediment off lease road into a vegetated area (approximately 6/10<sup>th</sup> of a mile from location)**

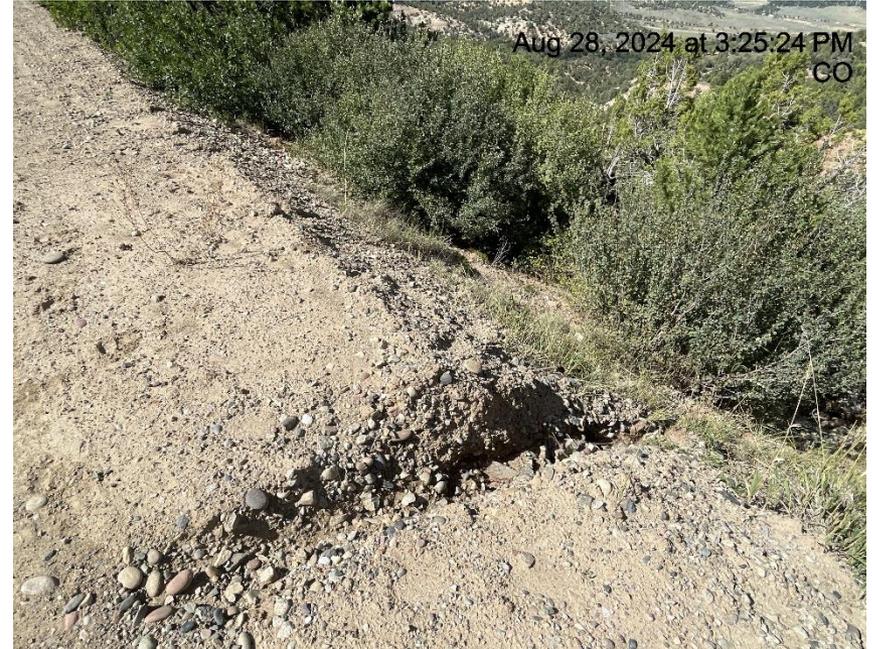
**Photo # 7183 Erosion on lease road & transport of sediment off lease road into a vegetated area (approximately 6/10<sup>th</sup> of a mile from location)**

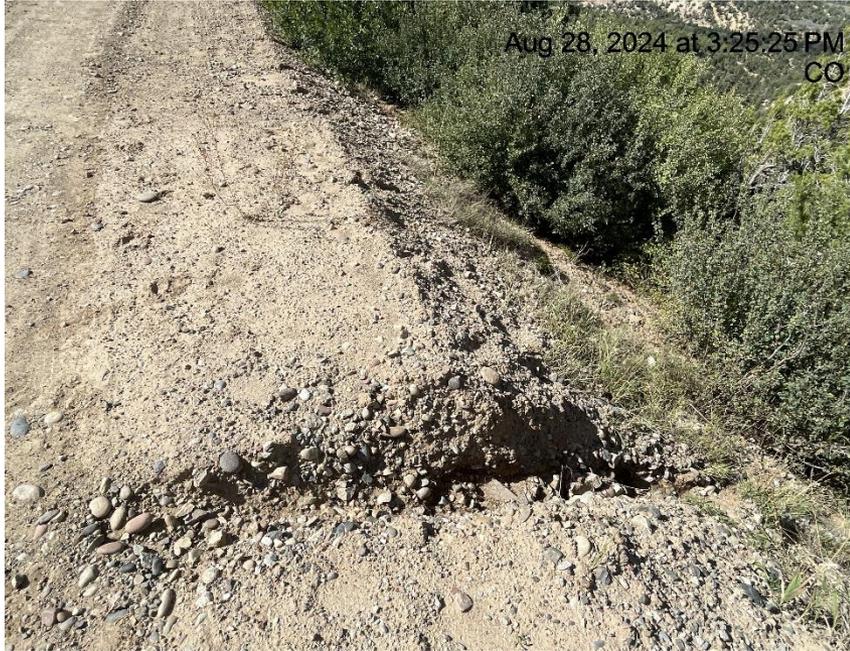
**Photo # 7184 Erosion on lease road & transport of sediment off lease road into a vegetated area (approximately 6/10th of a mile from location)**

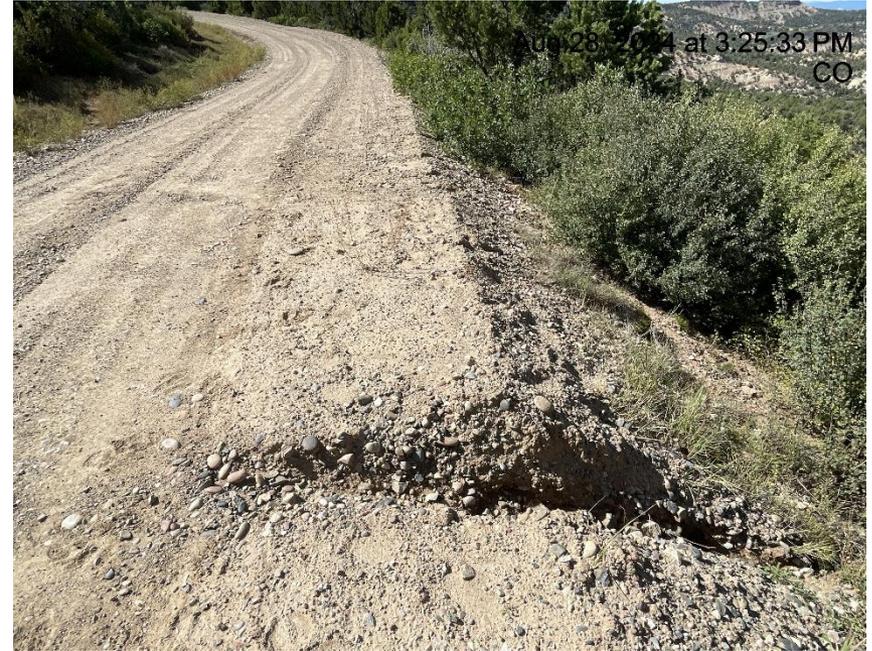
**Photo # 7185 Erosion on lease road & transport of sediment off lease road into a vegetated area (approximately 6/10th of a mile from location)**
