Inspection Photos

Location Name: CAERUS PICEANCE LLC HMU 1-11C (I2SW) Pad

Location ID: 324349

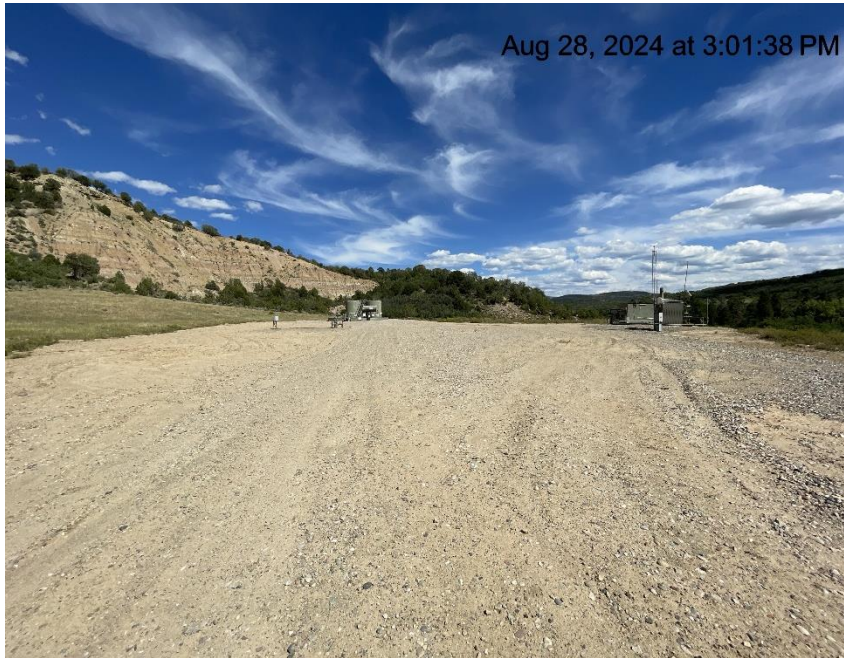
Photo # 7164 From entrance to location

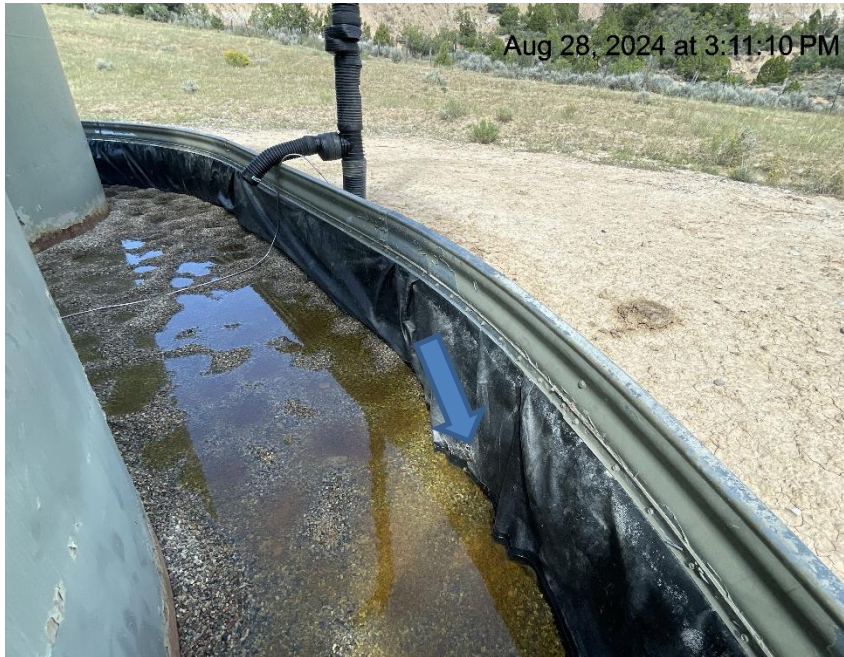
Photo # 7170 Hole in liner/liner needs maintenance

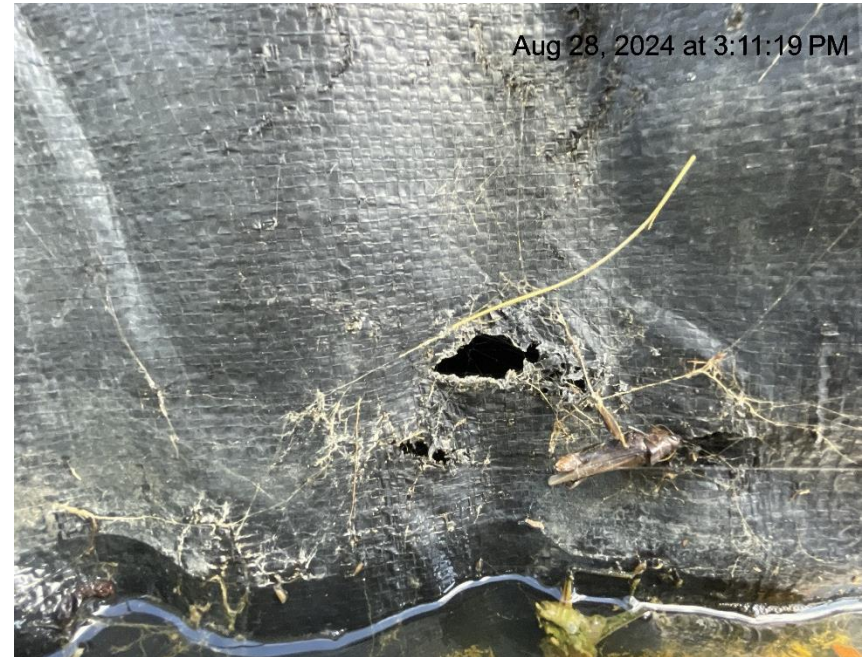
Photo # 7171 Hole in liner/liner needs maintenance

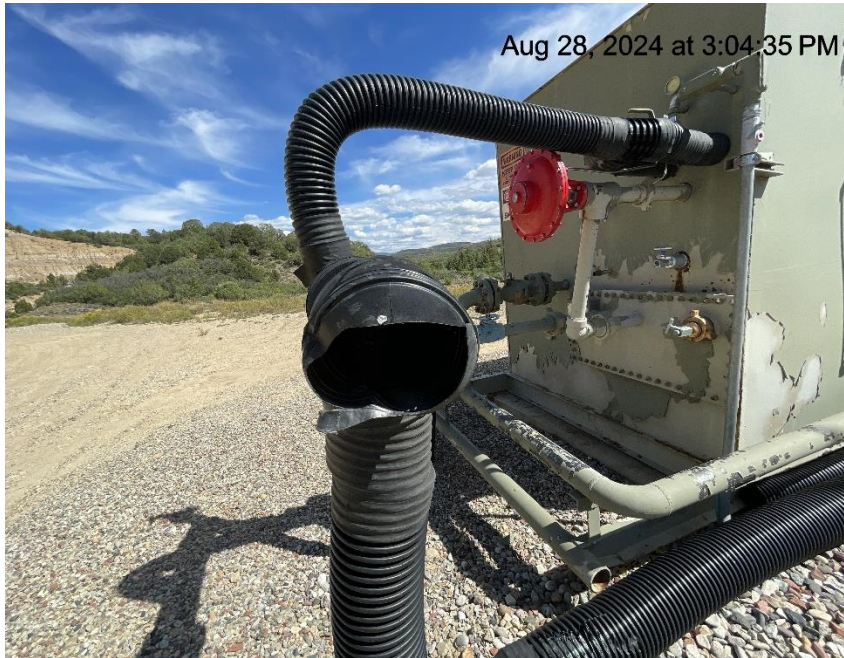
Photo # 7172 Flowline heating insulation open ended/available for entry by wildlife/wildlife hazard

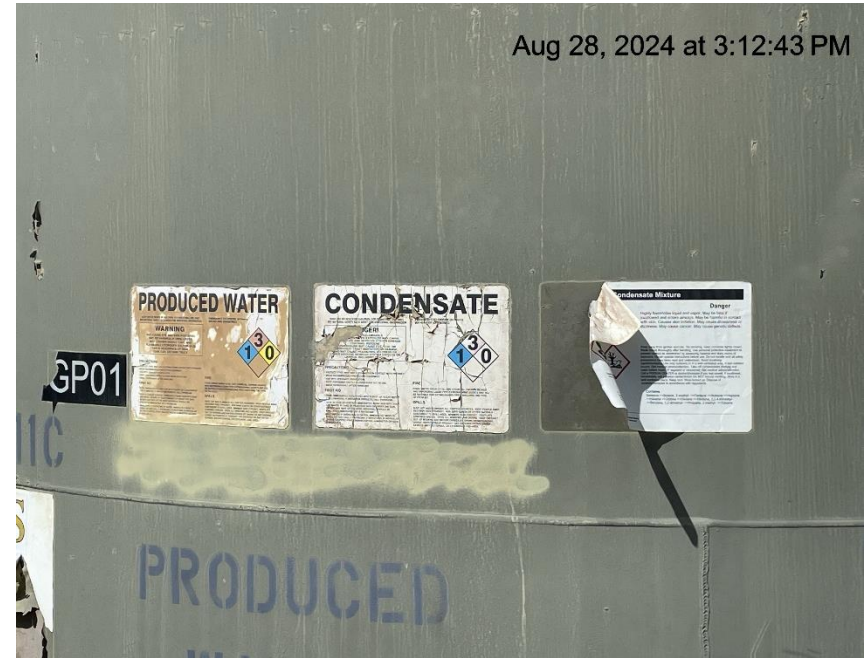
Photo # 7173 Tank labels weathered & 1 label starting to peel
