Caerus Piceance LLC
Figure Four Unit 8010D J11 498
Location ID: 316433

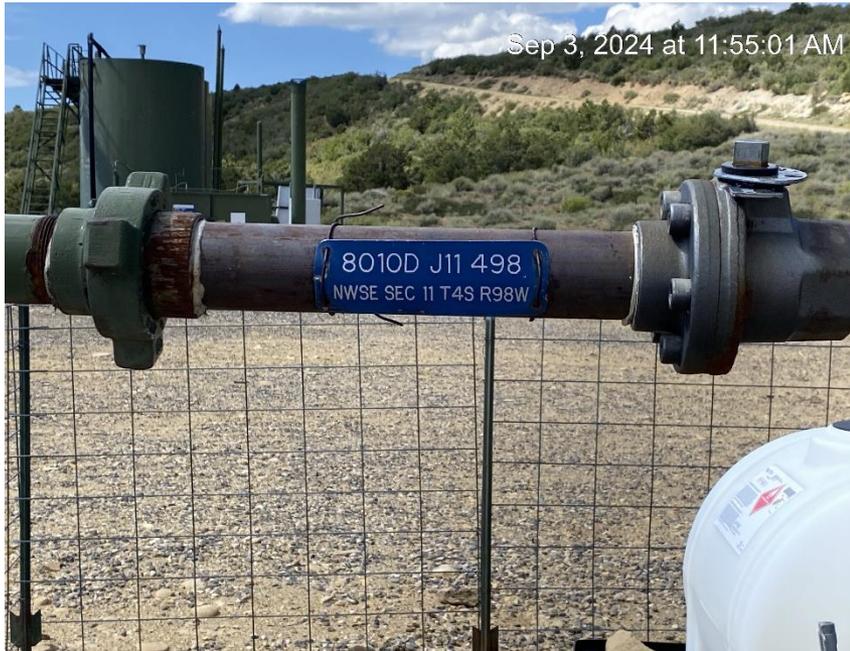
When replaced additional information is required

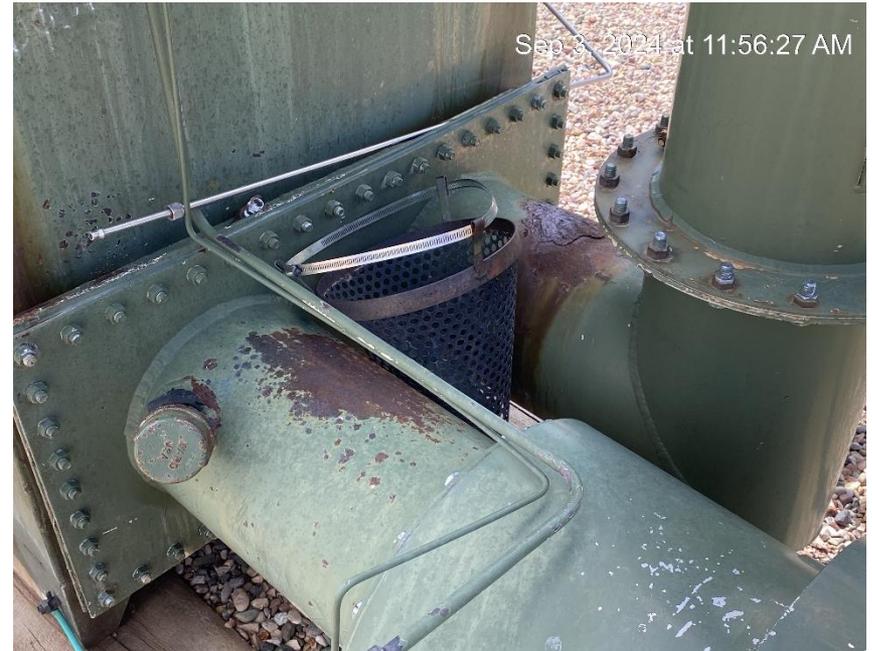
Debris

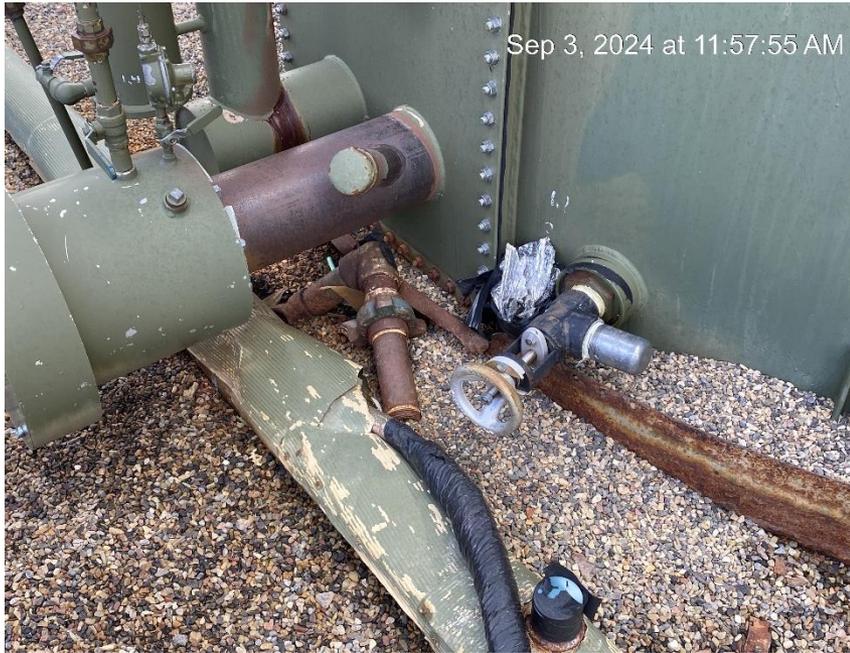
Debris

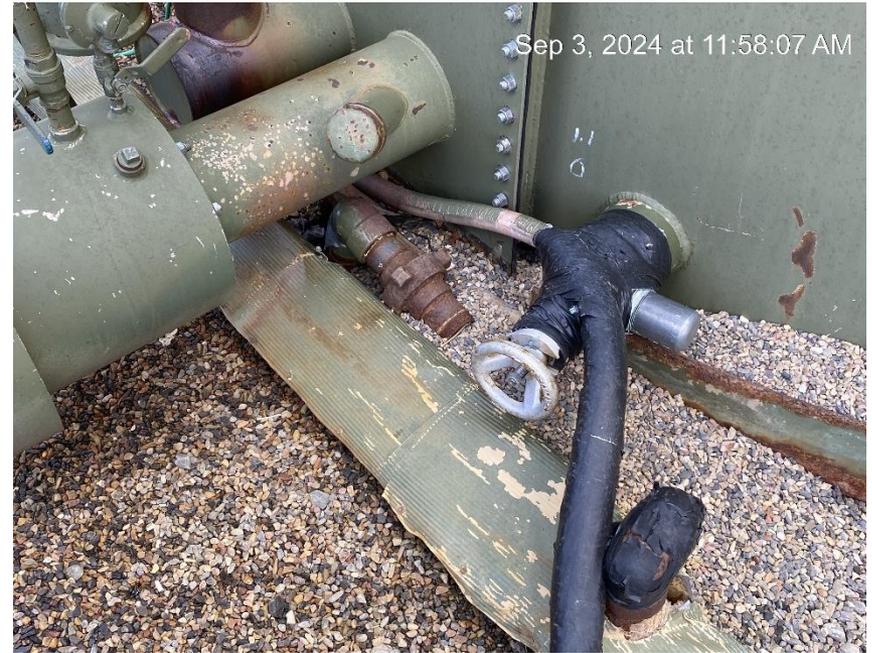
Debris

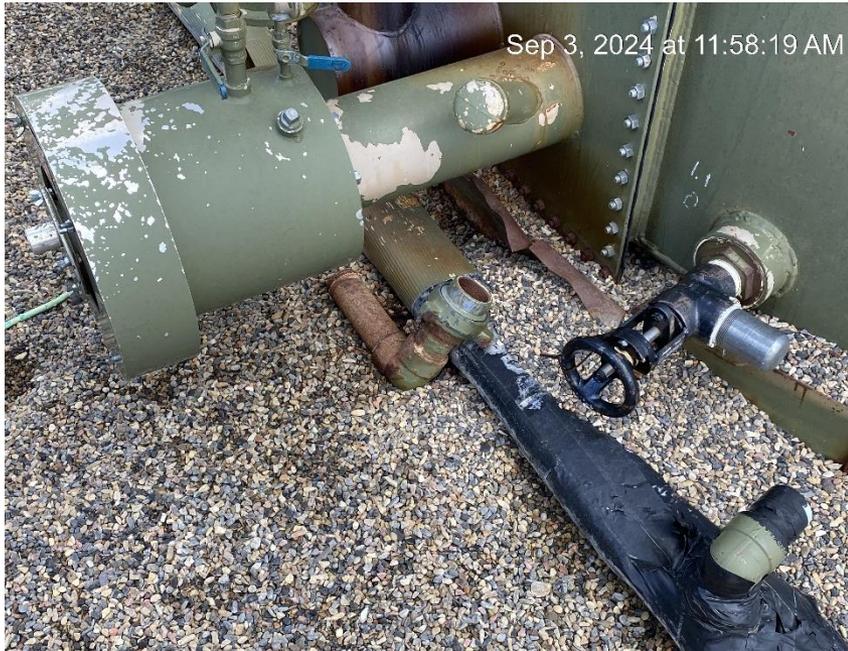
Debris

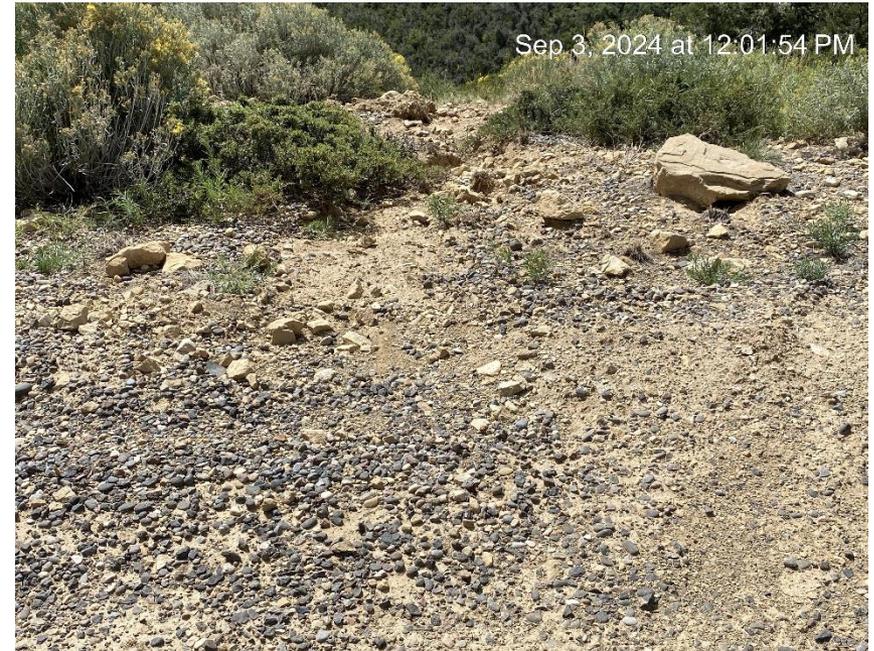
Stormwater BMP maintenance required
