Inspection Photos
Operator: Simcoe LLC
Location Name: Joe Martin 1
API: 05-067-06724

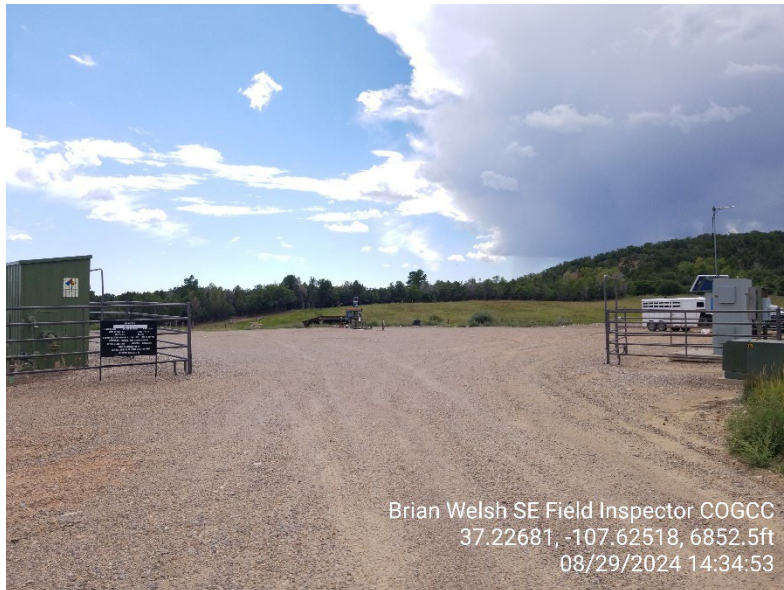
1. Location overview

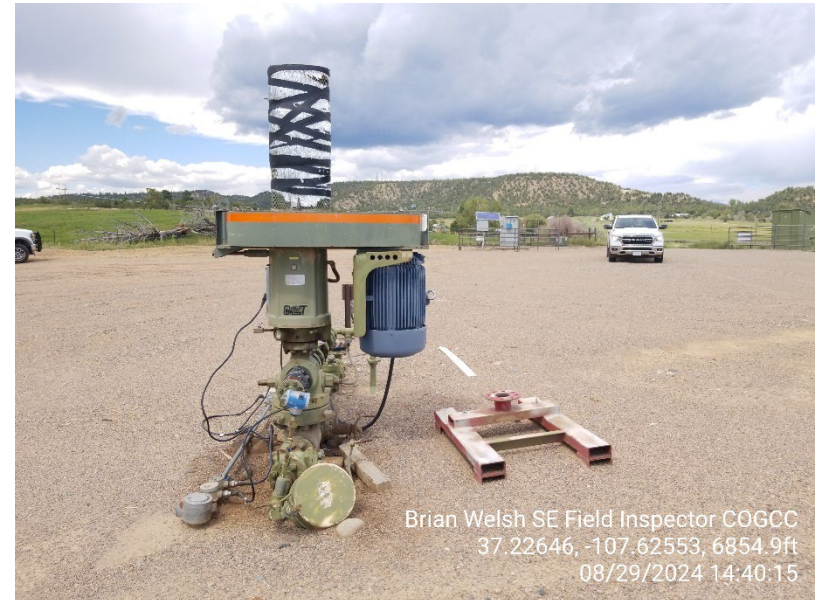
2. Progressive cavity on wellhead

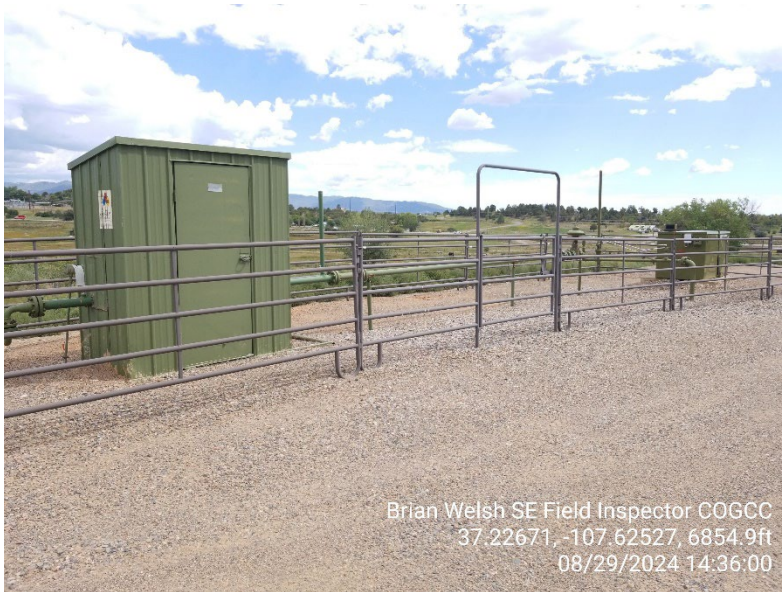
3. Production equipment

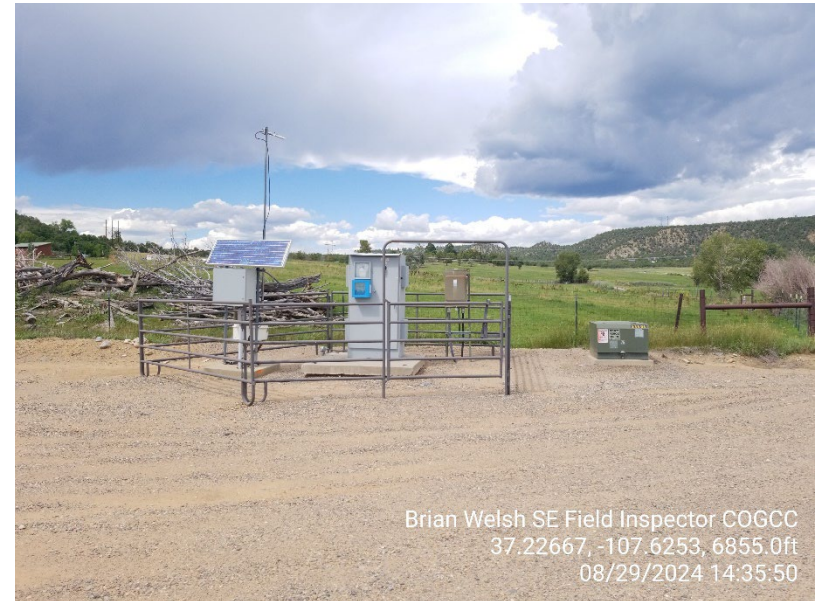
4. Ancillary equipment

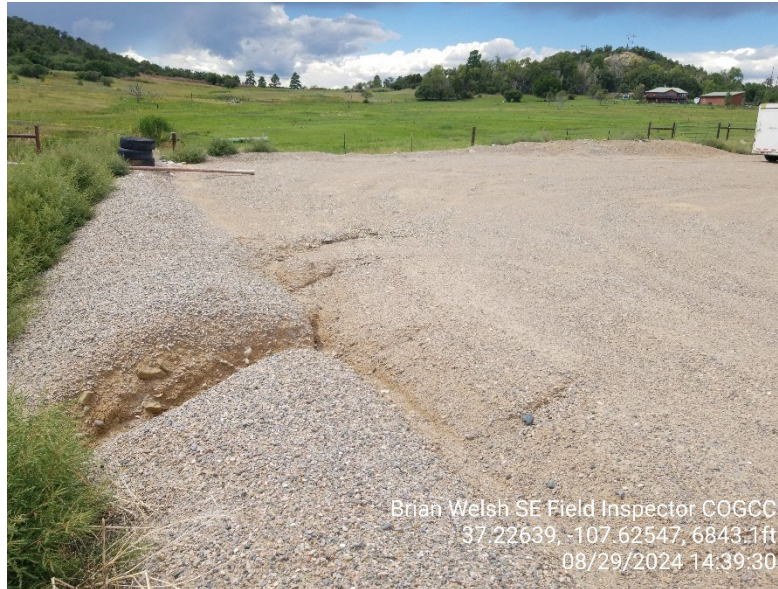
5. Erosion on the south edge of location needs to be repaired
