Inspection Photos

Location Name: TEP ROCKY MOUNTAIN LLC, AP-66S95W/18NENW

Location ID: 335996

Date: 8/29/2024

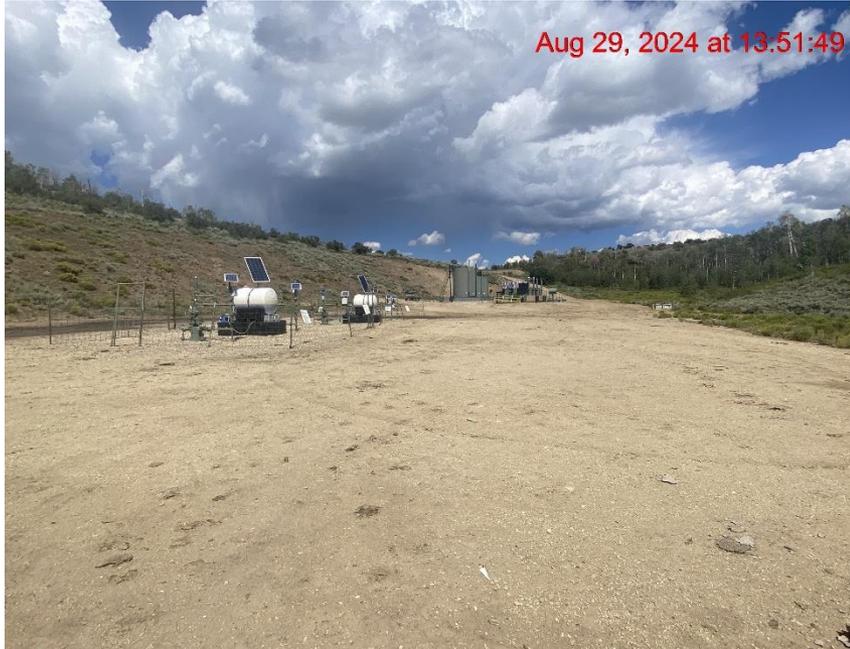
Southwest Corner of Location – Photo #03197

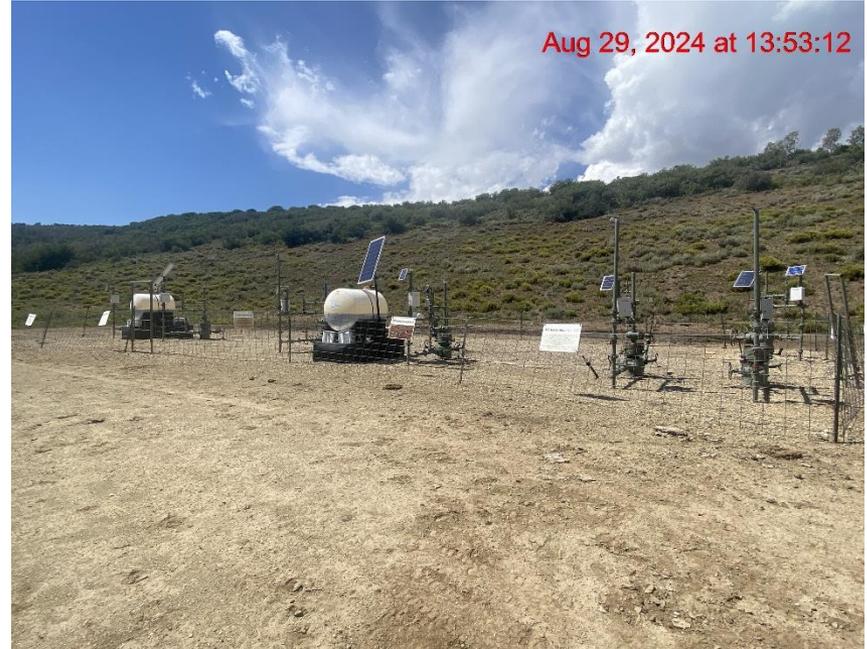
Wellheads – Photo #03201

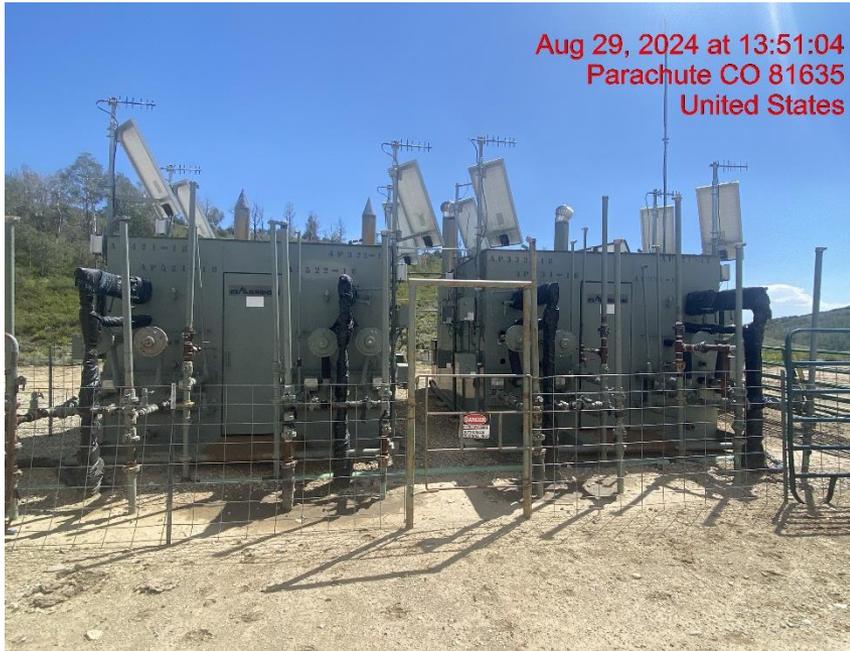
Separators – Photo #03196

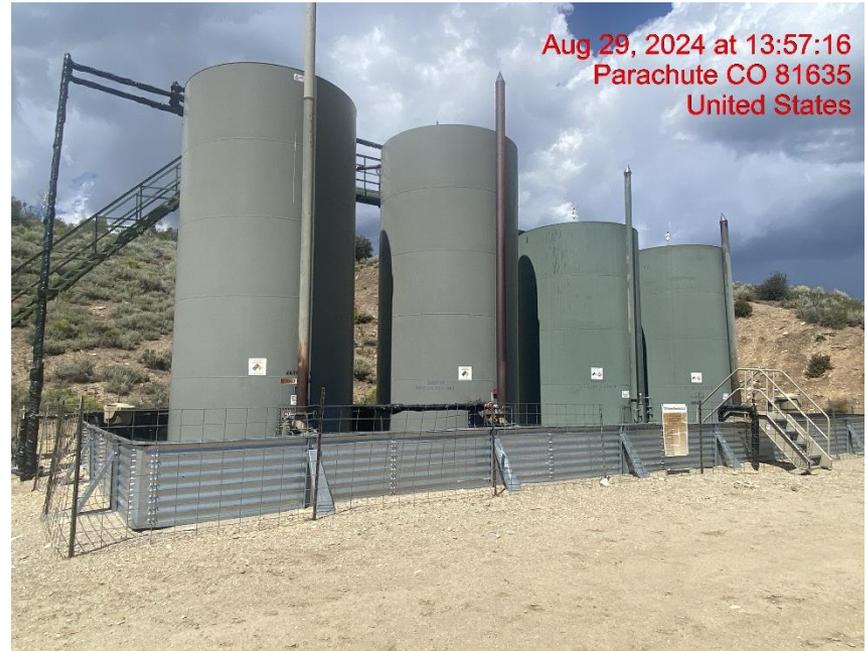
Tank Battery – Photo #03209

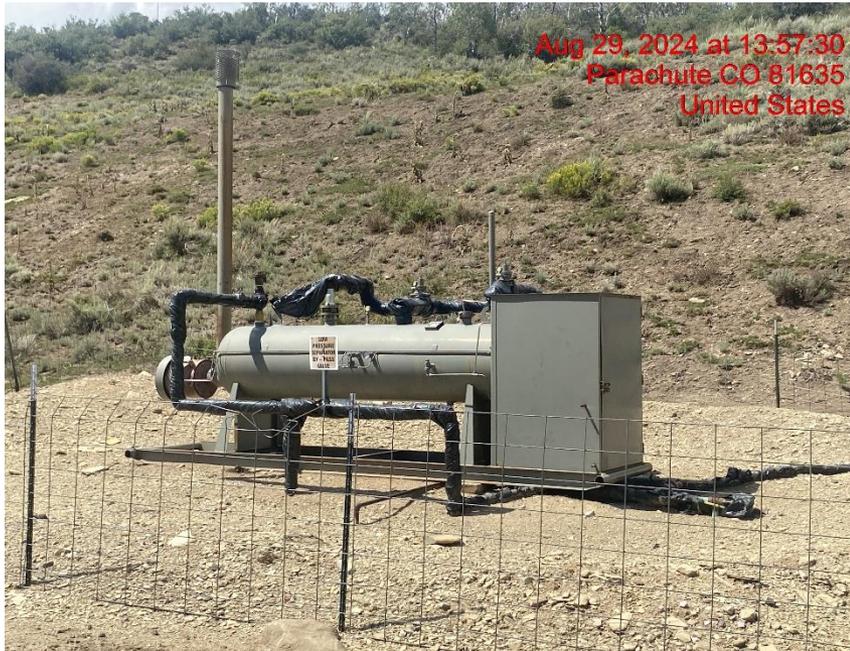
Heater Treater – Photo #03210

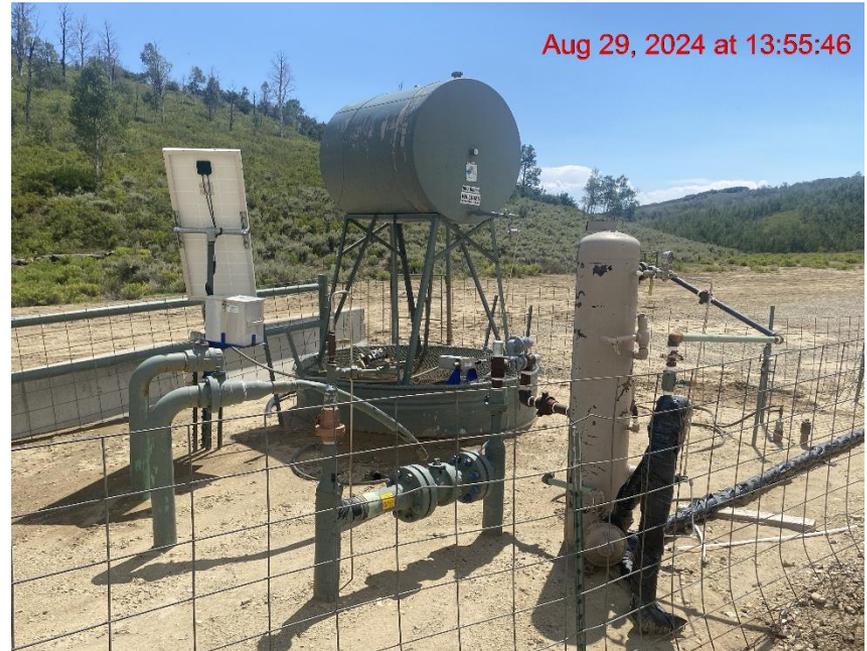
Location – Photo #03205

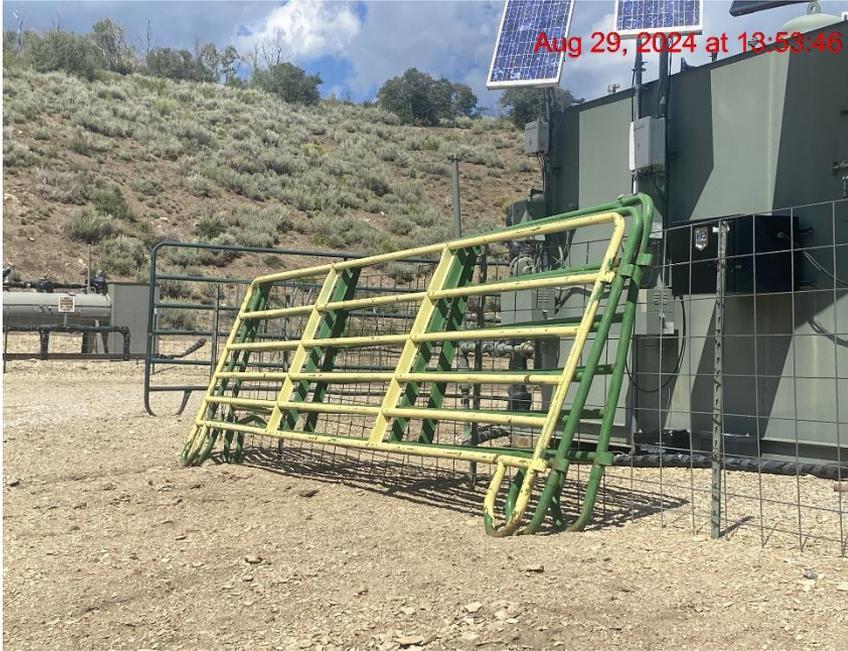
Stored Supplies – Photo #03202

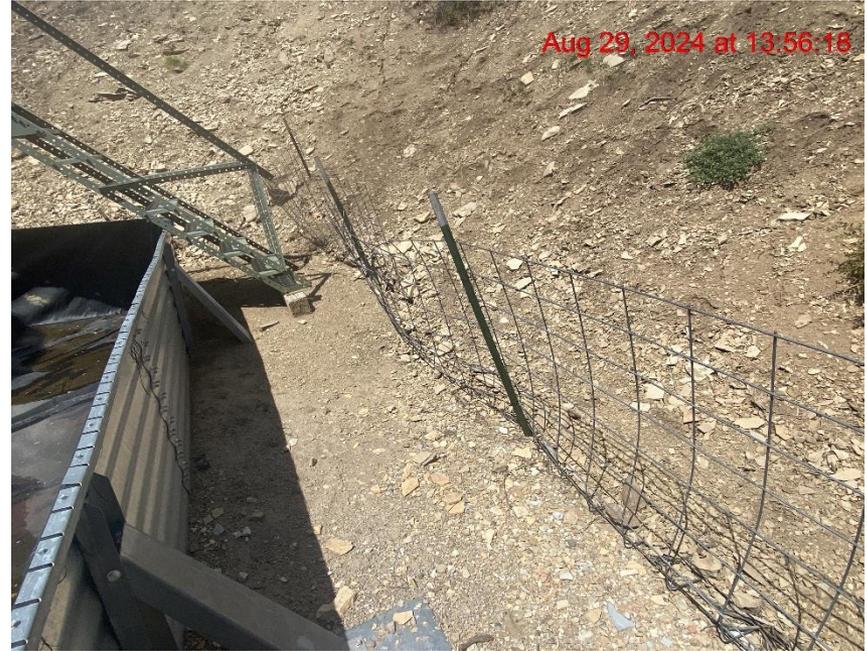
Insufficient Erosion Control – Photo #03206

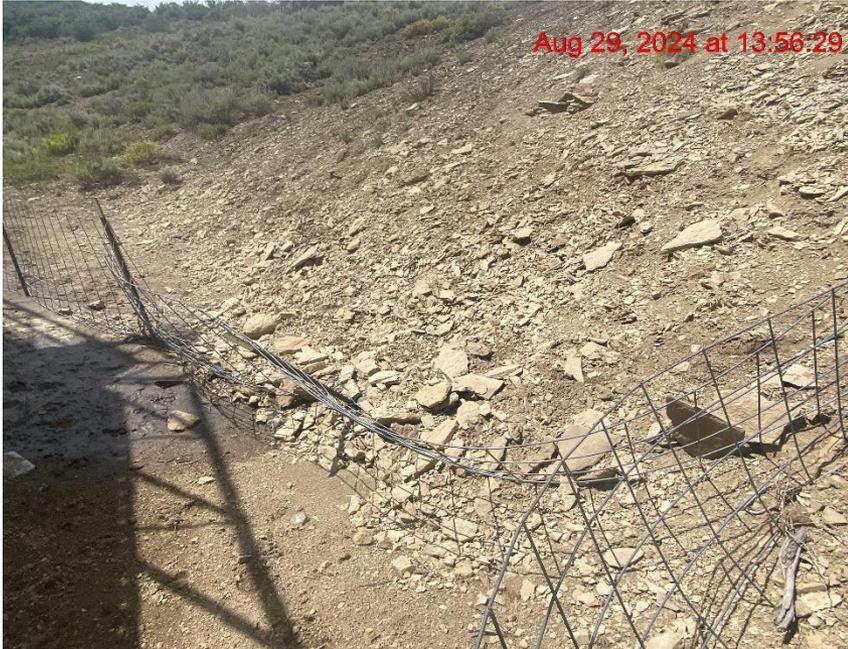
Insufficient Erosion Control/Damaged Fencing – Photo #03207

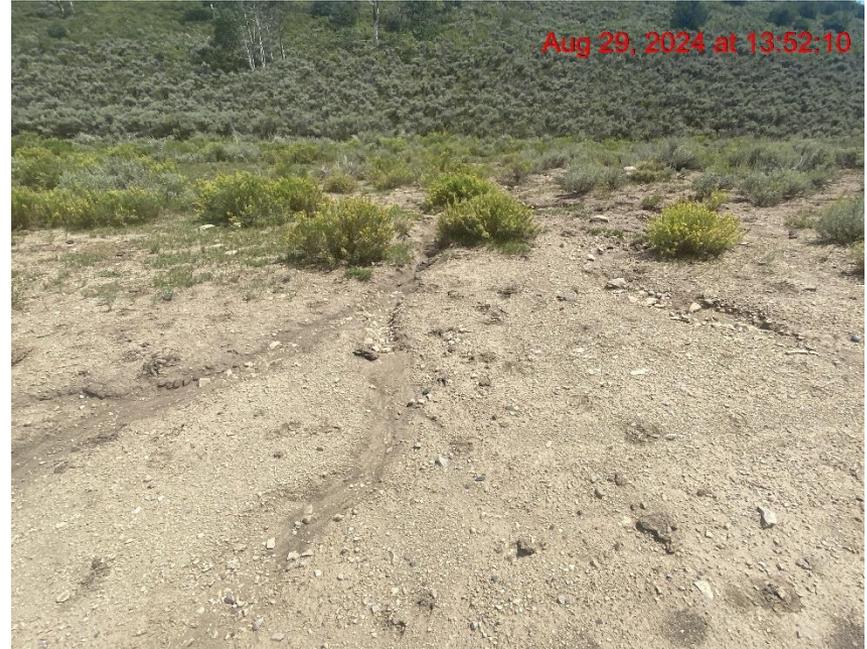
Transport of Sediment Off-Site – Photo #03198

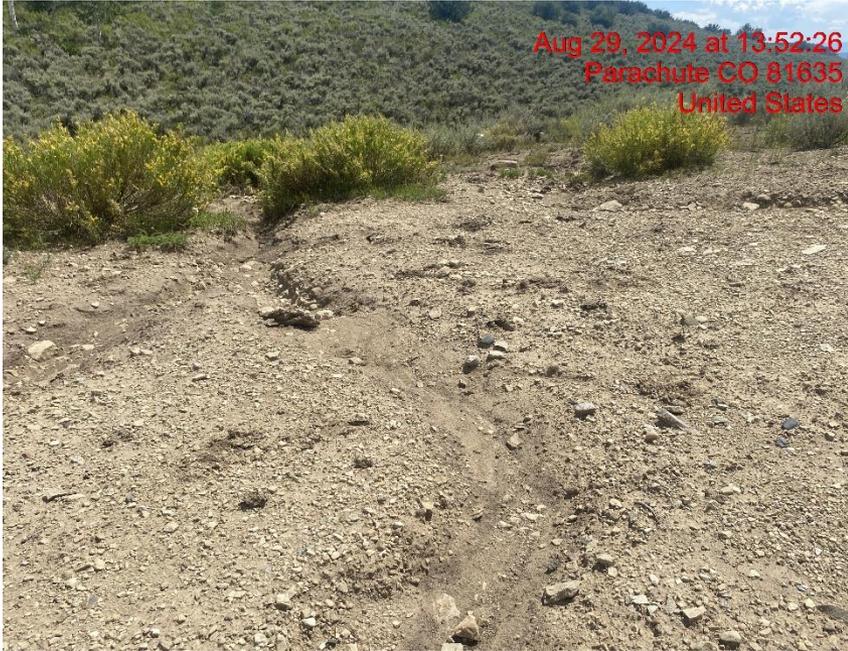
Transport of Sediment Off-Site – Photo #03199

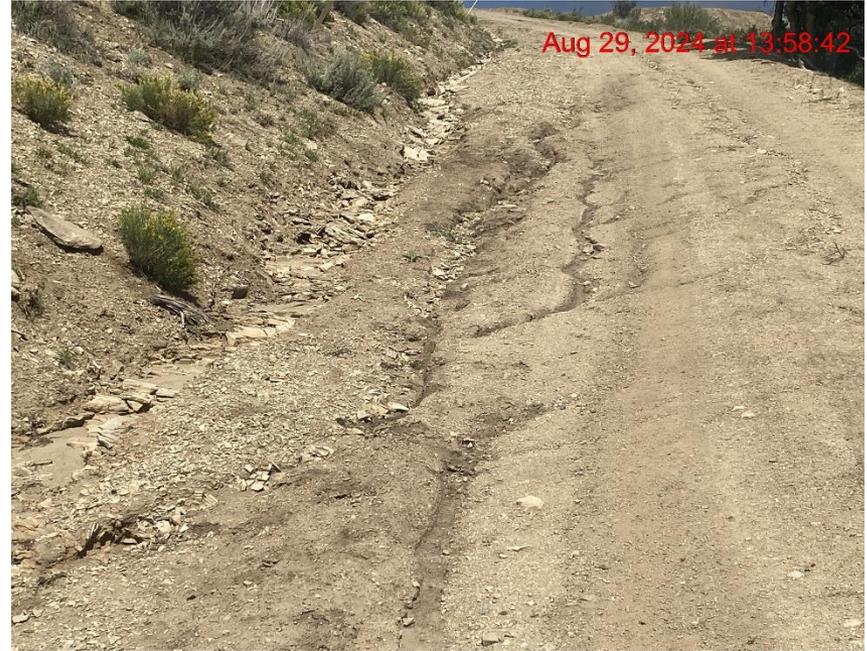
Insufficient Erosion Control – Photo #03211
