Interim Reclamation and Stormwater Inspection

Operator: KP KAUFFMAN COMPANY INC - 46290

Inspection Document #: 708201581

Location Name: Elkhorn CO-62N67W 21 NENW

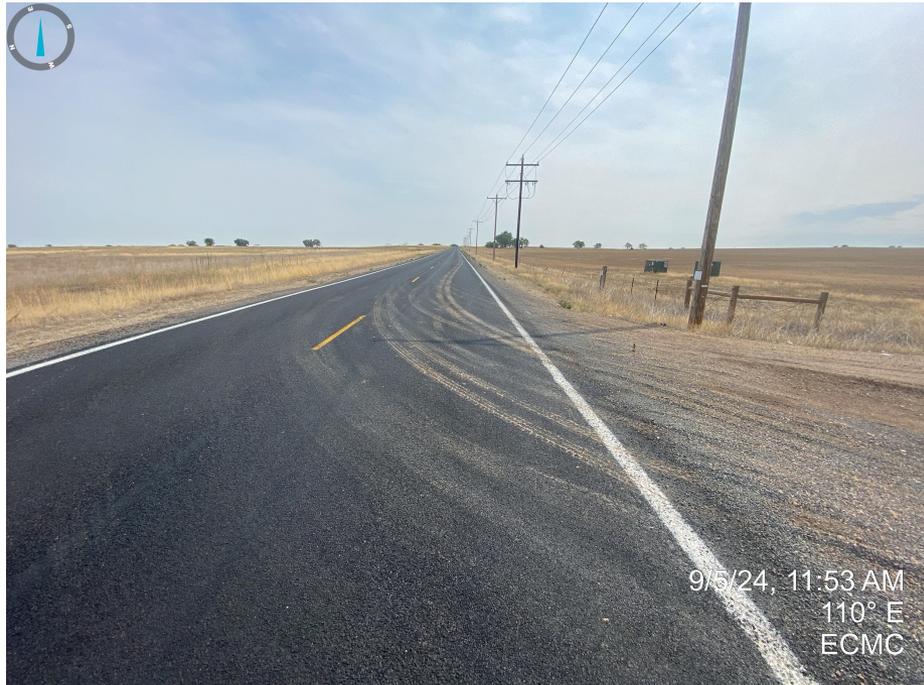
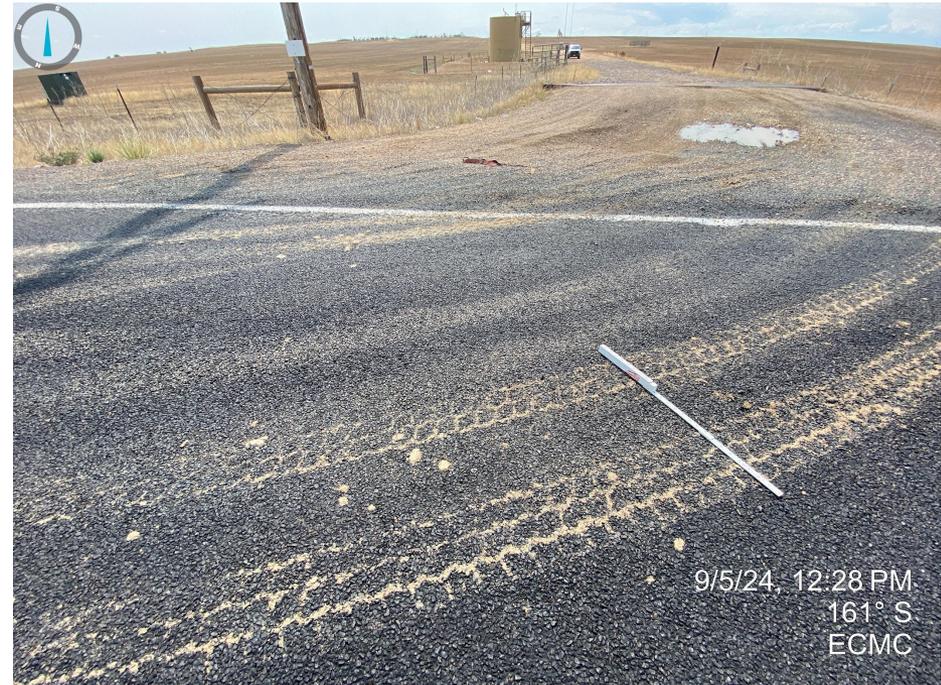
Photos 1 & 2. Vehicle track out, originating from the tank battery, was observed for approximately 100 yards onto eastbound WCR 20.

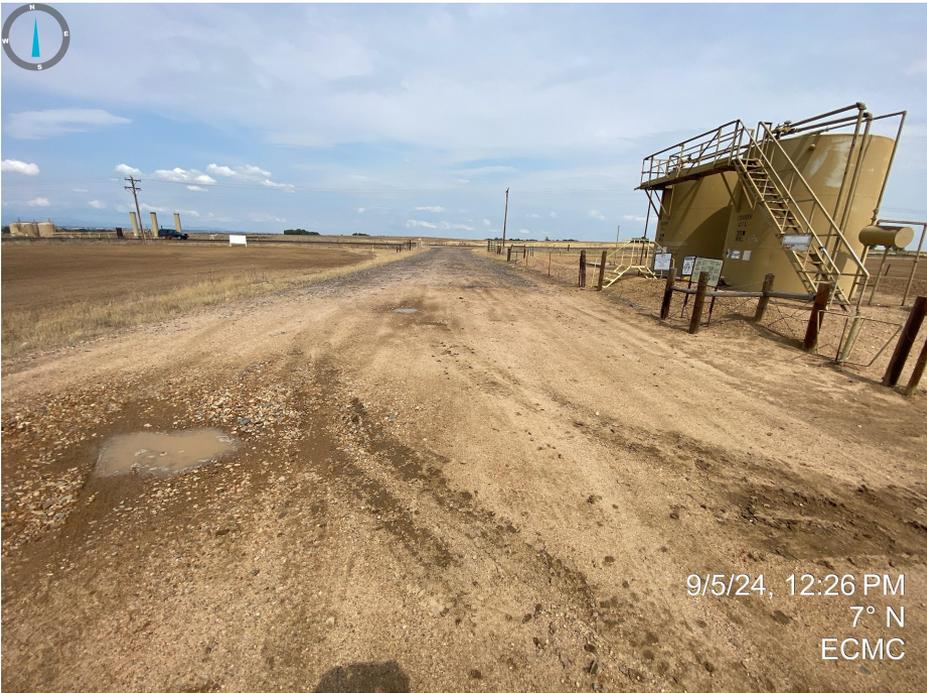
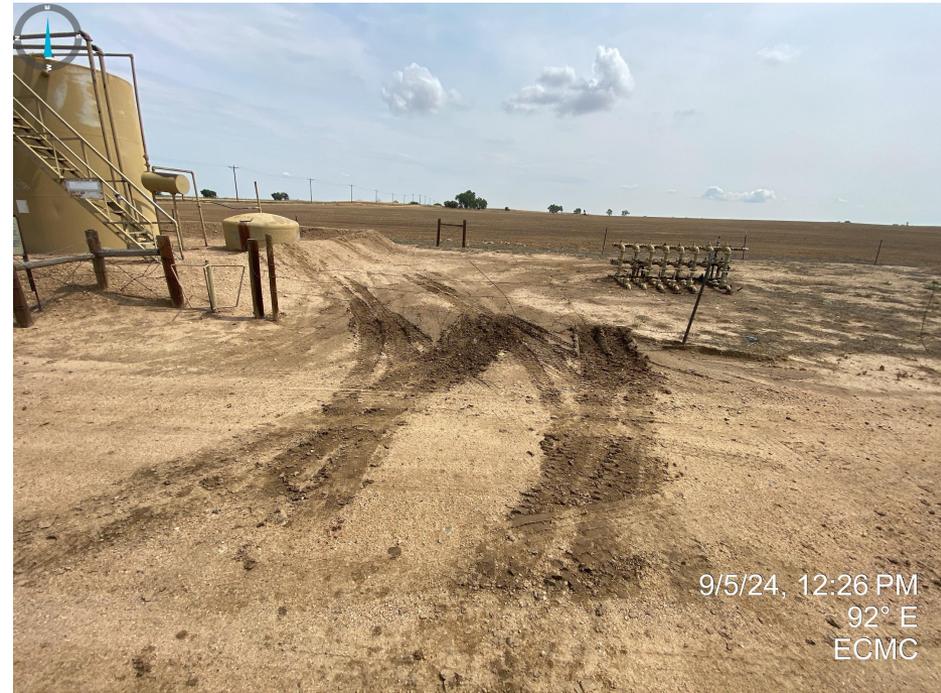
Photos 3 & 4. Vehicle track out appears to have originated from the tank battery area, which does not appear to be properly stabilized to minimize erosion or prevent site degradation in accordance with Rule 1002.e.(1).

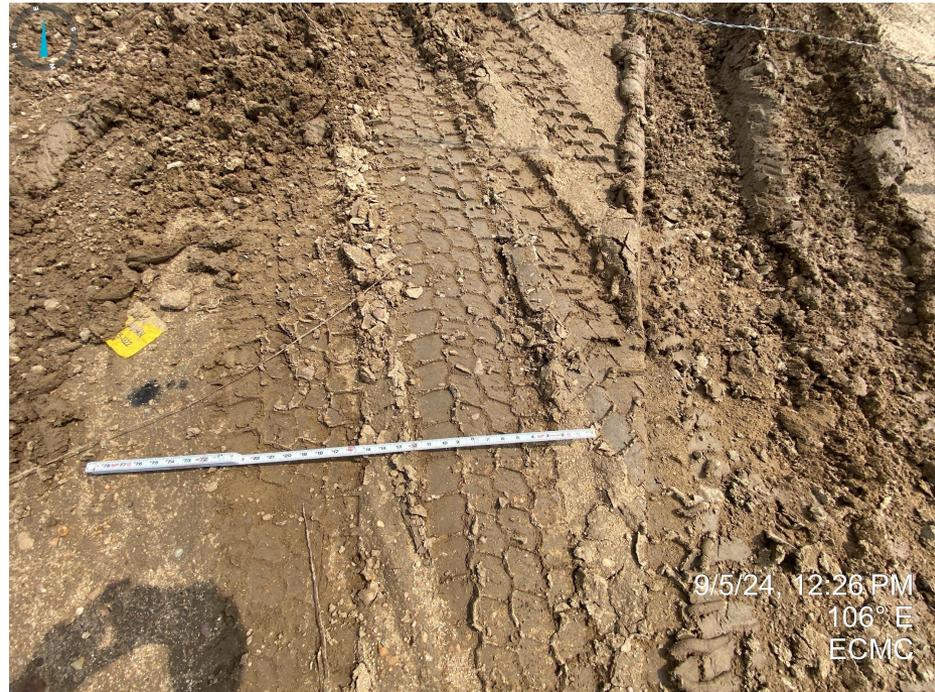
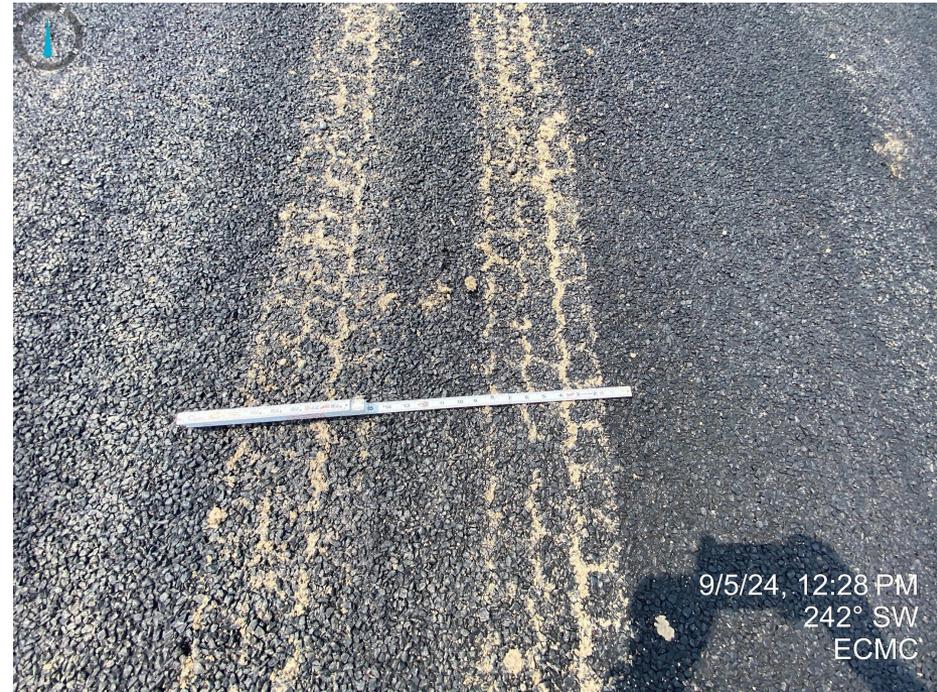
Photos 5 & 6. Photo 5 (left) and Photo 6 (right) taken from the tank battery area and WCR 20, respectively. Tire tracks appear to be similar to one another.

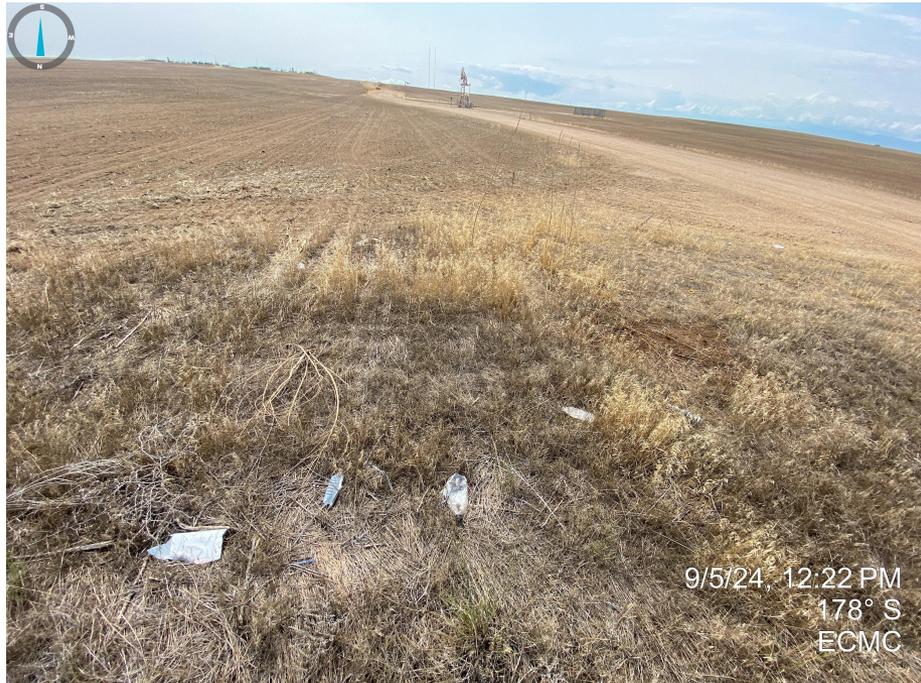
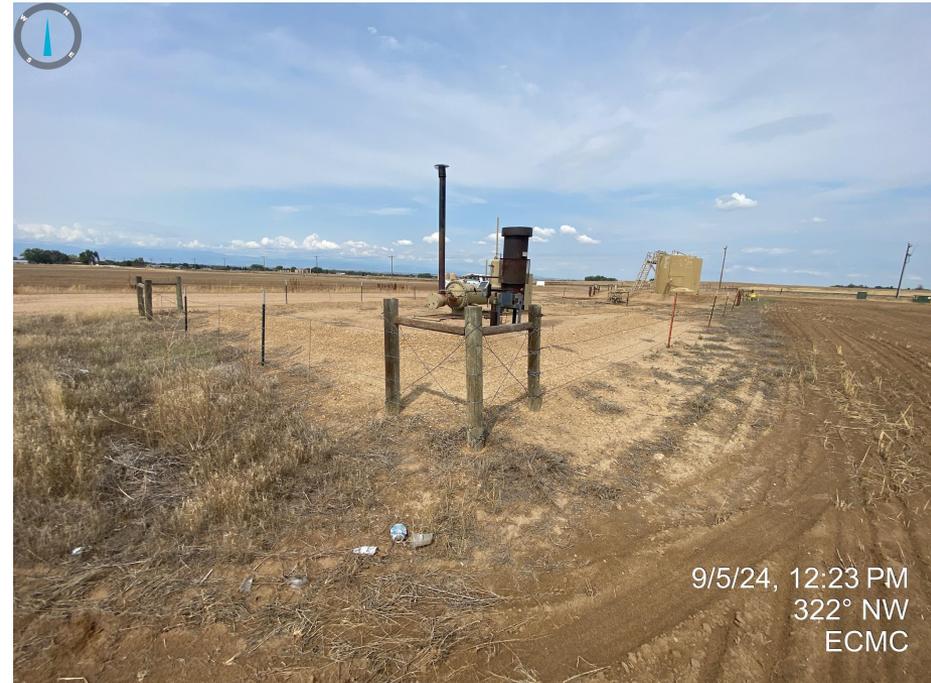
Photos 7 & 8. Trash was observed on the southern portion of the tank battery.

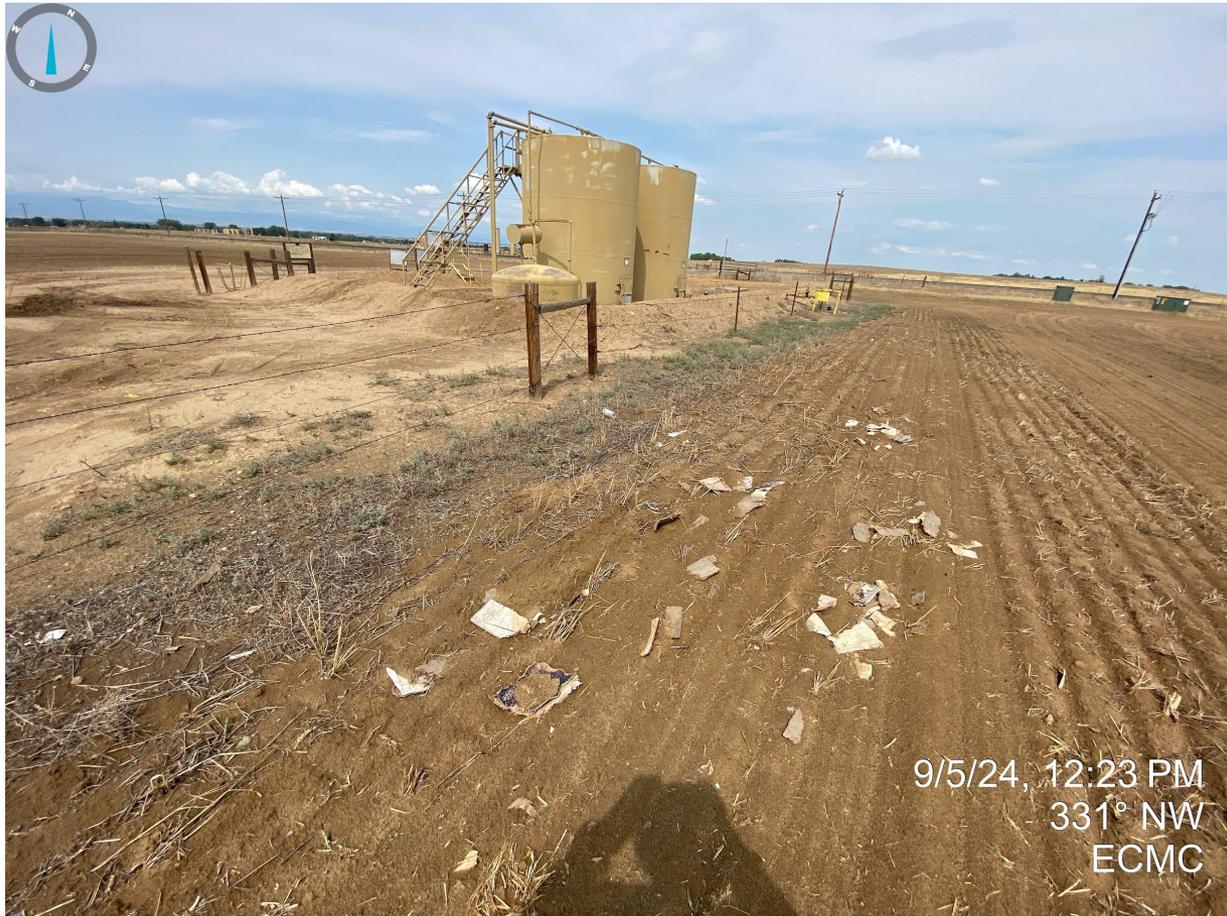
Photo 9. Trash observed on the eastern portion of the tank battery.

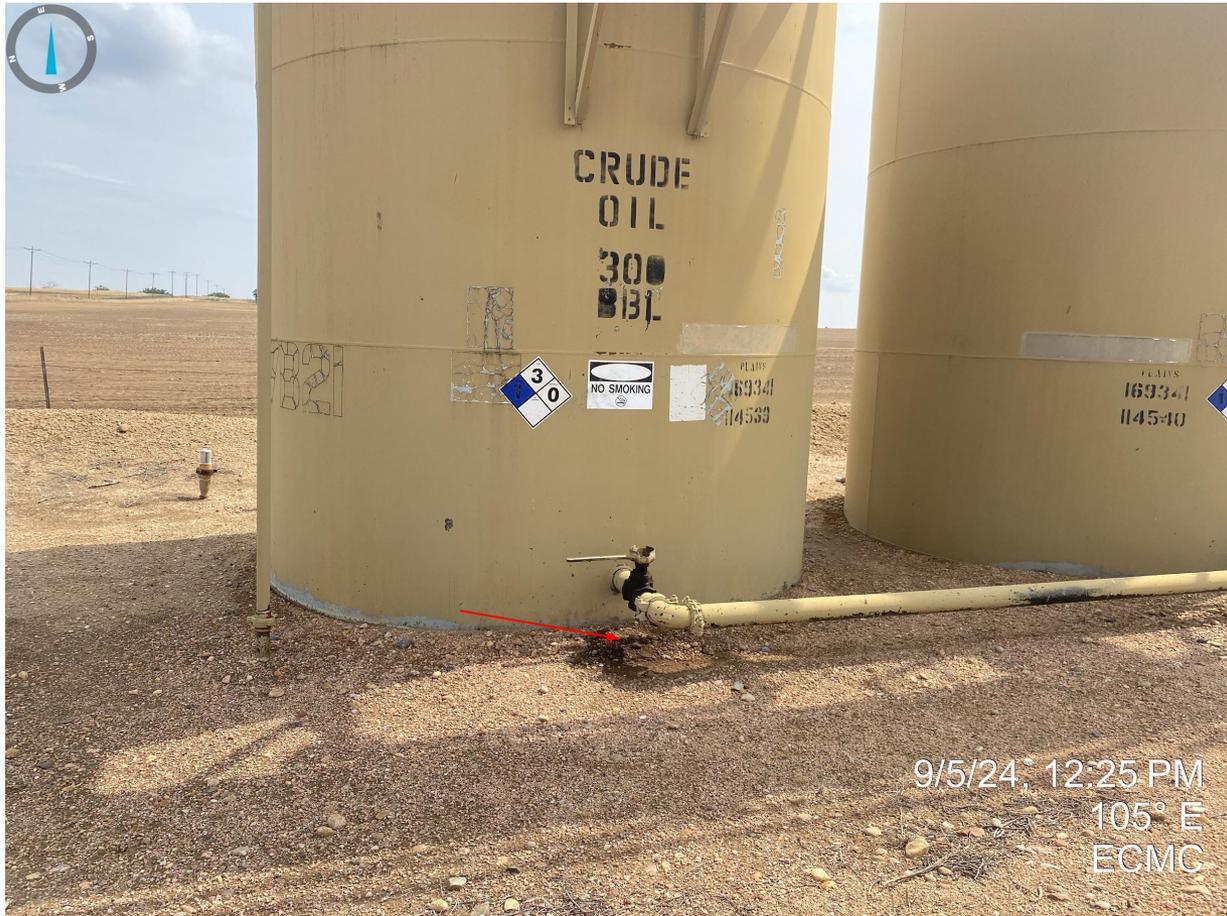
Photo 10. Stained soil observed near the northern vertical AST.

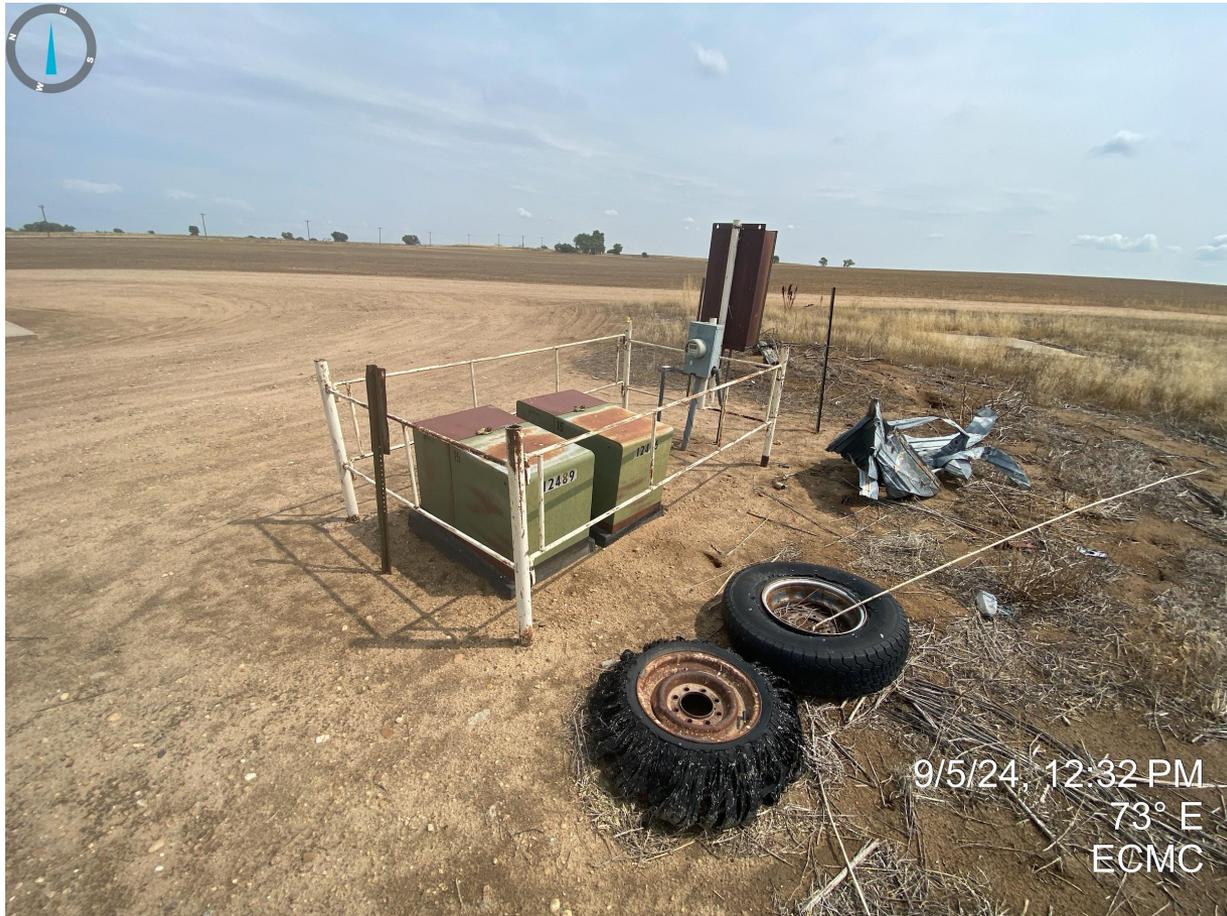
Photo 11. Trash/debris observed near the pumpjack at Well API 123-08391.
