Inspection Photos

Location Name: CAERUS PICEANCE LLC SHIDELER 25-12 (L25W) Pad

Location #: 334613

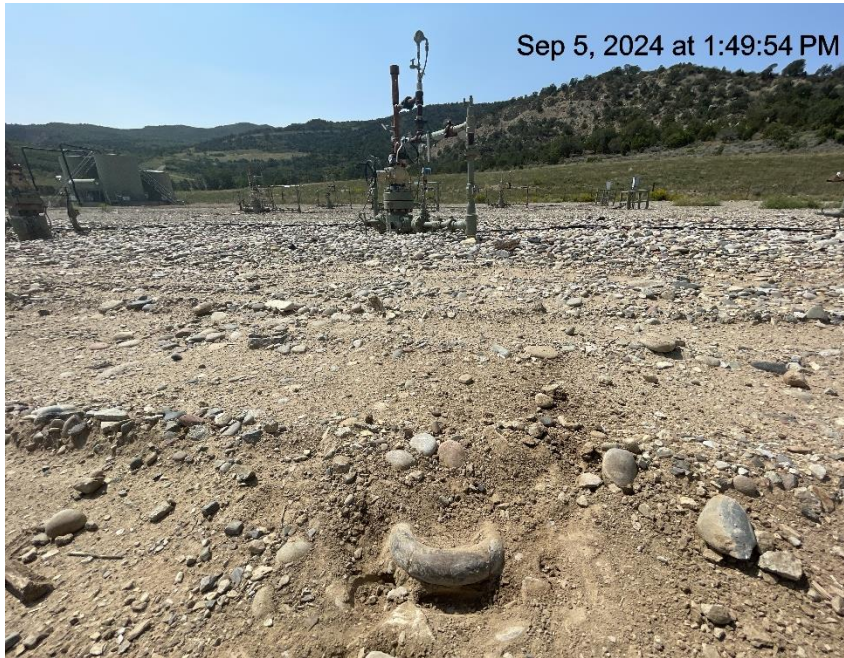
Photo # 8313 Unmarked deadman near SHIDELER FEDERAL 26-8C1 wellhead

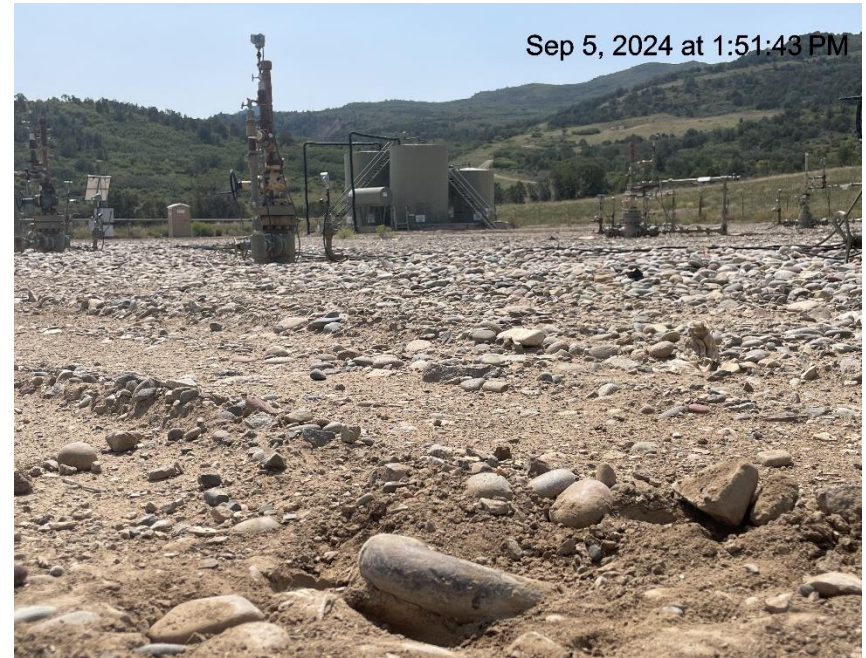
Photo # 8314 Same unmarked deadman

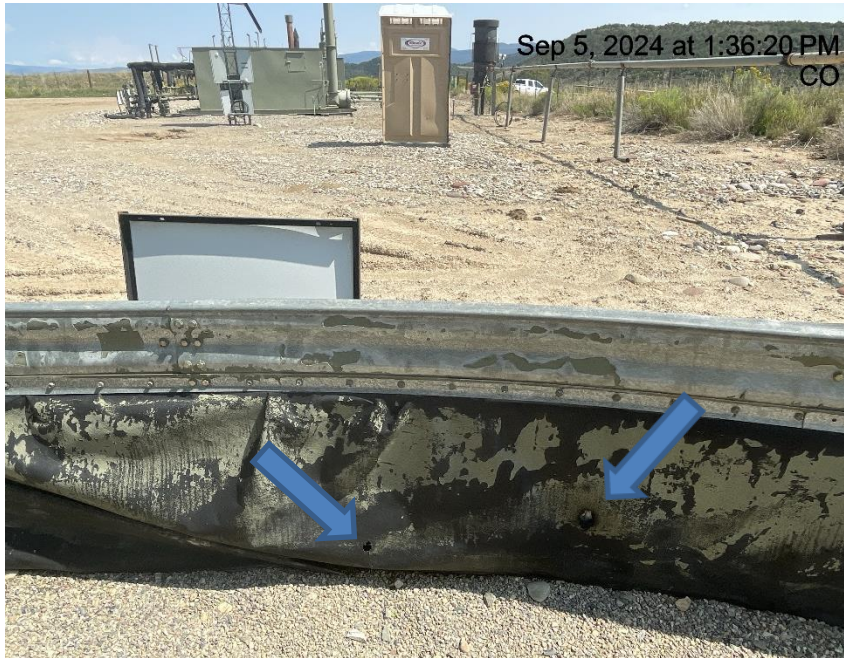
Photo # 8315 Multiple holes in liner/liner needs maintenance

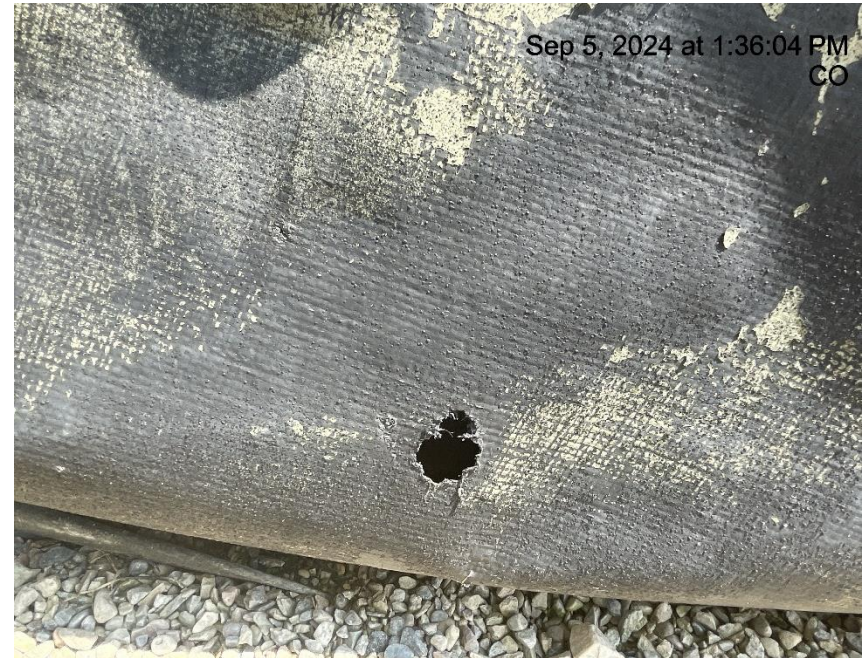
Photo # 8316 Hole in liner/liner needs maintenance

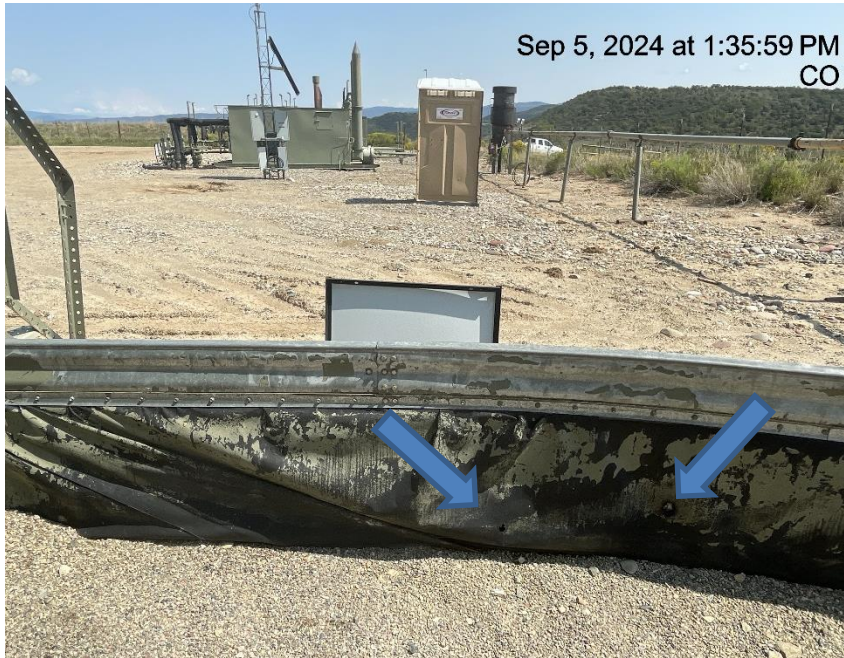
Photo # 8317 Multiple holes in liner/liner needs maintenance

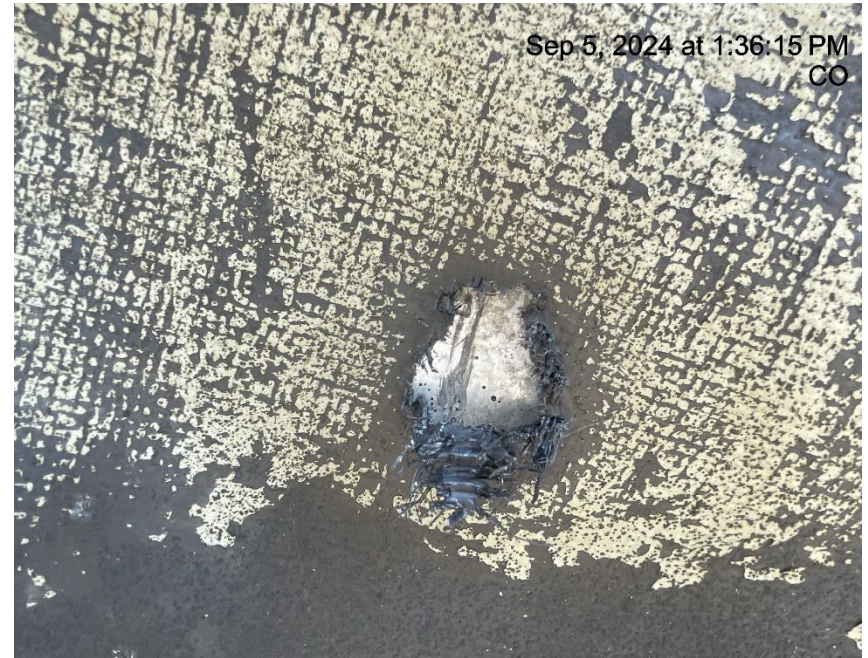
Photo # 8318 Hole in liner/liner needs maintenance

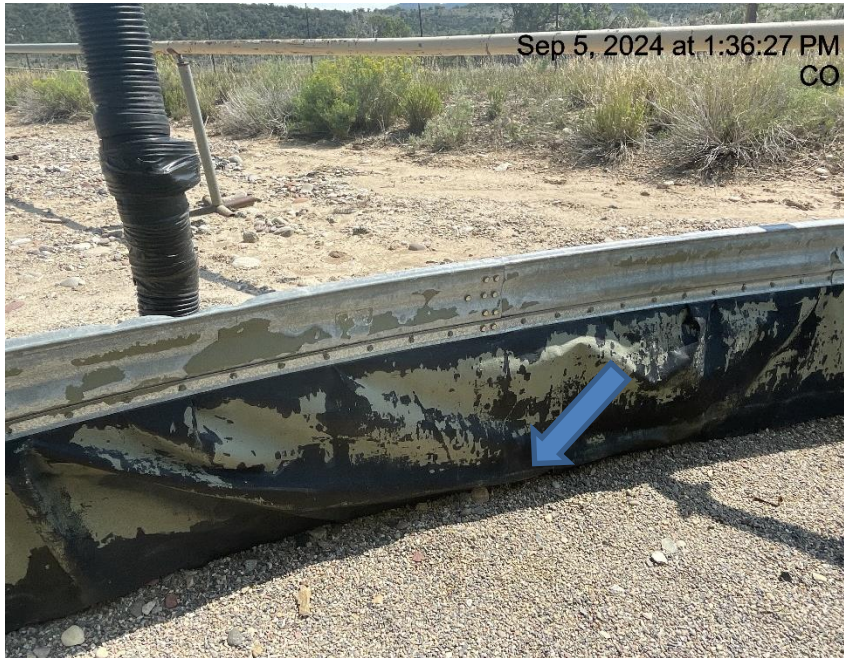
Photo # 8319 Hole in liner/liner needs maintenance

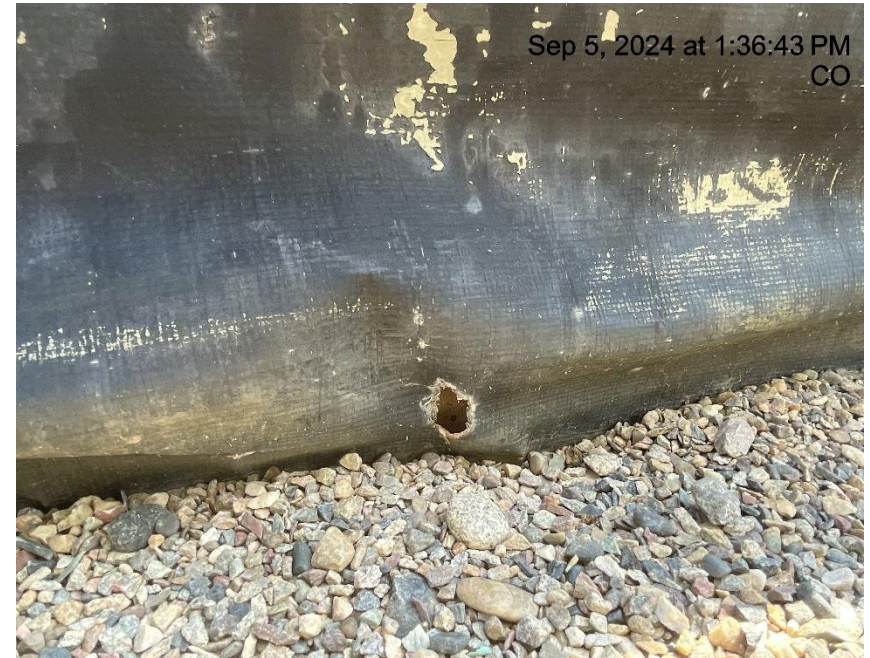
Photo # 8320 Hole in liner/liner needs maintenance

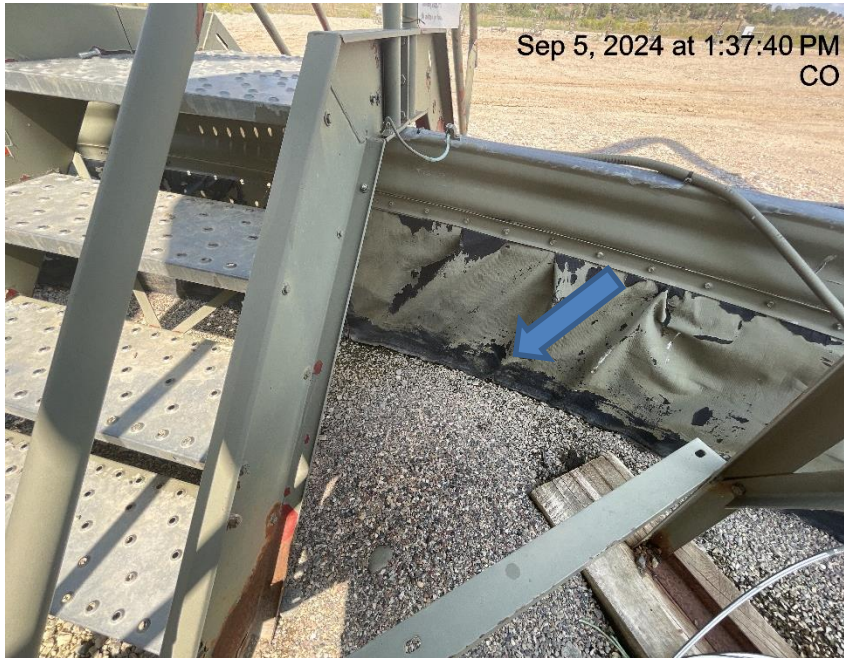
Photo # 8321 Hole in liner/liner needs maintenance

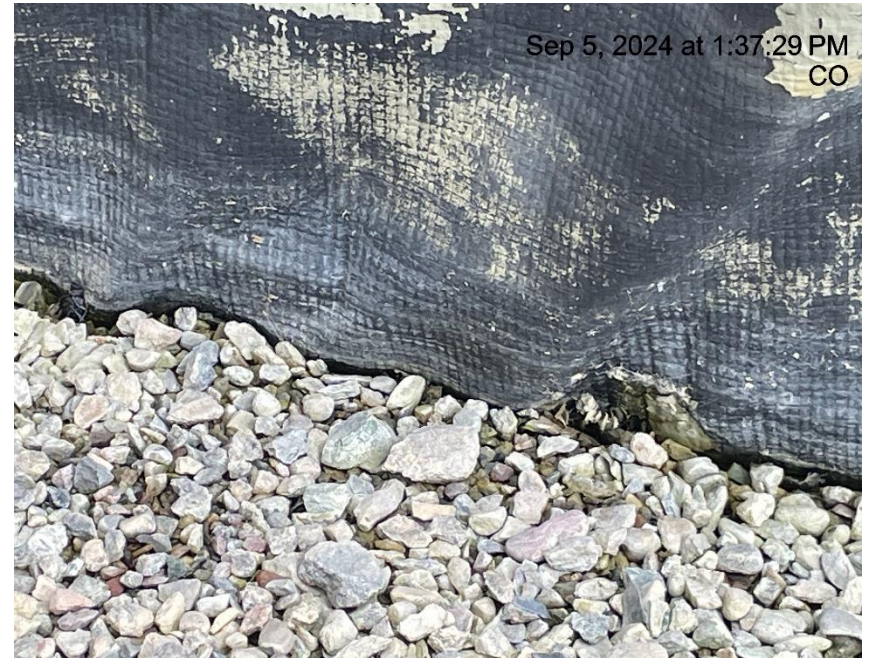
Photo # 8322 Hole in liner/liner needs maintenance

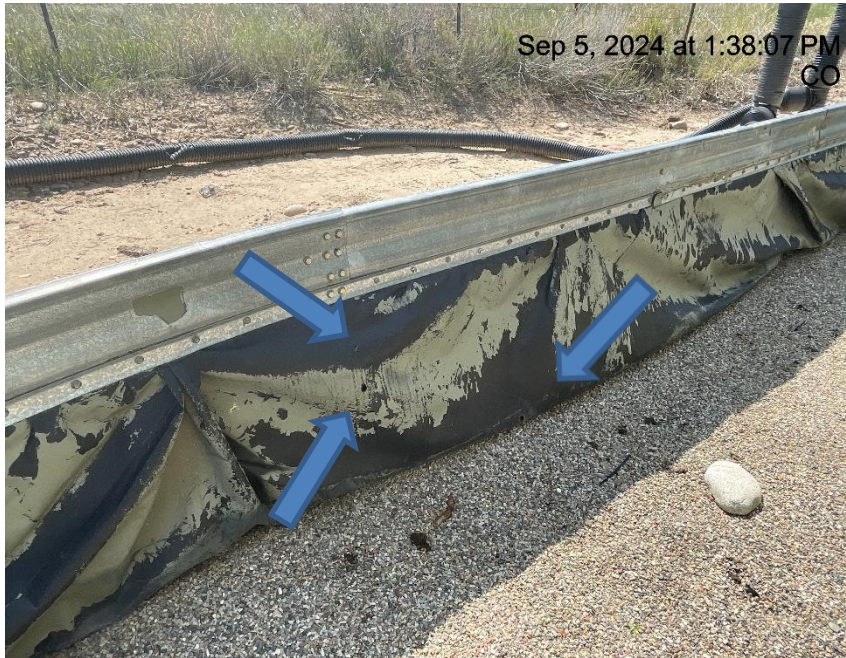
Photo # 8323 Multiple holes in liner/liner needs maintenance

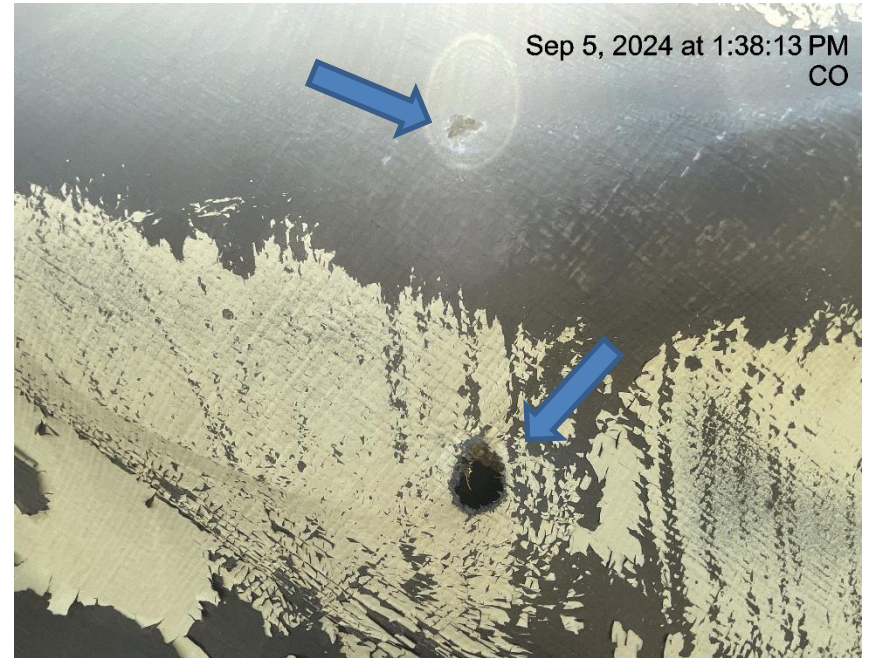
Photo # 8324 Hole in liner/liner needs maintenance

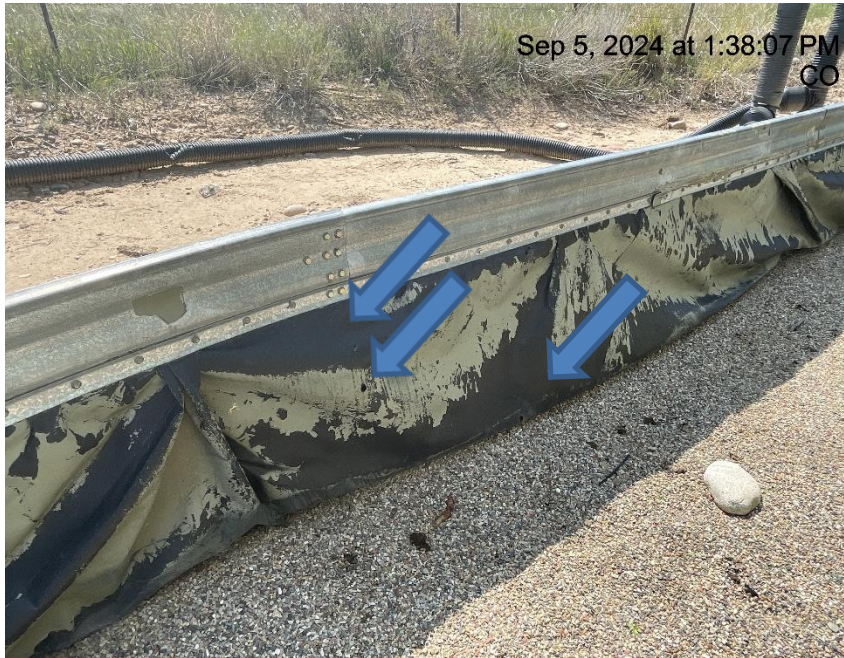
Photo # 8325 Multiple holes in liner/liner needs maintenance

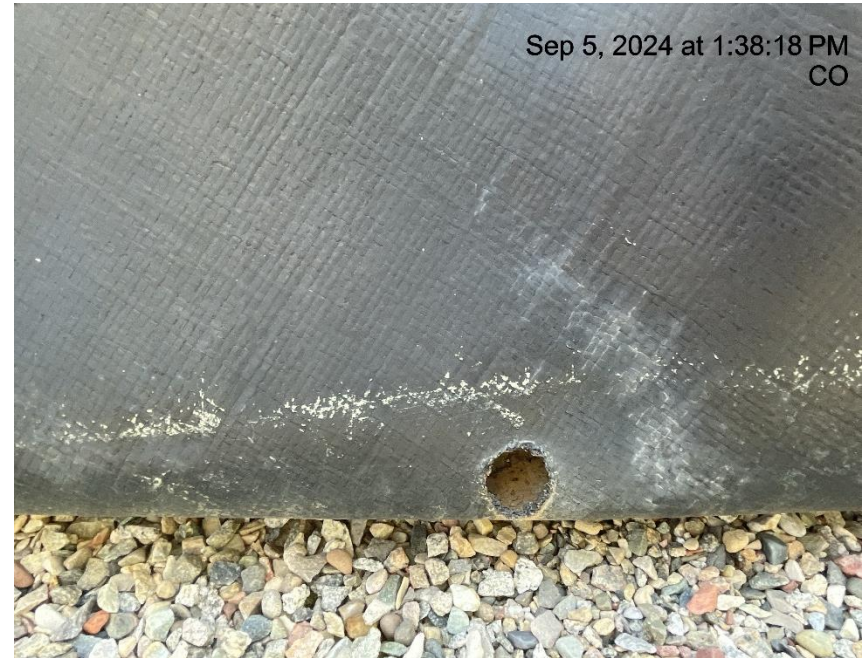
Photo # 8326 Hole in liner/liner needs maintenance

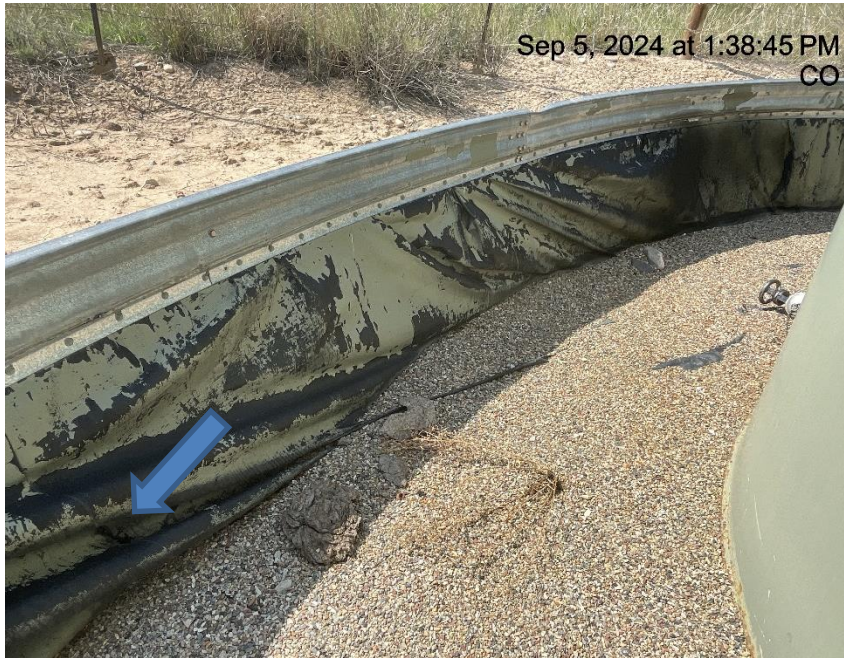
Photo # 8327 Hole in liner/liner needs maintenance

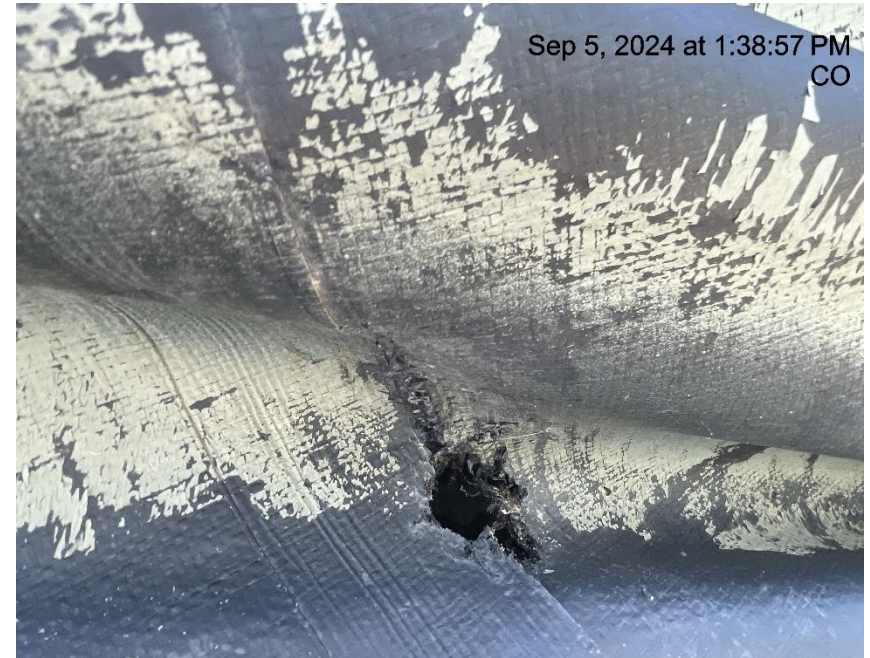
Photo # 8328 Hole in liner/liner needs maintenance

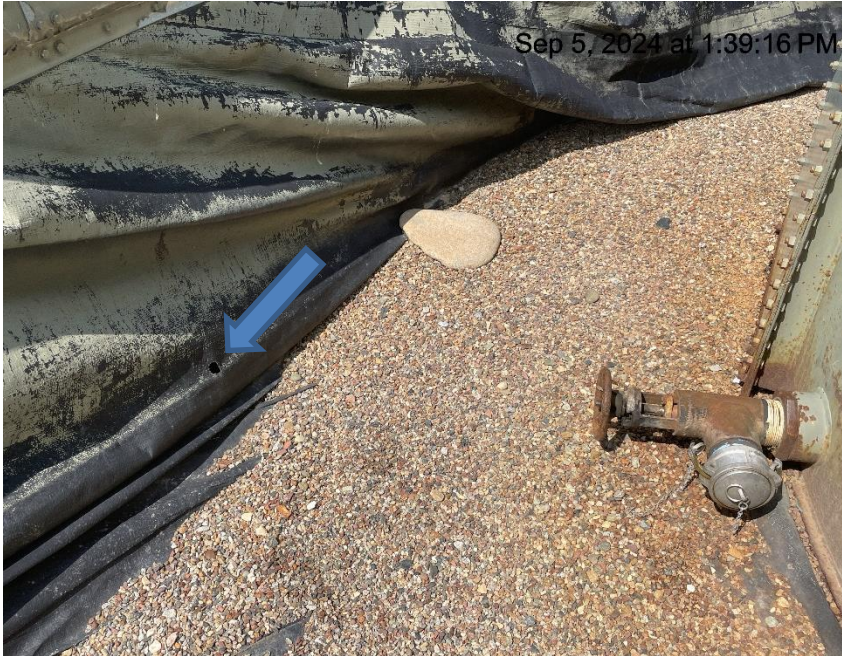
Photo # 8329 Hole in liner/liner needs maintenance

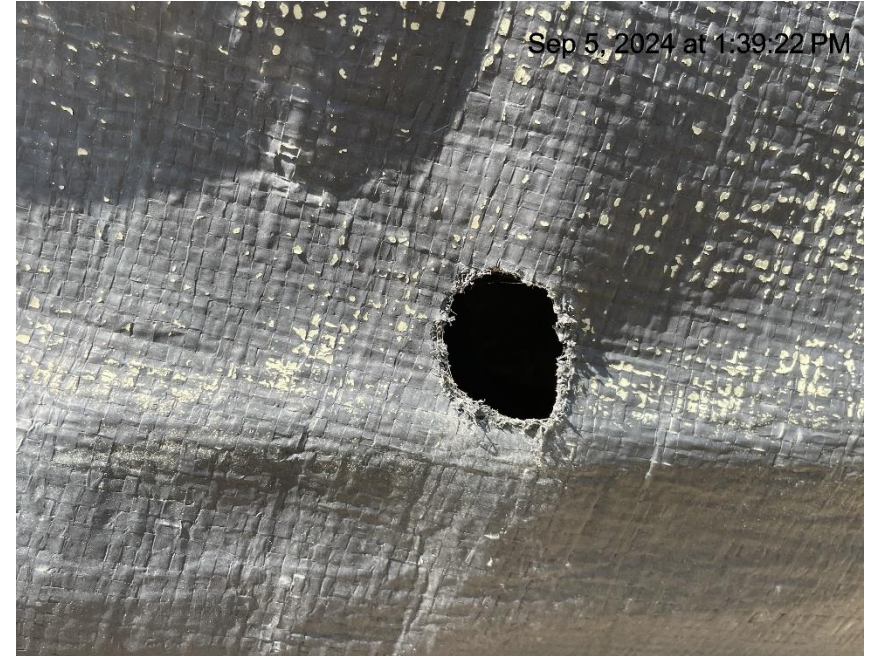
Photo # 8330 Hole in liner/liner needs maintenance

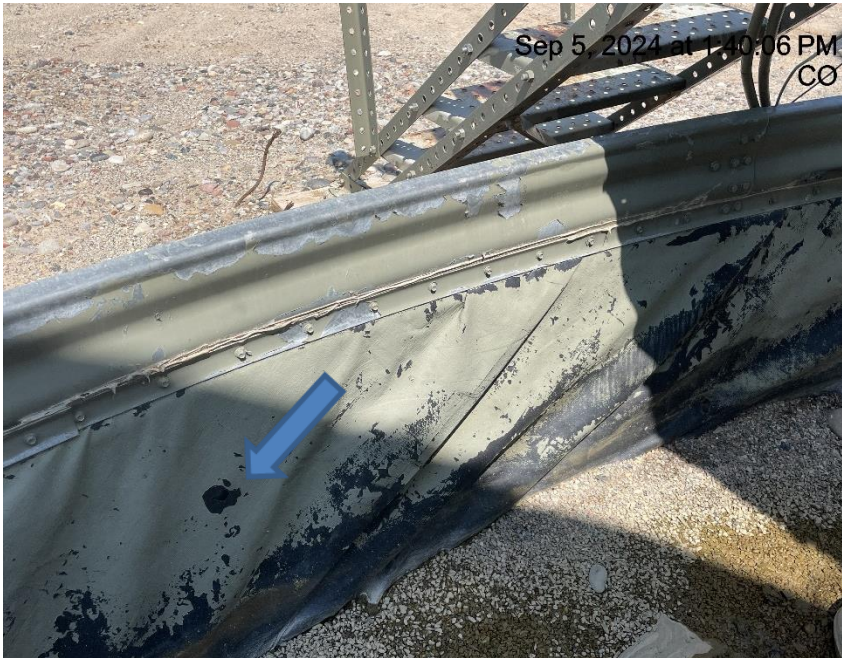
Photo # 8331 Hole in liner/liner needs maintenance

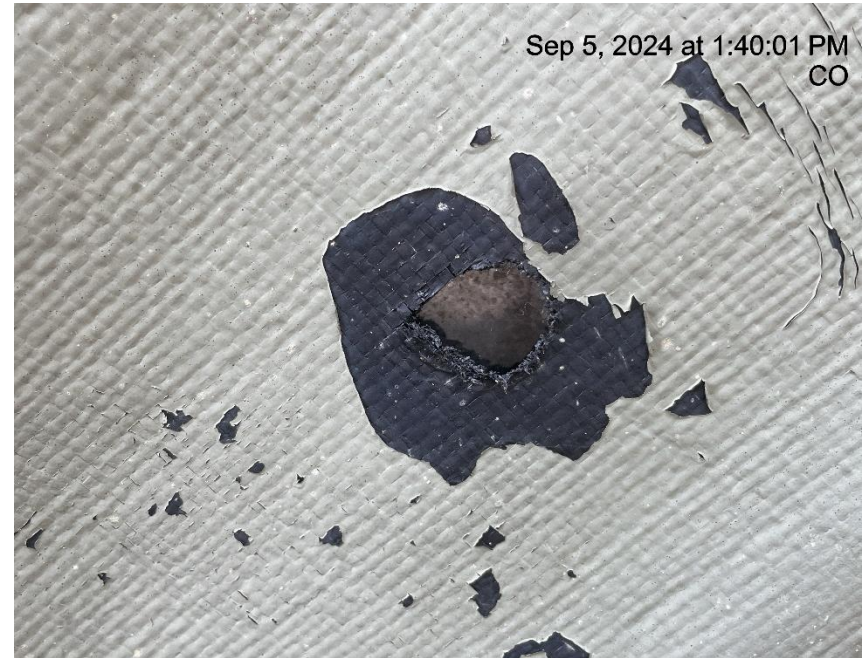
Photo # 8332 Hole in liner/liner needs maintenance

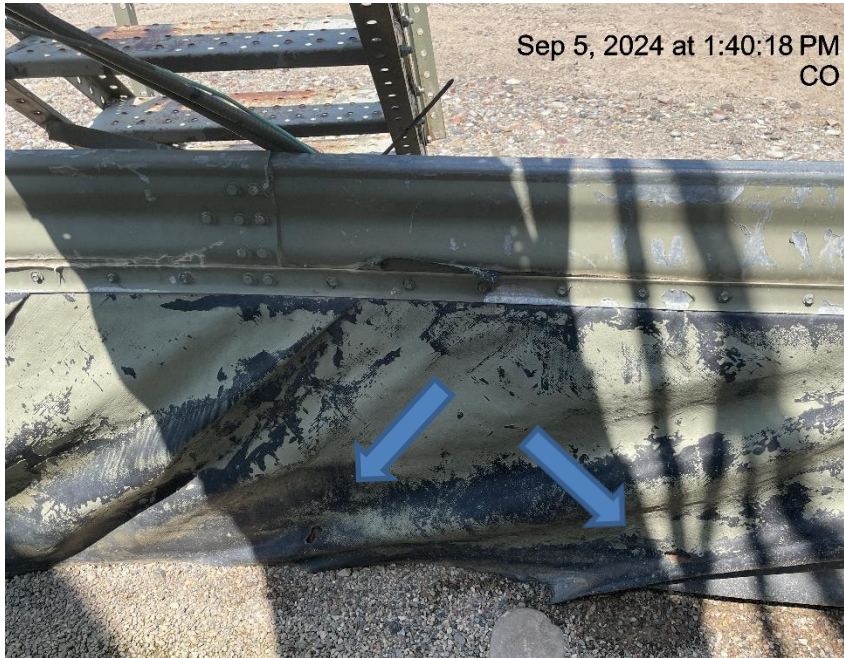
Photo # 8333 Multiple holes in liner/liner needs maintenance

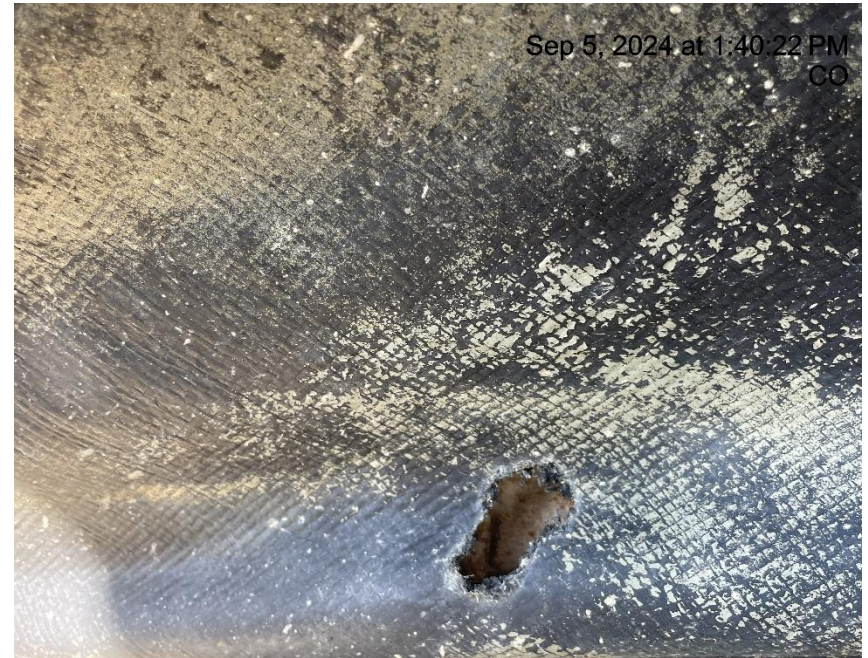
Photo # 8334 Hole in liner/liner needs maintenance

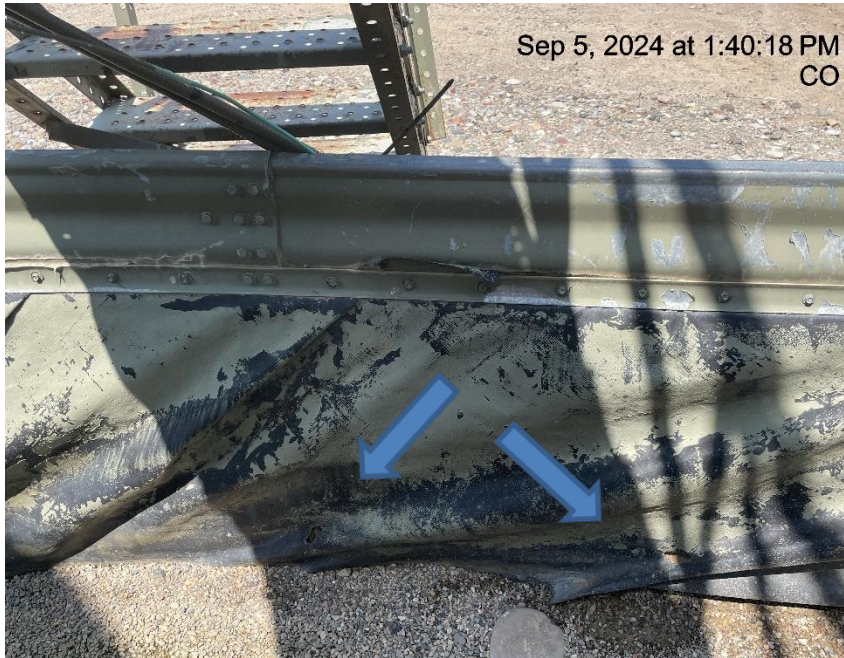
Photo # 8335 Multiple holes in liner/liner needs maintenance

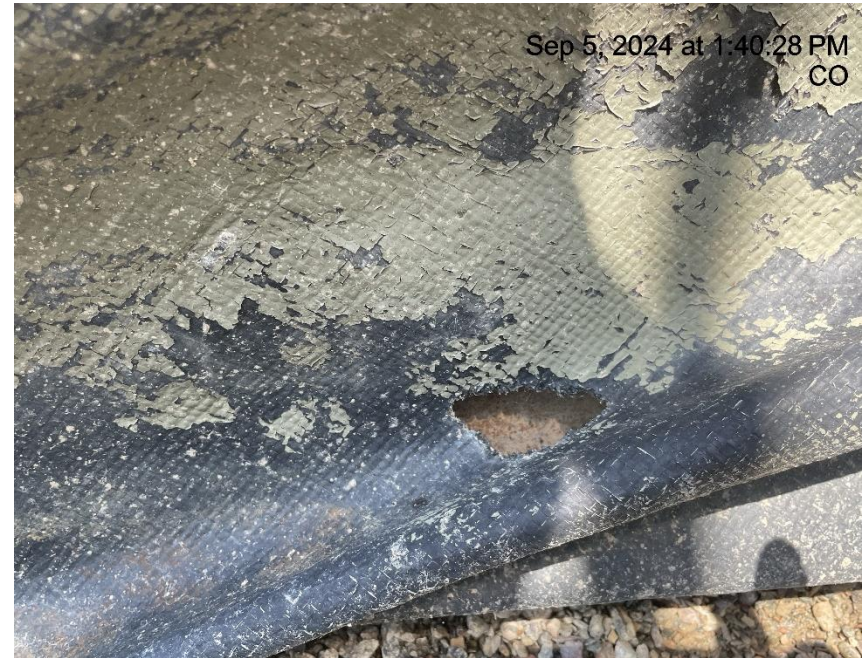
Photo # 8336 Hole in liner/liner needs maintenance

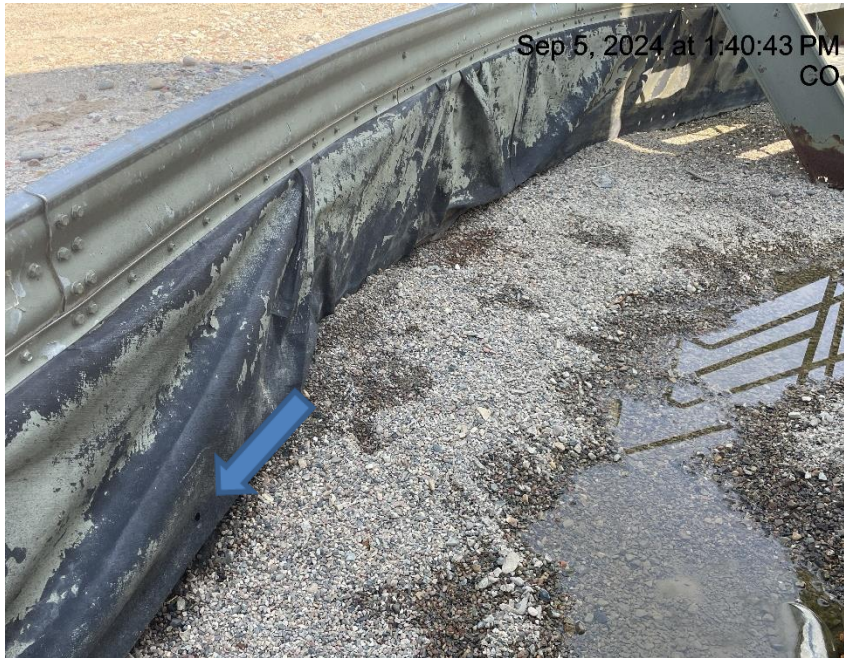
Photo # 8337 Hole in liner/liner needs maintenance

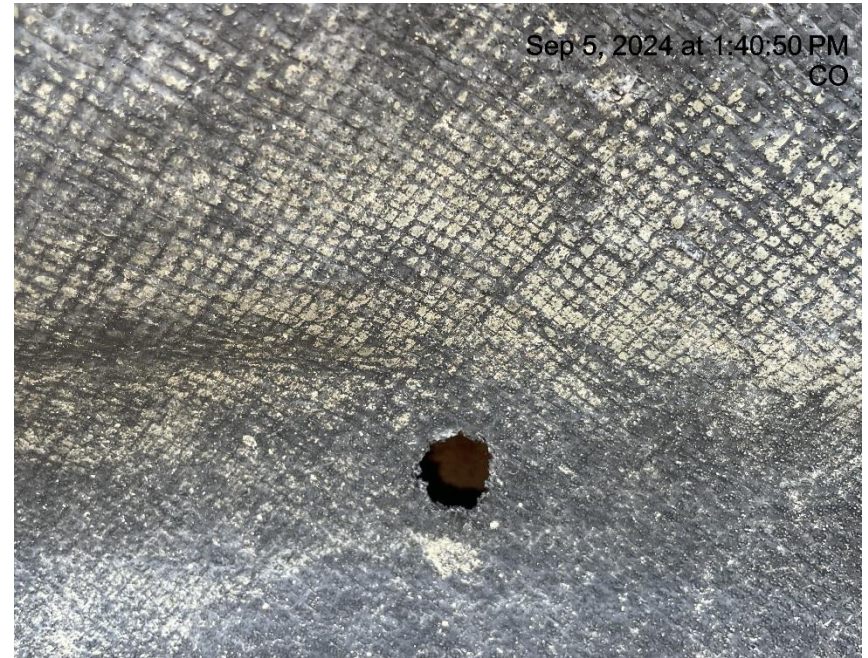
Photo # 8338 Hole in liner/liner needs maintenance

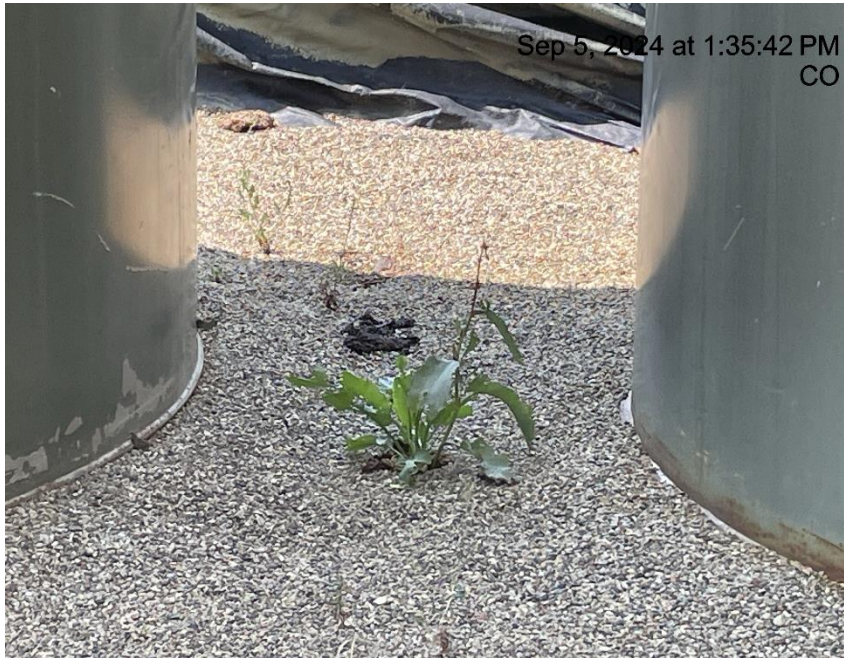
Photo # 8339 Small amount of weeds in secondary containment

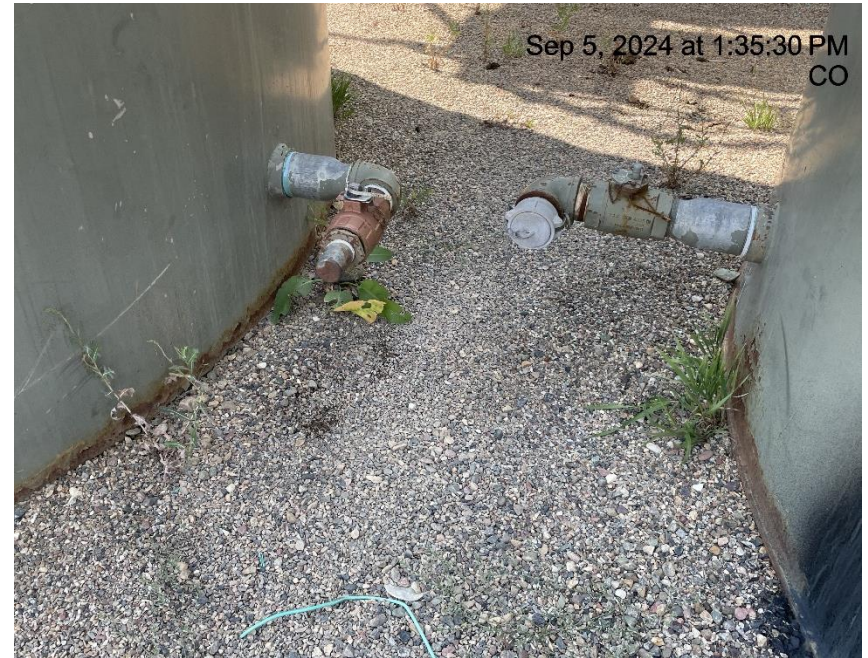
Photo # 8340 Small amount of weeds in secondary containment

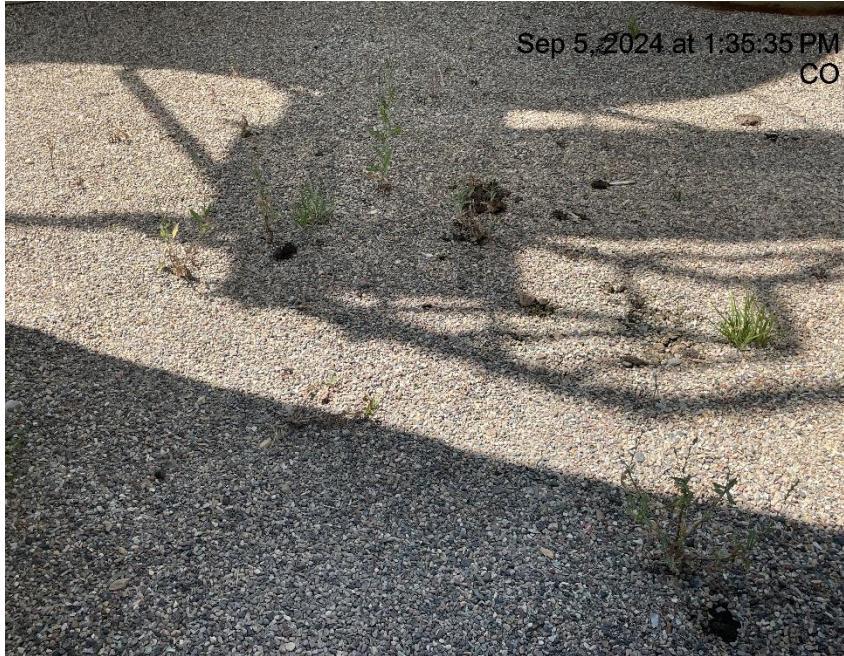
Photo # 8341 Small amount of weeds in secondary containment

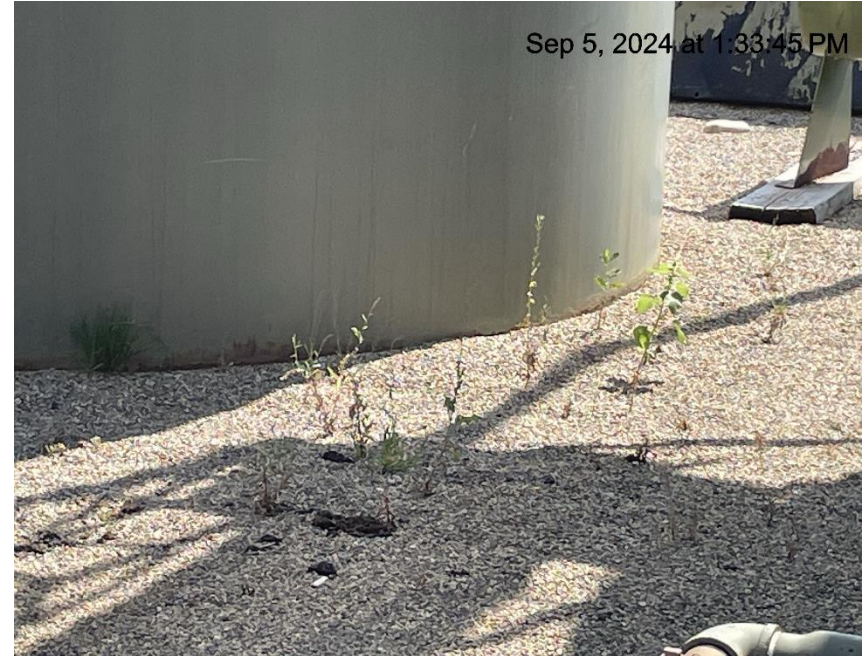
Photo # 8342 Small amount of weeds in secondary containment

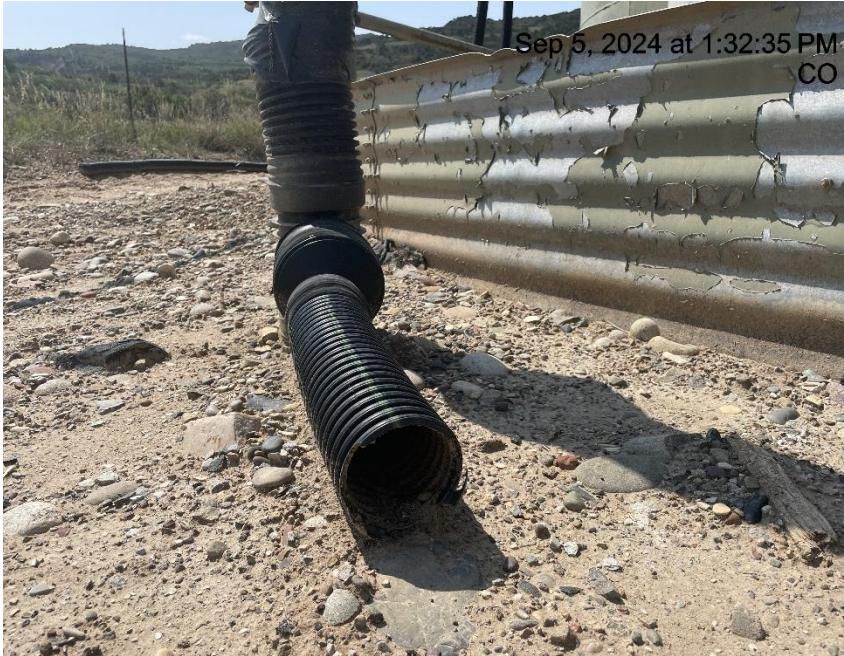
**Photo # 8343 Flowline heating insulation open ended
/available for entry by wildlife/wildlife hazard**
