Inspection Photos

Operator: Hilcorp Energy

Location Name: Huber Kaime 1-12U API: 067-07697

Location Name: Huber Kaime 3-12U API: 067-09237

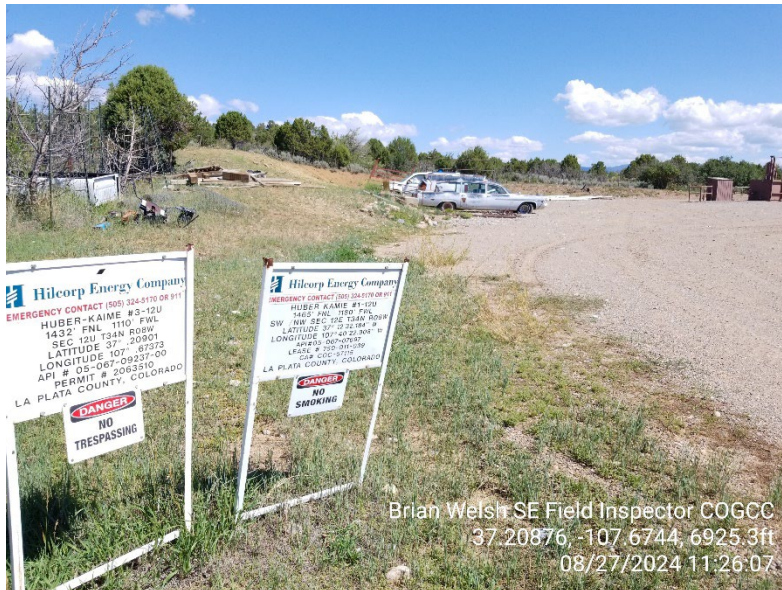
1. Lease signs at southwest corner of location.
Landowner stored equipment on west side of location

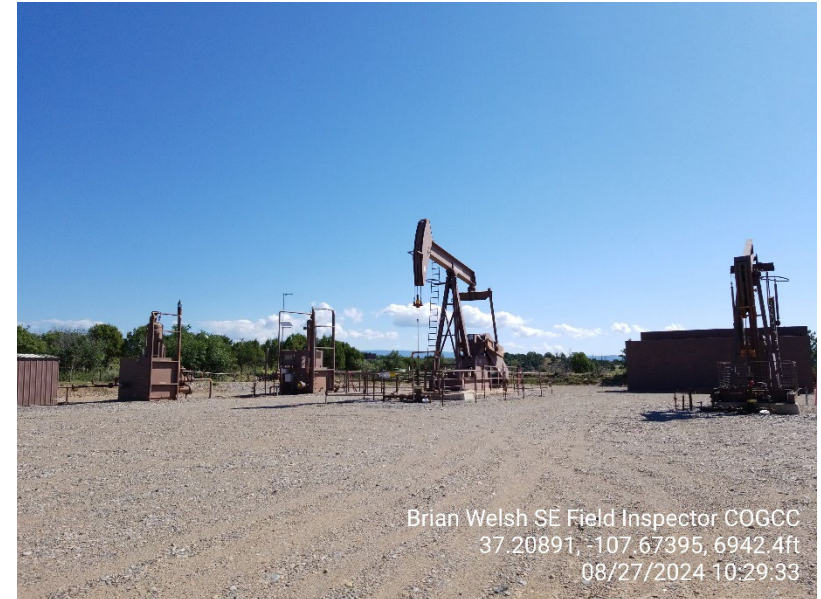
2. West side of pumping units

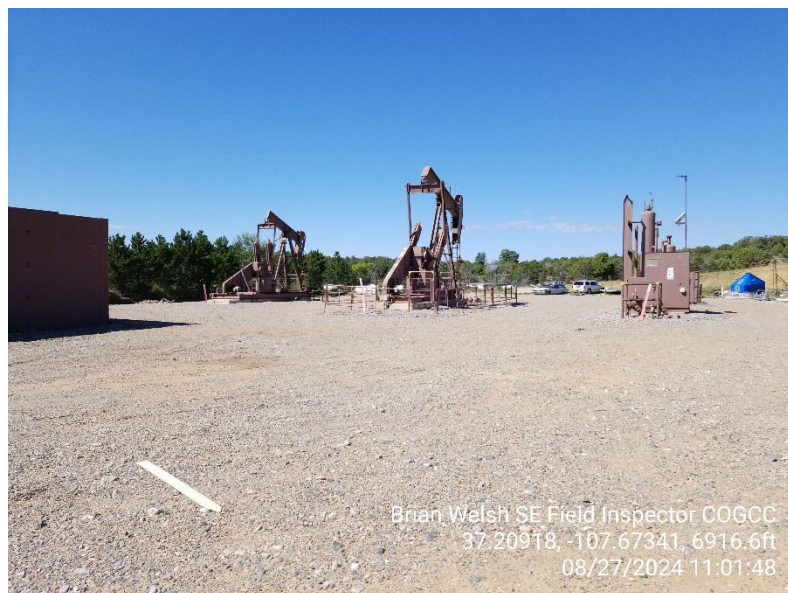
3. Northeast corner of location looking southwest

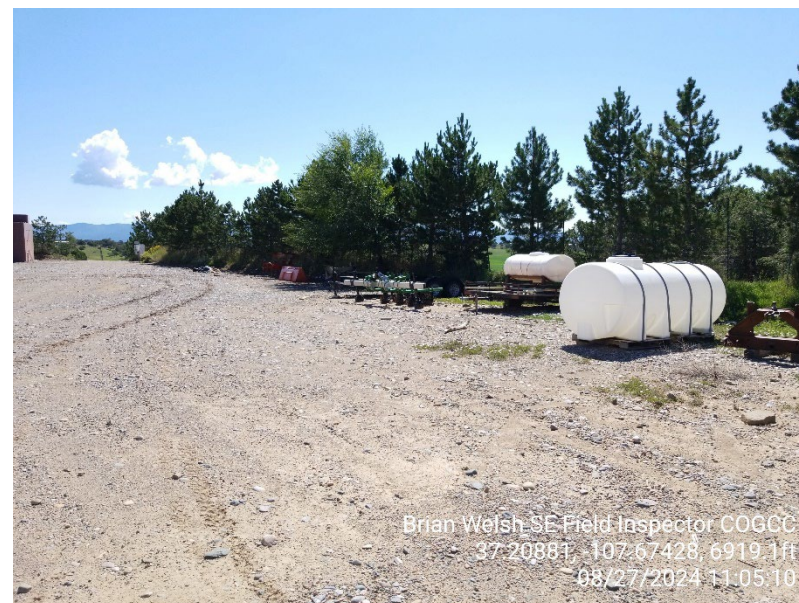
4. South edge of location. Landowner is storing equipment along south side of location

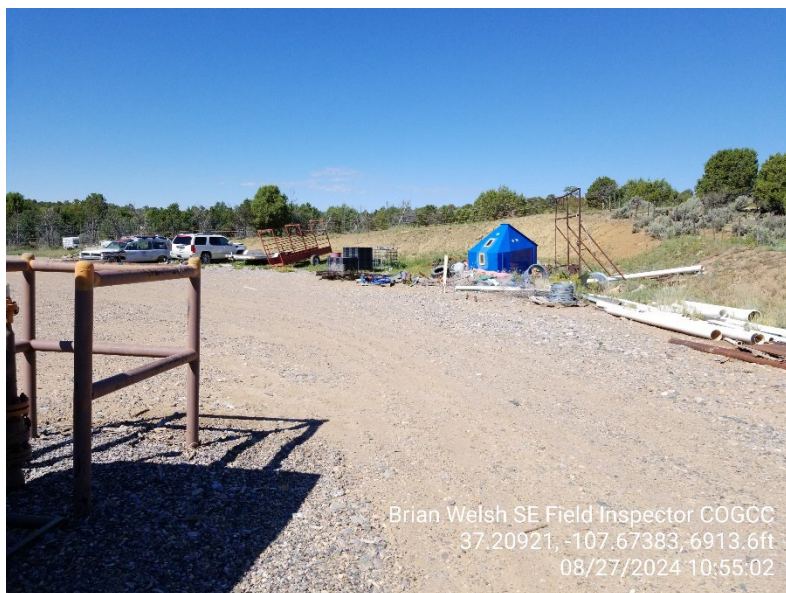
5. North side of separators looking west. Misc equipment stored on west side of location

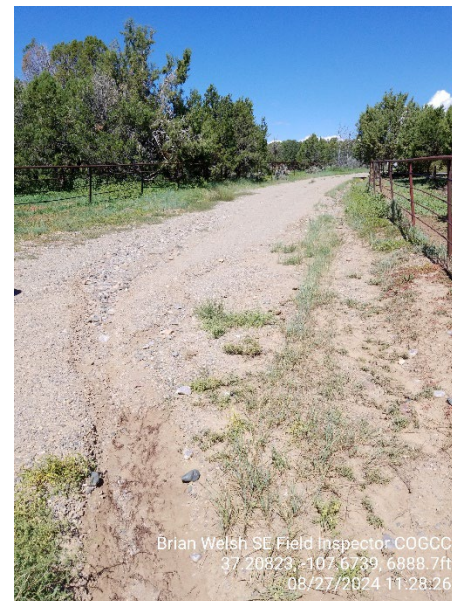
6. Erosion on access to location
