Inspection Photos
Location: Lola 21-3 TR
Location ID: 309177
API # 05-071-09209

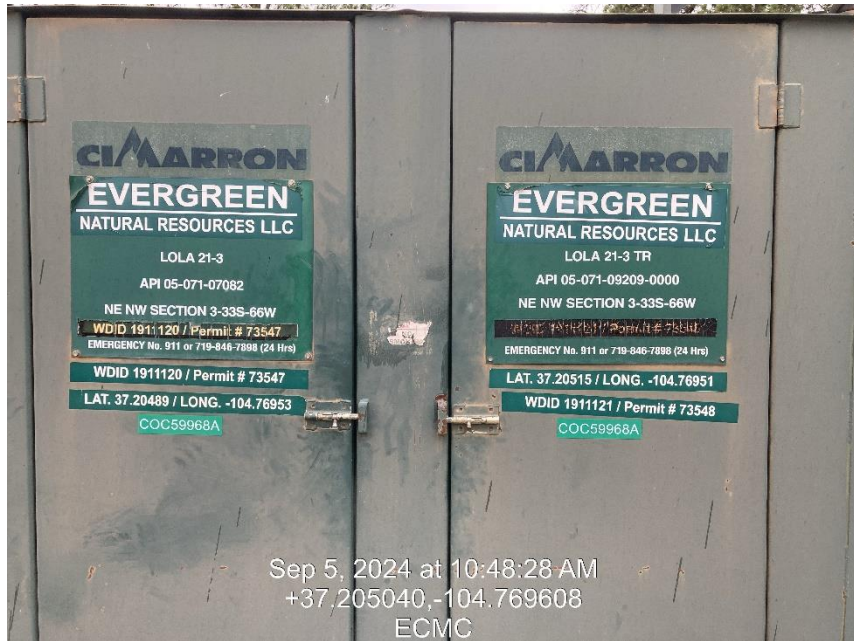
Photo 1 – Well placard on meter house.

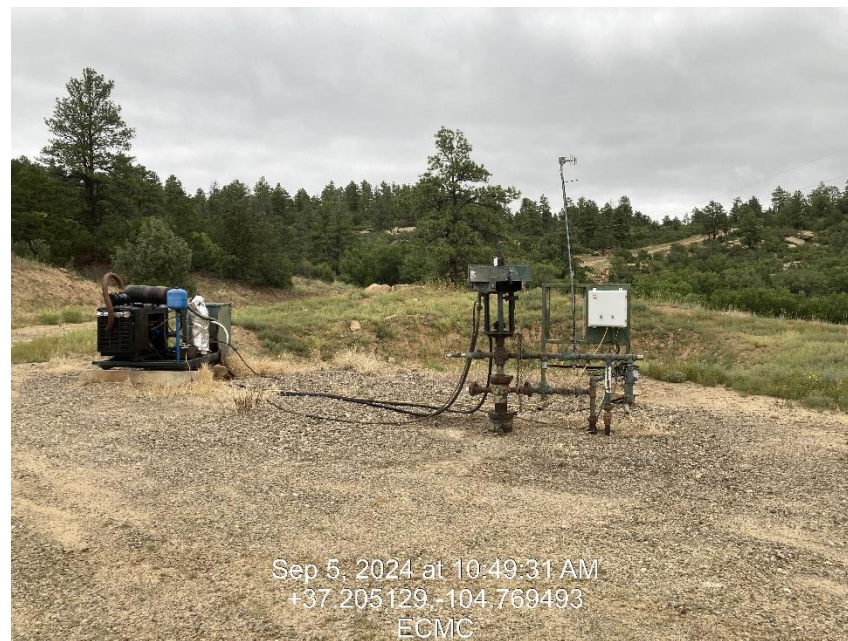
Photo 2 – Wellhead and equipment.

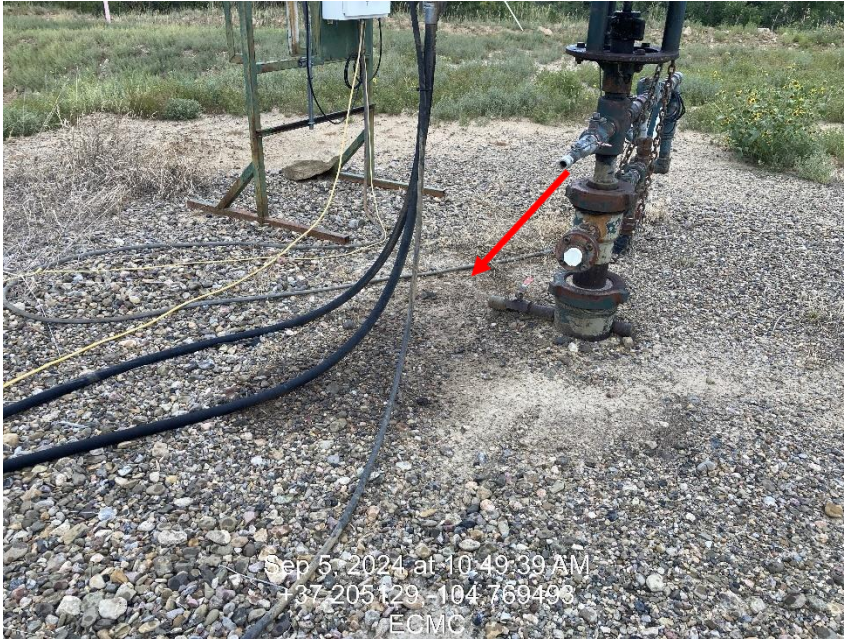
Photo 3 – Oil stained soils at wellhead

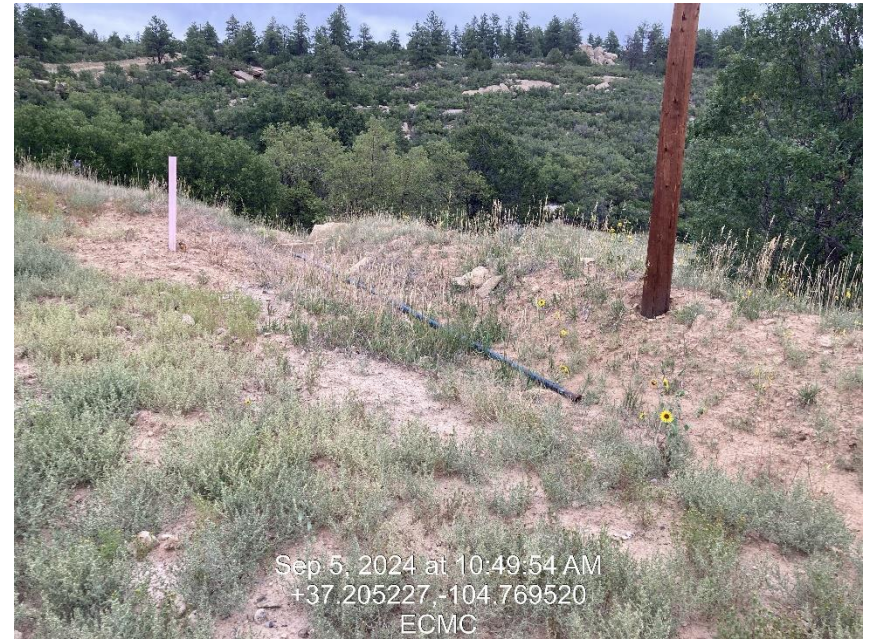
Photo 4 – Pit Flowline in stormwater BMP.

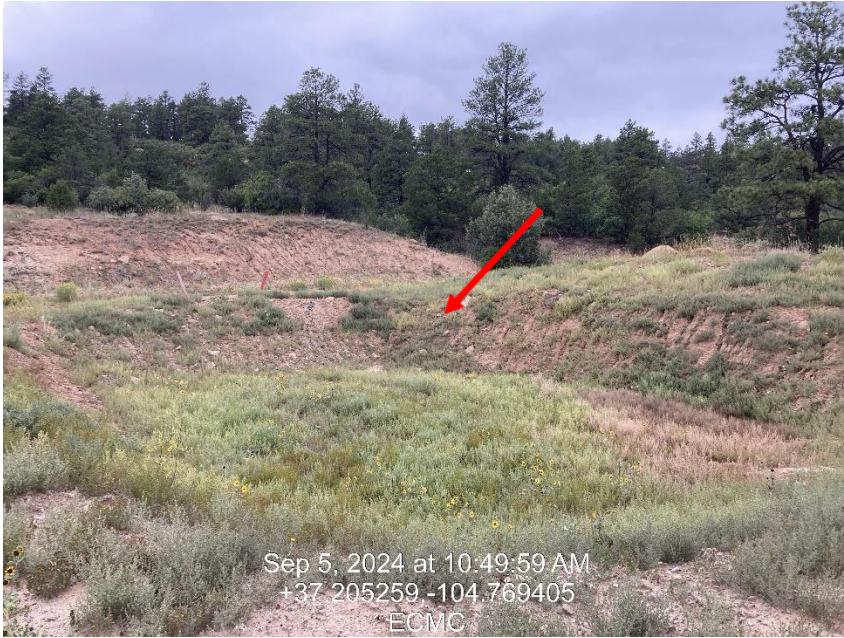
Photo 5 – TR pit Facility ID 301194, in the process for closure.

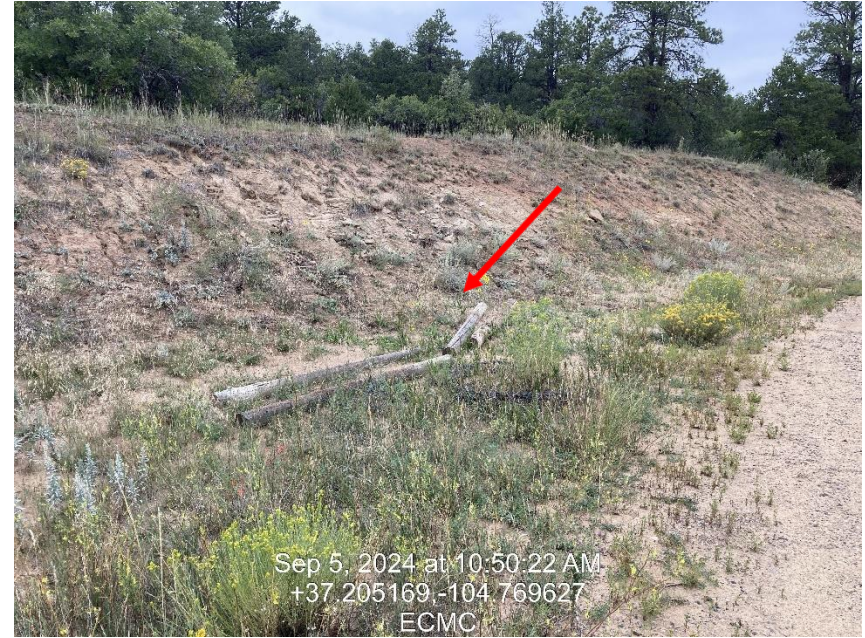
Photo 5 – Unused fencing materials

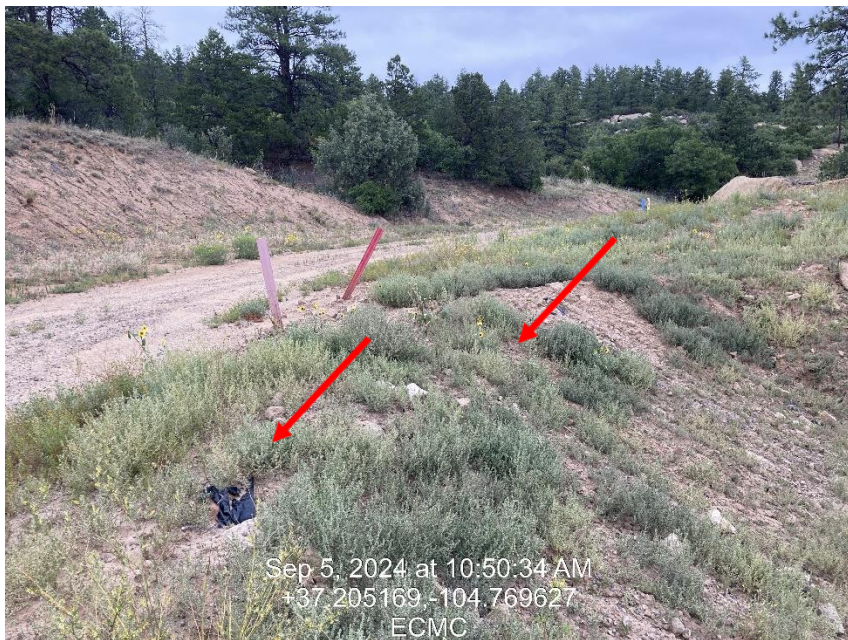
Photo 7 – Pieces of pit liner material on west edge of pit
