**Inspection Photos**  
**Location: Barndoor 24-13**  
**Location ID: 334396**  
**API # 05-071-09654**

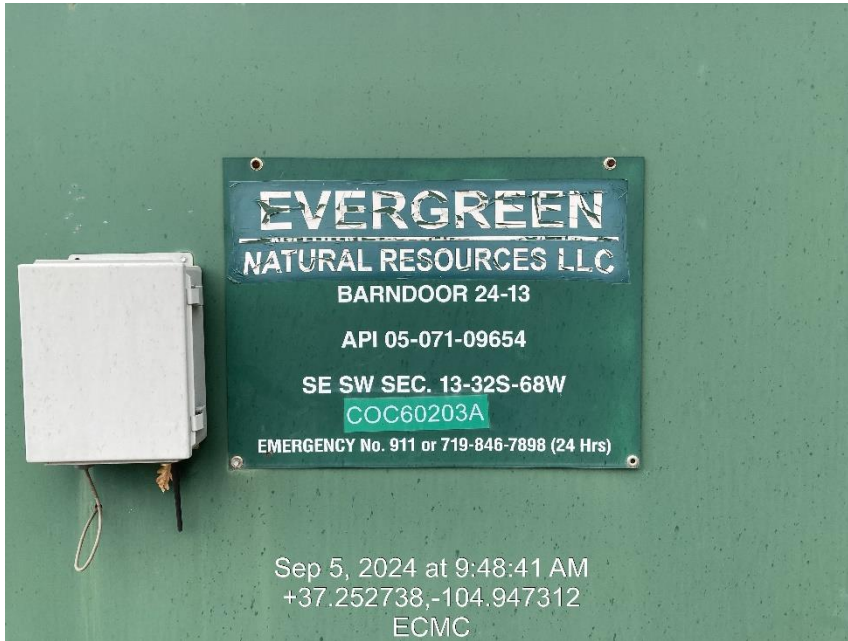
**Photo 1 – Well placard on meter house**

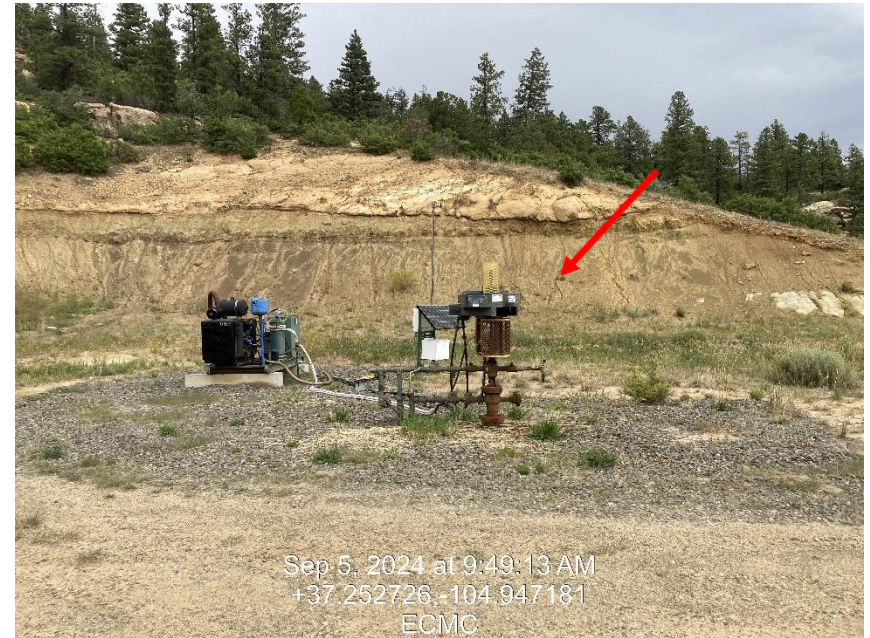
**Photo 2 – Wellhead and equipment**

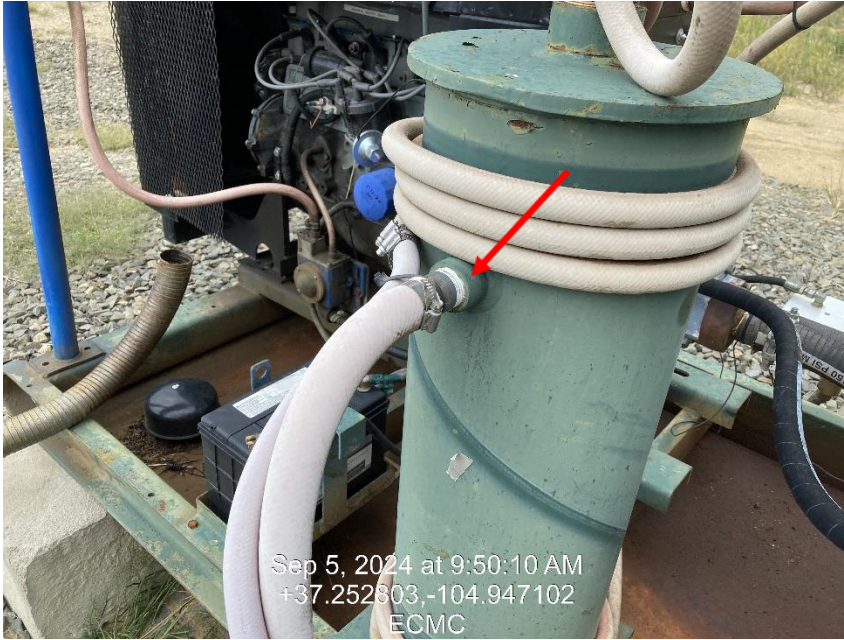
**Photo 3 – Audible leak at fuel pot**

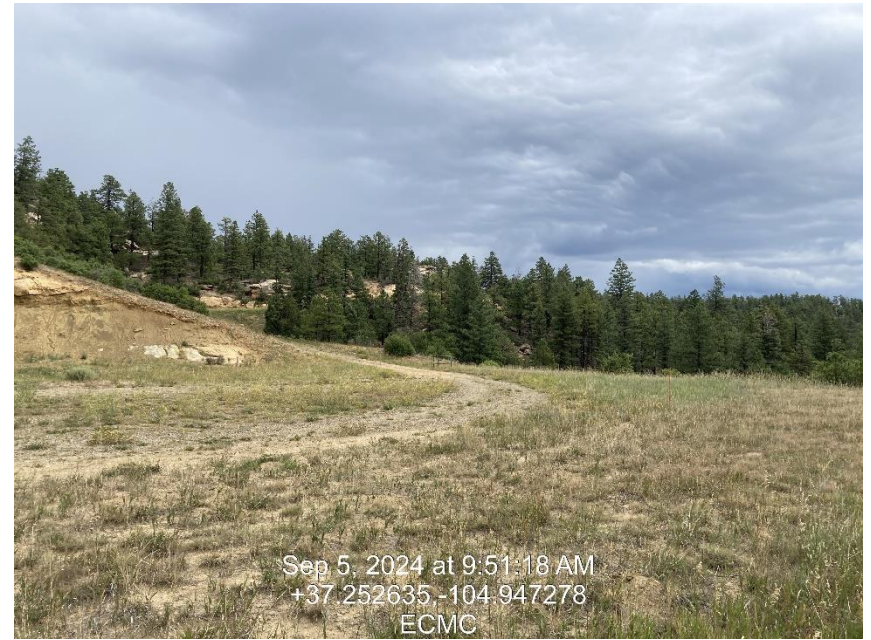
**Photo 4 – Location looking to road access**

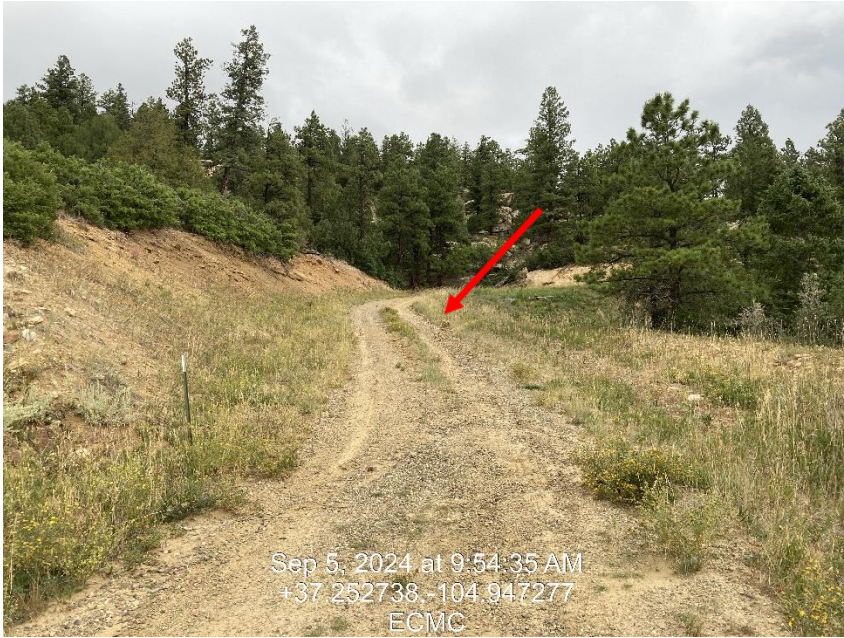
**Photo 5 – Stormwater is running down the center of the access road causing riling.**

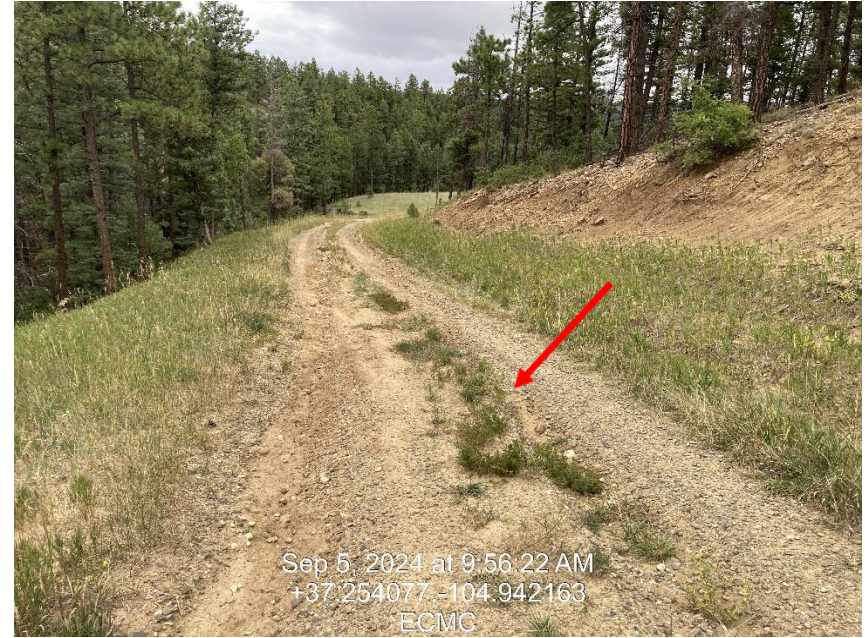
**Photo 5 – Stormwater is running down the center of the access road causing riling.**

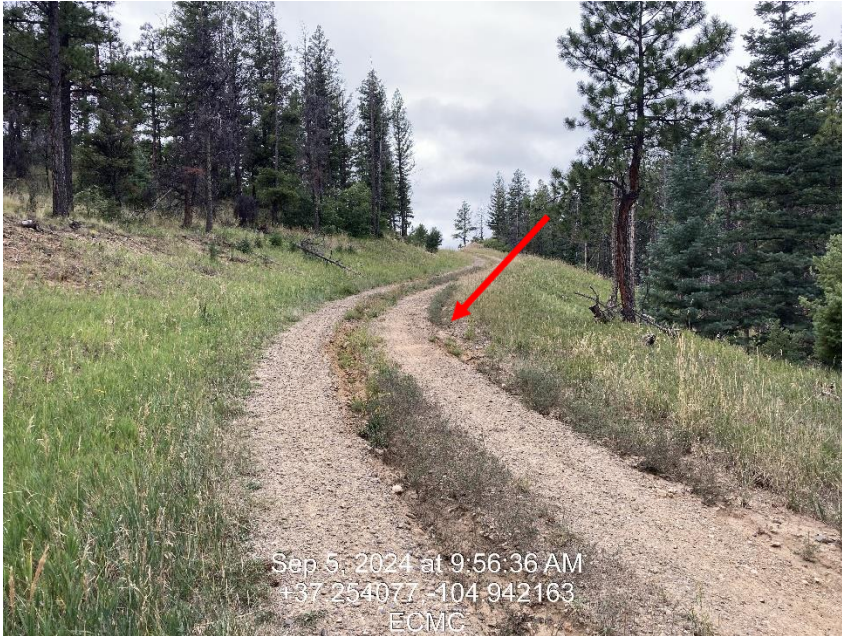
**Photo 7 – Stormwater is running down the center of the access road causing riling.**

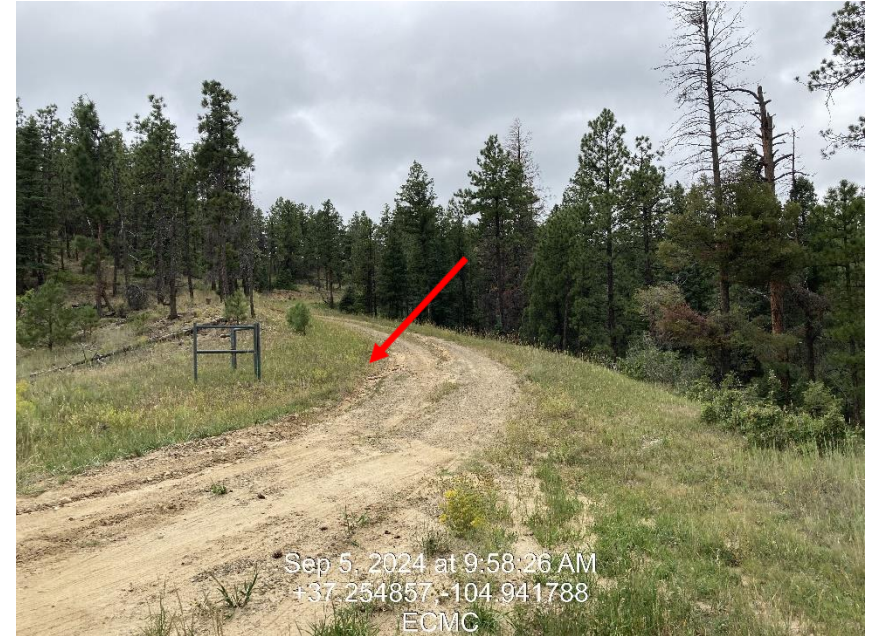
**Photo 8 – Stormwater is running down the center of the access road causing riling.**
