Final Reclamation and Stormwater Inspection

Date: 8/28/24

Operator: Bonanza Creek Energy Operating
Company LLC - 8960

Location ID: 332761

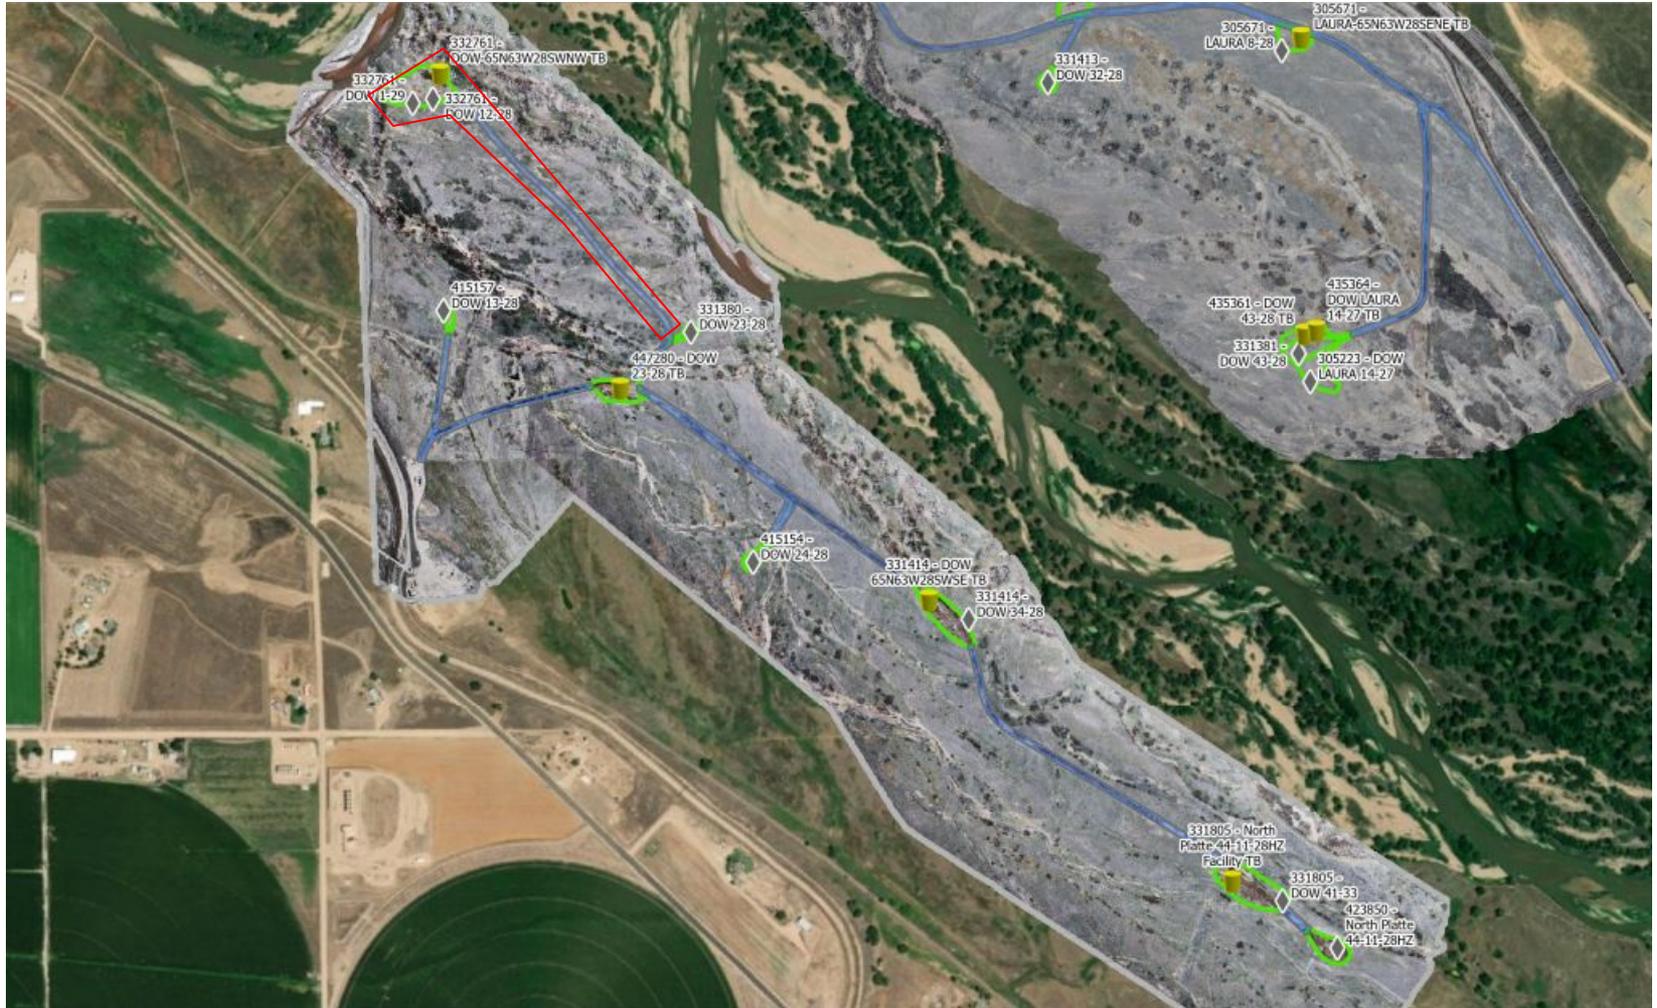
Photo 1. The photo is imagery from Operator supplied Document #403596817, CPW Centennial Valley State Wildlife Area Reclamation Report. The photo illustrates an overview of the access roads and facilities in the area under the reclamation plan. Outlined in Red are the facilities that will be associated with this inspection based on Operator determined layouts.

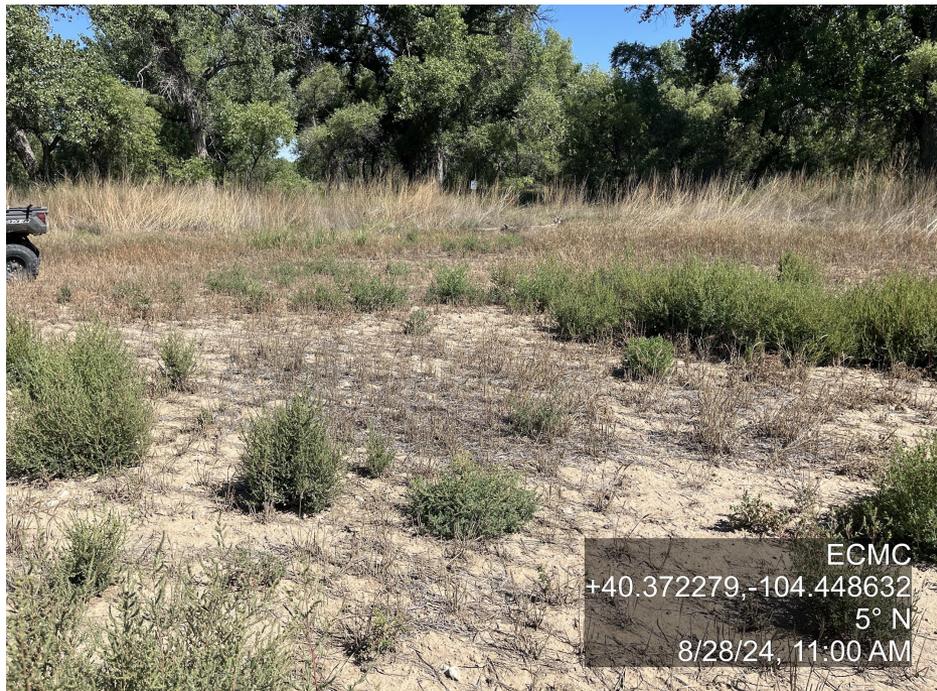
Photo 2. The photo was taken at the well location facing North. The photo illustrates the location is dominated by weeds and bare soil that is not reflective of reference areas.

Note - Cultivated wheat and cereal rye was also observed having germinated from what appeared to be the crimped straw.

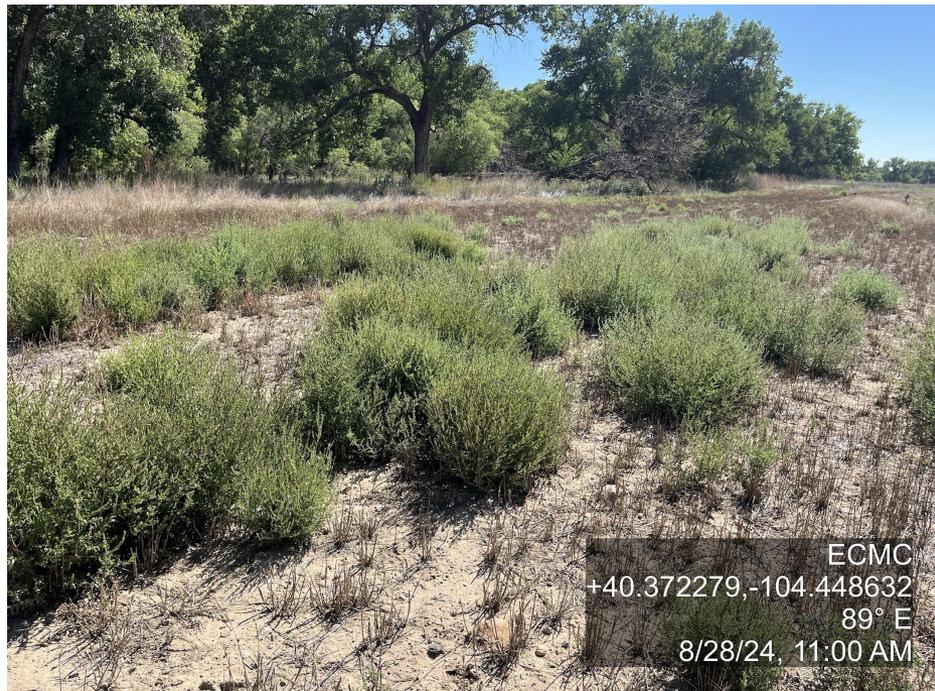
Photo 3 The photo was taken at the well location facing East. Refer to the comment for photo 2.

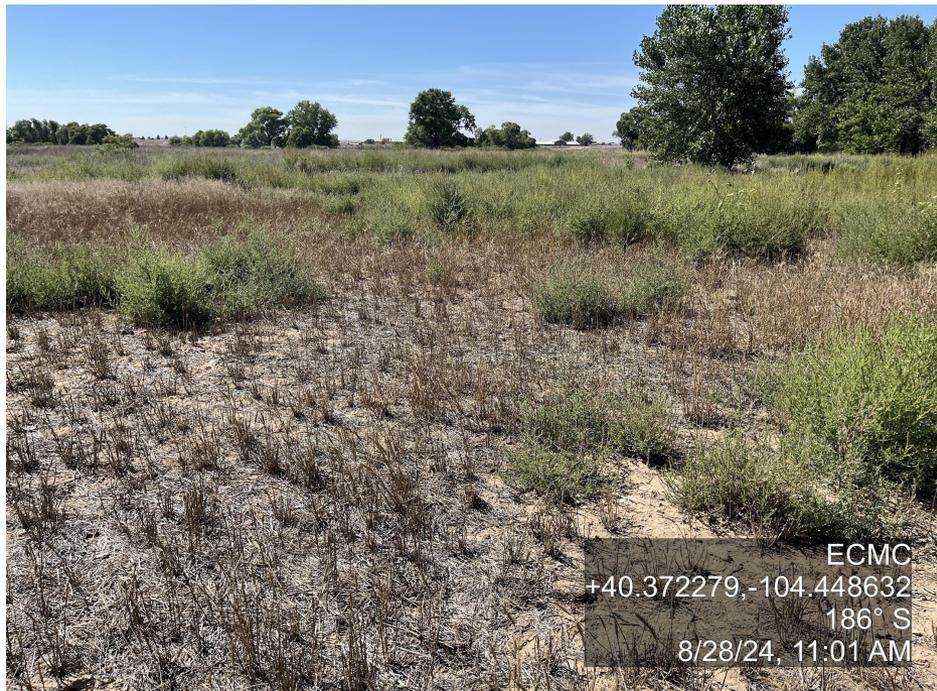
Photo 4. The photo was taken at the well location facing South. Refer to the comment for photo 2.

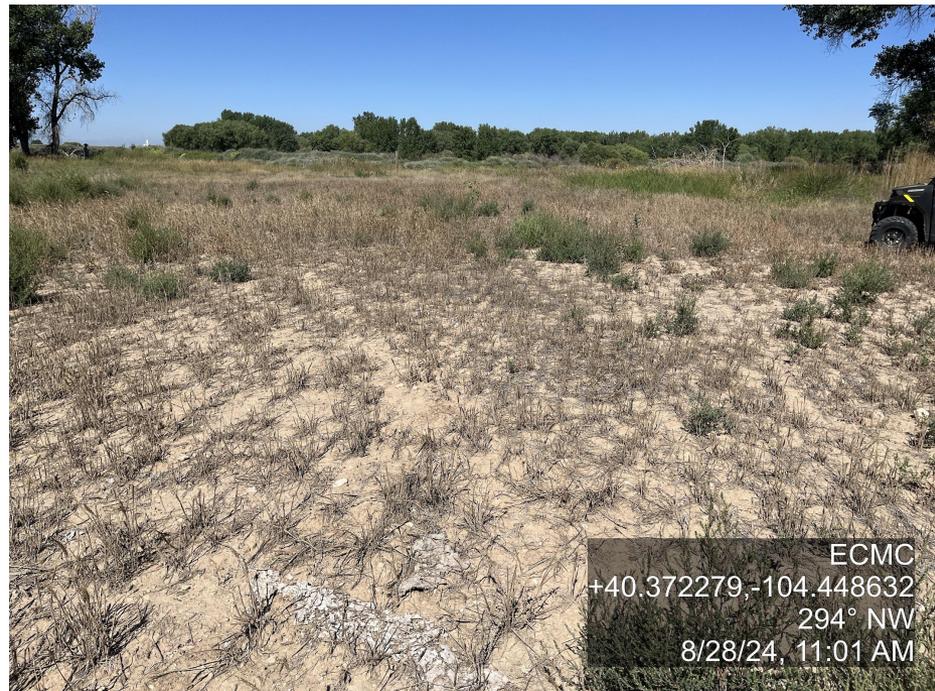
Photo 5. The photo was taken at the well location facing West. Refer to the comment for photo 2.

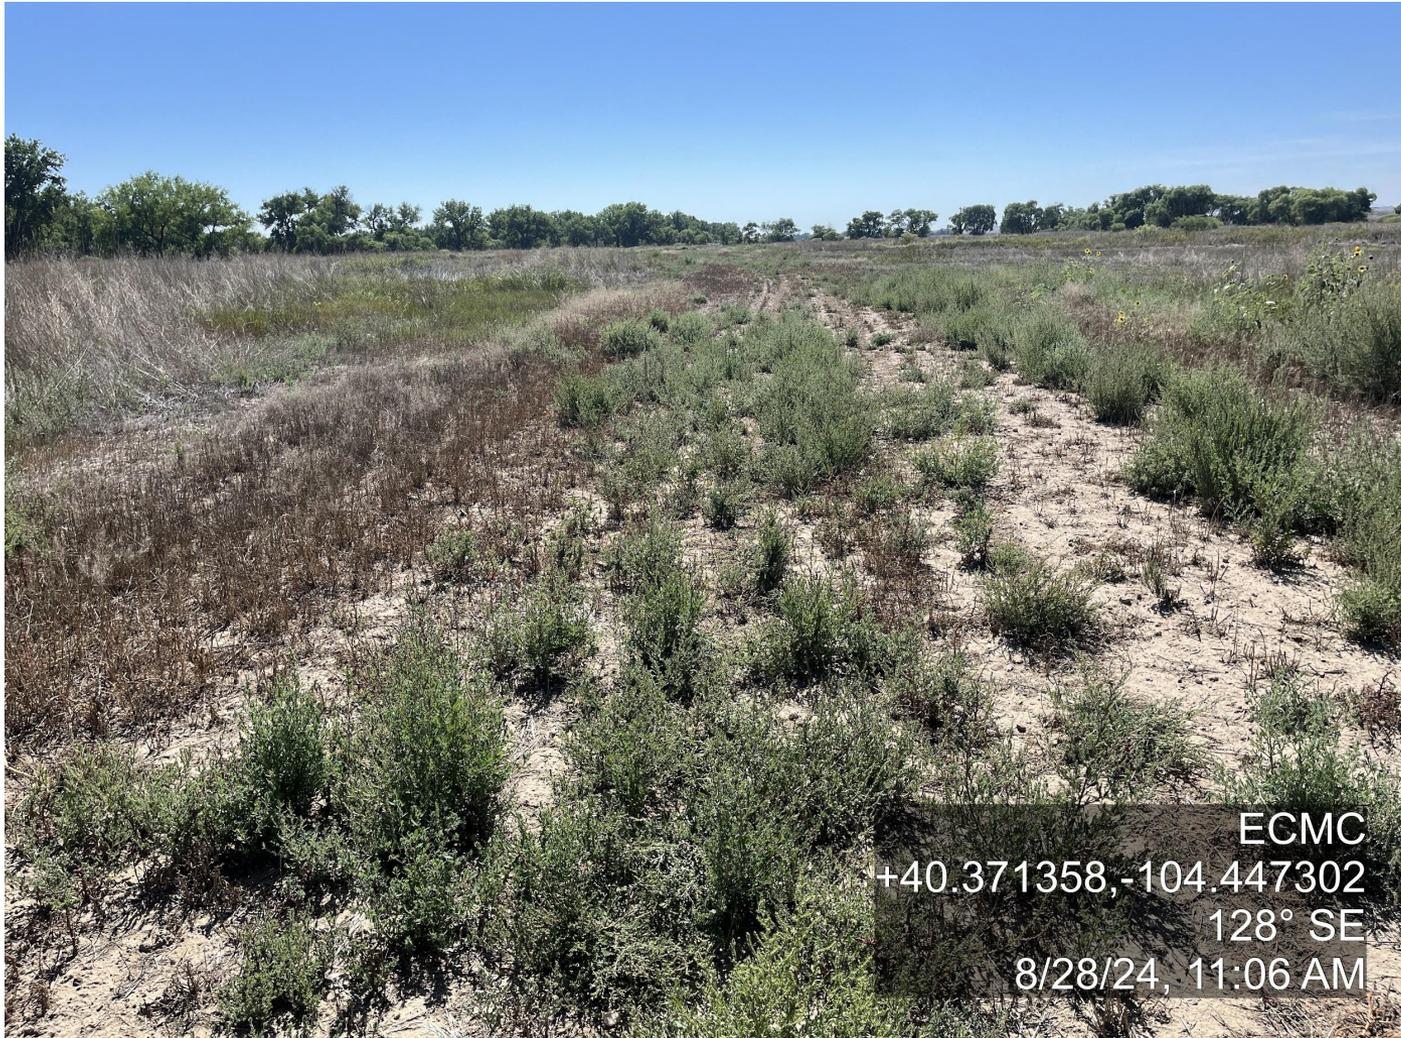
Photo 6. The photo was taken along the access road facing Southeast. Refer to the comment for photo 2.
