Final Reclamation and Stormwater Inspection

Operator: Bonanza Creek Energy Operating
Company LLC - 8960

Location ID: 331414

Inspection Document #: 713900952

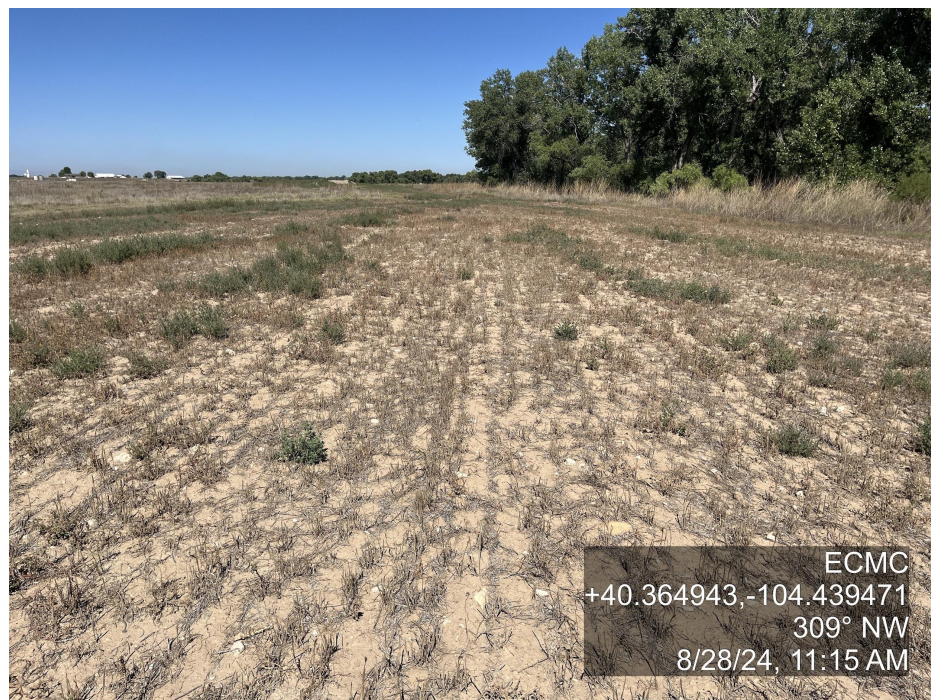
Photo 2. The photo was taken at the well location facing Northwest. The photo illustrates the location is dominated by weeds and bare soil that is not reflective of reference areas.

Note - Cultivated wheat and cereal rye was also observed having germinated from what appeared to be the crimped straw.

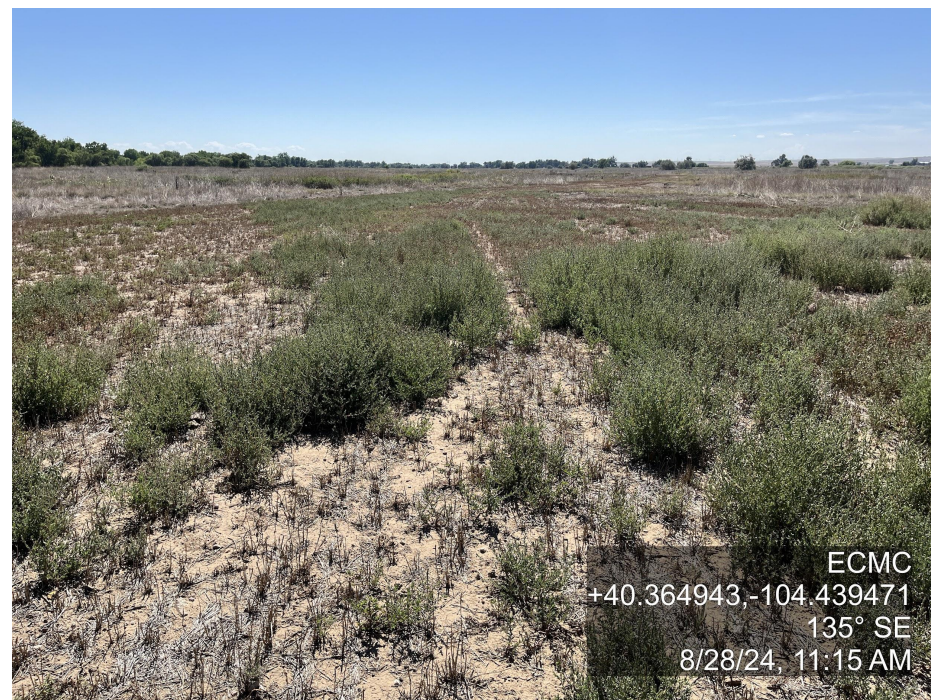
Photo 3 The photo was taken at the well location facing Southeast. Refer to the comment for photo 2.

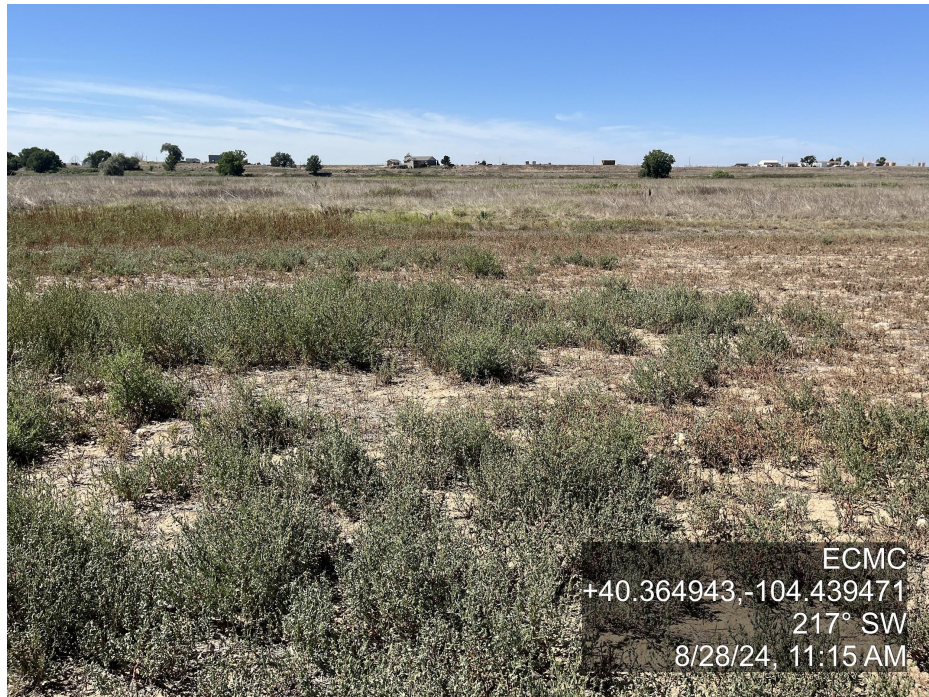
Photo 4. The photo was taken at the well location facing Southwest. Refer to the comment for photo 2.

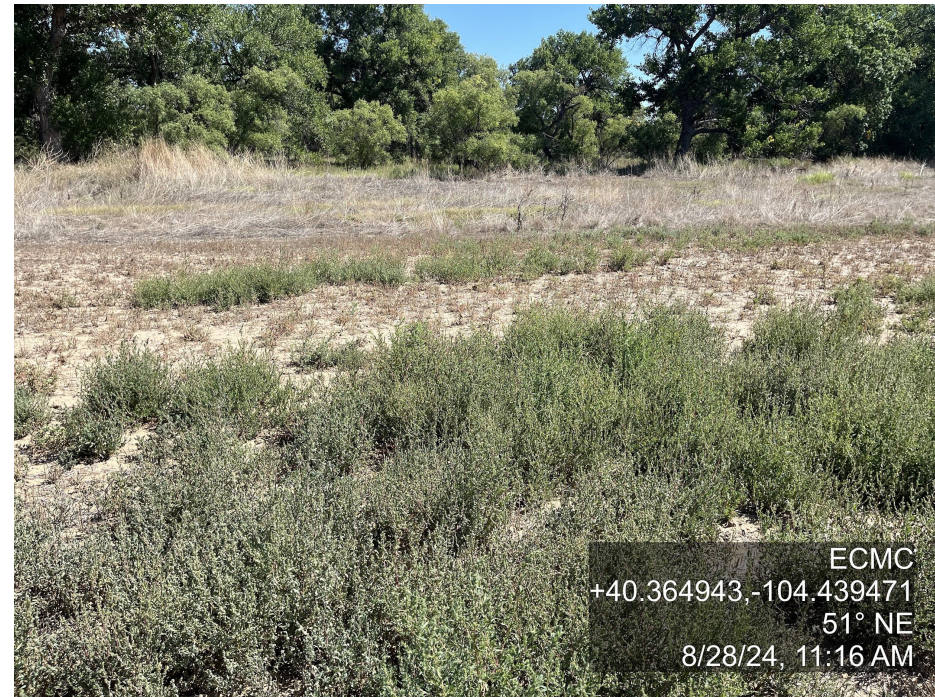
Photo 5. The photo was taken at the well location facing Northeast. Refer to the comment for photo 2.

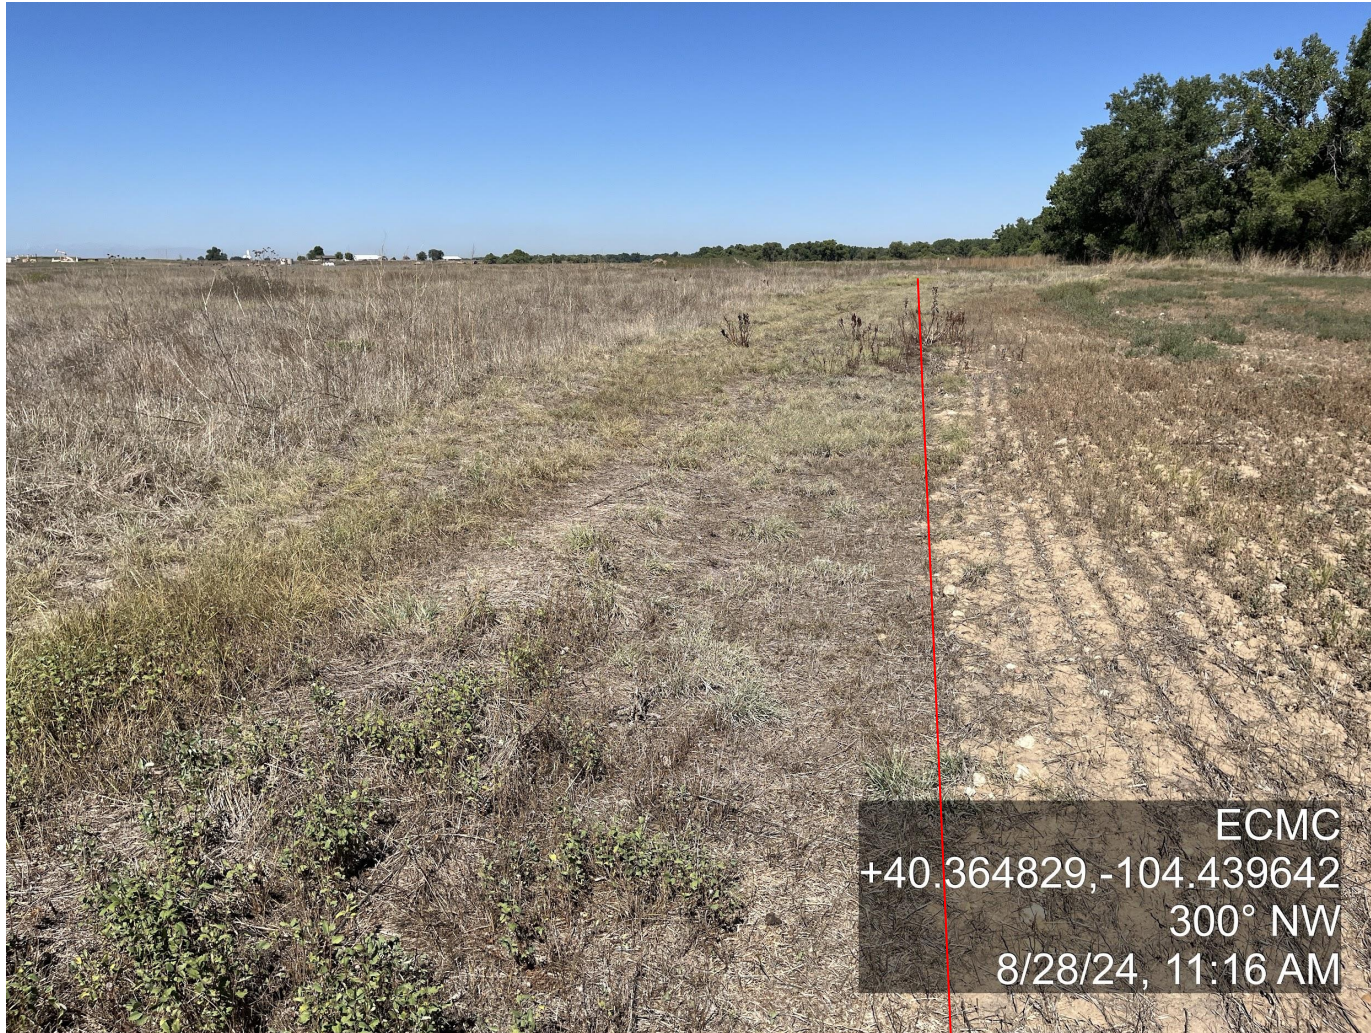
Photo 6. The photo was taken at the boundary of the well location facing Northwest. The photo illustrates the boundary of the location disturbance and reference areas.
