**Operator: 8 North**

**Location Name: DF RANCH-611N61W 15SENE**

**Loc ID: 310707**

**Inspection: 696300873**

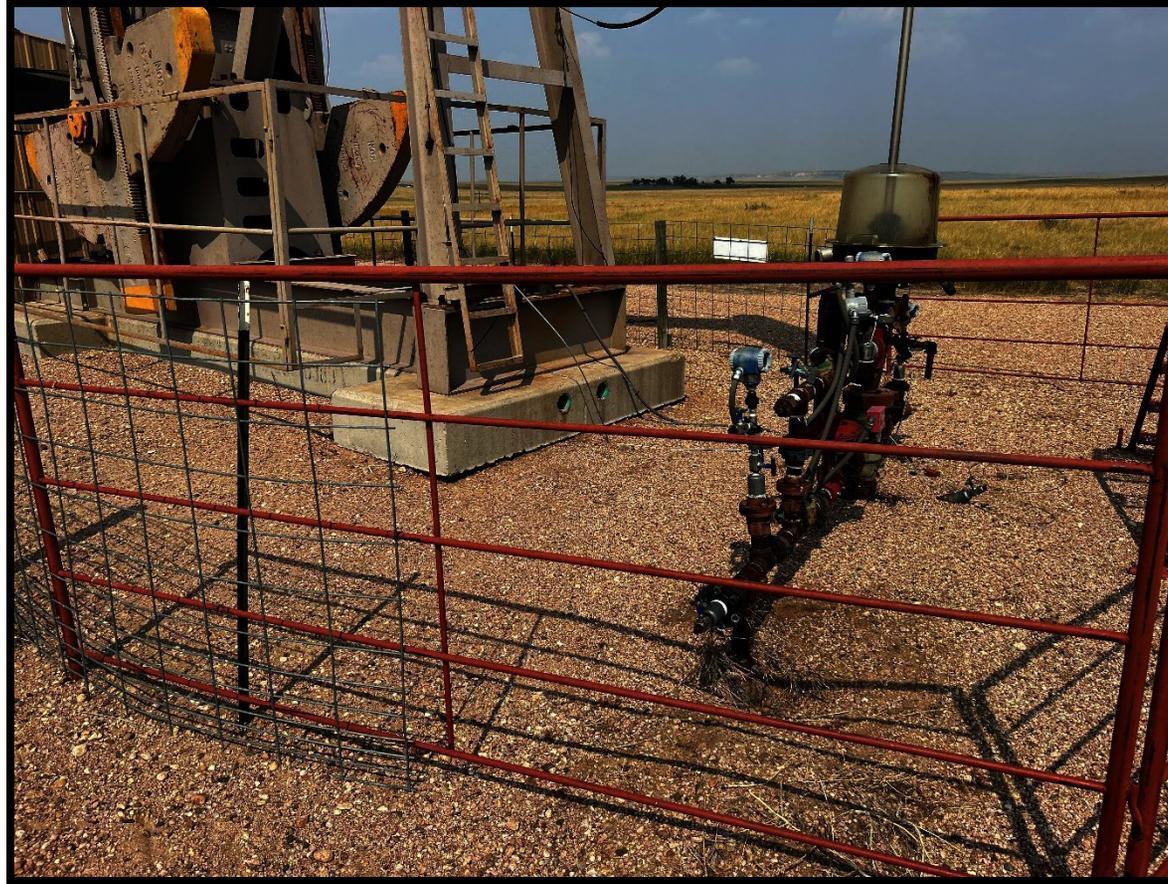
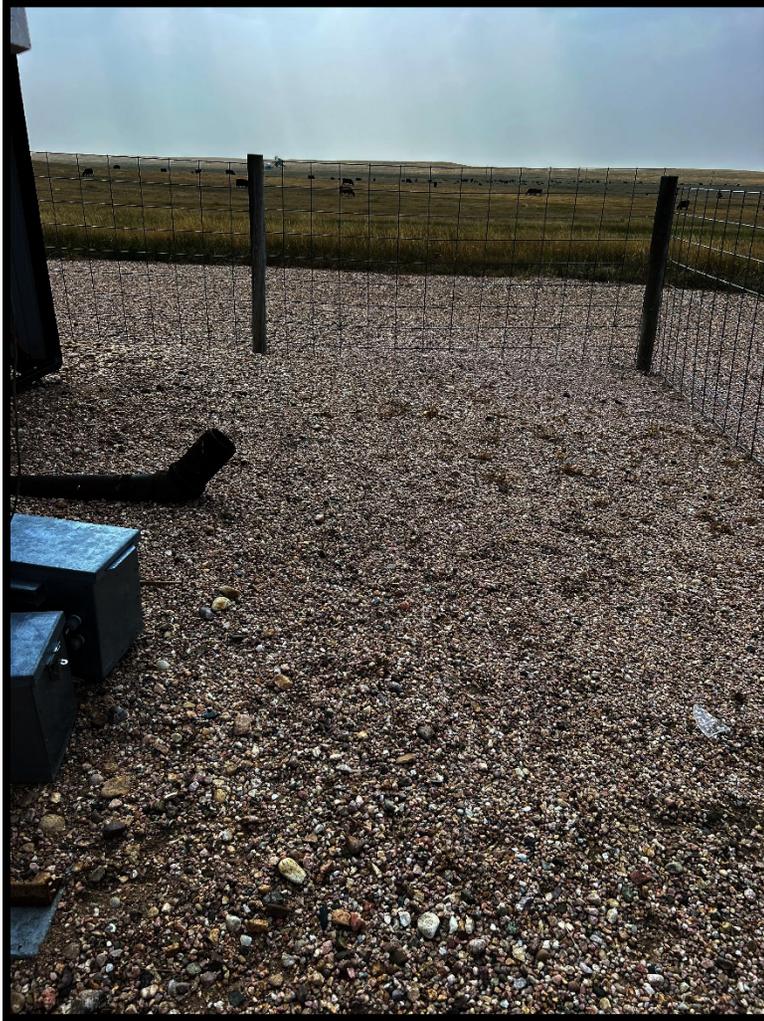
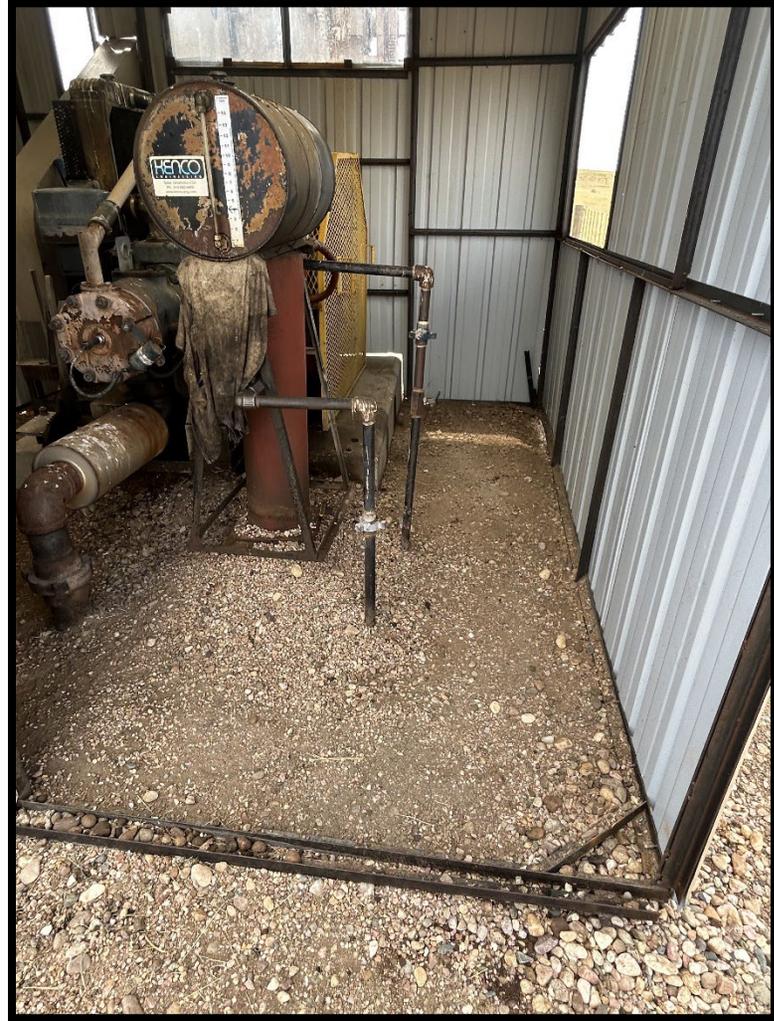
**CA:** Stained Soil at Wellhead, Exhaust, and Gas Engine. See photos 2, 3, 4, 5. Corrective Action: Properly treat or dispose of oily waste in accordance with 907.e  
**CA Resolution:** Operator has provided photo evidence to show that the stained soil has been appropriately removed/cleared and mechanical issues leading to the leak have also been addressed.
