## Inspection Photos

Location Name: CAERUS PICEANCE LLC HMU Federal 24-13A1 (D25W) Pad

Location #: 334618

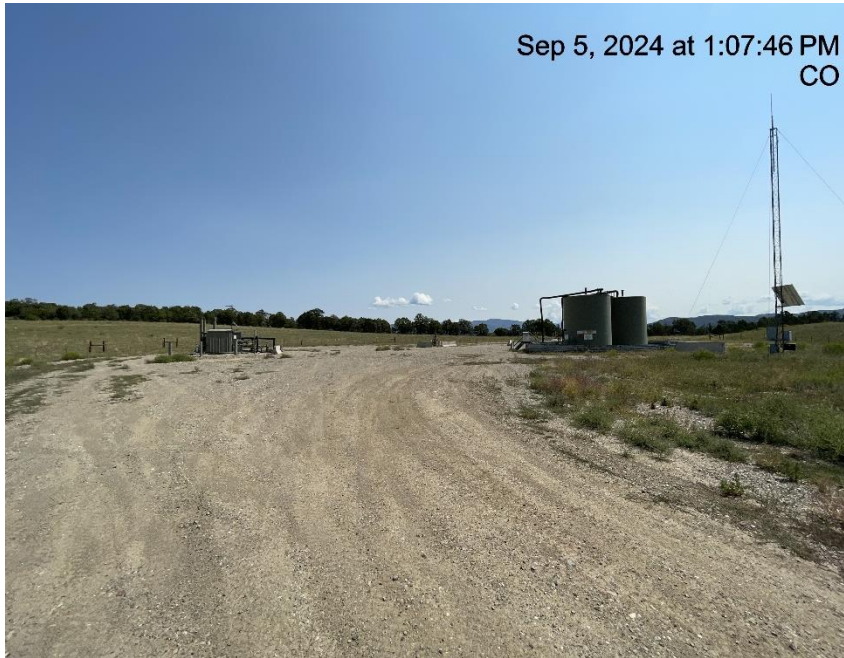
Photo # 8261 From Entrance to location

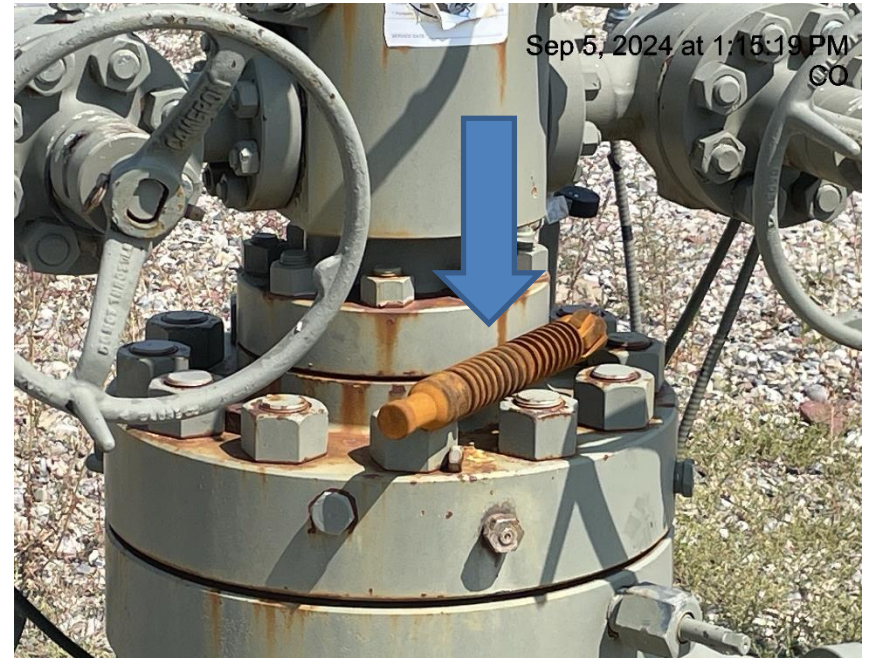
Photo # 8268 Debris
