Inspection Photos

Operator: BEEMAN OIL & GAS INC - 7125

Location ID: 425419

Inspection Doc: 696206205

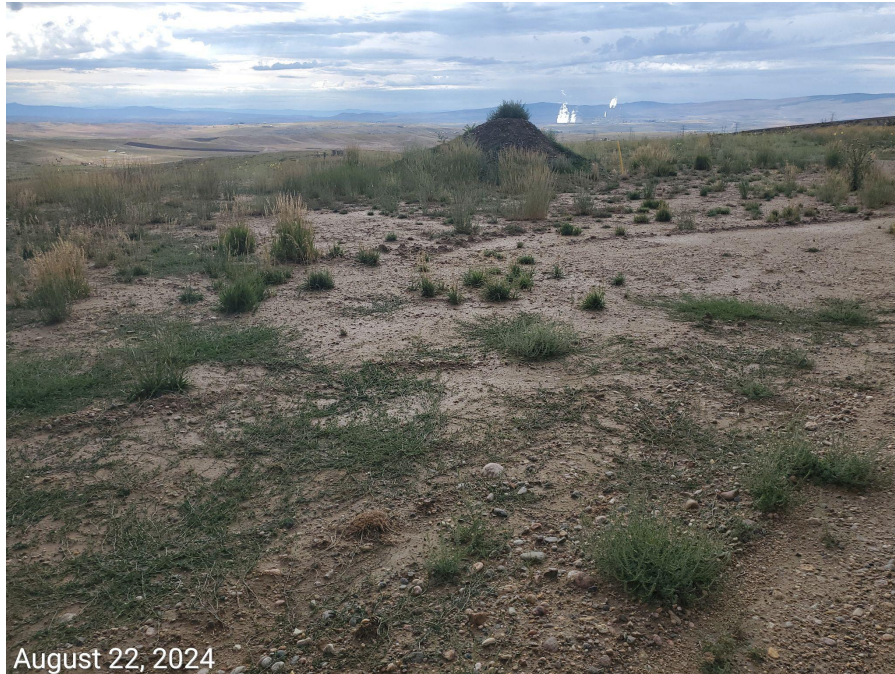
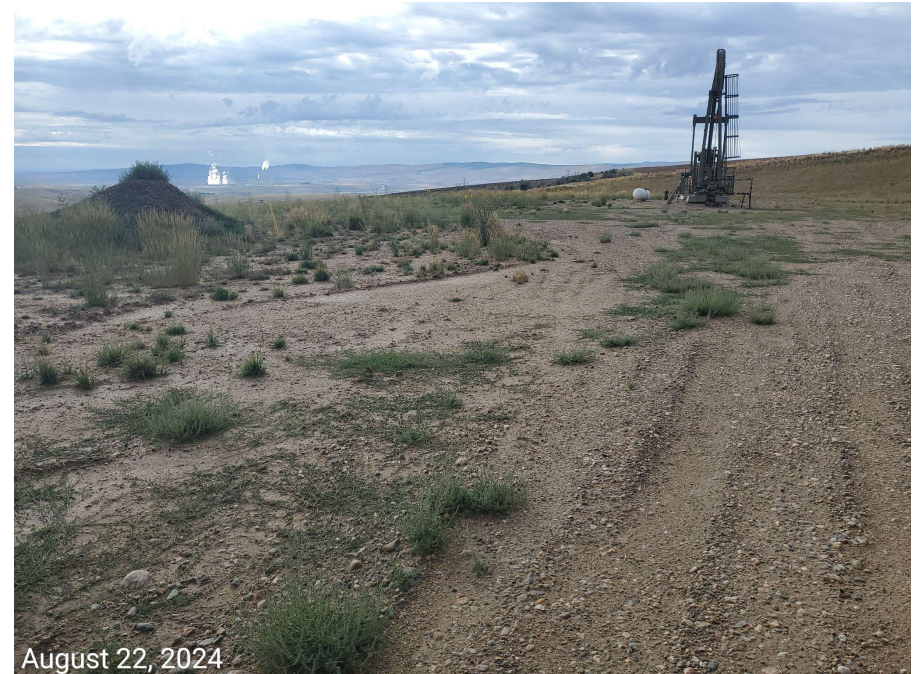
Photo 1: Photos 1-2 taken from the Location entrance, on the north end of the Location. Photos provide an overview of the Location from east, southeast, southwest to west. Photos also shows Undesirable Plant Species established throughout the working pad surface of the Location; including Kochia, Russian thistle, Prostrate Knotweed, Scotch thistle, etc...

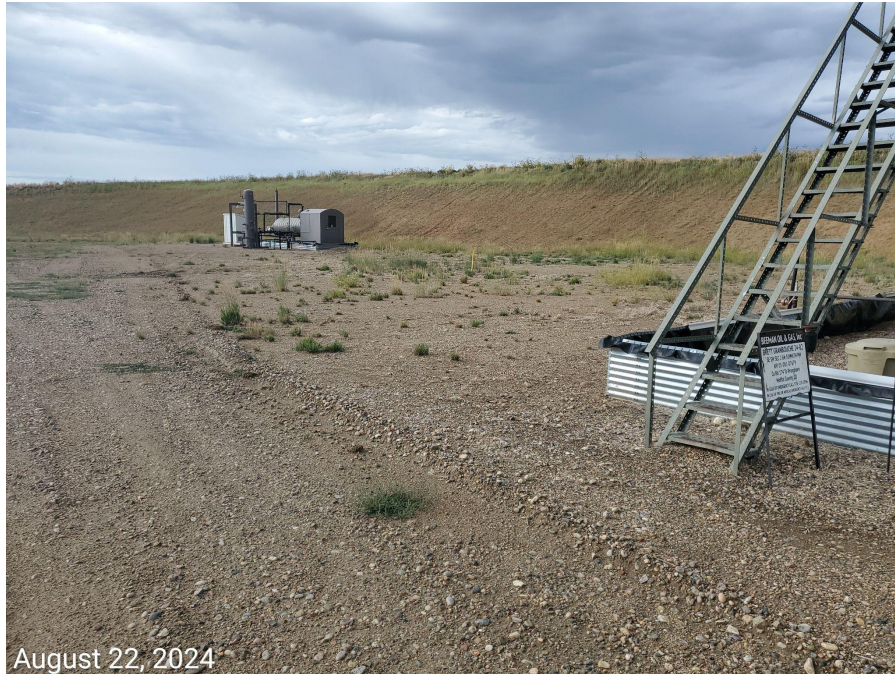
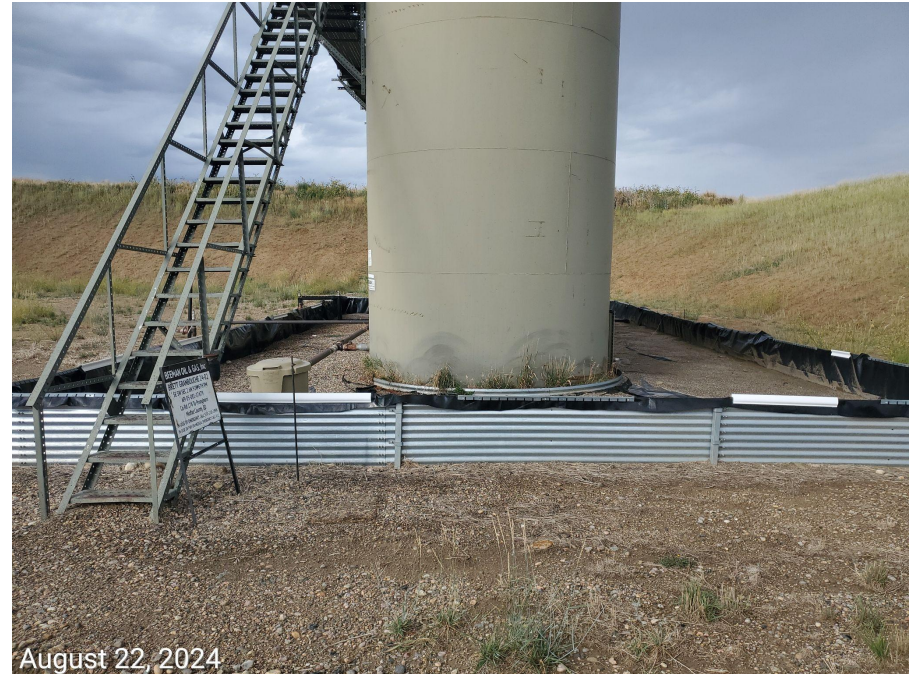
Photo 2: See comments under photo 1.

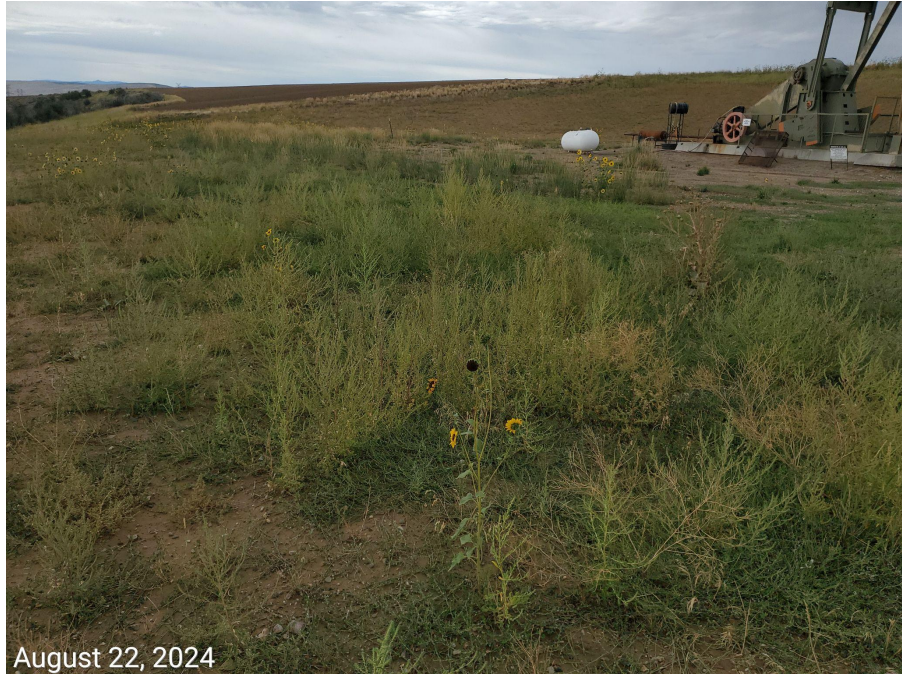
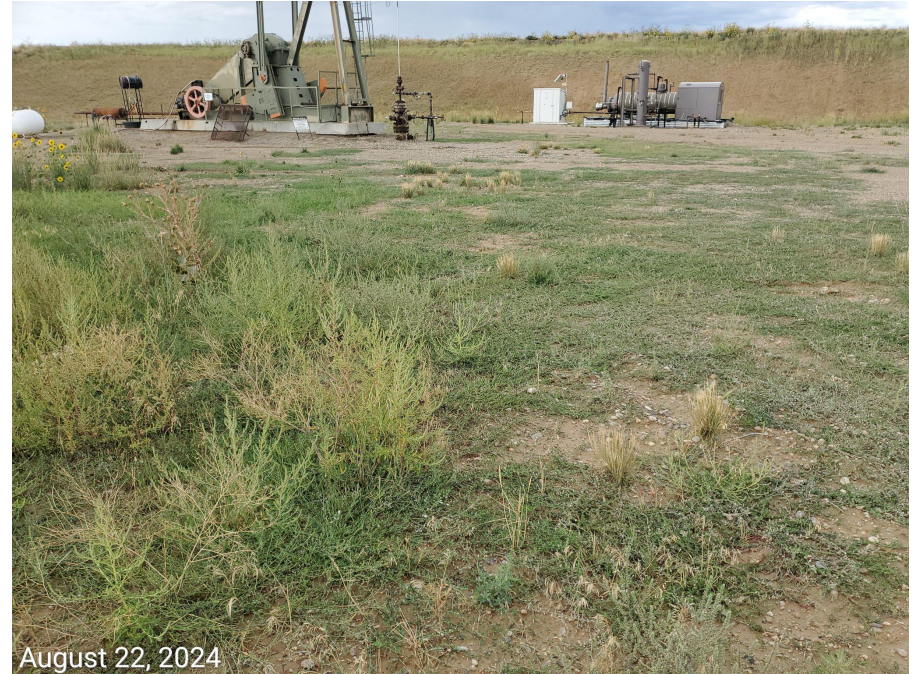
Photo 3: Photos 3 taken from the east end of the Location. Photos provide an overview of the Location from south, southwest, west to northwest. Photos also shows Undesirable Plant Species established throughout the working pad surface of the Location; including Kochia, Russian thistle, Prostrate Knotweed, Scotch thistle, etc...

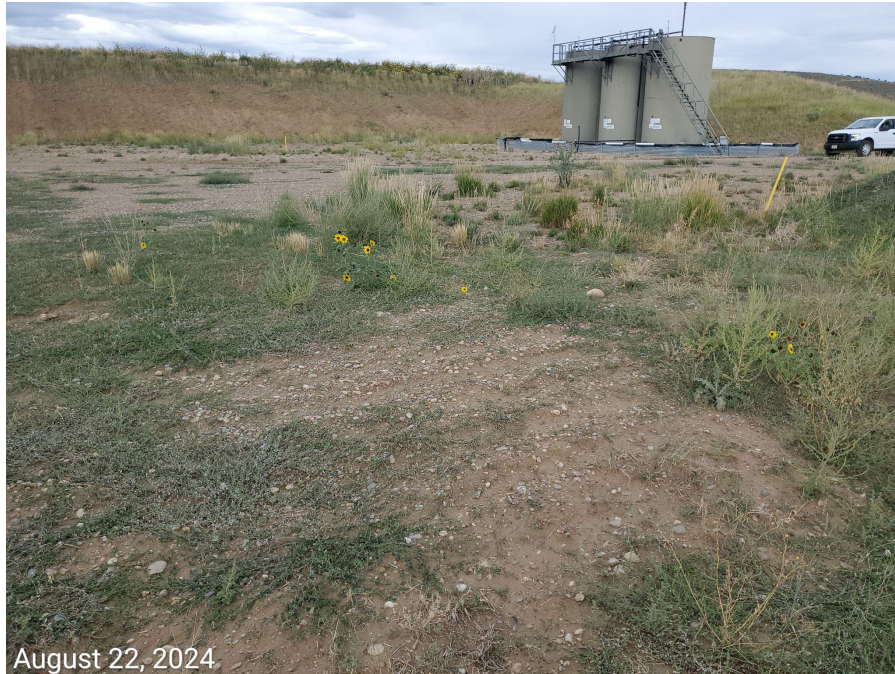
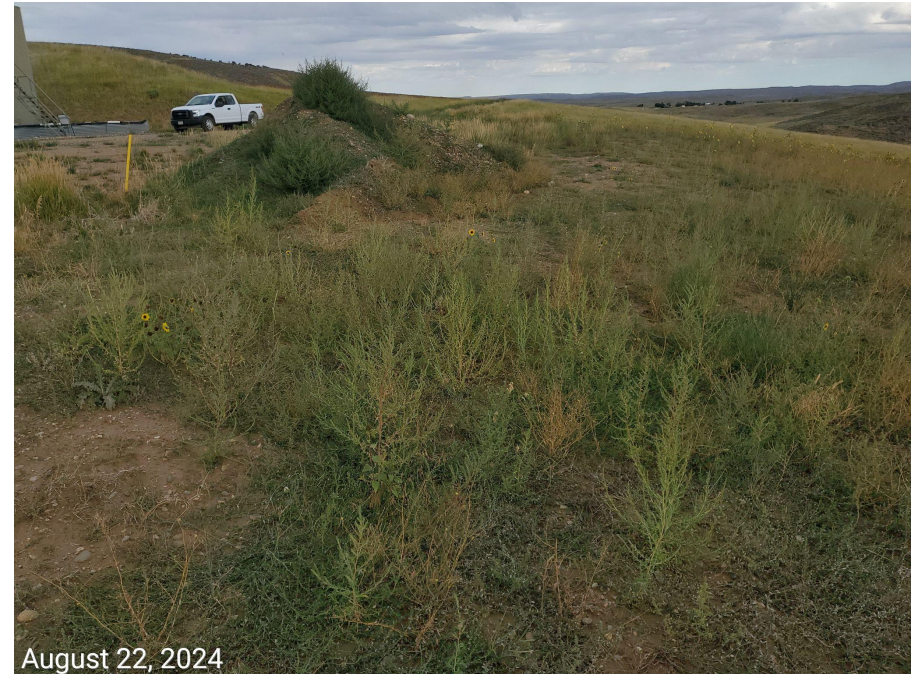
Photo 4: See comments under photo 3.

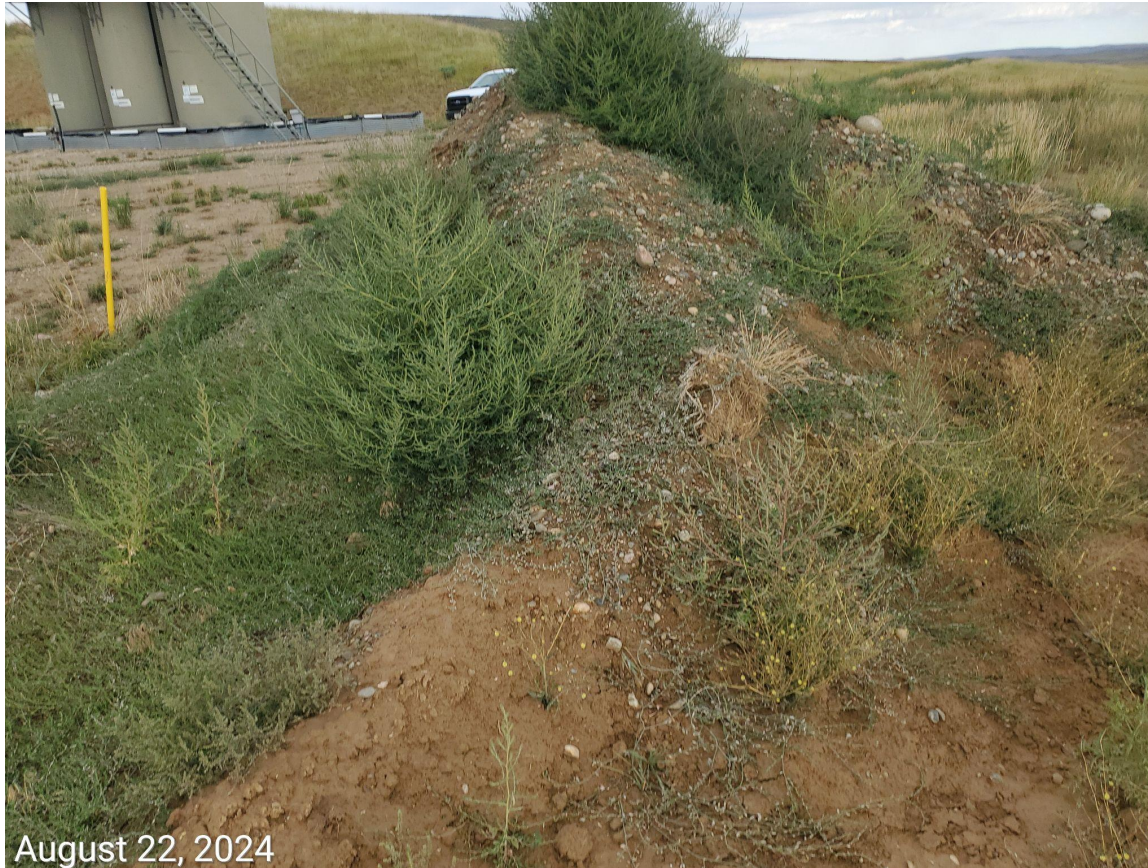
Photo 5: Photo taken from the northeast end of the working pad surface. Photo shows stockpile of material stored on Location. Photo also shows that BMPs to protect the stockpile from wind/water erosion, BMPs to minimize sediment transport, and BMPs to protect stockpile from weed establishment are missing or insufficient. BMPs required pursuant to Rule 1002.c and 1002.f, or, If materials are not necessary, materials require removal.

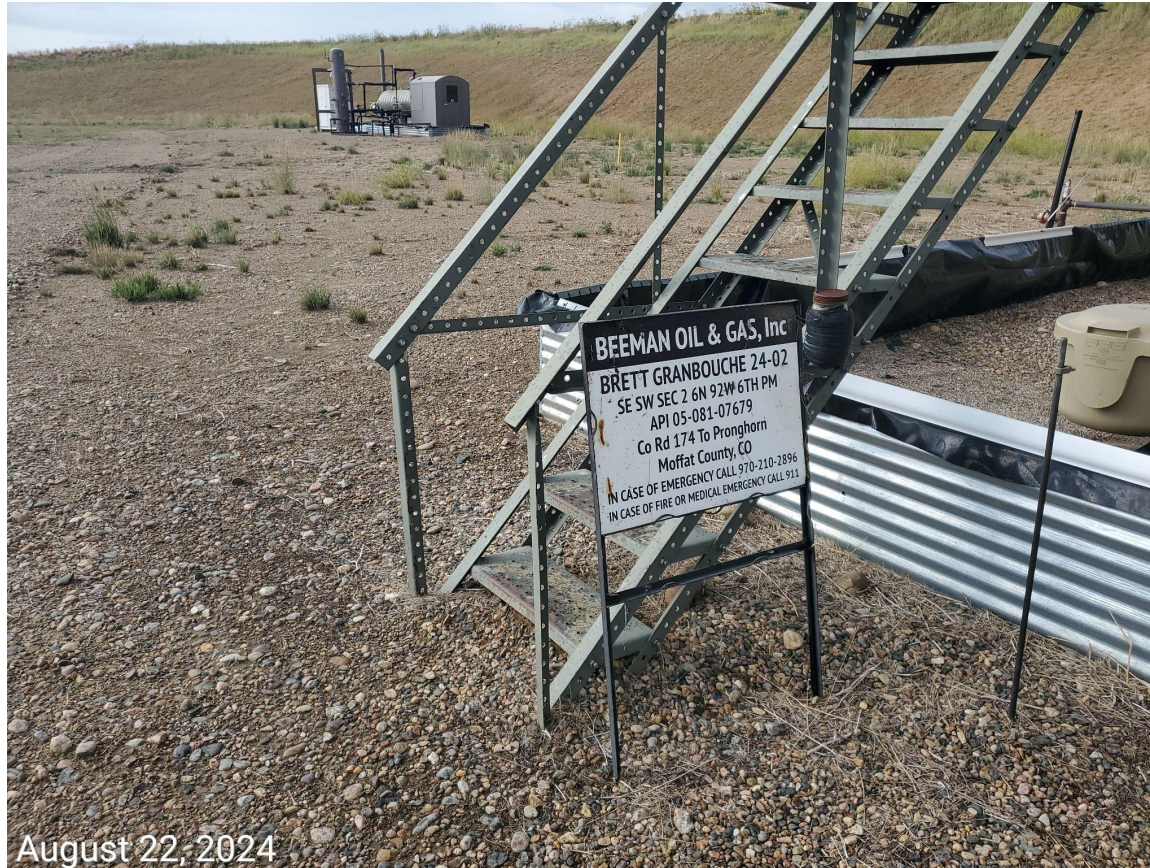
Photo 6: Photo taken from the tank battery facility on the north end of the Location, facing south. Photo shows signage at the facility has been installed.

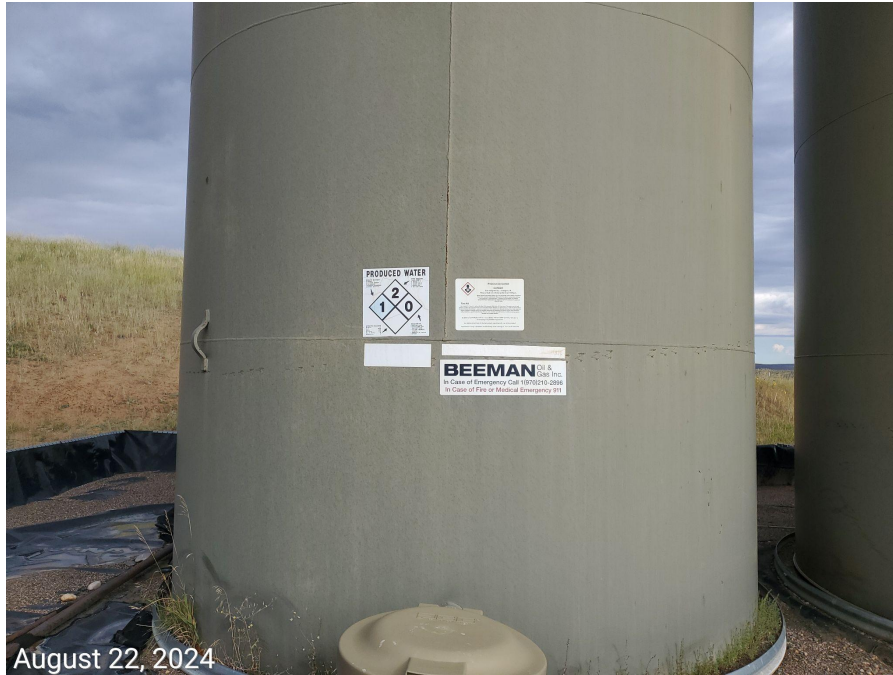
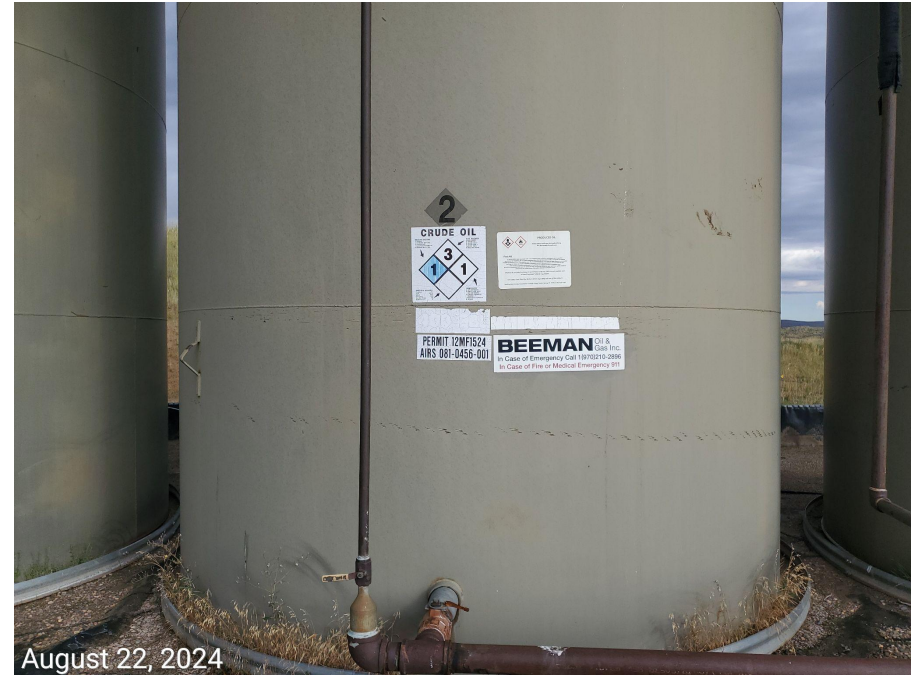
Photo 7: Photo taken from the tank battery facility on the north end of the Location, facing north. Photos examples showing information pursuant to Rule 605.h (NFPA Label, Capacity information) has not been posted.

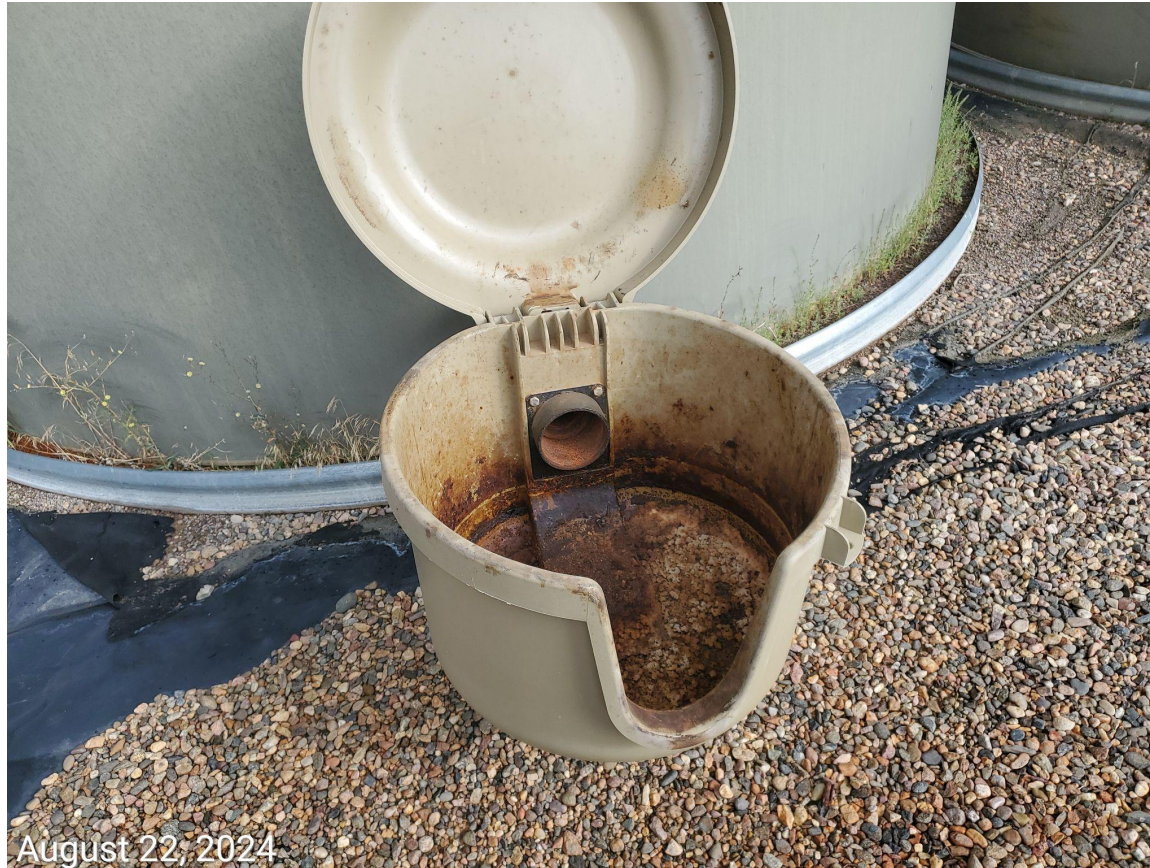
Photo 8: Photo taken from the tank battery facility on the north end of the Location. Photo shows line at tank has not been capped or plugged.

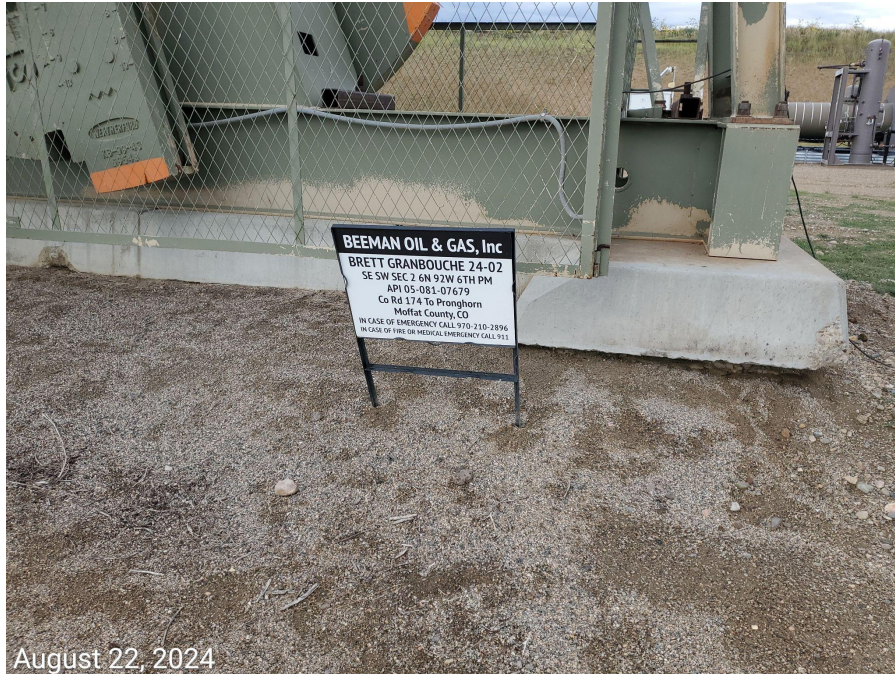
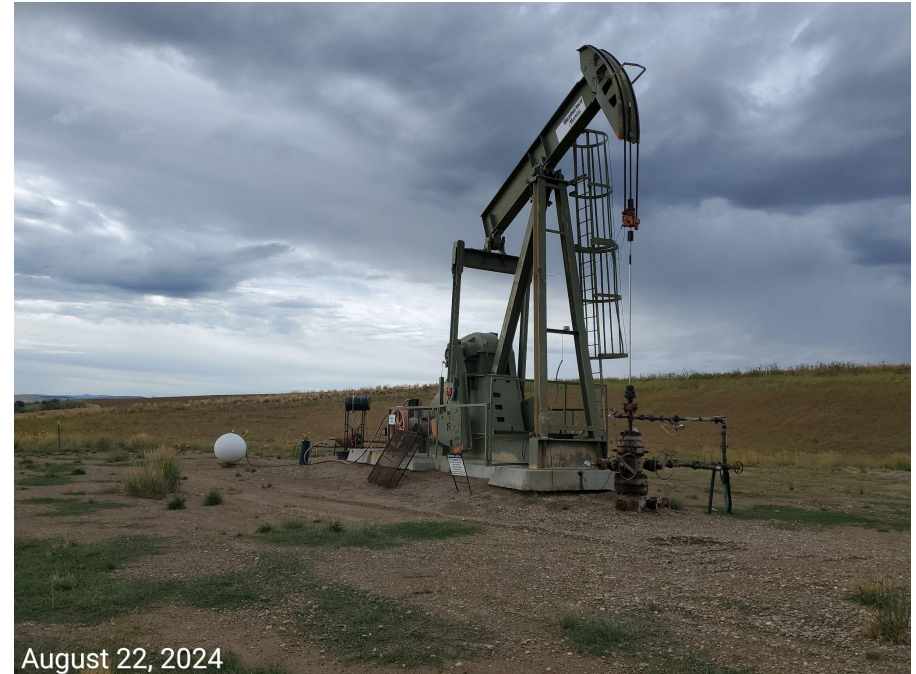
Photo 9: Photos taken from the well/pumpjack. Photo left show well signage has been posted pursuant to Rule 605.d

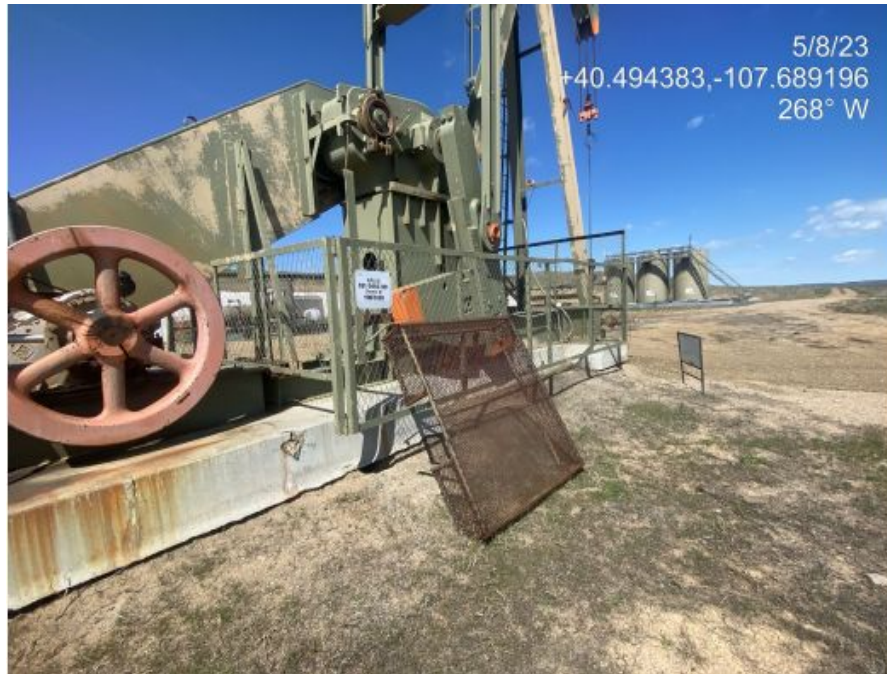
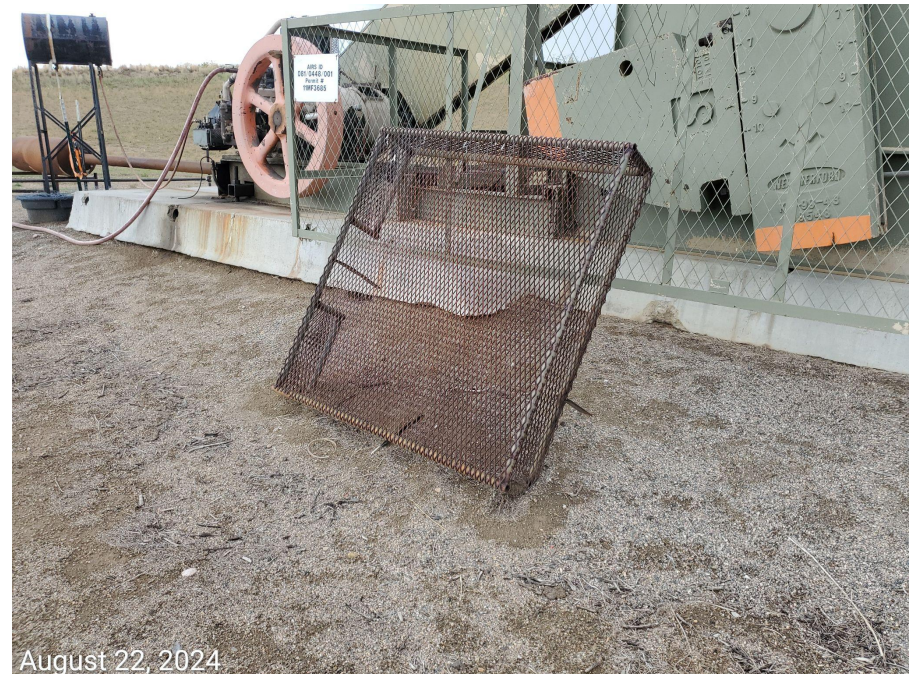
Photo 10: Photo left taken during the 5/8/2023 inspection. Inspection noted that the guard was not installed on the pumpjack. Operator submitted a Resolution stating guard was replaced. Photo right taken 8/22/2024 and show guard remains improperly stored, and has not been replaced.

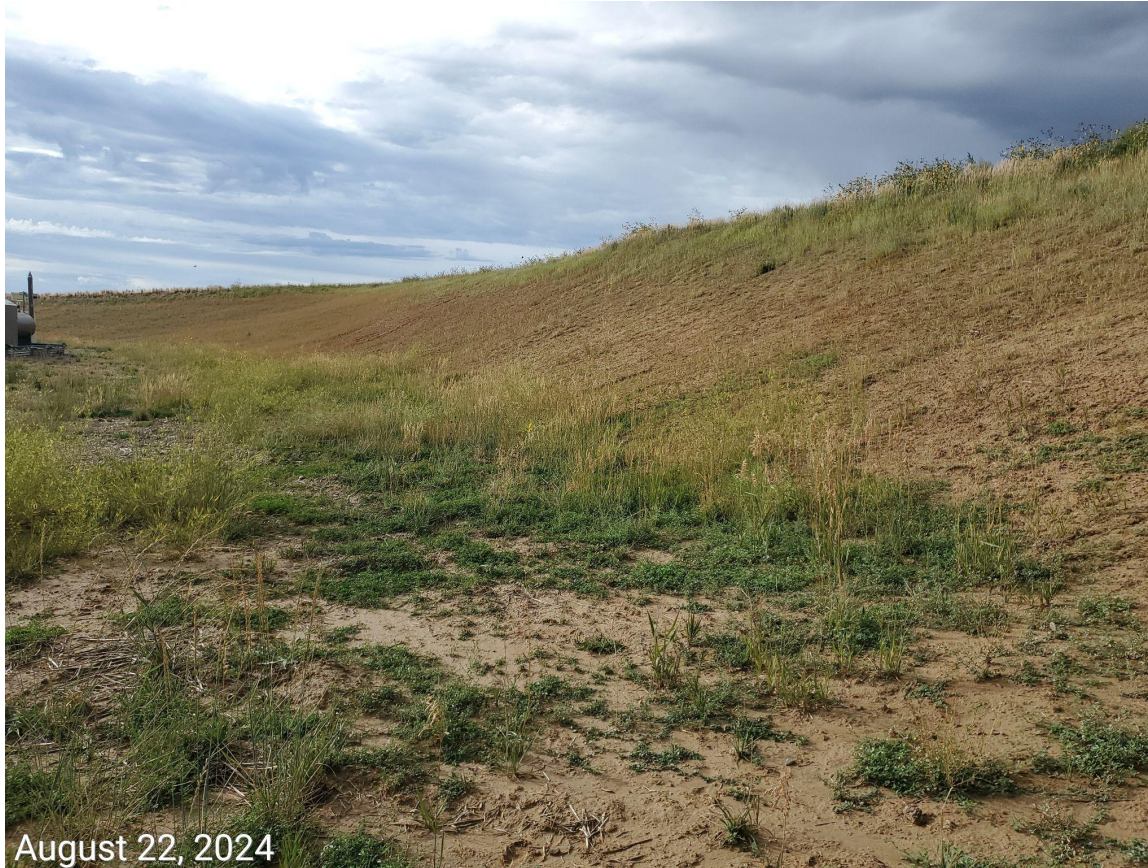
Photo 11: Photo taken from the west end of the Location facing southeast. Photo shows cut slopes have been recontoured. Vegetation establishing on the slopes are predominantly undesirable plant species.

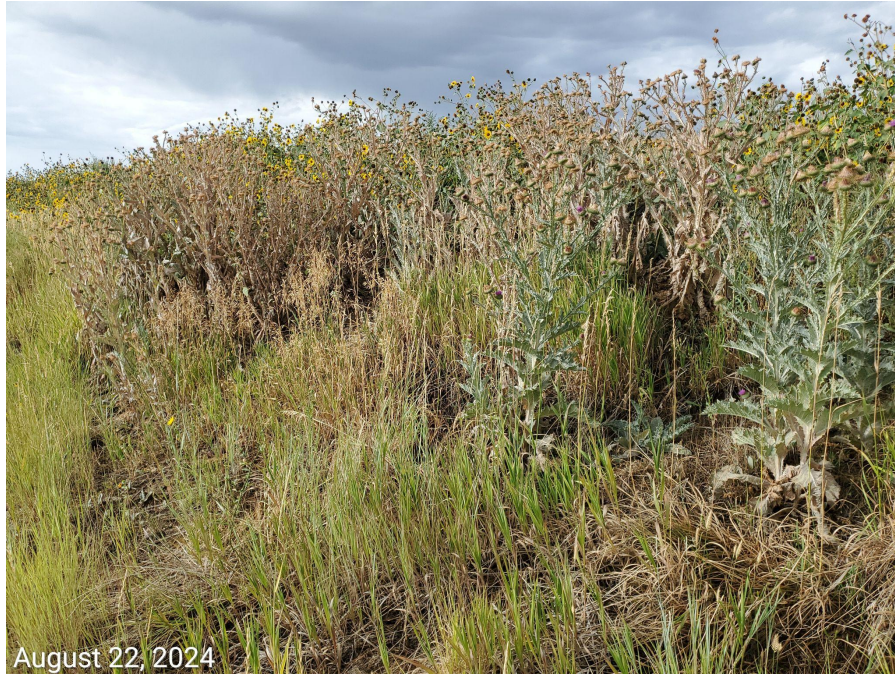
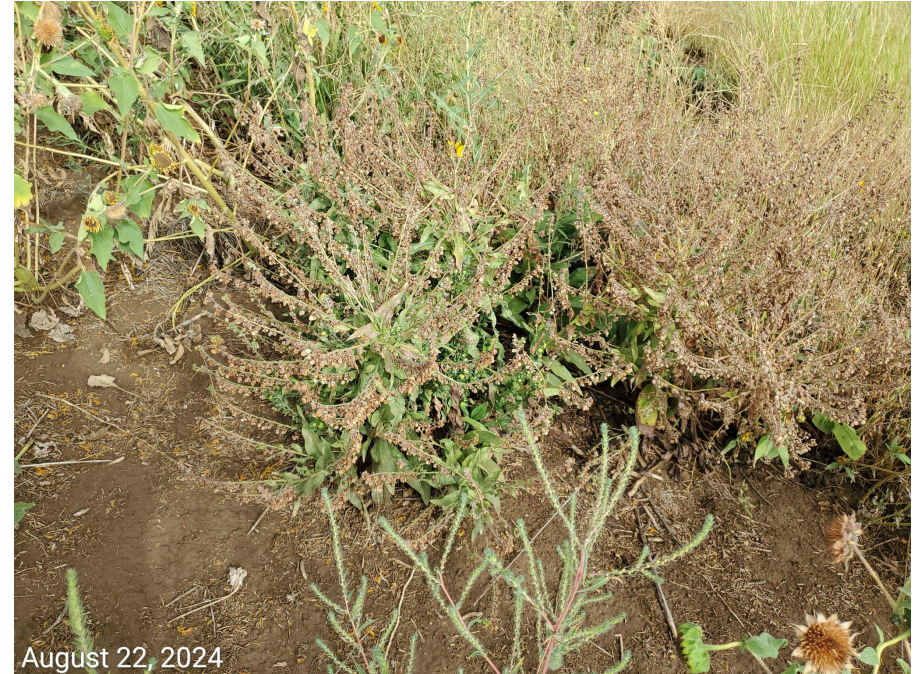
Photo 12: Photos taken from the top of the cut slopes along the west end of the Location. Photos examples showing Noxious Weed establishment (Scotch thistle, Houndstongue). Weed management efforts have not been performed, or has been insufficient.

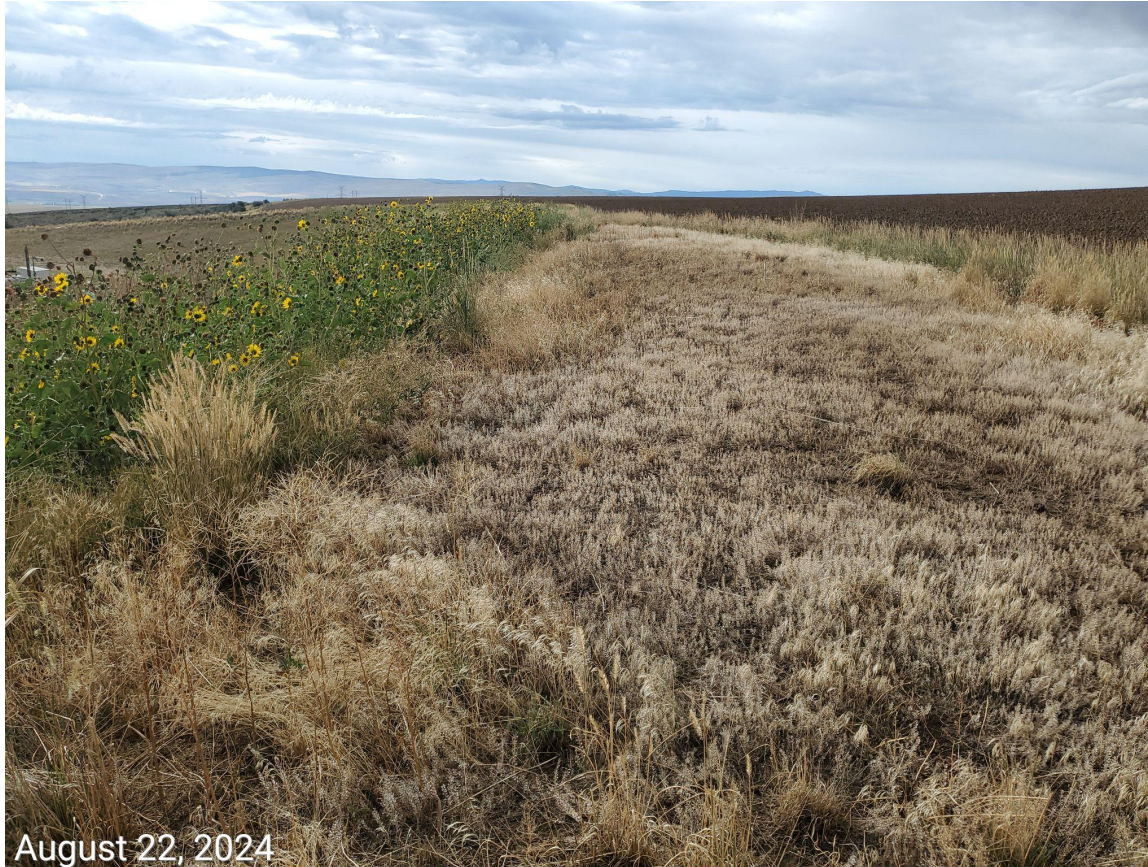
Photo 13: Photo taken from the west end of the Location, facing southeast. Photo shows areas of the Location where interim reclamation does not appear to have been performed. Vegetation is predominantly Undesirable Plant Species such as Cheatgrass, Field Pennycress, etc...

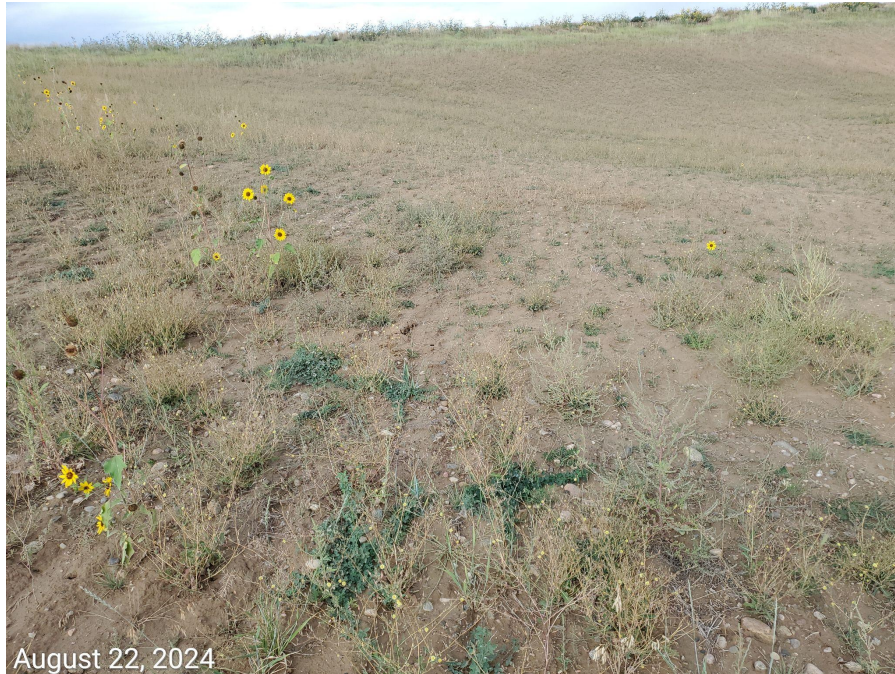
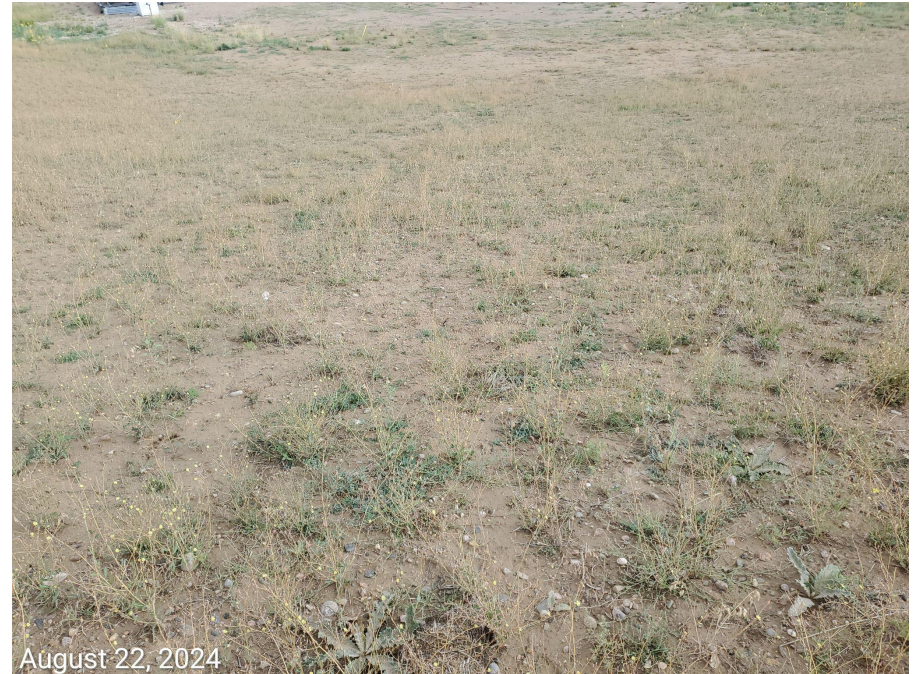
Photo 14: Photos taken from the top of the fill slopes on the south end of the Location, facing northwest and north. Revegetation efforts have not been performed, or have failed; desirable plant germination/establishment was not observed within the recently reclaimed areas. Vegetation within photos are predominantly Undesirable and Noxious Plant Species. Unable to find evidence that soils had been "crimped" with any materials such as mulch. BMPs along slopes have either not been implemented or not maintained until long-term stabilization is achieved; slopes remain predominantly bare.

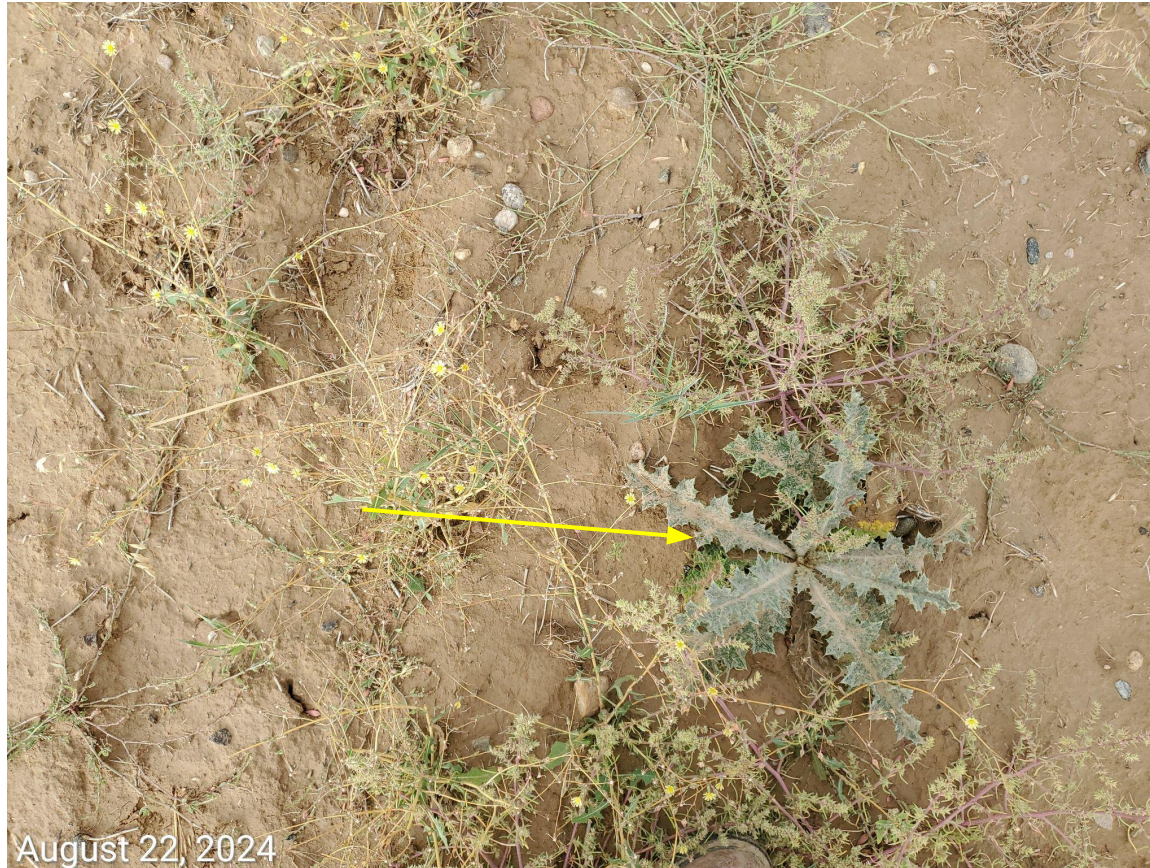
Photo 15: Continued from photo 14. Desirable plant germination/establishment was not observed within the recently reclaimed areas. Vegetation establishing within the interim areas are predominantly Undesirable and Noxious Plant Species, including Scotch thistle (arrow).

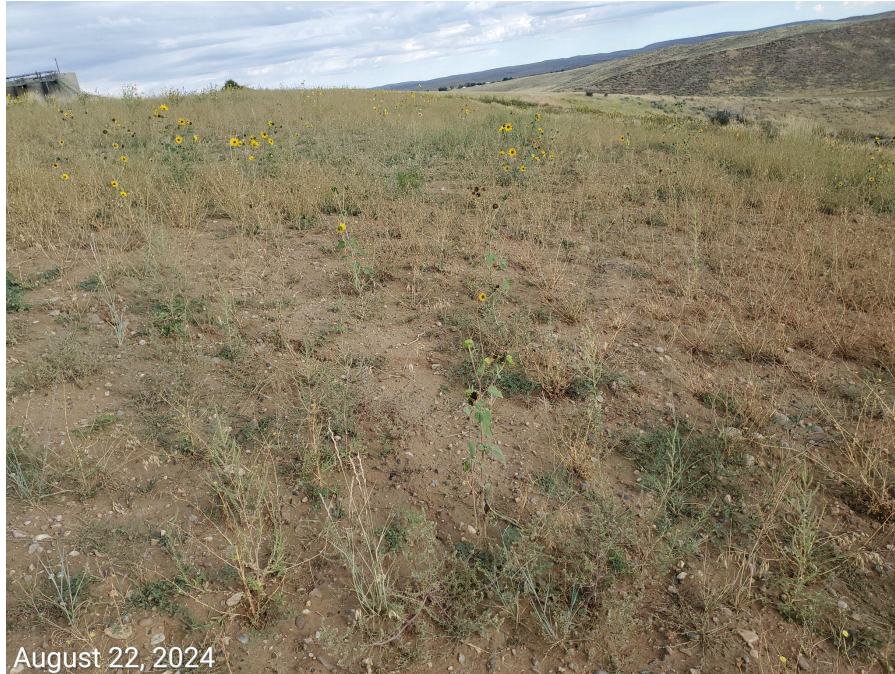
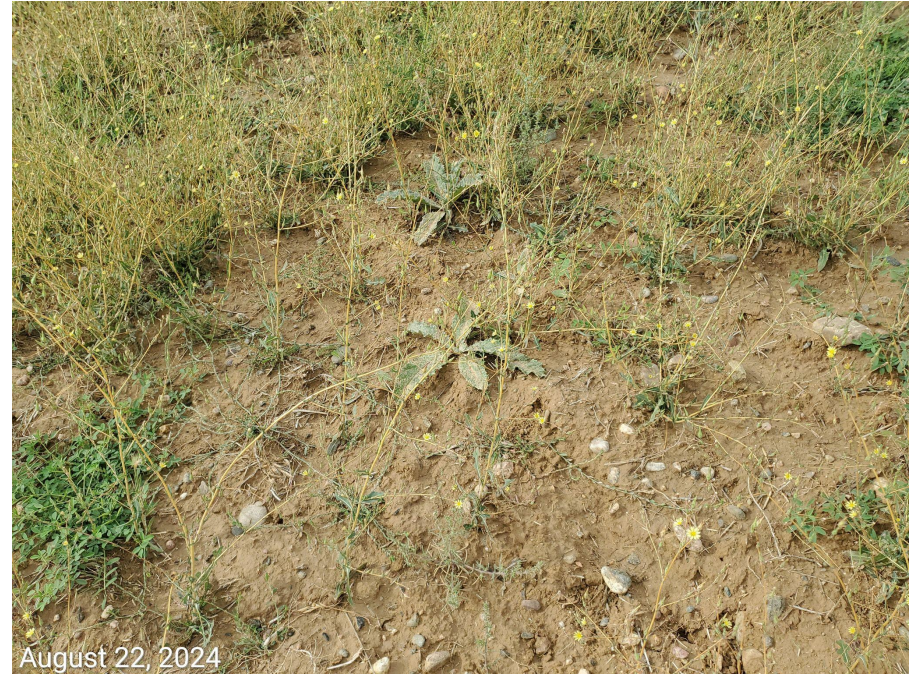
Photo 16: Photos taken from the interim areas/fill slopes on the east end of the Location, facing northwest. Revegetation efforts have not been performed, or have failed; desirable plant germination/establishment was not observed within the recently reclaimed areas. Vegetation within photos are predominantly Undesirable and Noxious Plant Species. Unable to find evidence that soils had been "crimped" with any materials such as mulch. BMPs along slopes have either not been implemented or not maintained until long-term stabilization is achieved; slopes remain predominantly bare.

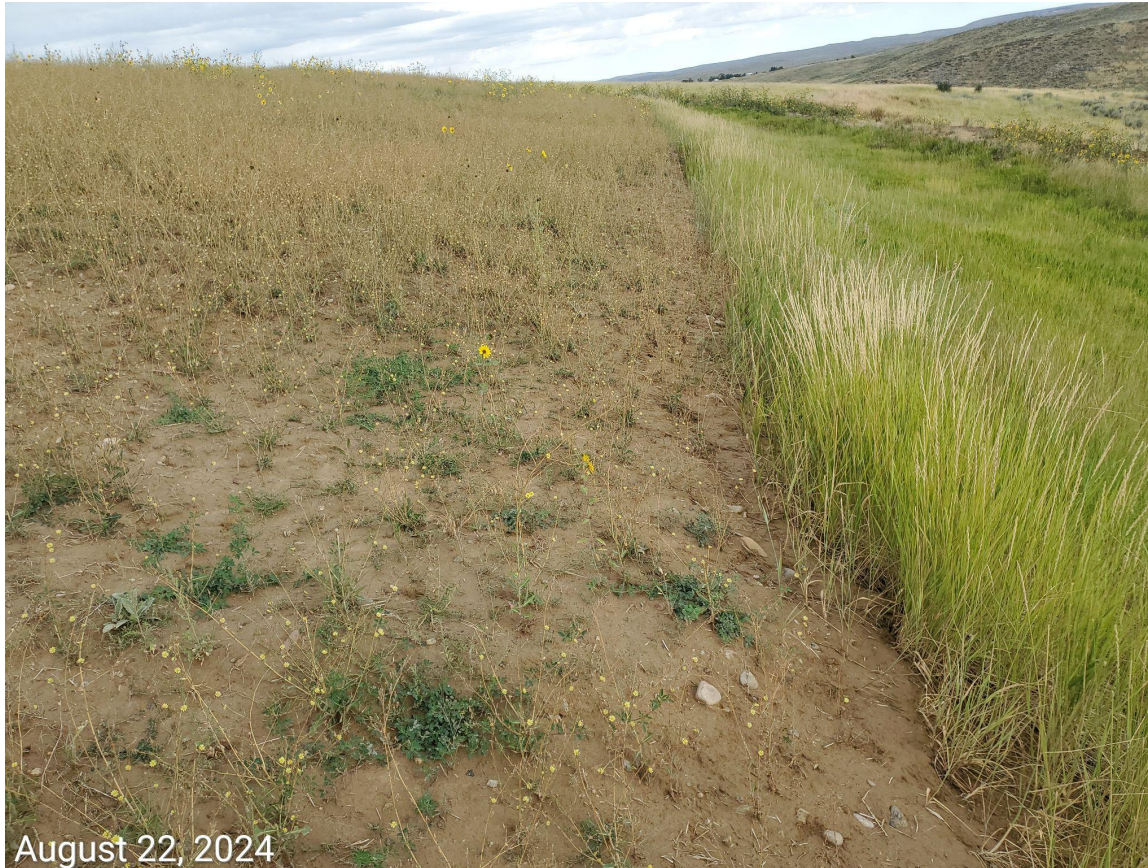
Photo 17: Photos taken from the interim areas/fill slopes on the east end of the Location, facing northwest. Photo shows boundary of the reclaimed areas, and vegetation at the toe of the slope. See comments under photo 16.

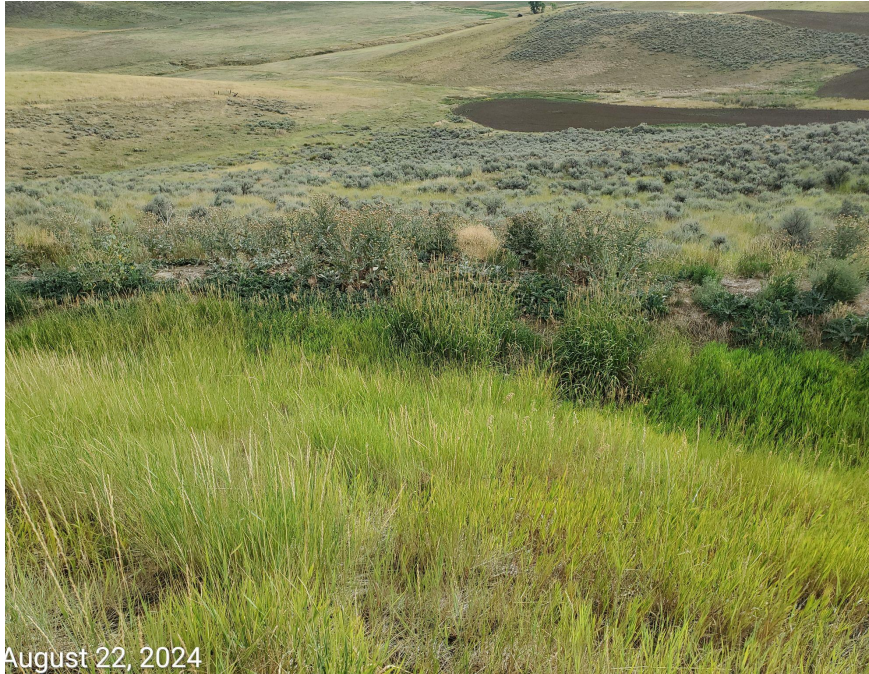
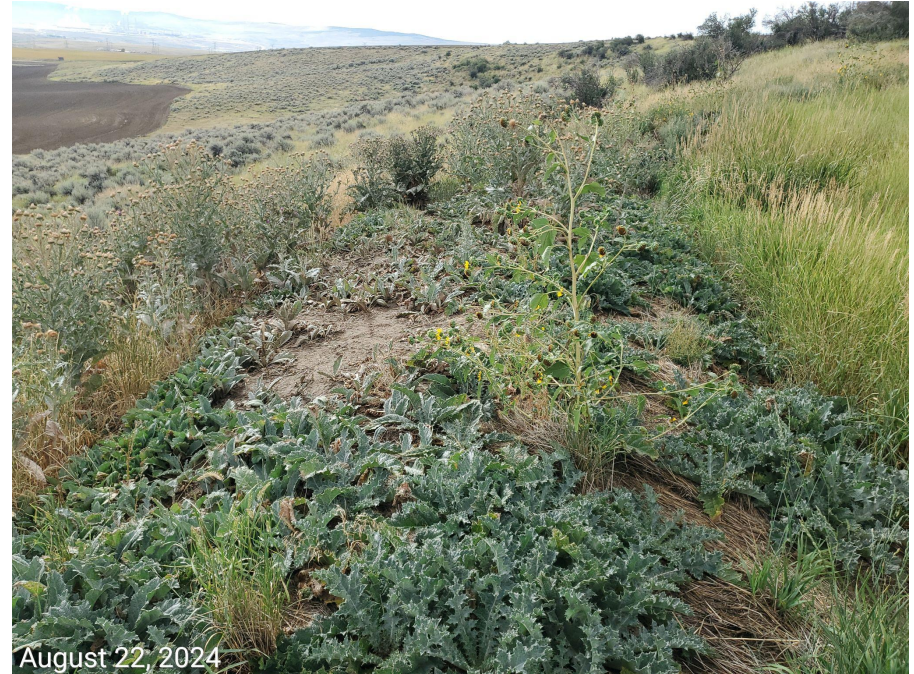
Photo 18: Photos taken from the east end of the Location. Photos show Noxious Weeds (Scotch thistle) have continued to spread and establish on the fill slopes and berms of the Location. Weeds are also spreading onto the adjacent, off-location areas.

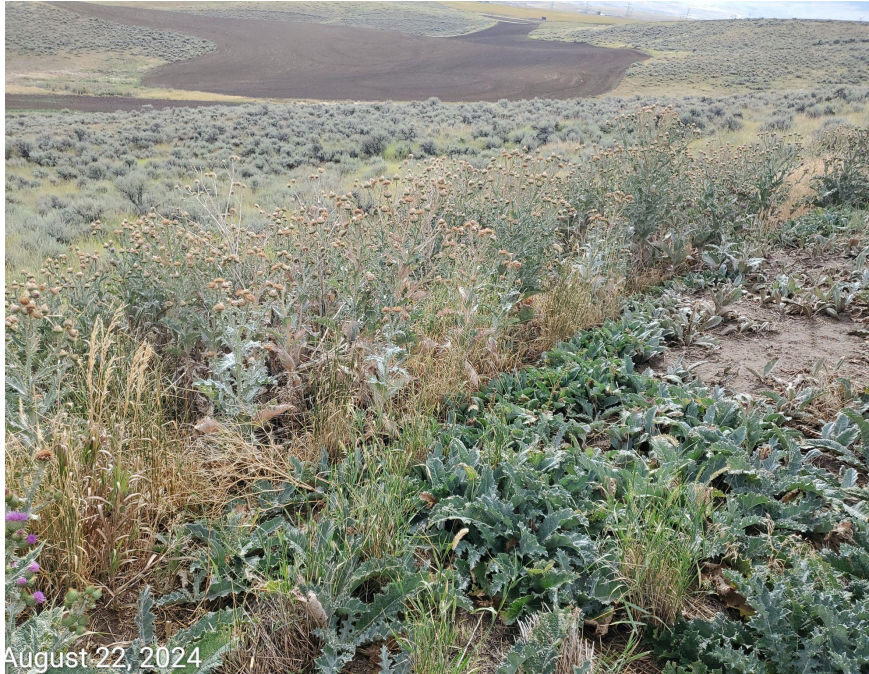
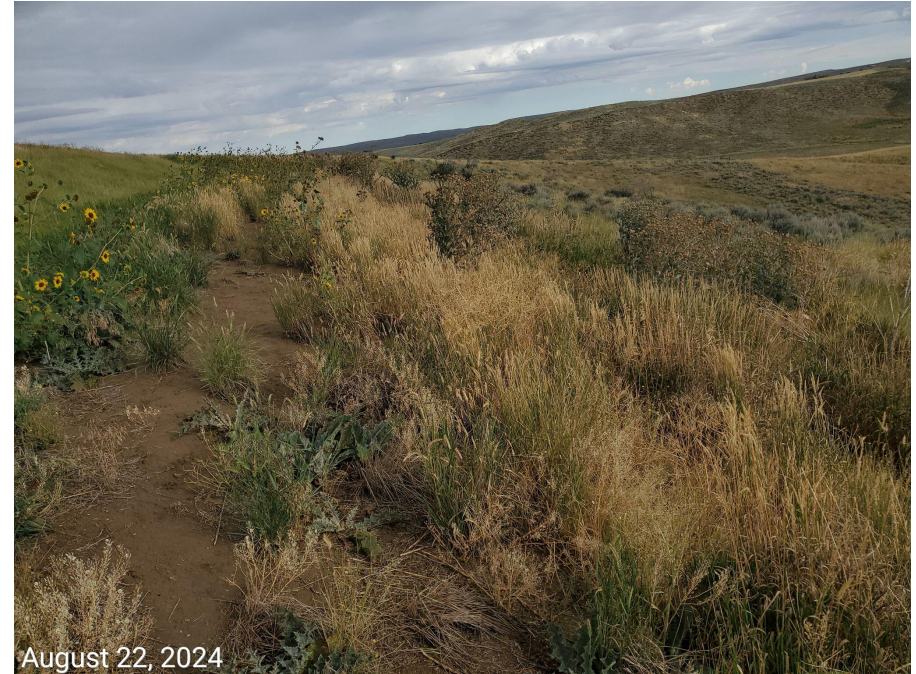
Photo 19: See comments under photo 18.
