Inspection Photos

Operator: BEEMAN OIL & GAS INC - 7125

Location ID: 425419

Inspection Doc: 696206205

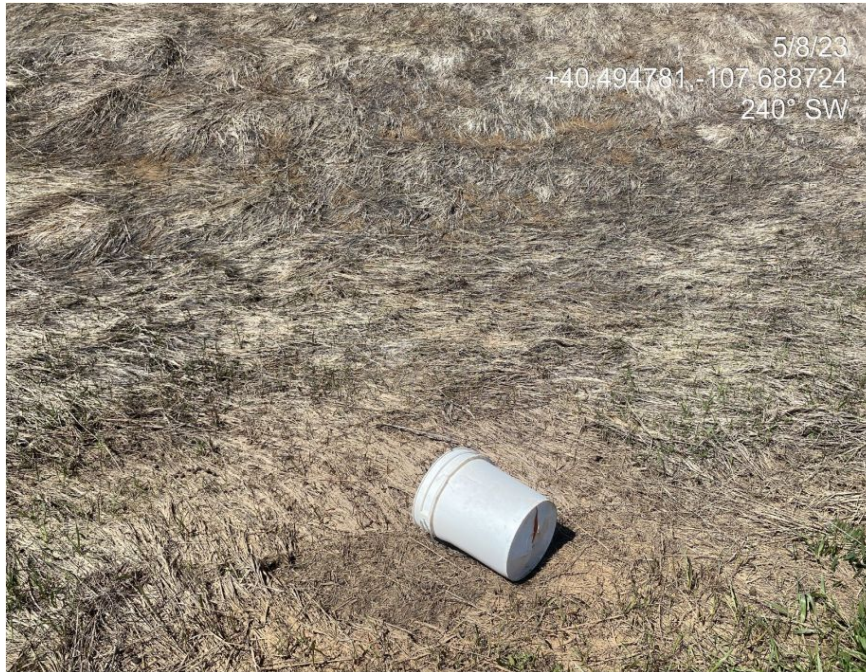
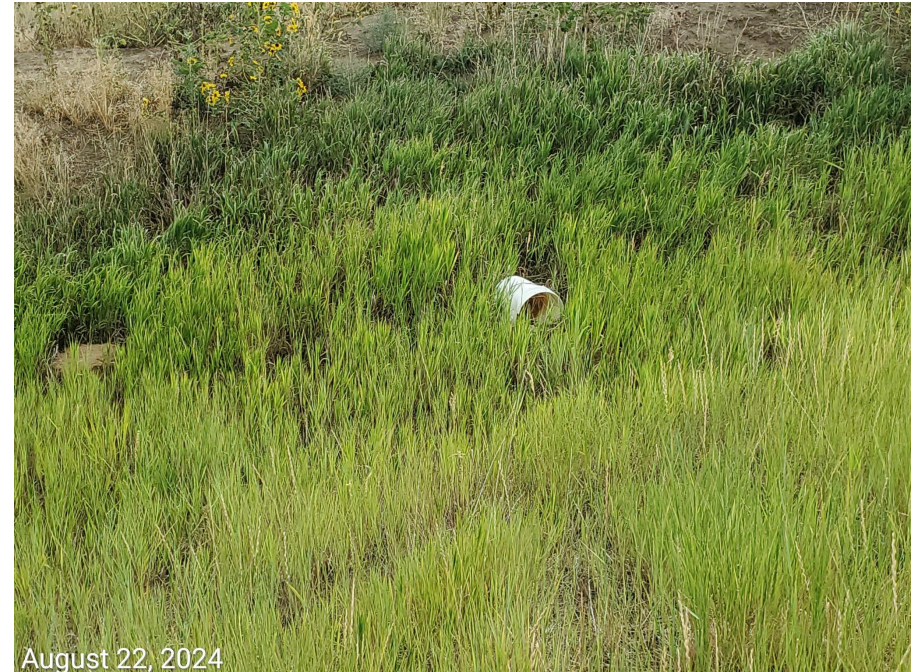
Photo 20: Photo left from the 5/8/2023 inspection. Photo right from the 8/22/2024 inspection. Photo example showing trash debris remaining

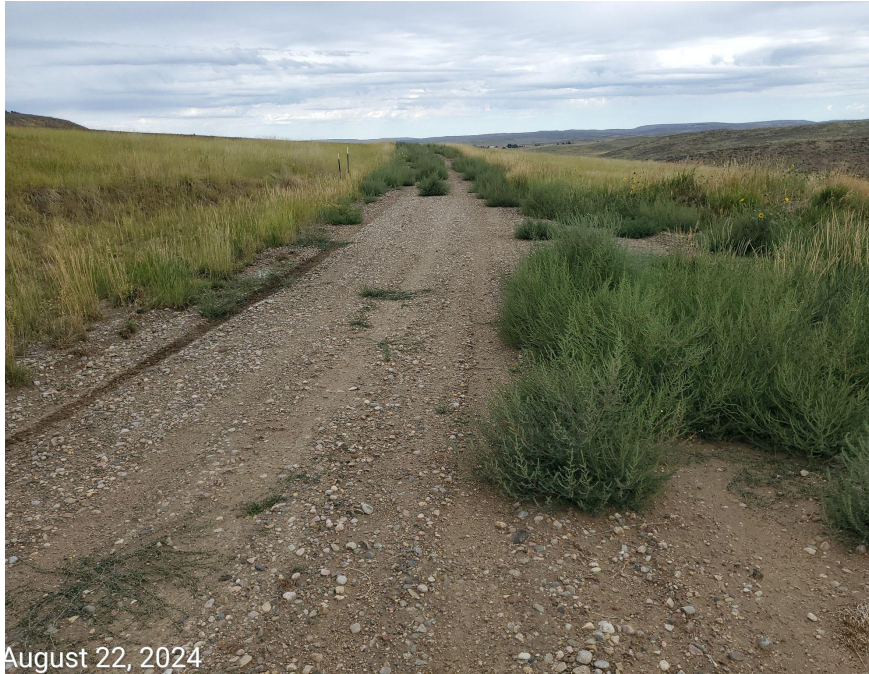
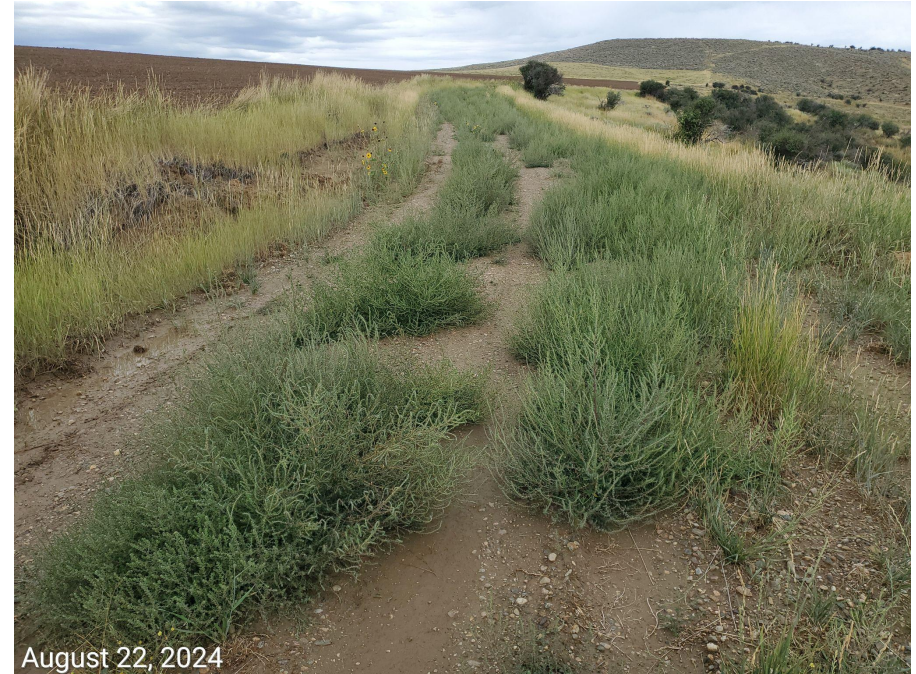
Photo 21: Photos 21-22 taken from the access road. Photos show weeds (Russian thistle, Kochia, Scotch thistle) have continued to spread and establish along the access road.

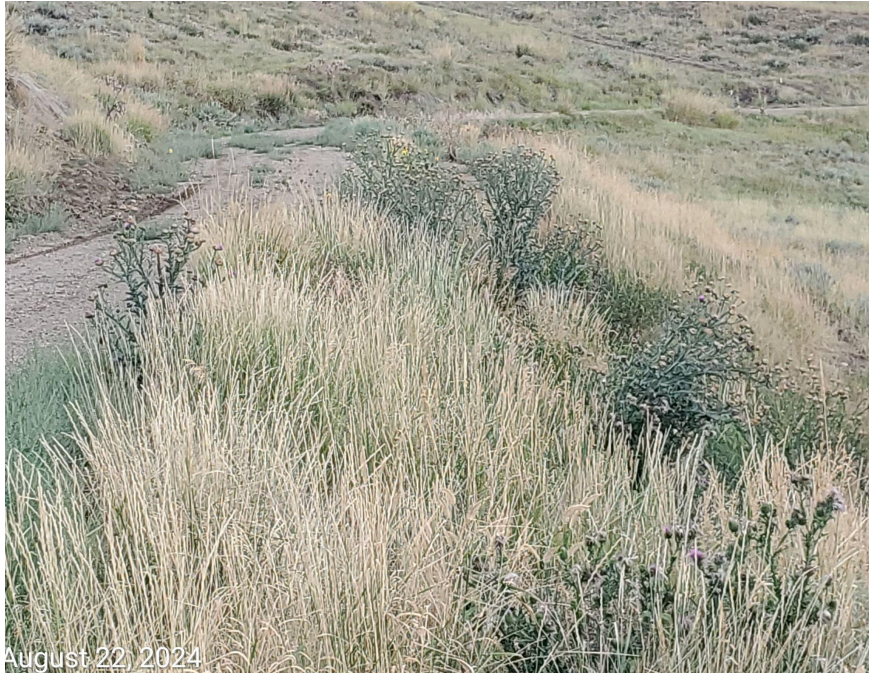
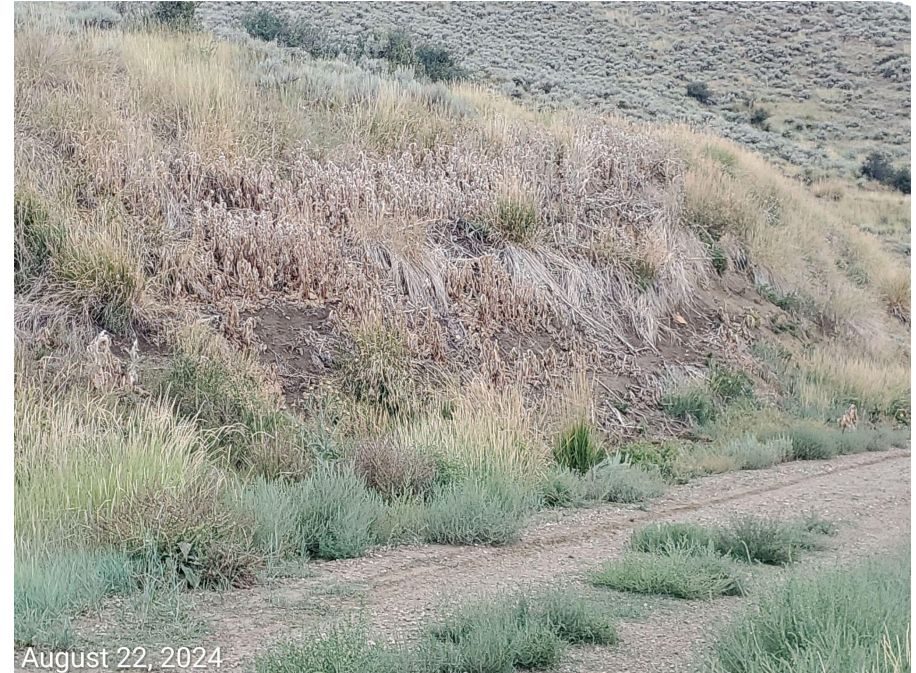
Photo 22: See comments under photo 21.
