**FORM
INSP**

**State of Colorado
Oil and Gas Conservation Commission**

FIELD INSPECTION FORM

Loc ID: 316836 Inspector Name: BROWNING, CHUCK On-Site Inspection: 2A Doc Num: _____

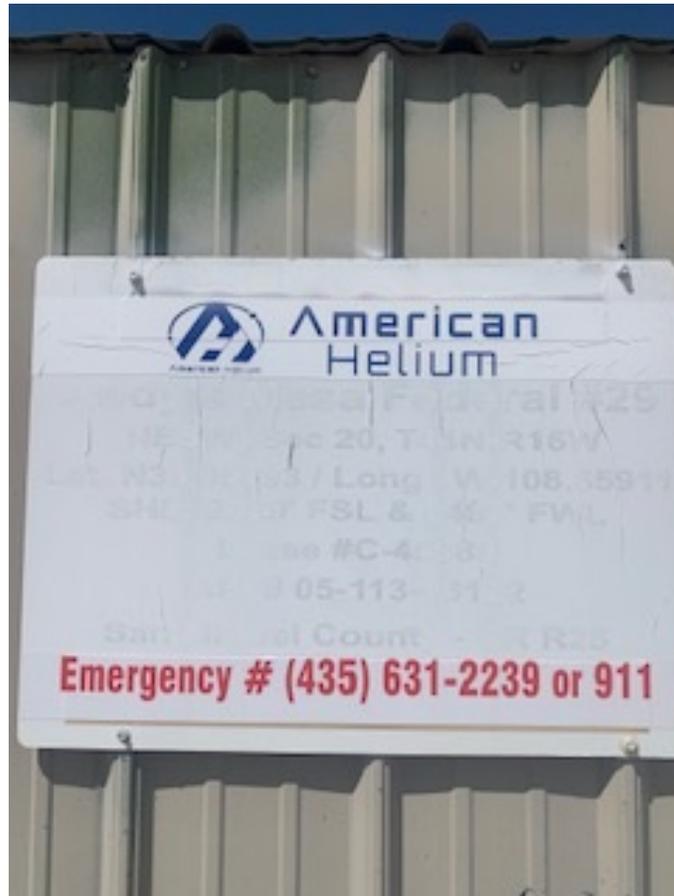
| Location | | | |
|--|--|---|---|
| Comment: | Sign on meter housing. Sign not legible | | |

AM 29 well location ID signage at meter. New Sign on order 9-9-24

Sign on order 9-9-24 for replace. *Danny L White* 9-8-24

| Location | | | |
|--|--|---|---|
| Corrective Action: | Install sign to comply with Rule 605.g | | Date: 09/30/2024 |

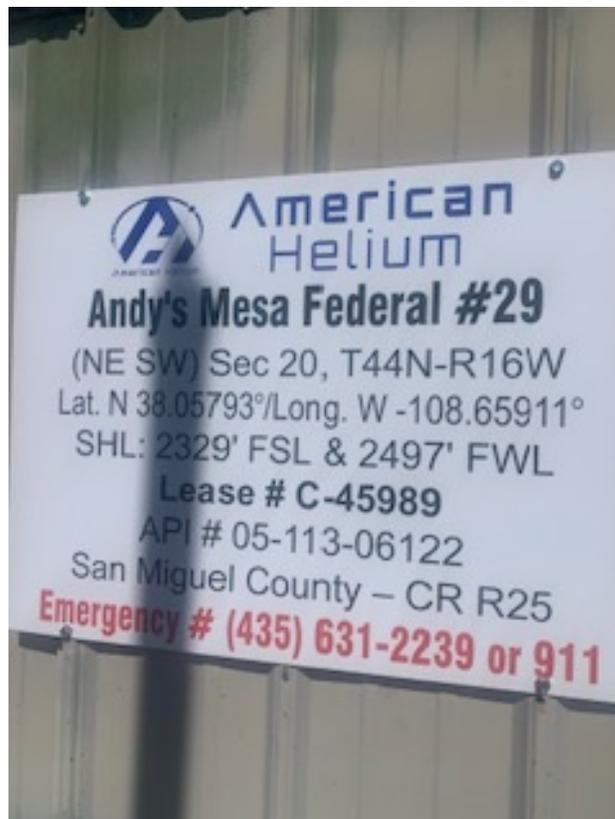
AM 29 location ID signage at Meter replaced 9-10-24

New sign replaced on meter 9-10-24. Please see photo's. *Danny L White* 9-10-24

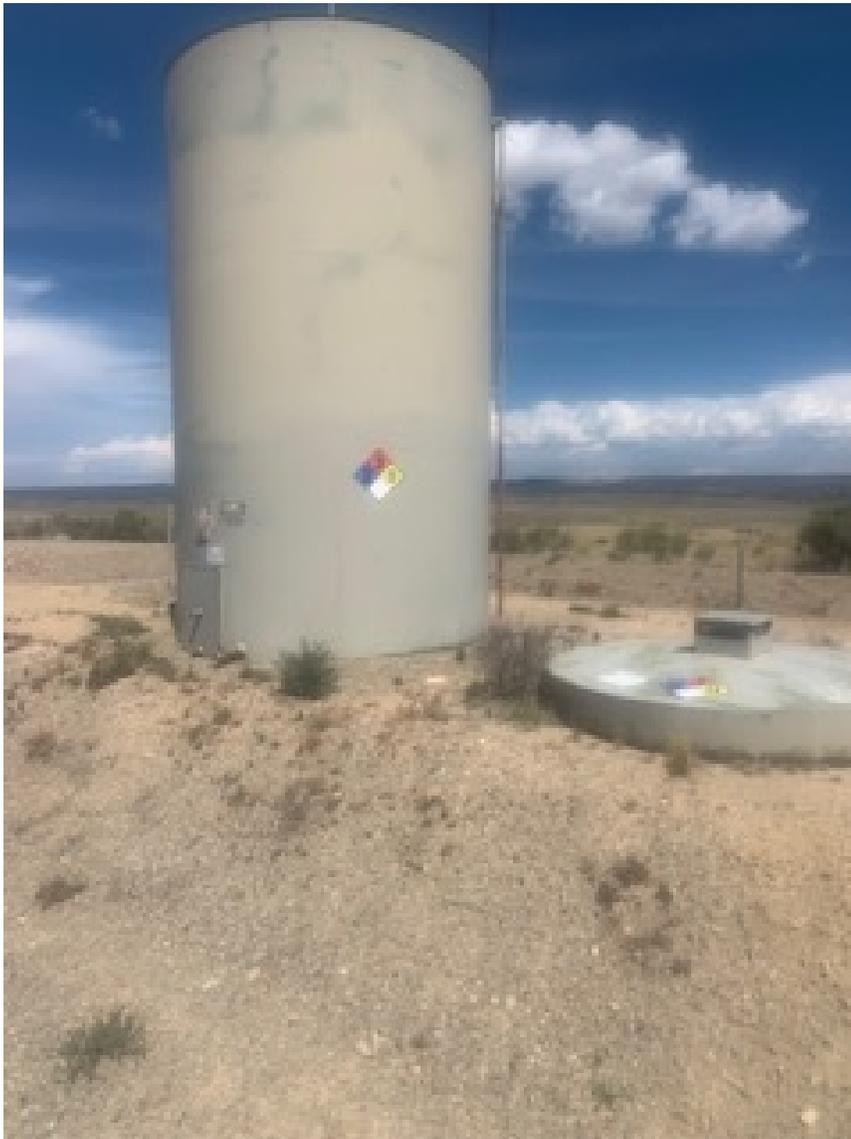
| Location | | | |
|--|--|---|---|
| Comment: | Sign or label not posted or information inaccurate on tanks or containers or sign/label too small to read at distance or installed in place where not visible. | | |

Placards installed on production tanks. 9-10-24

Placards installed on production tanks. 9-10-24. Please see attached photo.

| Location | | | |
|--|--|---|---|
| Corrective Action: | Install sign to comply with Rule 605.h. | | Date: 09/30/2024 |
